Delayed Coker Cutting Derrick Collapse

Presented by Mitch Moloney of **ExxonMobil**

@ Galveston TX coking.com May-2012

Delayed Coker **Partial Derrick Collapse**

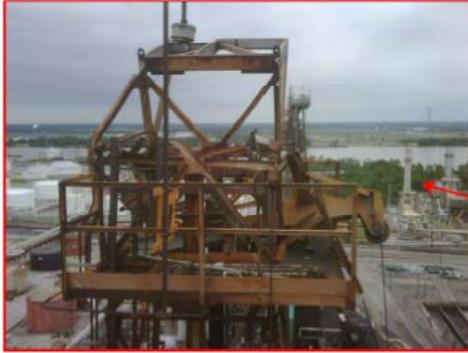
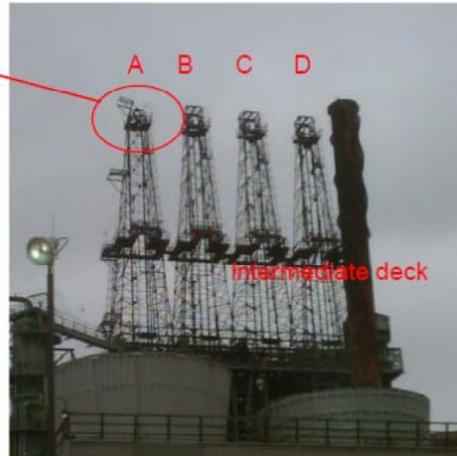
The Damage:

Sunday May 9, at approximately 9 AM the top 8-10 feet of the Coker derrick collapsed while cutting a drum and attempting to free a stuck drill stem.

In addition to the "A" drum, "B" drum was rendered inoperable since the two drums share a common bottom un-heading system. The "A" bottom head was un-headed at the time of the derrick failure.

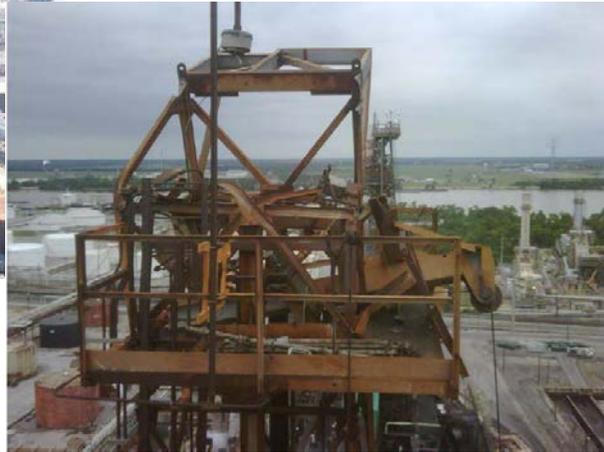
After

At approximately 7:30 AM, it was discovered that the top 8-10 feet of the Coker derrick had collapsed.

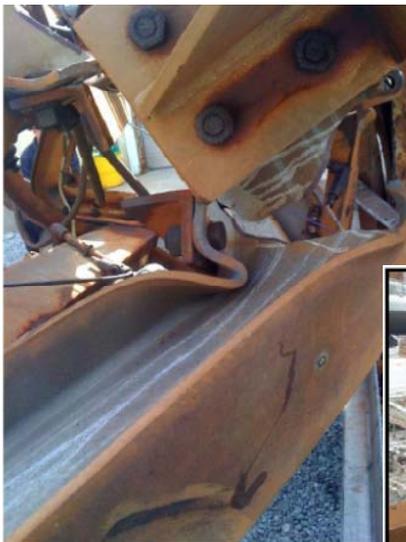
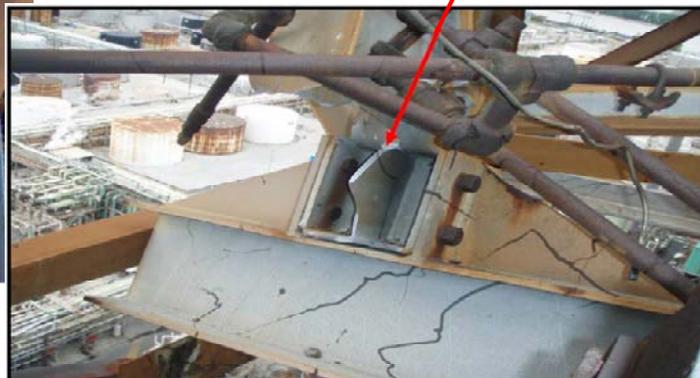
Torn W8 x 24 Beam

The ultimate tensile strength of the W8 x 24 beam was calculated to be on the order of 55k lbs (25k kg) of static load

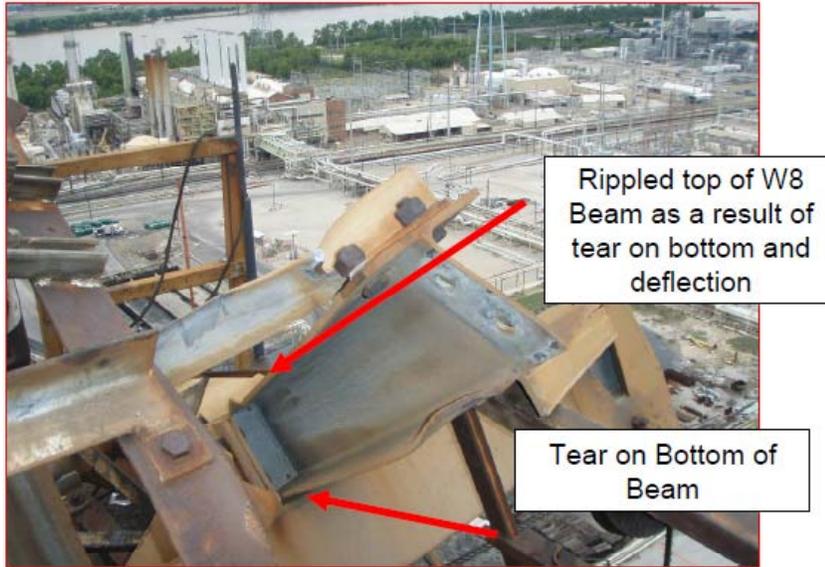
Another Failed W8 x 24 Beam

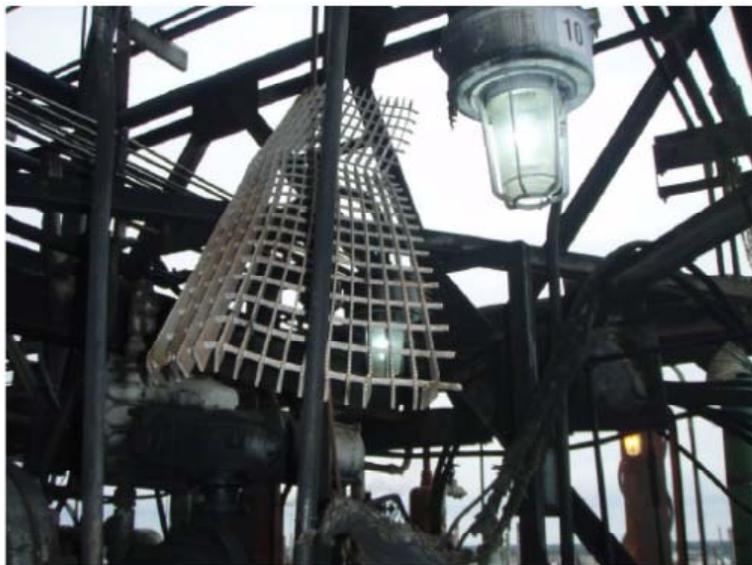
Grating fell 85 ft (26 m) to cutting deck (141 deck)

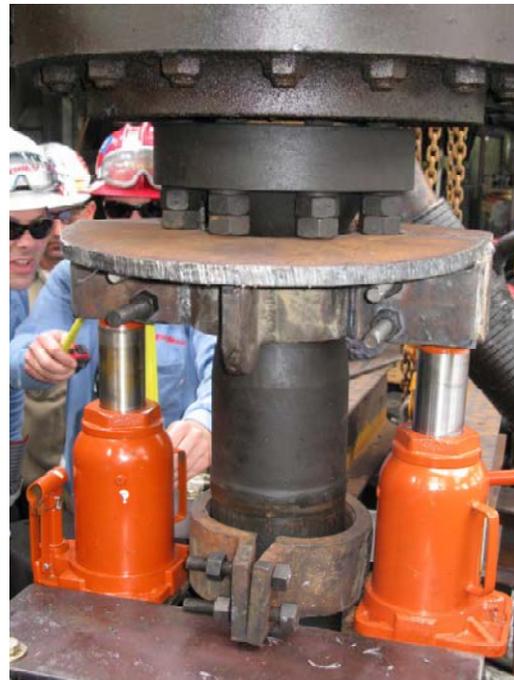
Hydraulic Jacks Photo:

- Two 30 ton jacks installed to lift drill stem
- Effort limited by top deck beam deflection limits & inability to supplement with winch pull, since the top derrick was destroyed.

This coker (Site-1) found that 60,000 lbs (27,000 kg) was maximum load the coke drum structure beams could support. And they did detect beam deflection on the structure when that force was applied.

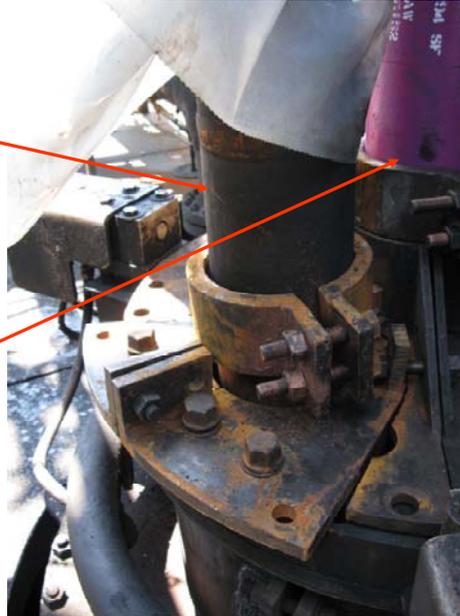
Freeing the Stem - Attempt 2:

Stuck Drill Stem, after detaching from rotary joint, was clamped to Side

Second drill stem provided to cut coke from bottom.

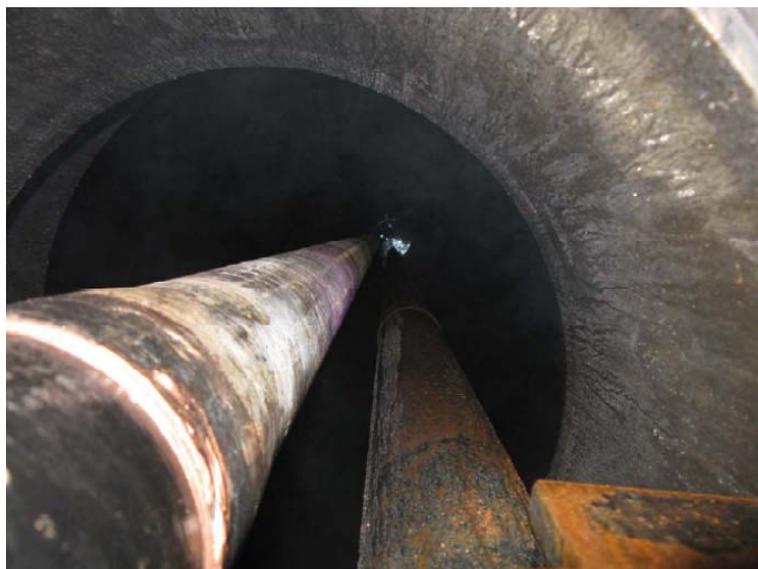
Attempt 2 Successful:

View down the hole, after 2nd drill stem cut through the coke

The majority of coke had fallen through when the cone area was being enlarged.

The partially coked resid had stuck in that lower area. The second drill stem allowed the coke to be cut into the pit.

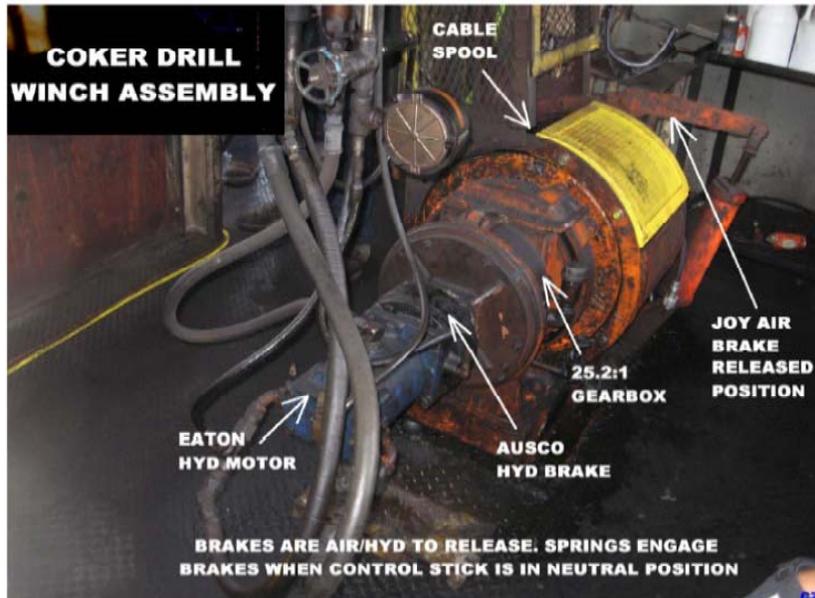
The winch brakes worked (no disc/rotor burns). Sheaves all in proper position.

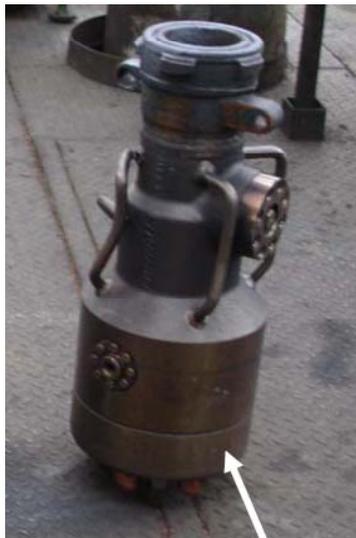
The new, sleek 13-inch (33 cm) diameter RuhrPumpen tools were in place
