Coker Vessel Life Extension Repair Implementation

REFCOMM
BAHRAIN 2015

Delayed Coker Unit Karlsruhe Germany

Coke drum D-001 B

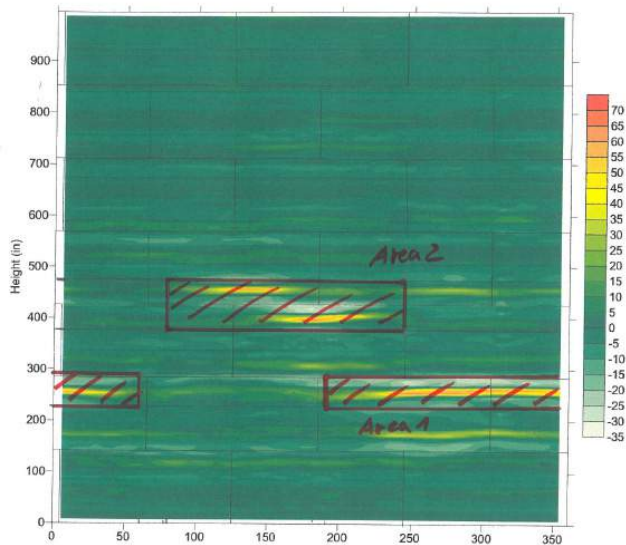
- Plastic Strain Index Study performed
- 2 bulge repair areas defined
 - #1 23m2
 - #2 27m2
- Design required additional structural thickness:
 - 0.56" (14.3mm)

Contour plot of the Plastic Strain Index (PSI) looking from the outside of the drum

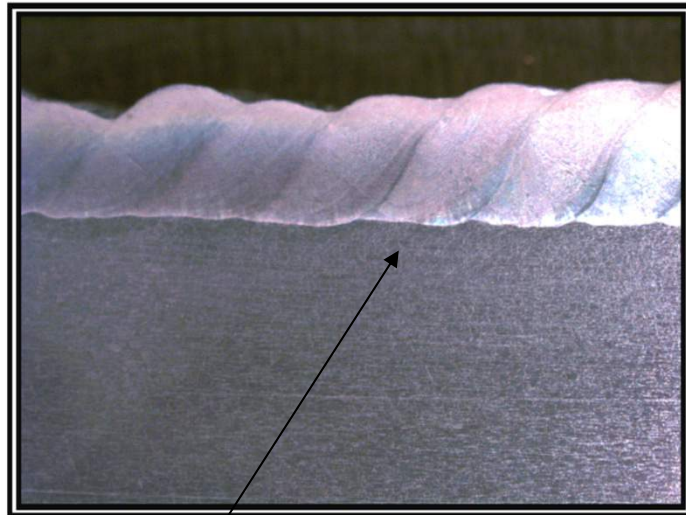
HAZ created by 1st weld layer

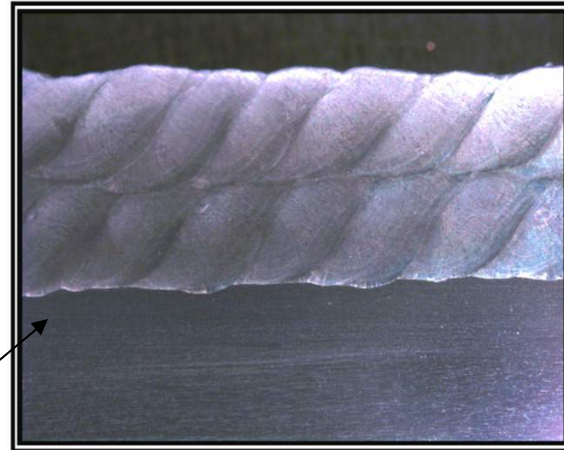
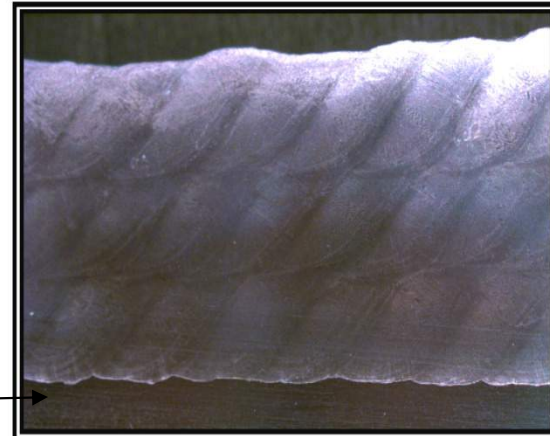
HAZ is tempered by deposition of successive layers

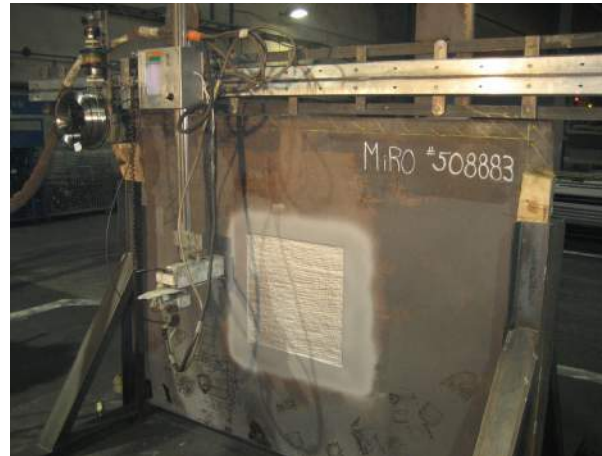
Removal of bonded cladding

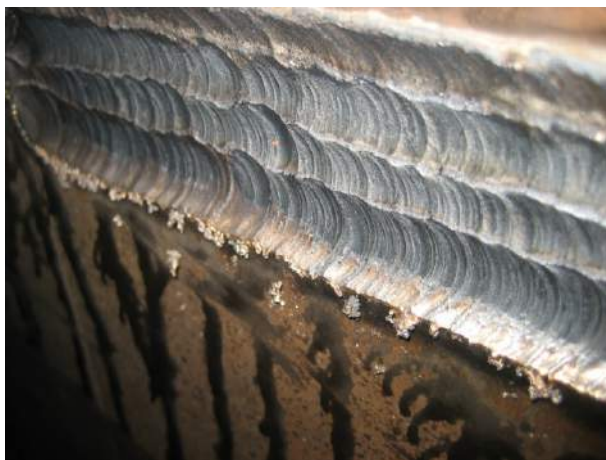
*“Skim” gouging with Carbon Electrodes
2-3mm thickness removed*

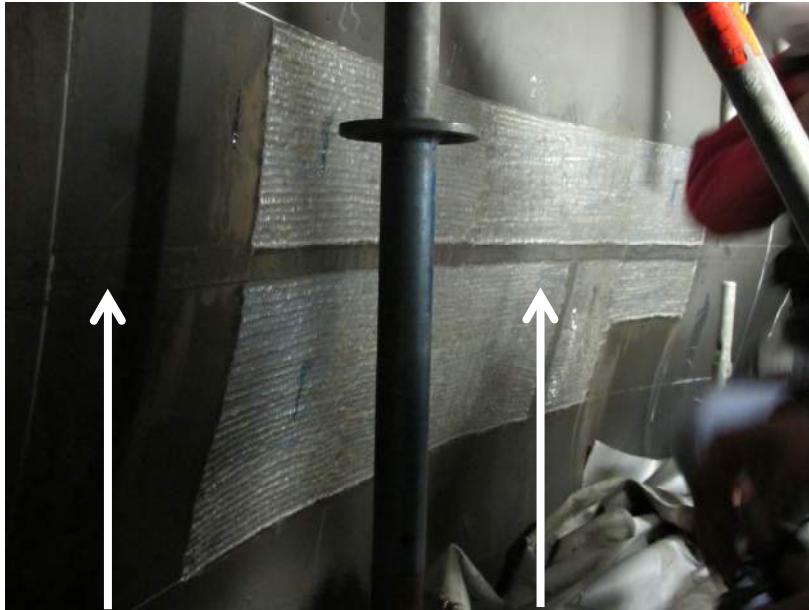
*Surface "prepped"
410 cladding*

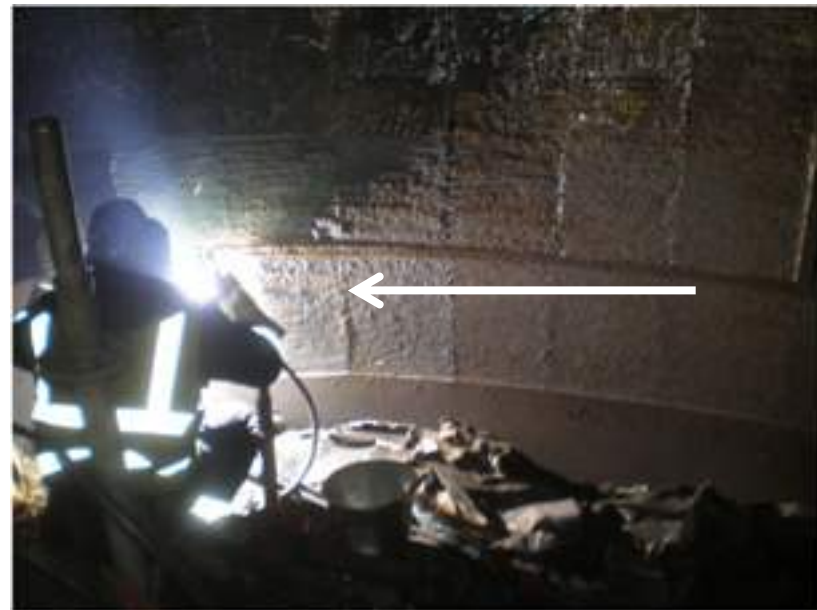
Gouging in process 2 – 3 mm material removed
