Extending the Creep Life of a High Temperature Refinery Reactor

Gerald W. Wilks
Lemont Refinery
CITGO Petroleum Inc.

Topics Covered in this Presentation

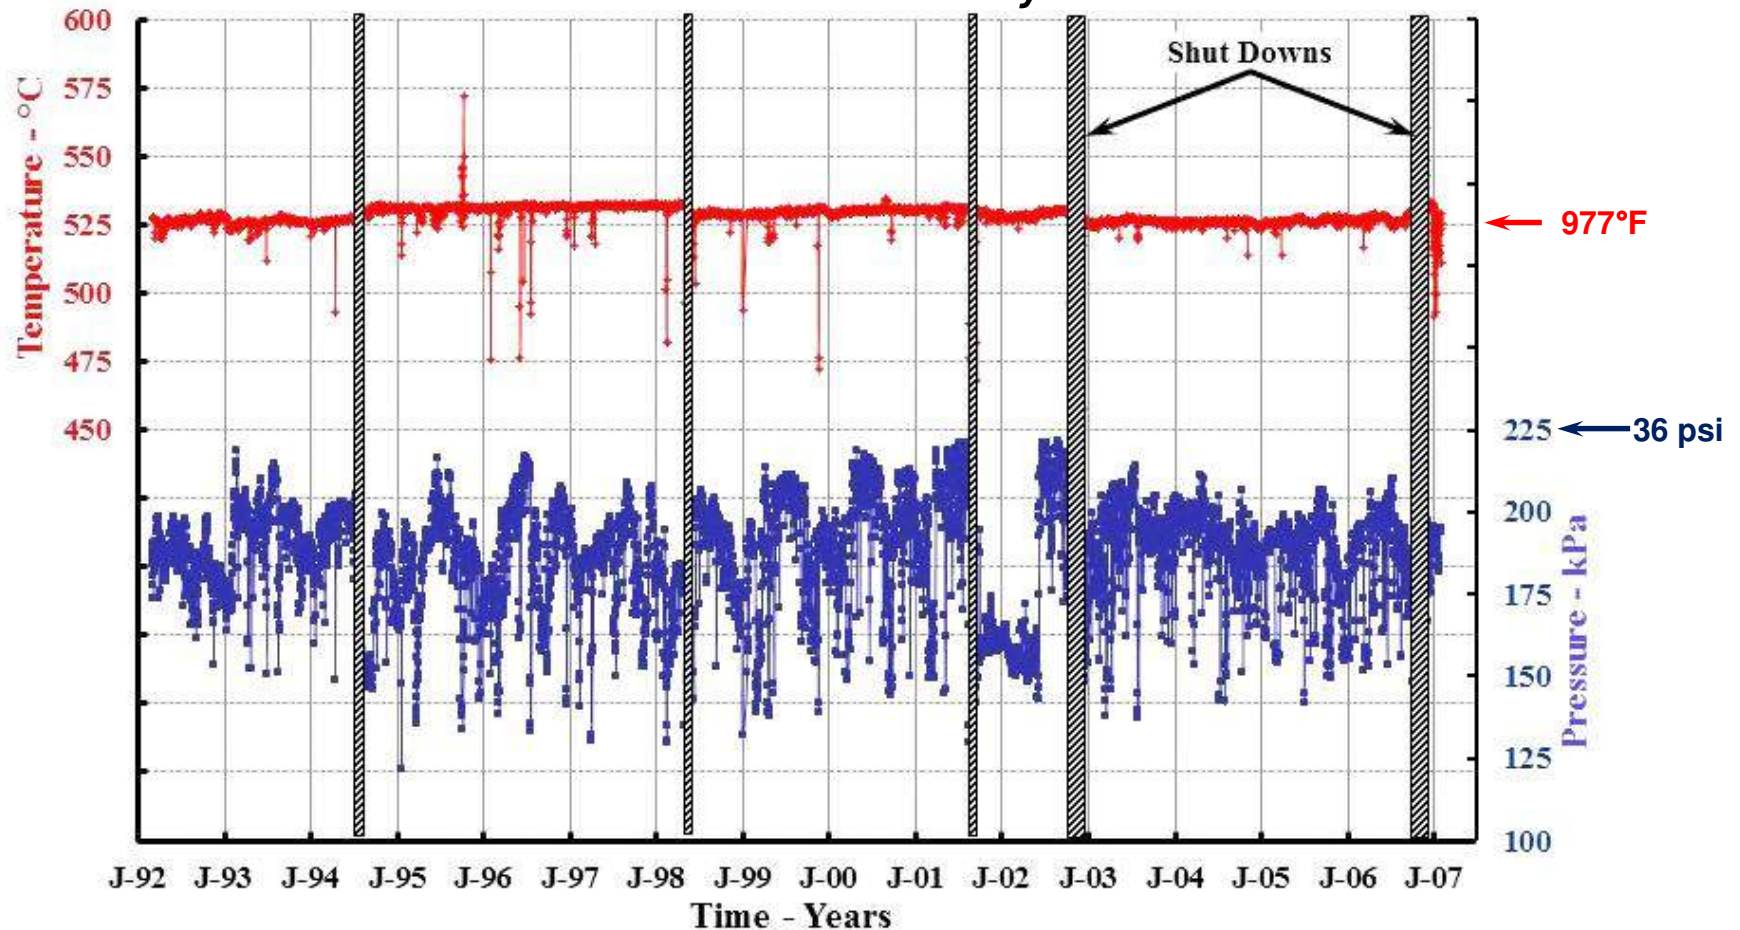
Daily Average Reactor Temperature and Pressure From March 1992 to January 2007

The pressure changes introduce the possibility that fatigue could influence creep life.

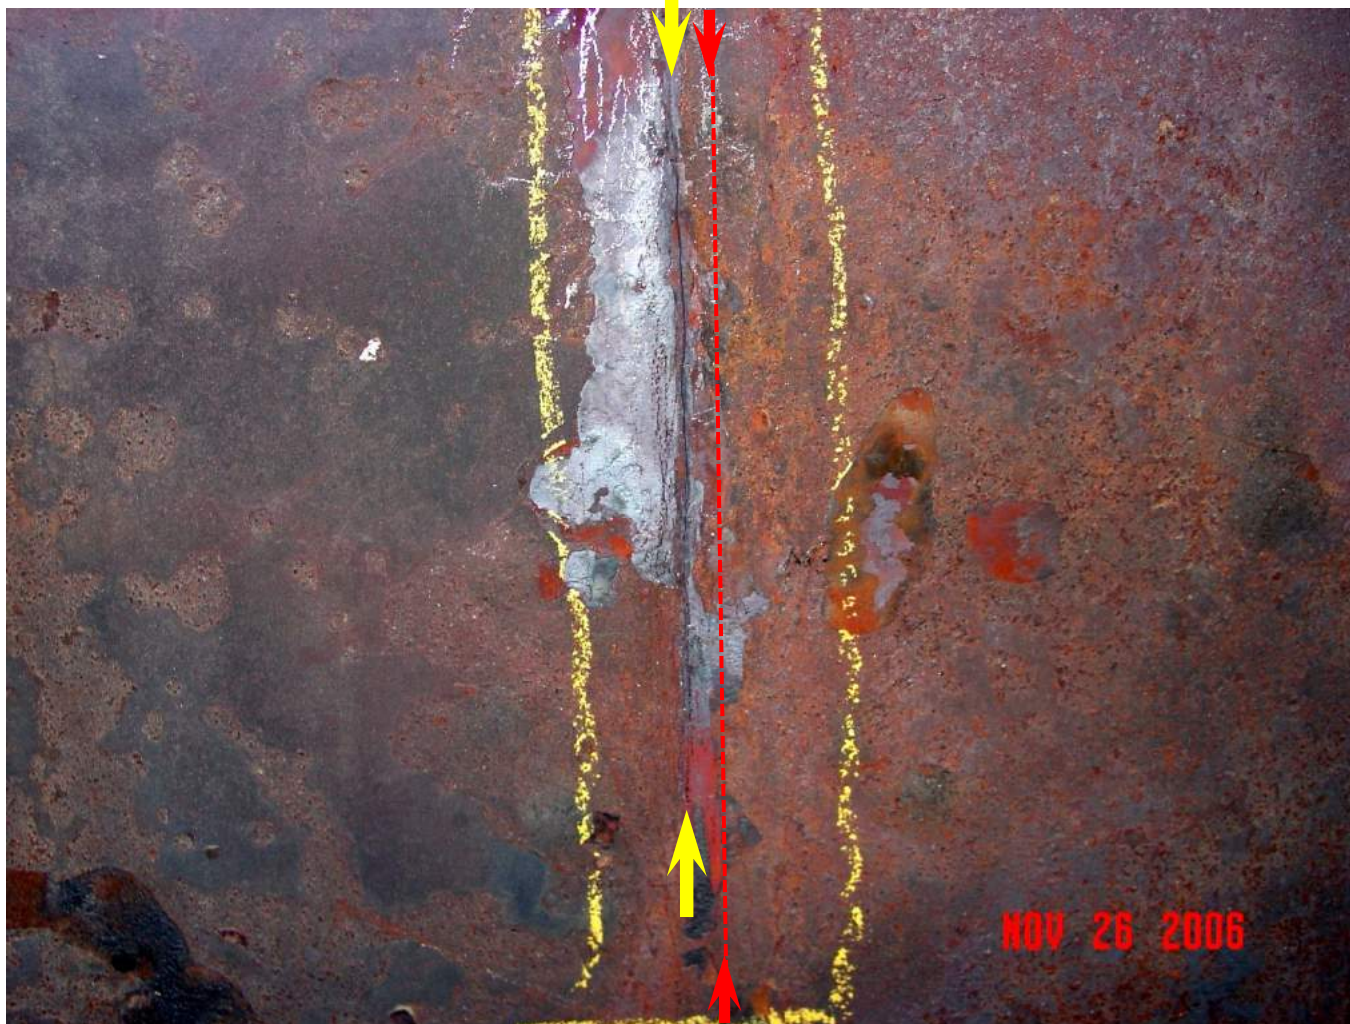
The 2006 Crack Along the Weld Toe

The creep crack is between
the yellow arrows

The weld center line is at the dashed
red line between the red arrows

- All vertical seams were UT shearwave inspected
- Defects and cracks were present all along the ruptured seam
- No defects were found in other weld seams
- Cracks were ground out.
- The cracked seam was rewelded with N06625
- GTAW process - temper bead technique
- No post weld heat treatment

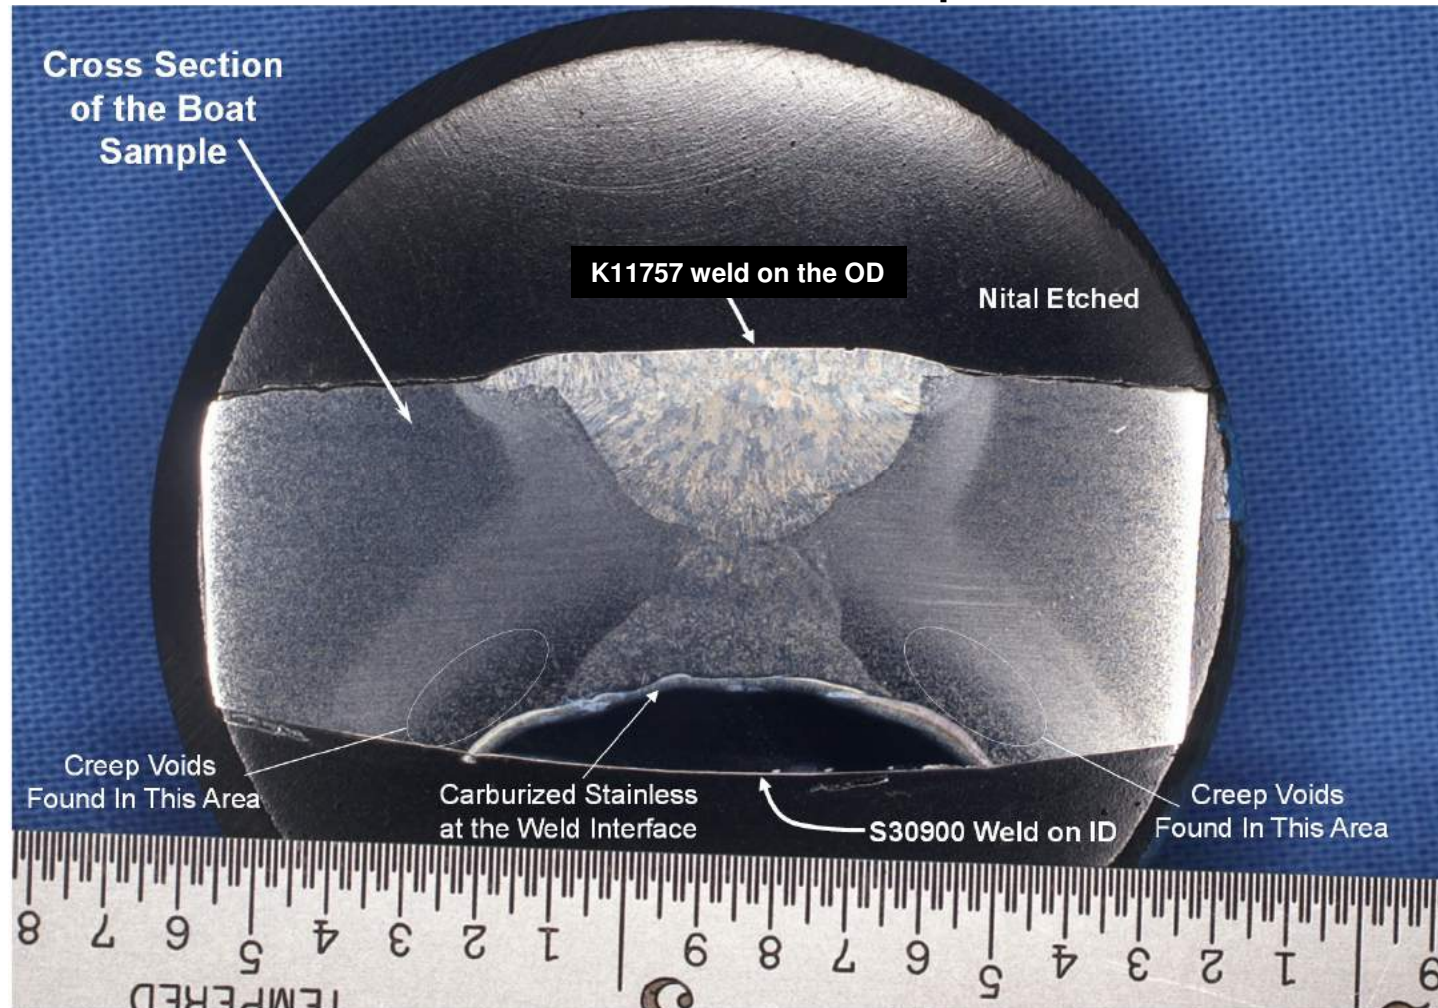
Vertical Weld Seam Boat Sample

Located 1.5 m from the rupture

The S30900 stainless on the ID was thicker than it should have been.

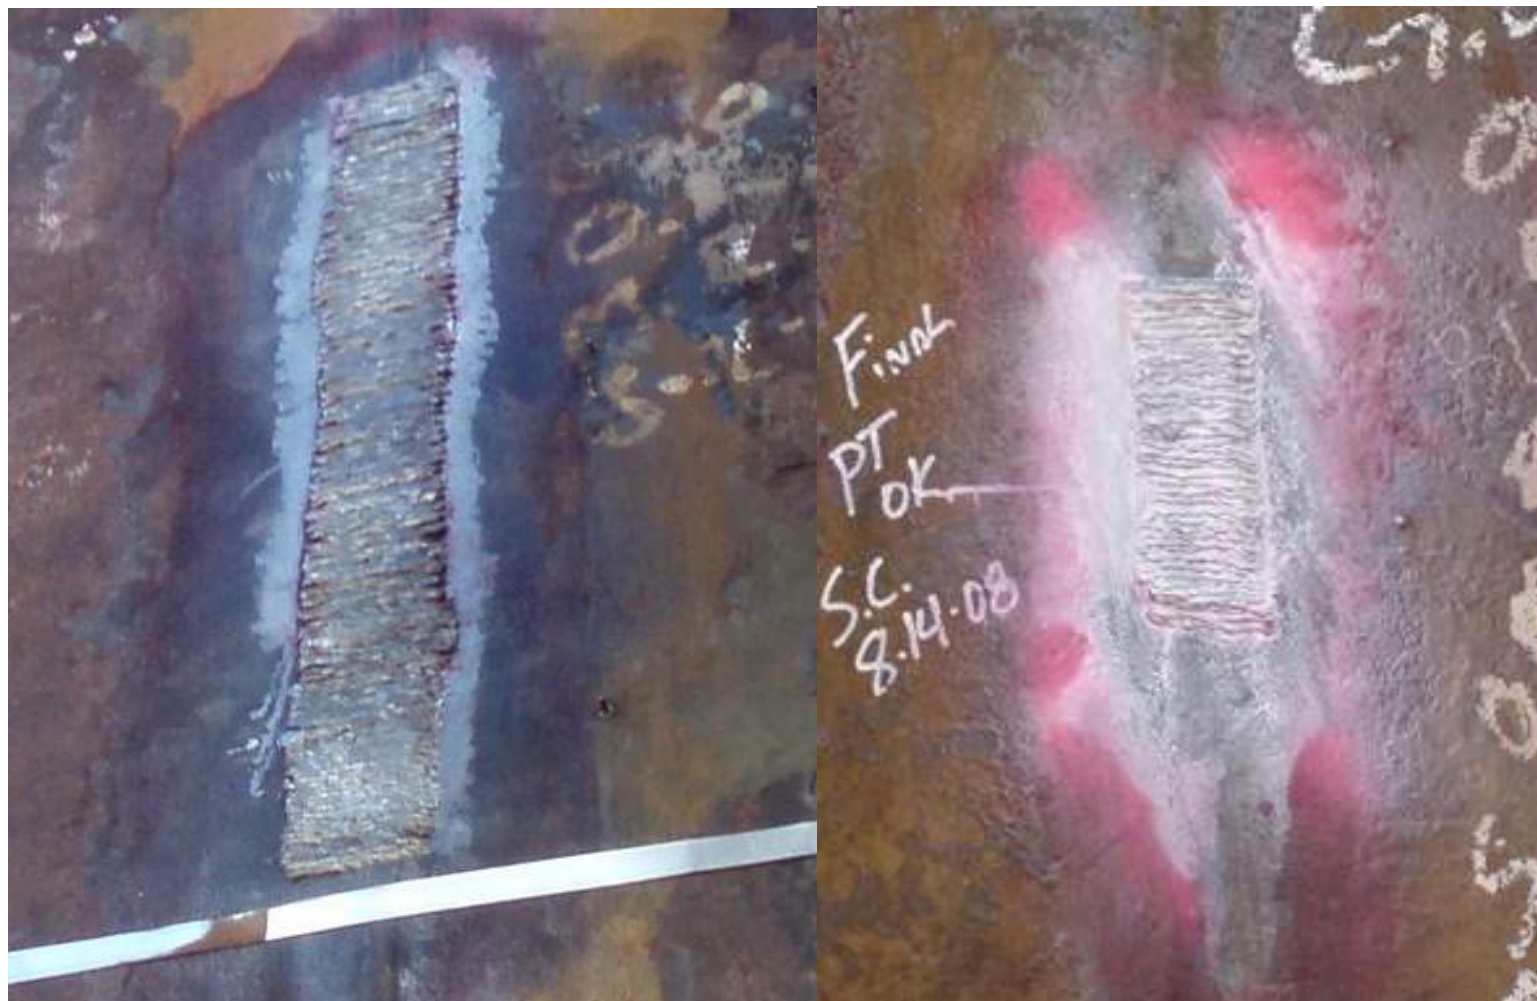
Weld Overlay Repairs in 2008

- In 2008 the unit was shut down due to regenerator problems making the reactor available
- UT inspections found defects in three vertical seams
- The defects had characteristics indicating they were creep cracks – indicating near end of life
- New repair technique tested - weld overlaying with N06625 – Inconel 625
- Weld overlay repairs:
 - SMAW process
 - Temper bead technique
 - No post weld heat treatment

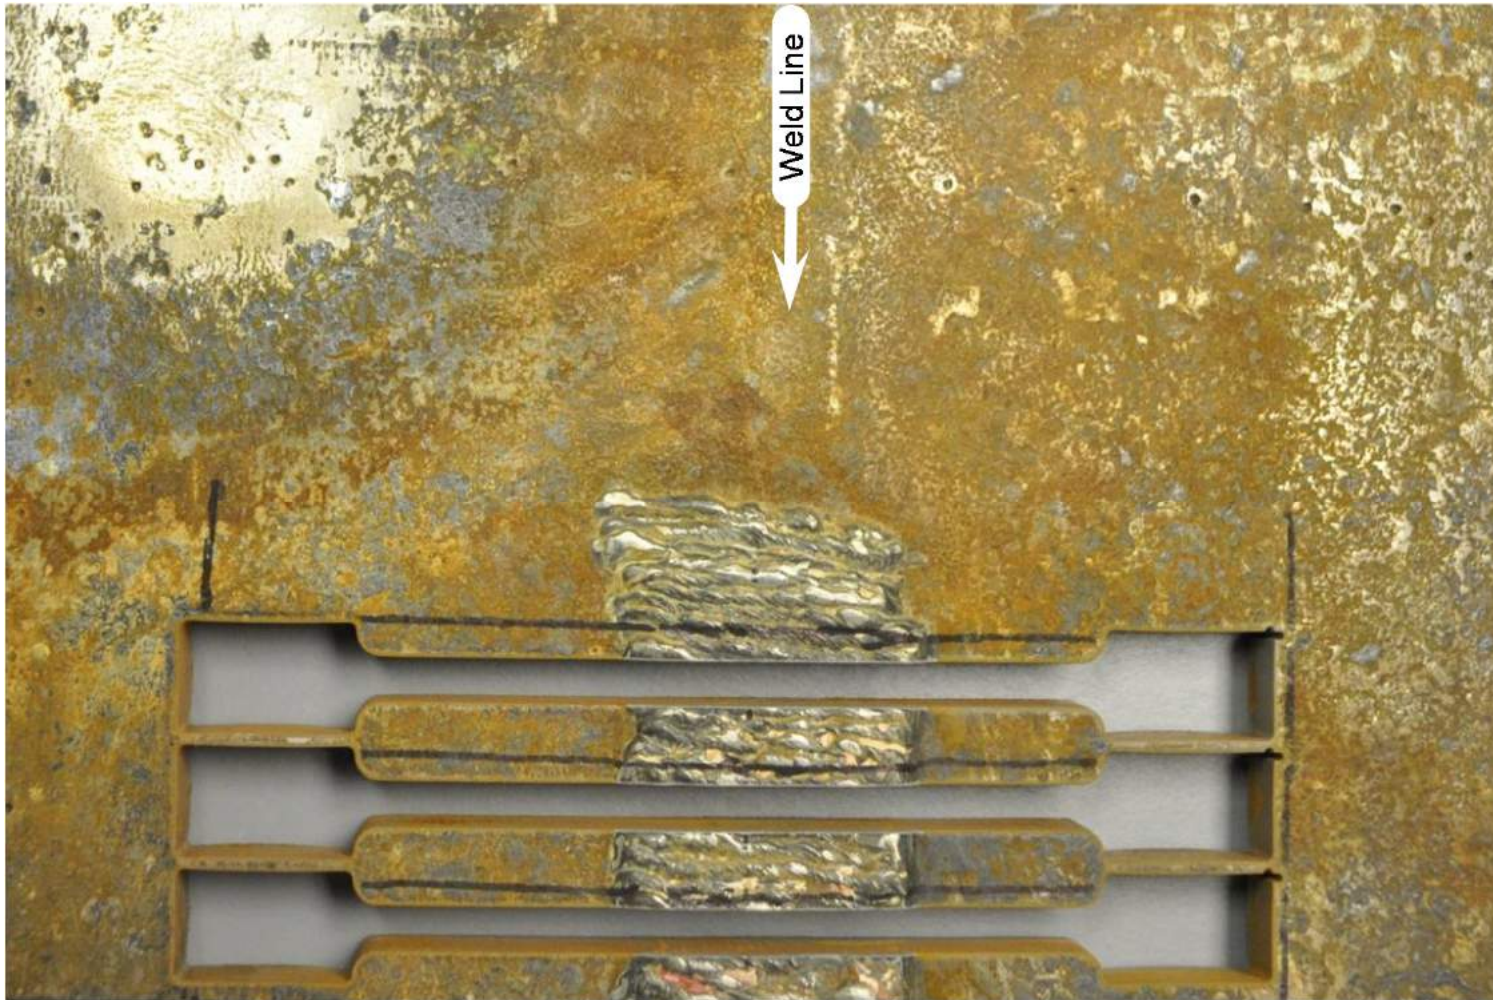
Creep Samples Cut Through the Weld Repairs

- 2008 weld overlay repairs were cut out, UT inspected, and creep tested
- Existing cracks had not grown in 2 years
- Weld overlay repairs had increased creep life relative to wall samples
- Creep specimens failed outside of the overlays
- Samples of distorted areas were cut out, inspected and creep tested
- Bulged and flattened areas had lower remaining life than undistorted wall

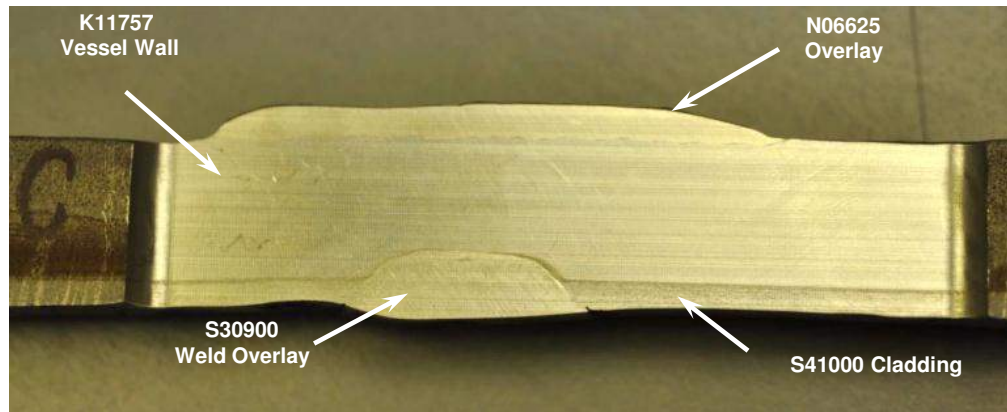
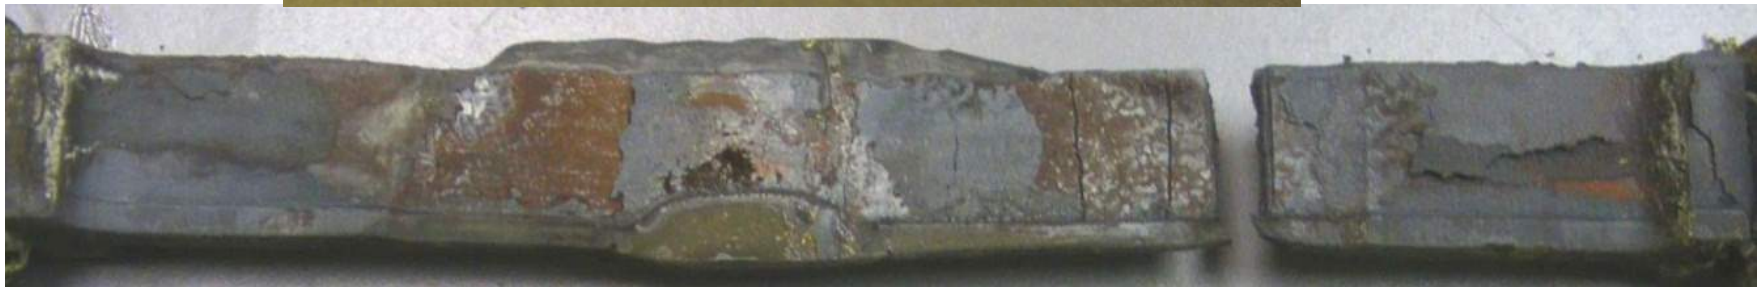
The Results of Creep Testing

All of the weld overlaid samples fractured outside of the weld overlaid areas.

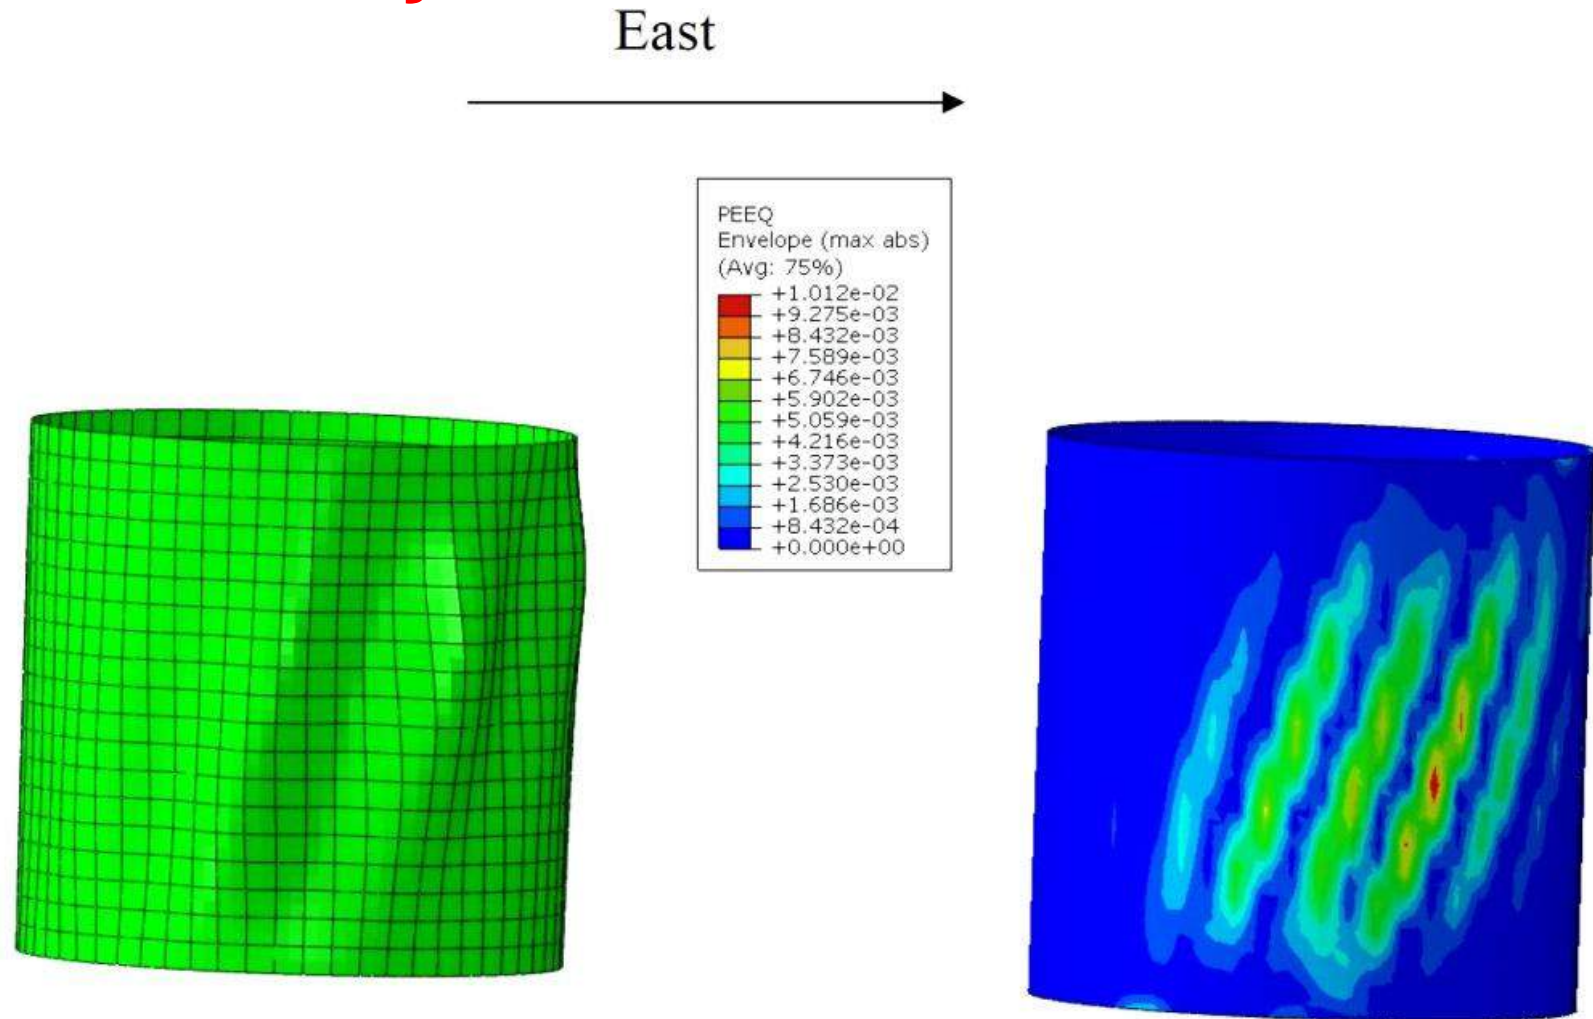
Analysis of Vessel Distortion

3D finite element analysis modeling revealed that minor bulges and flat areas were caused by the applied weight and wind loads.

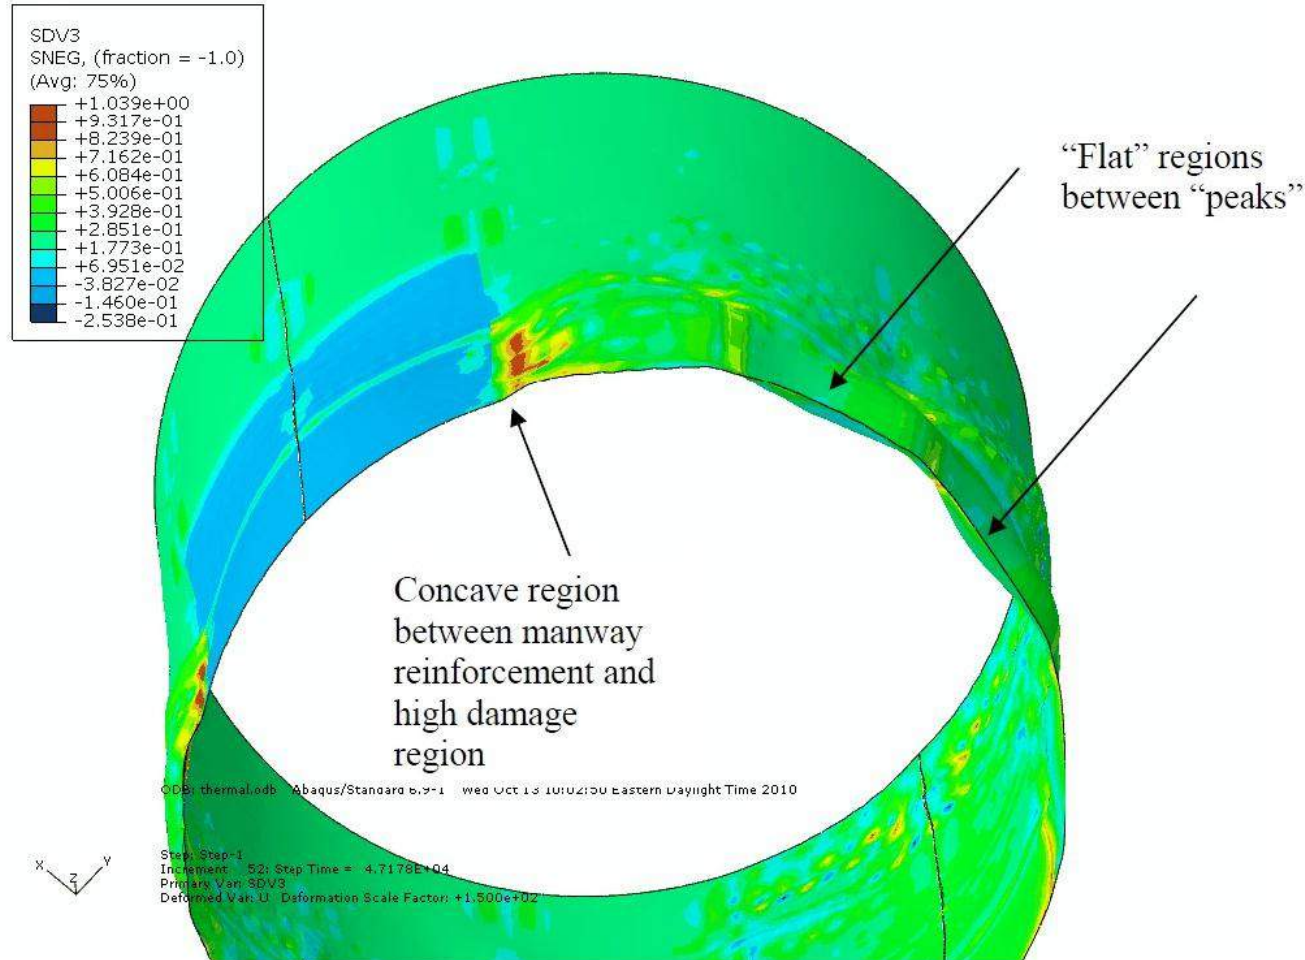
Localized Distortion Caused by Insulation Removal

Larger flat areas and bulges were caused by rapid removal of insulation that occurred in 2008 and 2010. The highest stress was near the manway.

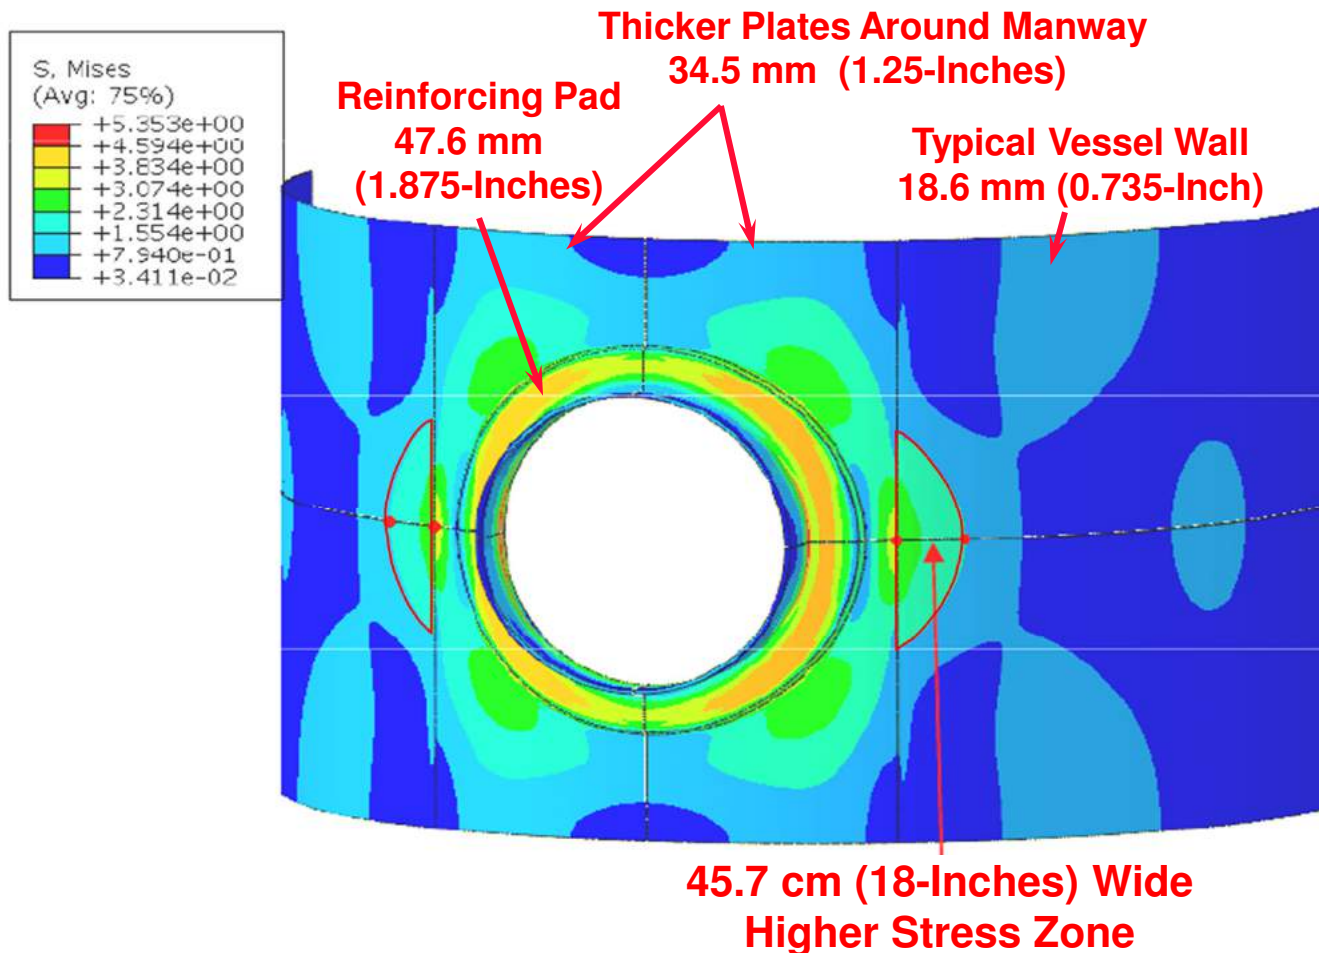
Thermal Stresses Around the Manway During Rapid Start-ups

3D finite element analysis indicated that rapid heating could produce 15.9-26.2 MPa (2.3-3.7 ksi) higher stress in zones adjacent to the manway reinforcing plates.

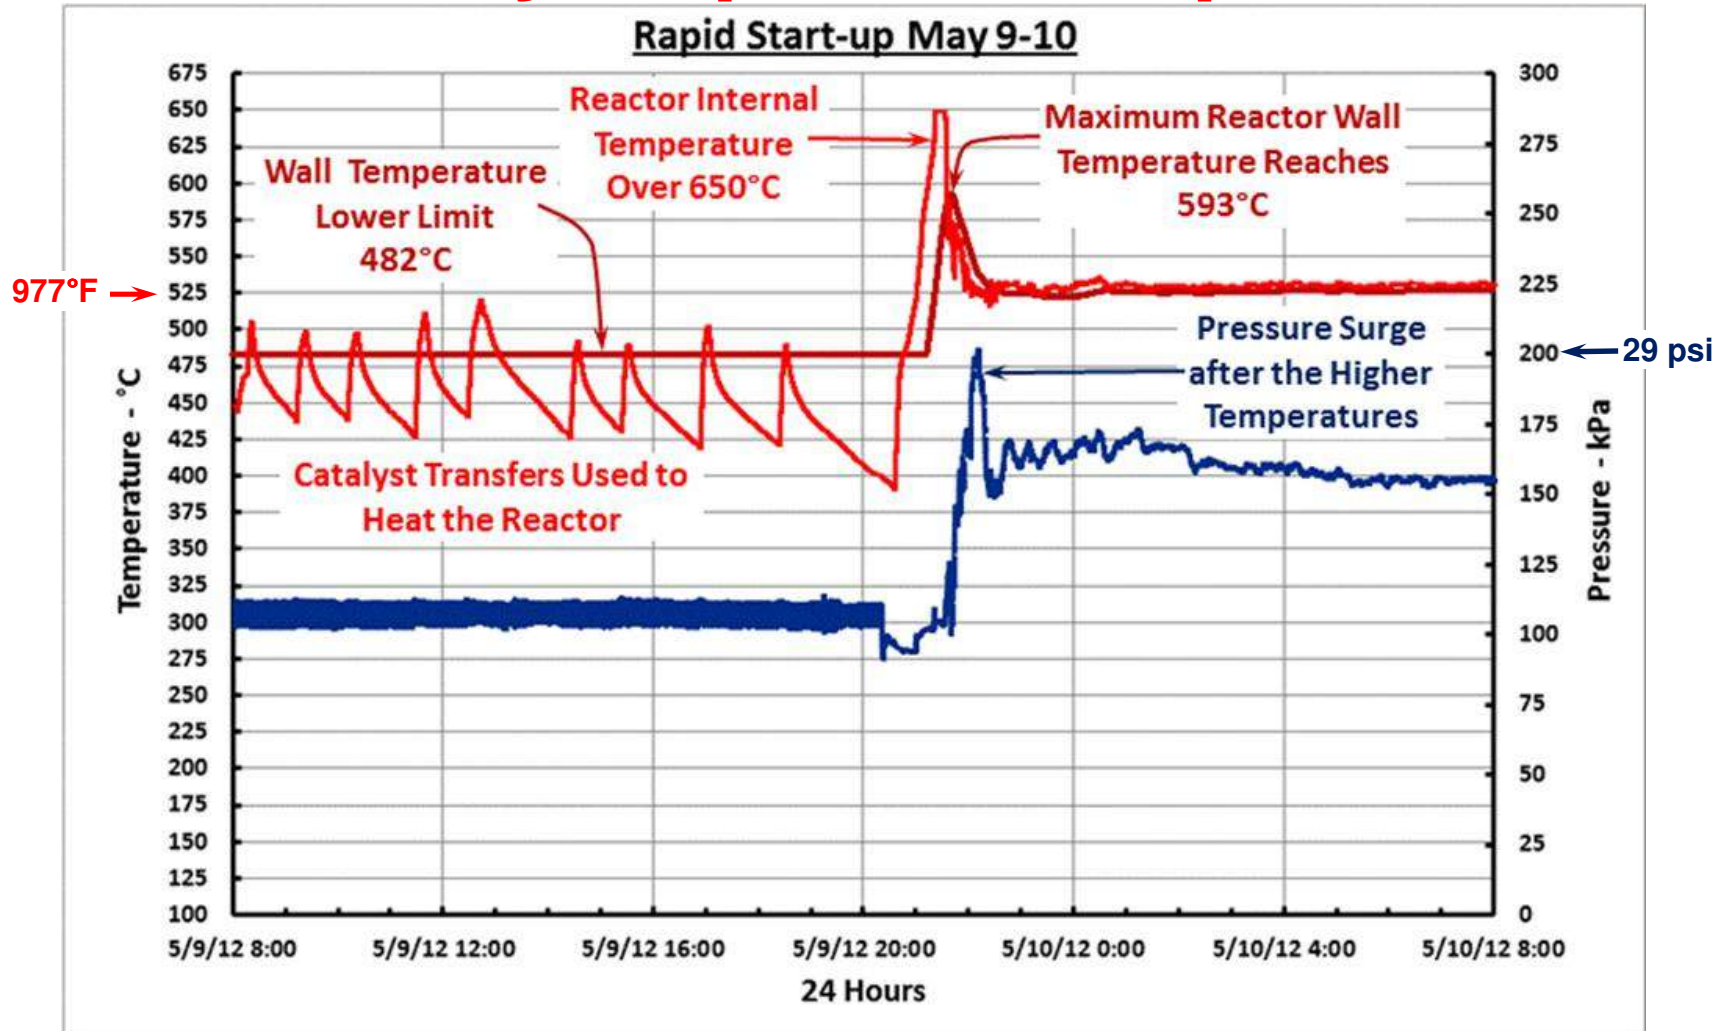
Unusually Rapid Start-up in 2012

Past rapid start-ups resulted in cracking 6-15 cm (2-6 Inches) away from the welds in the high stress zones surrounding the manway reinforcing plate.

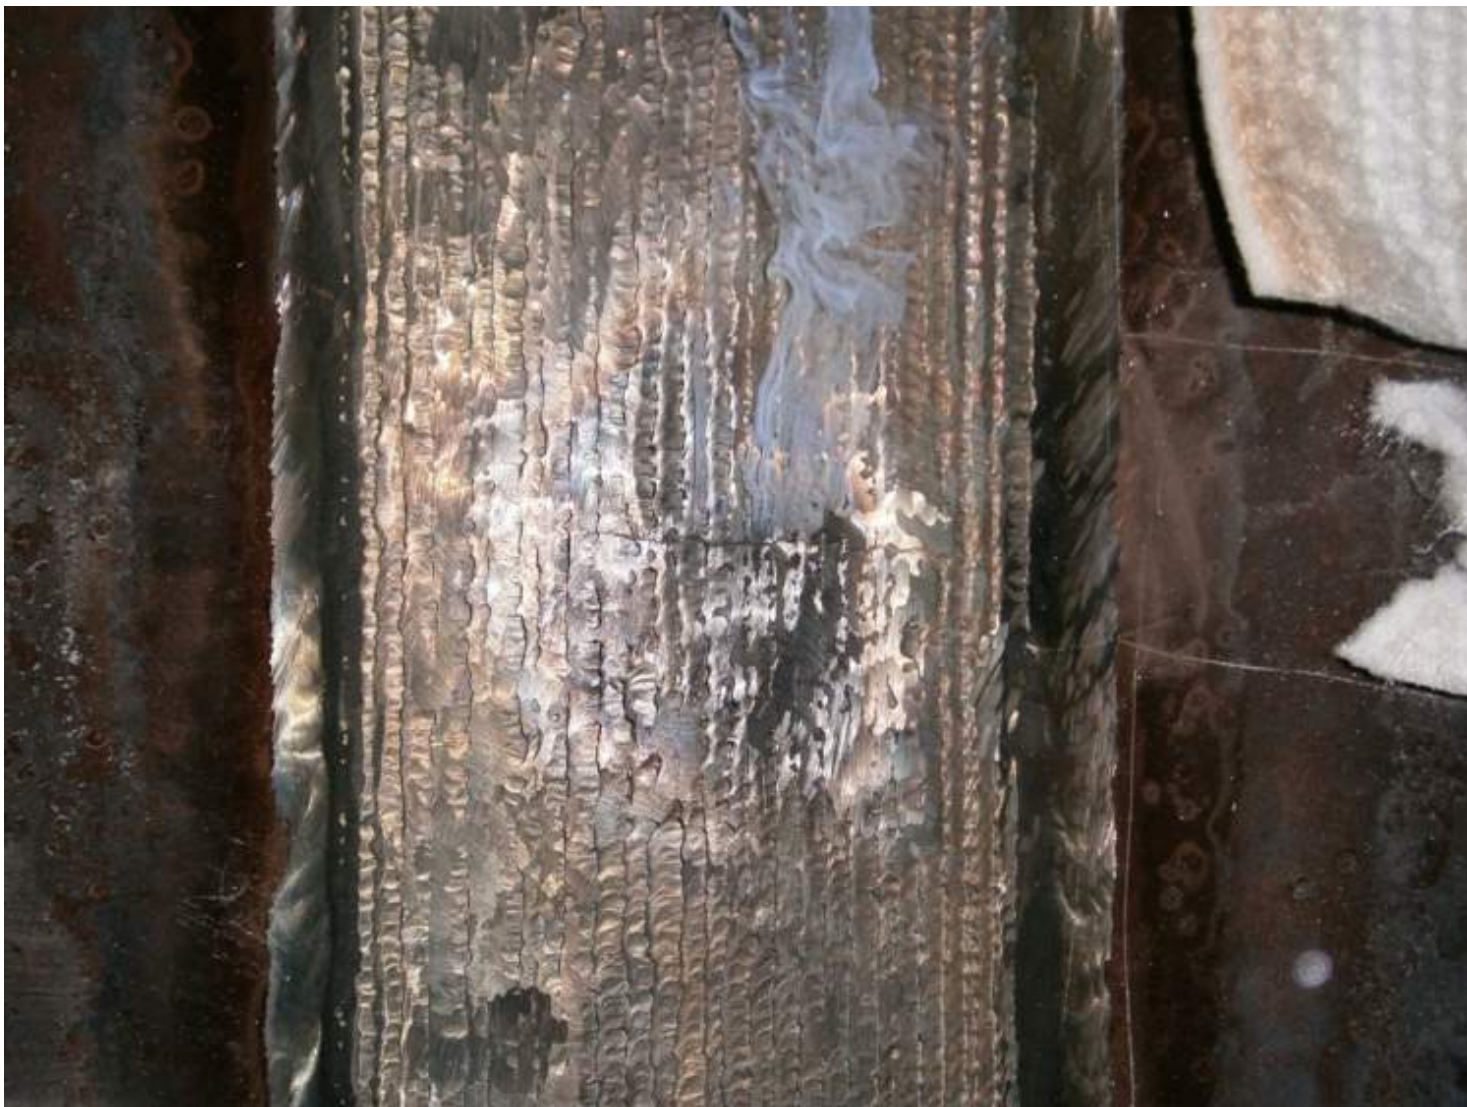
The 4.5-Inch Crack in a Vertical Weld Seam

- A different type of creep cracking occurred in January 2014 in the weld overlay
- Cracking was caused by residual stress in the Inconel 625 welds
- On-line repairs were made to keep the FCC operating in January
- First repairs involved installing a 10-Inch pipe cap over the crack following ASME PCC-2 guidelines – Article 2.4 “Welded Leak Box Repair”
- FEA analysis indicated the crack would be in compression and crack propagation would stop
- Critical creep crack size was 41-Inches – much larger than the cap size
- Acoustic emission monitoring was considered for monitoring cracks inside leak box repairs – this wasn’t done since the critical size was large
- FEA analysis and Omega creep life analysis indicated the vessel wall creep life would be greater than 3 years with the leak box repairs

This crack was tight, and it was easily peened to stop the leak until the pip cap was installed.
