DCU FURNACE TROUBLESHOOTING: “HIGH TUBE METAL TEMPERATURE”

C K SINHA

Senior Manager Technical Services,
sinhack@indianoil.in

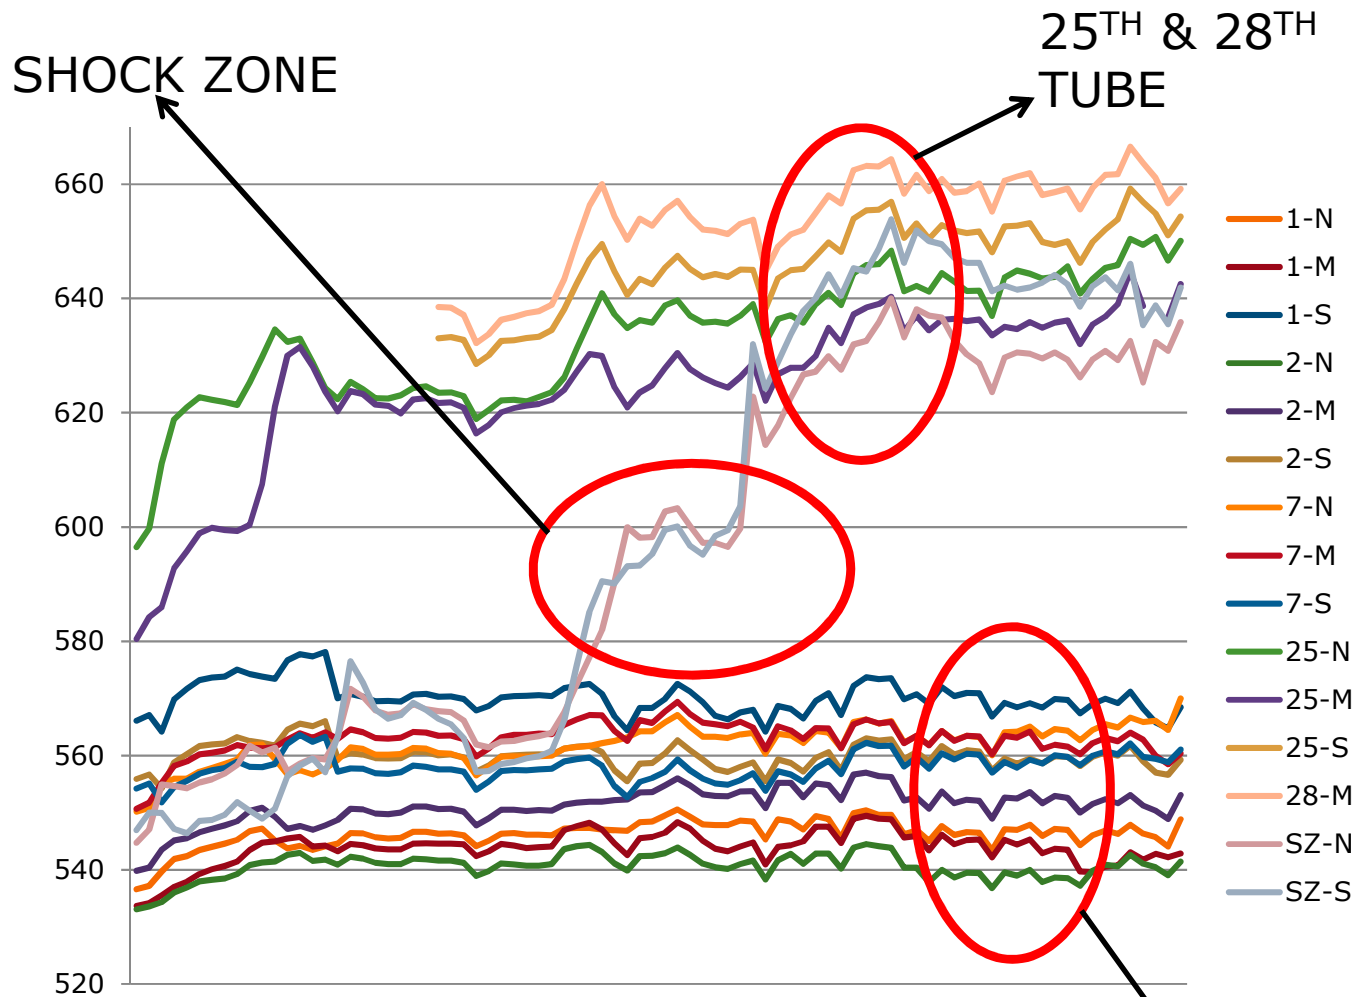
TMT TREND OF PAST RUN-3

***One additional t'couple installed on 25th in Middle position and on 28th in Middle position**

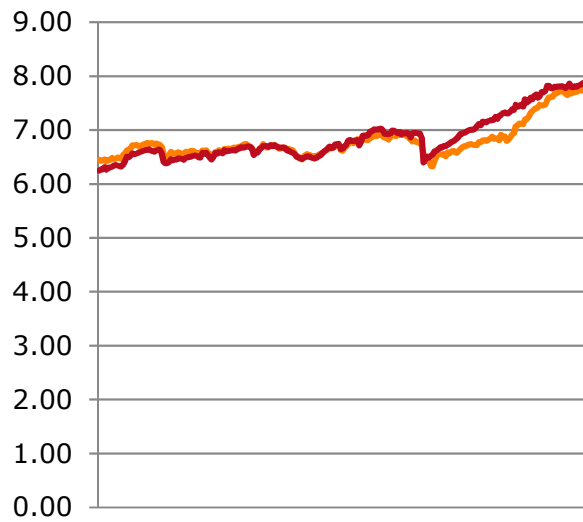
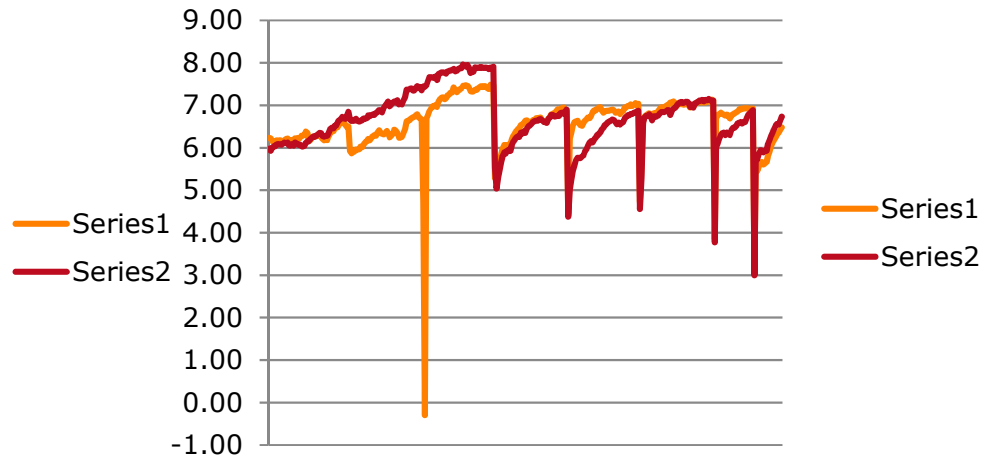
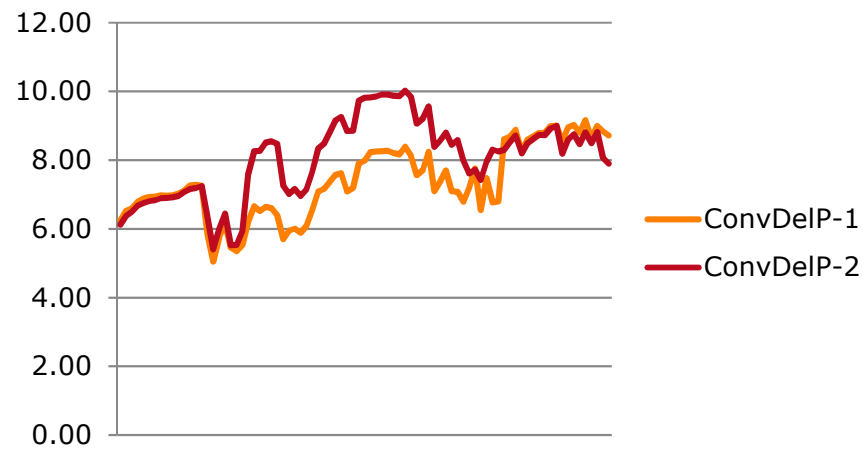
CONVECTION COIL PRESSURE DROP

- ❑ HIGH DRAFT, HIGH EXCESS AIR, HIGH TMT IN SHOCK ZONE & RADIANT TOP ZONE
- ❑ HIGH HEAT TRANSFER IN CONVECTION TUBES
- ❑ HIGH RADIATION INLET TEMP
- ❑ CONVECTION COIL FOULING
- ❑ HIGH AMOUNT OF HEAT AVAILABLE IN RADIATION TOP ZONE
- ❑ COKE FORMATION IN RADIATION TOP ZONE AT FAST RATE
- ❑ COKE LAYER IN 25TH & 28TH TUBE
- ❑ TUBE 1 & 2 VERY CLEAN

- Reduce the draft in the furnace box to shift the heat transfer to radiation bottom

- Increase the HC velocity at the radiation inlet to slow down coke layer formation in radiation top tubes
