DCU FURNACE TROUBLESHOOTING: “HIGH TUBE METAL TEMPERATURE”

C K SINHA

Senior Manager Technical Services,
sinhack@indianoil.in

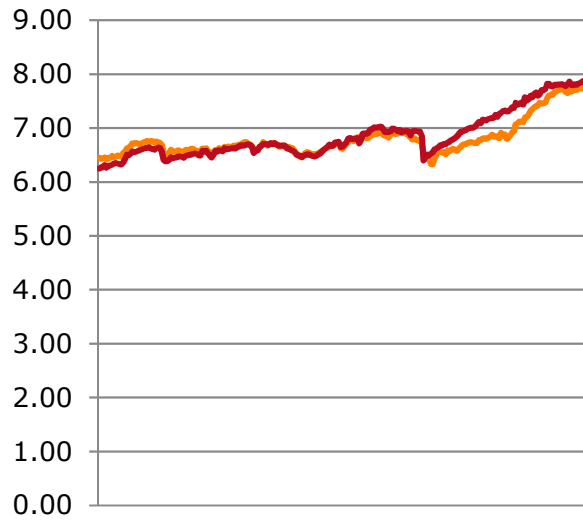
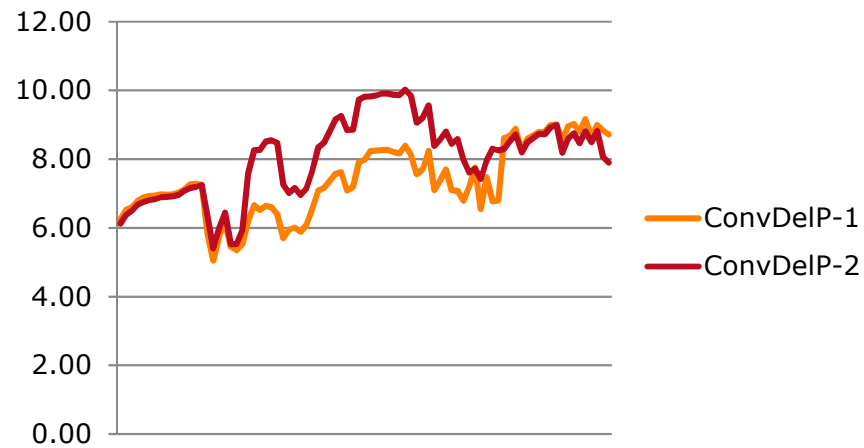
CONVECTION COIL PRESSURE DROP

- ❑ HIGH DRAFT, HIGH EXCESS AIR, HIGH TMT IN SHOCK ZONE & RADIANT TOP ZONE
- ❑ HIGH HEAT TRANSFER IN CONVECTION TUBES
- ❑ HIGH RADIATION INLET TEMP
- ❑ CONVECTION COIL FOULING
- ❑ HIGH AMOUNT OF HEAT AVAILABLE IN RADIATION TOP ZONE
- ❑ COKE FORMATION IN RADIATION TOP ZONE AT FAST RATE
- ❑ COKE LAYER IN 25TH & 28TH TUBE
- ❑ TUBE 1 & 2 VERY CLEAN

- Reduce the draft in the furnace box to shift the heat transfer to radiation bottom

- Increase the HC velocity at the radiation inlet to slow down coke layer formation in radiation top tubes

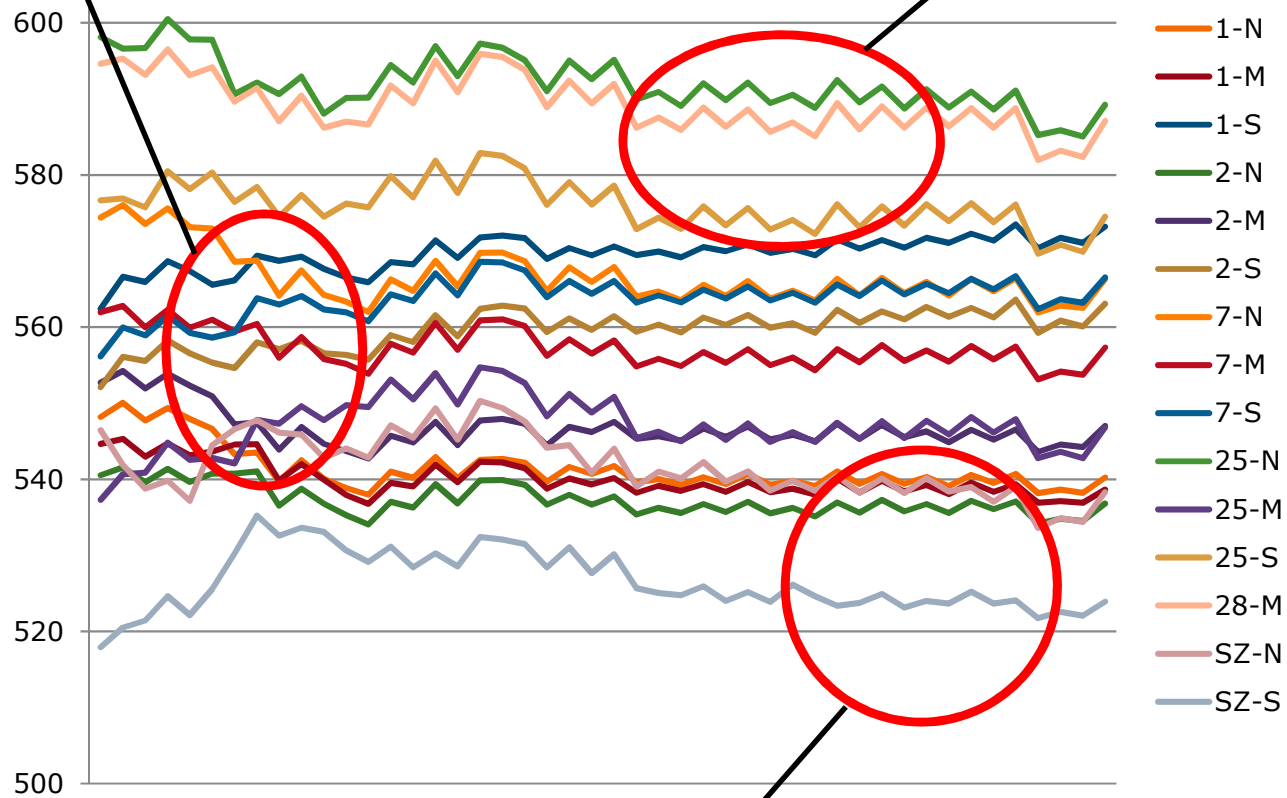
NEW TMT TREND RUN-2

7TH TUBE & BELOW

25TH & 28TH TUBE

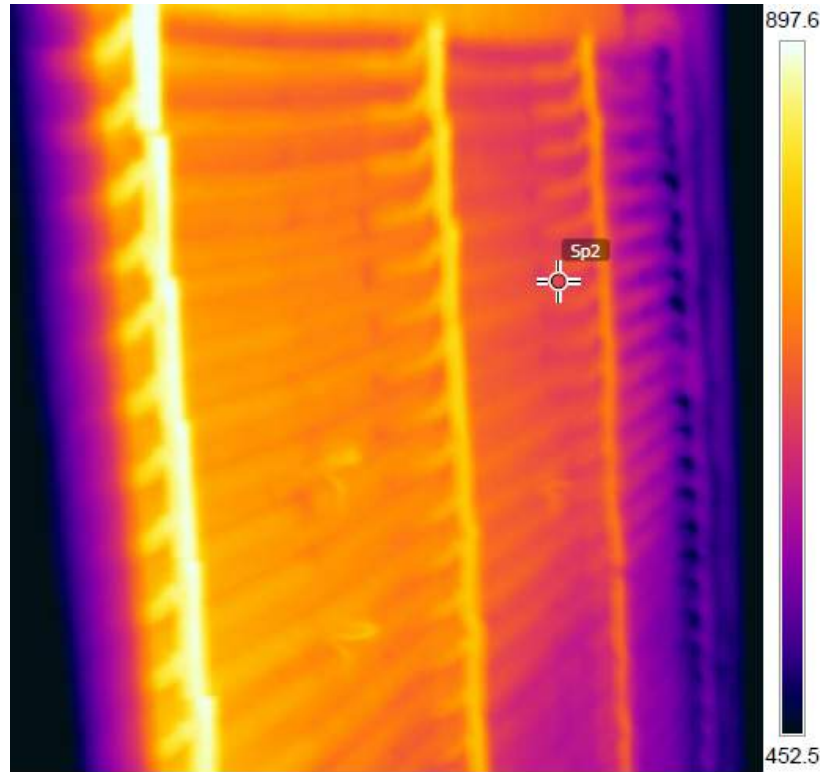
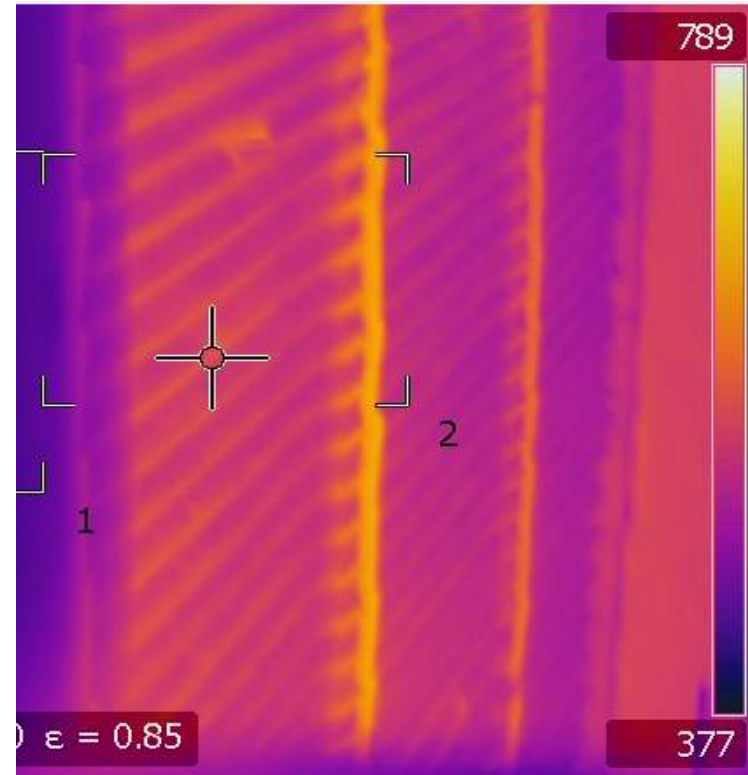
BEFORE

SHOCK ZONE
