Feed Interruption, Foamover, Tarball, and Cooked Drum Experience

Gary Gianzon
Heavy Oil Technologist
gmgianzon@marathonoil.com

Marathon Petroleum Company LLC
April 2010

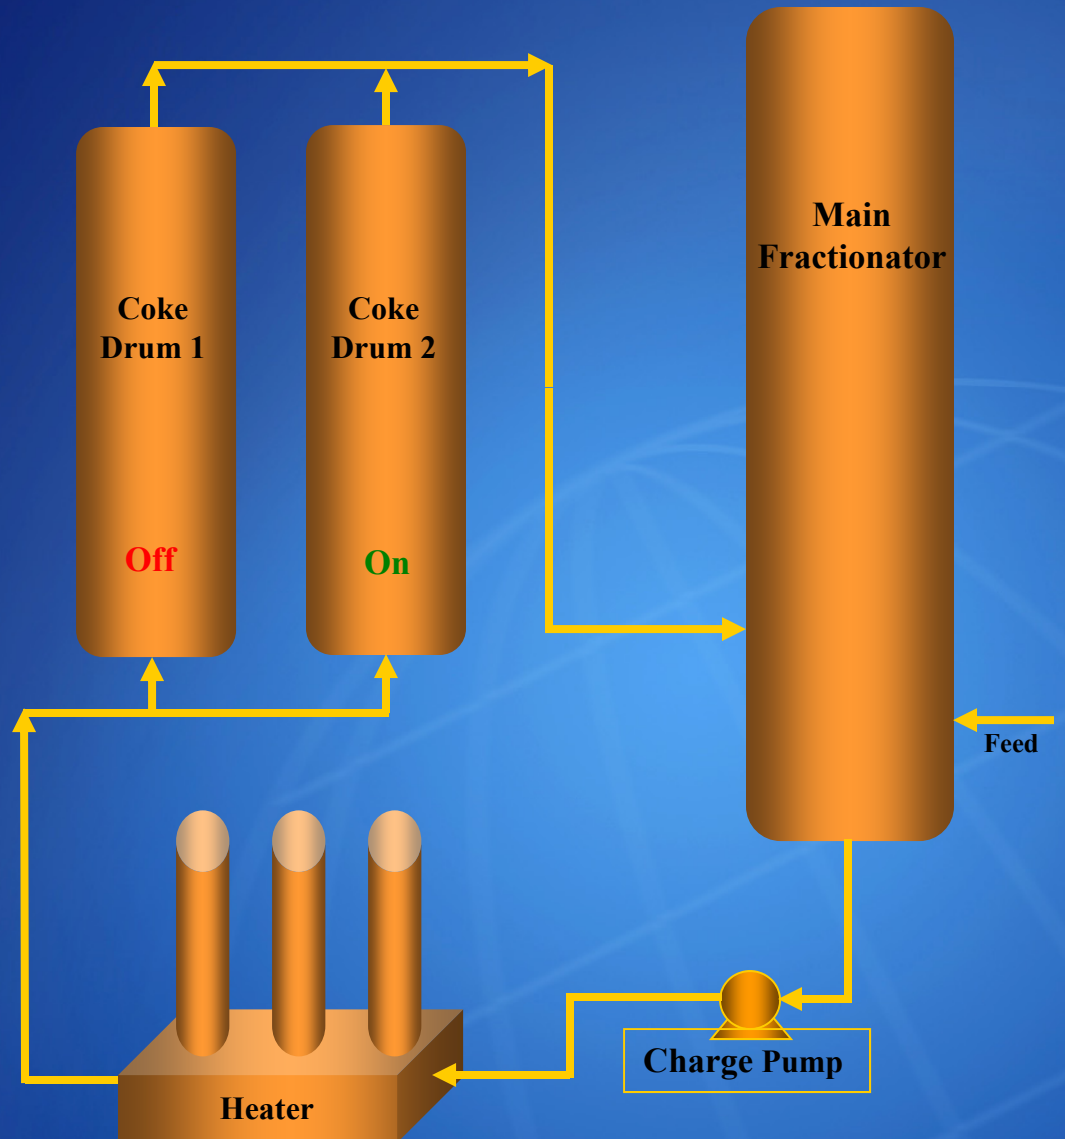
0716 hours

- The Coker Charge Pump cavitates
 - Water or light hydrocarbon is the expected cause of the cavitation

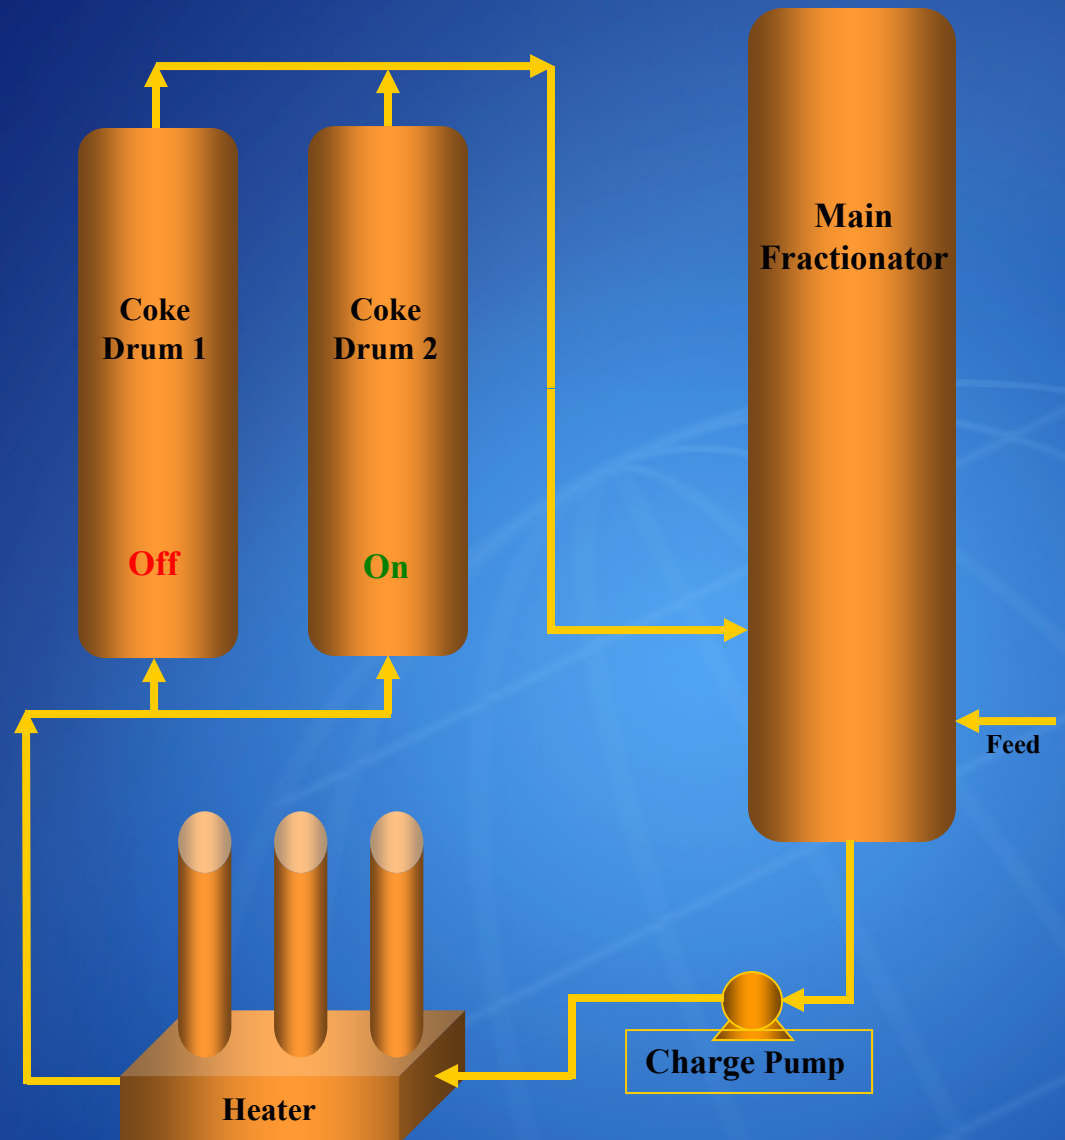
0716 hours *(continued)*

- The cavitating pump causes the heater to trip
 - Low flow should only trip the main burners
 - The pilots trip due to loss of flame indication
 - A complete purge cycle is now required to restart the heater

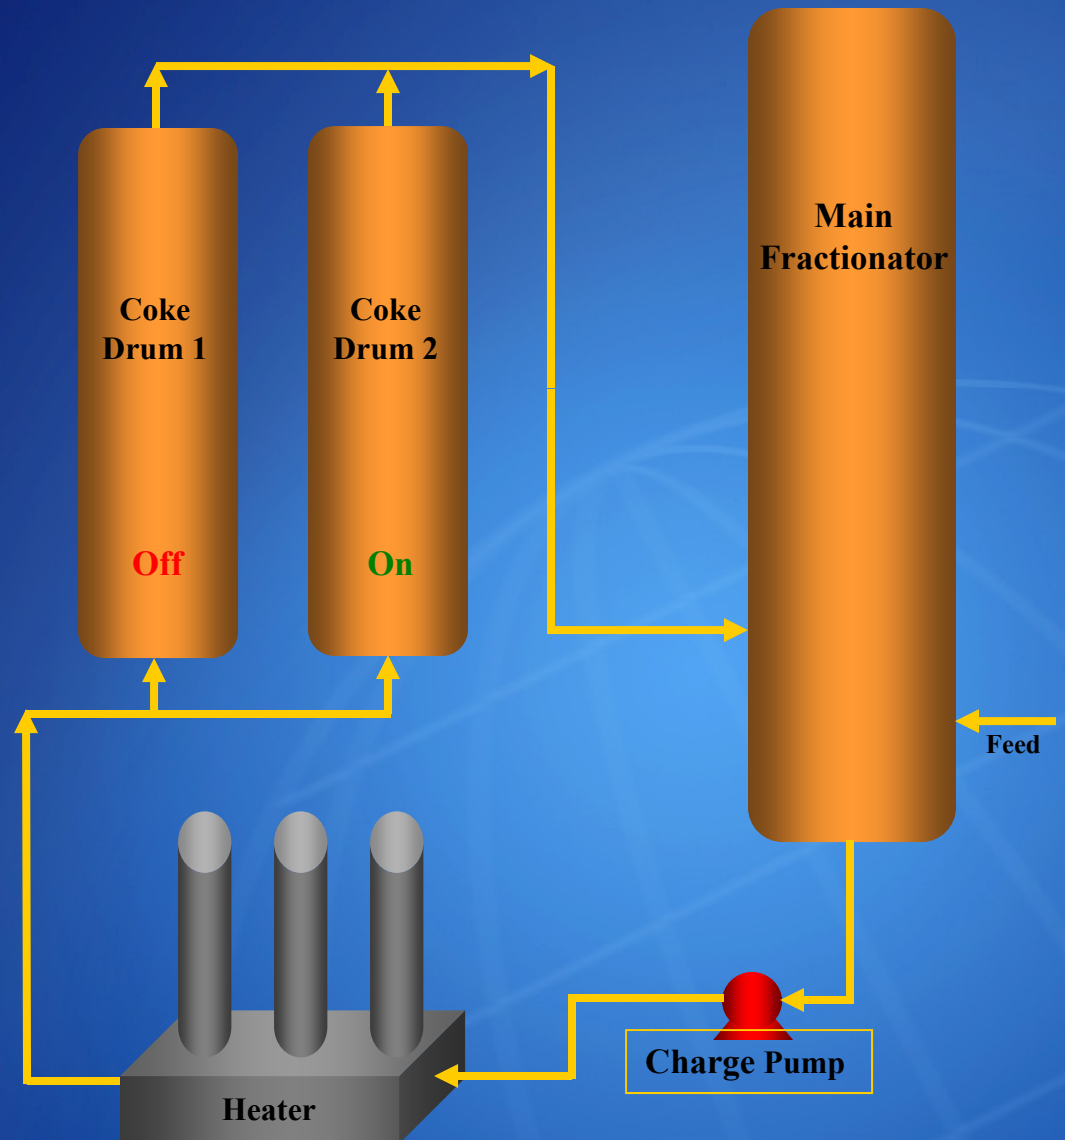
0747 hours

- The purge cycle is completed and all of the pilots are relit
- There are 168 pilot/burner assemblies in the heater
 - The Drum 2 inlet temperature drops from 900°F to 600°F
 - Feed rate is reduced from 38,000 BPD to 29,000 BPD
 - Antifoam is maximized

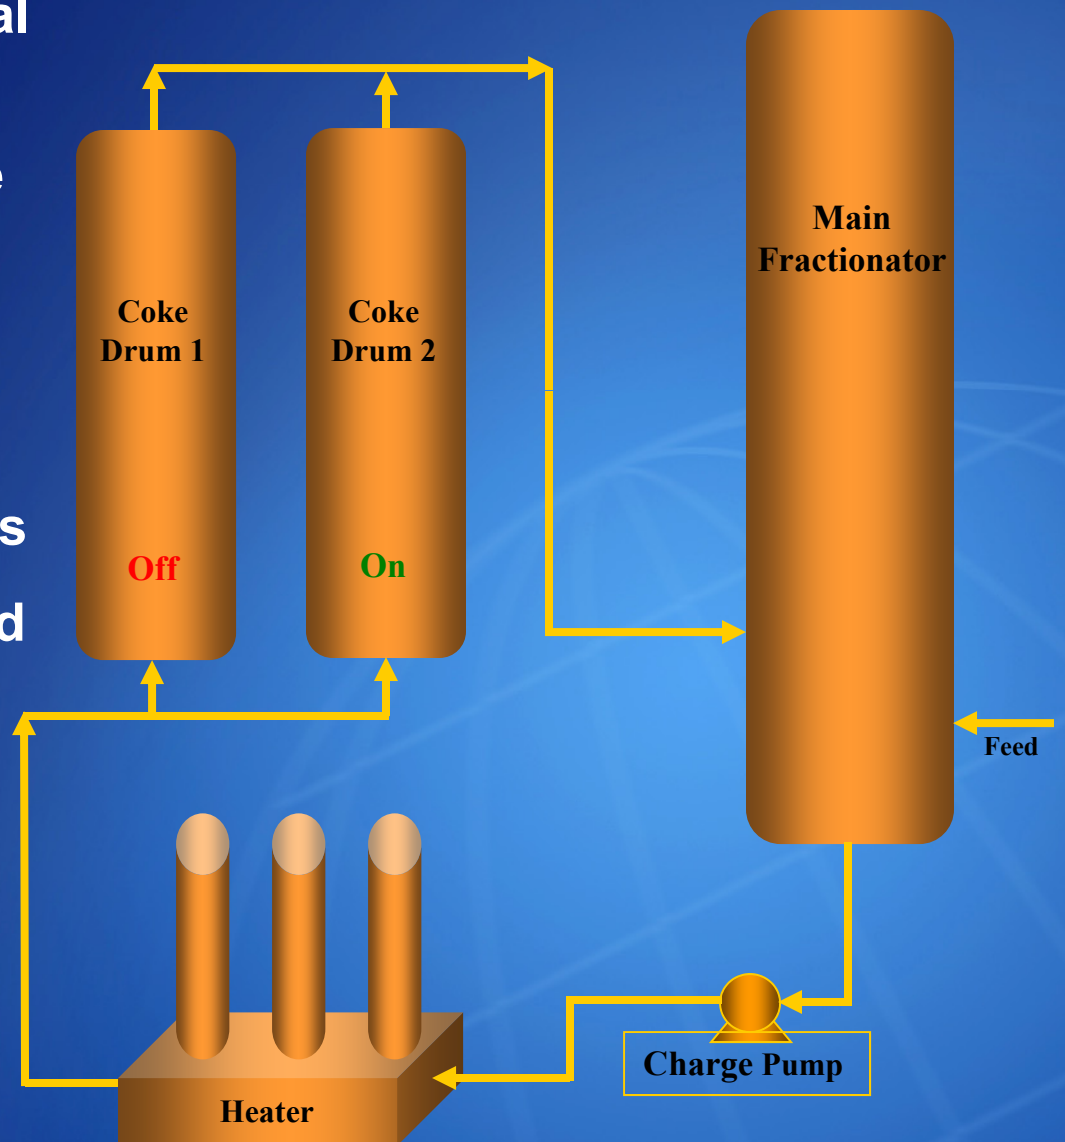
0815 – 1000 hours

- The Coker returns to normal operation
 - Drum 2 Inlet temperature reaches 900°F @ 0900 hours (150% more time than typical)
 - Feed rate returns to 38,000 BPD @ 1000 hours
 - No problems are reported

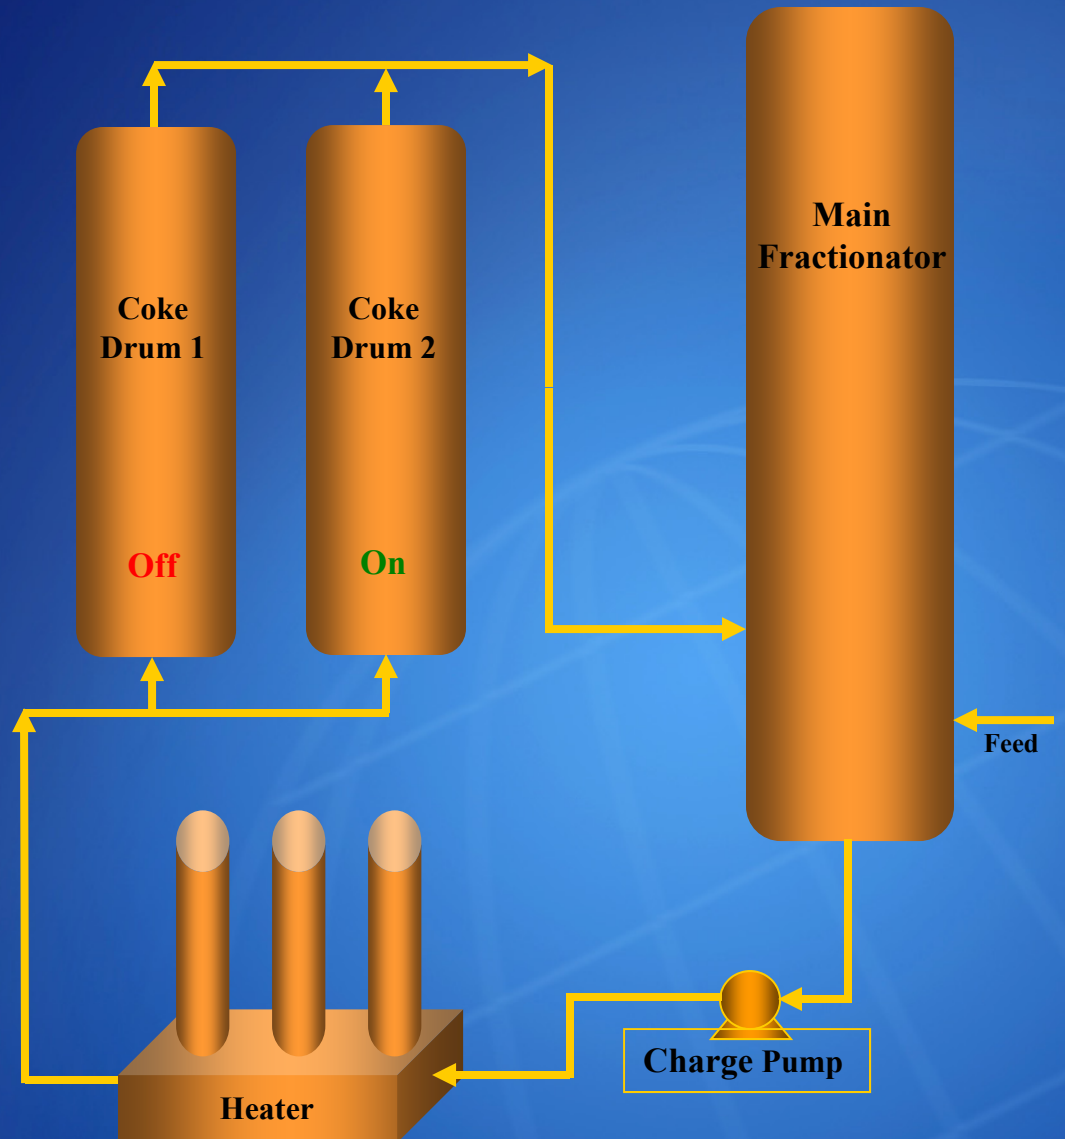
1000 – 1400 hours

- The Coker runs normally with no noted concerns
- Drum 2 outlet temperature reaches 790°F by 1400 hours. (temperature was 810°F before heater trip)

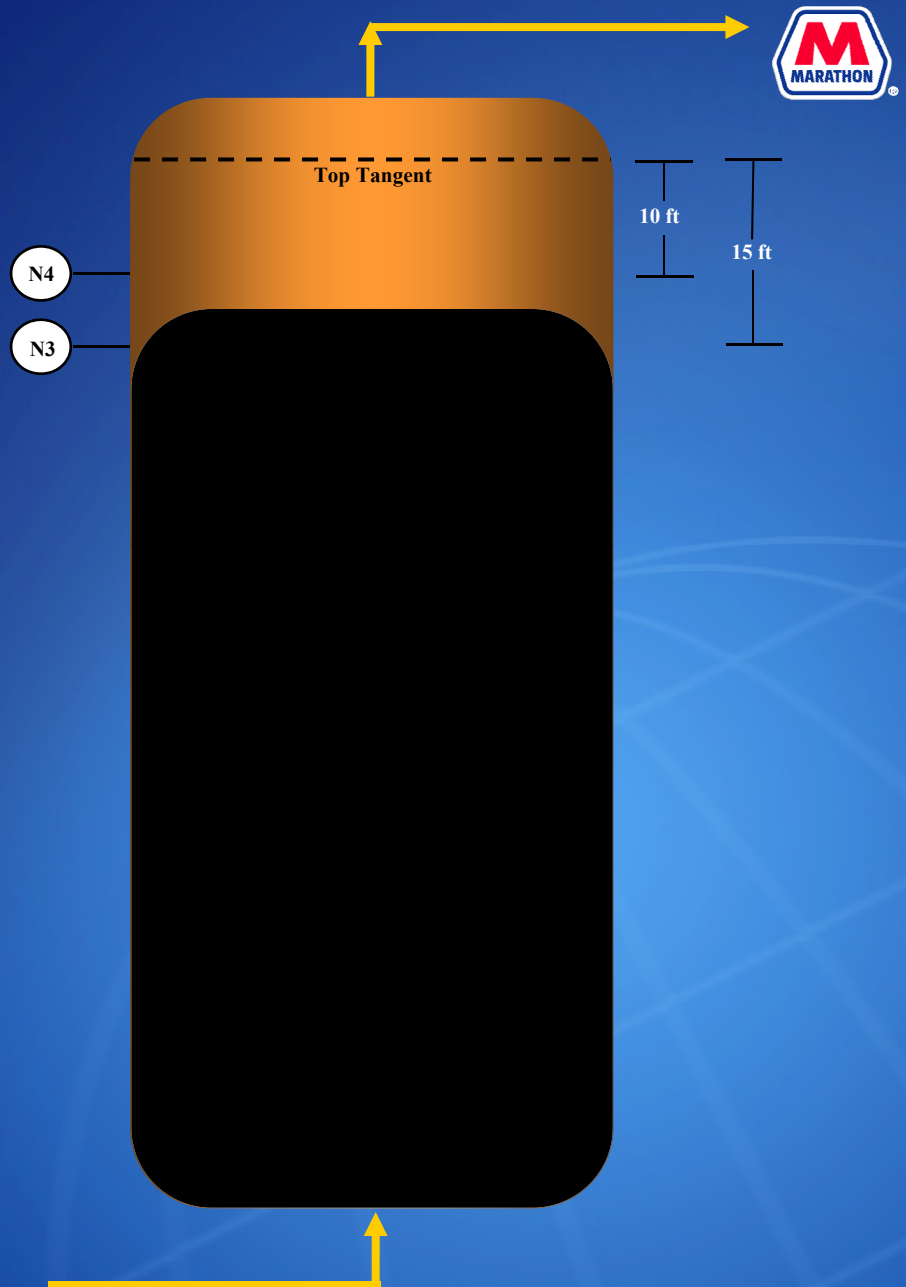
1425 hours

- The 3rd (of 4) nuclear level indication rapidly climbs from 14% to 100%
 - 3 minutes vs. the typical 15 minute time frame
 - This detector is calibrated to indicate coke, not foam, @ 100% of scale
 - This is approximate 1.5 hours before the scheduled drum switch time

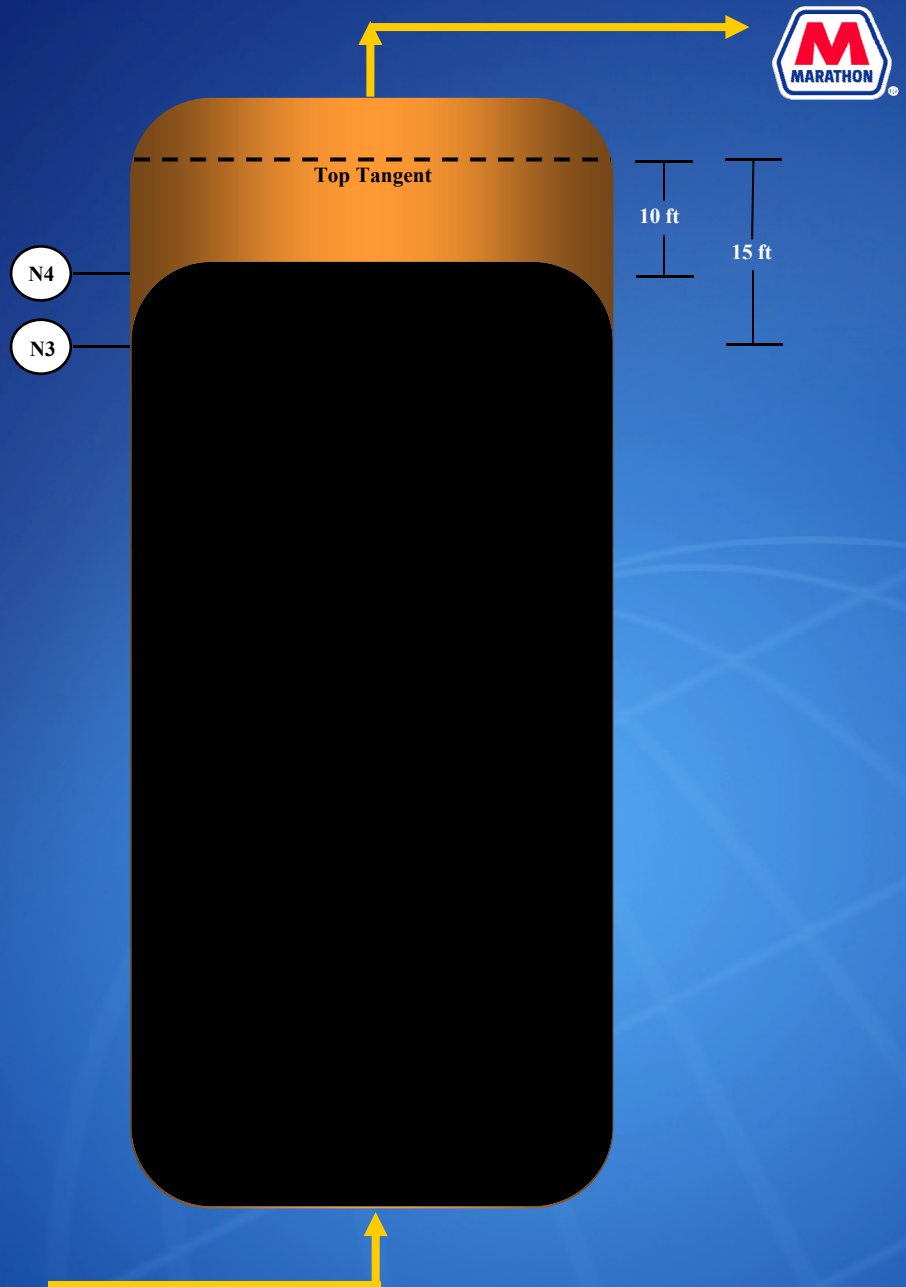
1430 hours

- The 4th (of 4) nuclear level indication shows movement to 28%
 - This detector is calibrated to indicate foam @ 20% of scale
 - It normally takes 45 minutes to see activity after the 3rd nuke is activated
 - The decision to switch drums early is made by operations

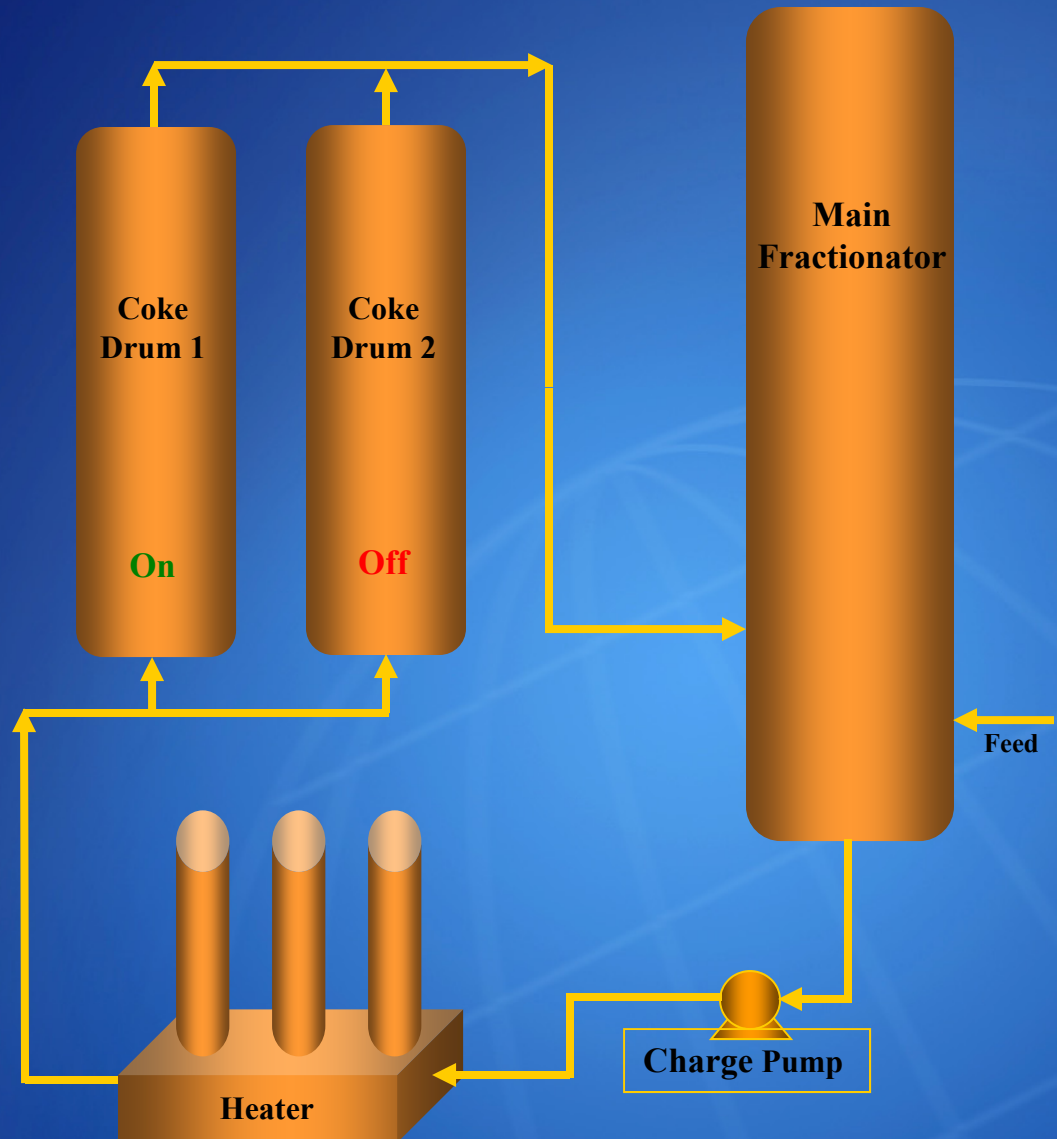
1445 hours

- Feed is fully routed to Drum 1
 - Drum 2 pressure drops 6 psig after the switch
 - This drop in pressure causes the foam height to grow as indicated by the 4th nuke reaching 100% by 1448 hours
 - Recall that feed is out of Drum 2 entirely
 - Drum 2 begins to carryover which is audible in the field

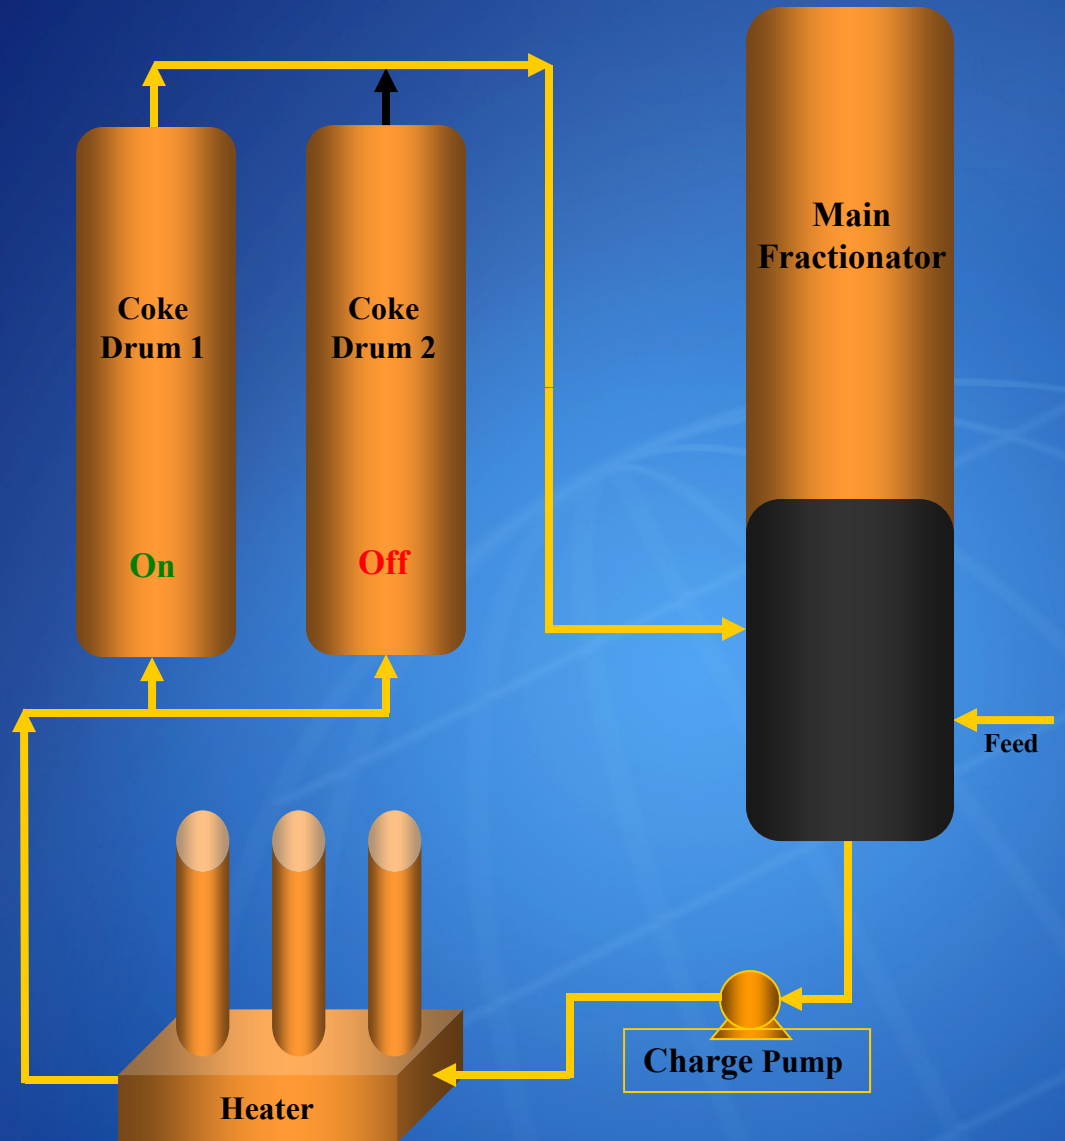
1505 – 1527 hours

- As the carryover occurs, back-pressure begins to be a problem for both Coke Drums
 - The combined outlet line begins to restrict
 - Drum 1 reaches 50 psig
 - Drum 2 reaches 80 psig
 - At 80 psig, the relief valve (RV) opens on Drum 2
 - Coke is carried into the Main Fractionator and the Blowdown system via the RV

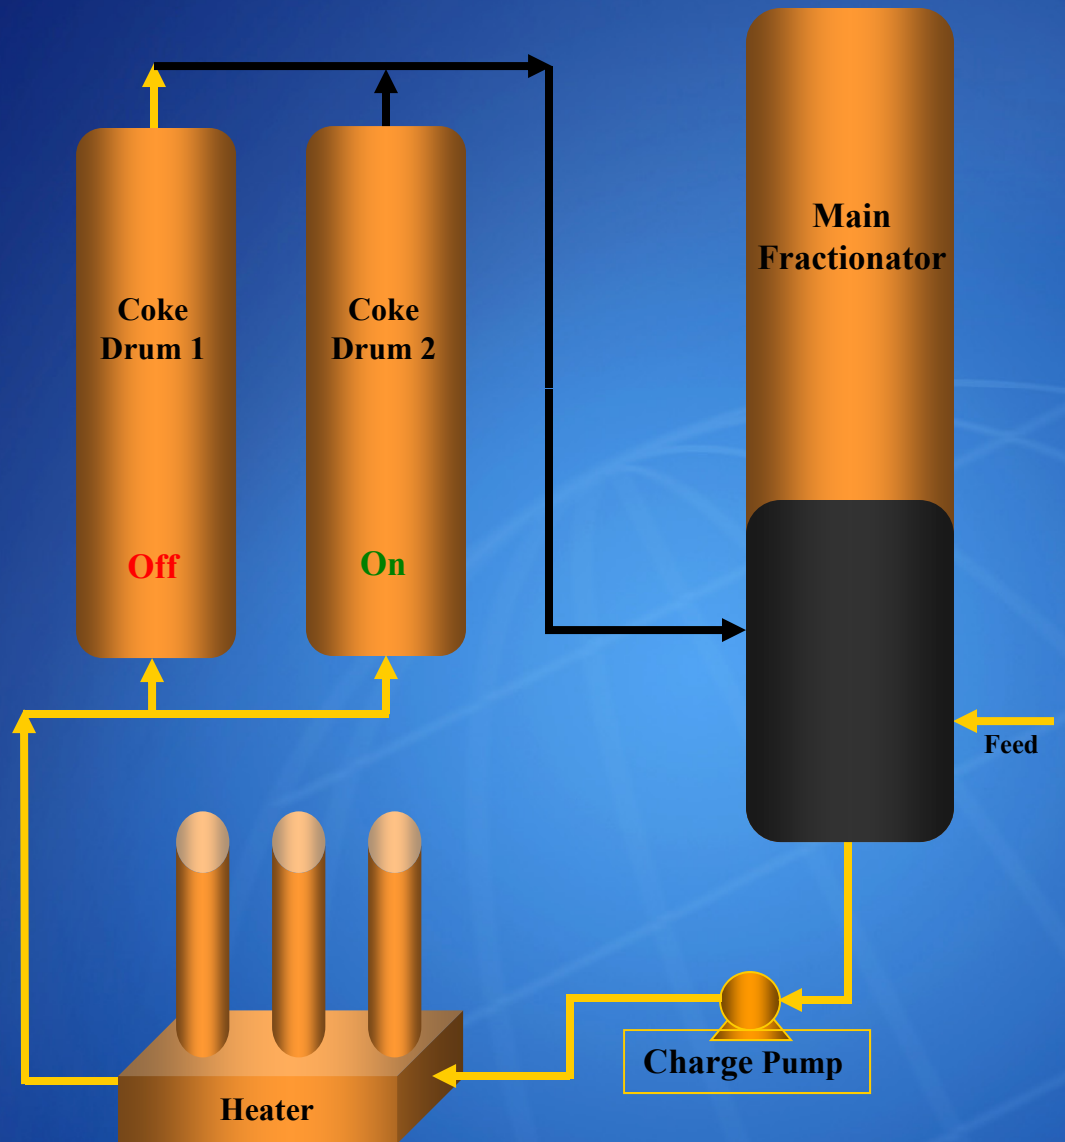
1530 - 1619 hours

- The Coker is shutdown
- The system pressure reaches its automatic control point to vent to the flare through the Blowdown Drum
- The Wet Gas Compressor shuts down due to high level in the Interstage Drum
- At 1604 hours the Drum 2 4th nuke drops off indicating the foaming has stopped
- All flaring stops @ 1619 hours

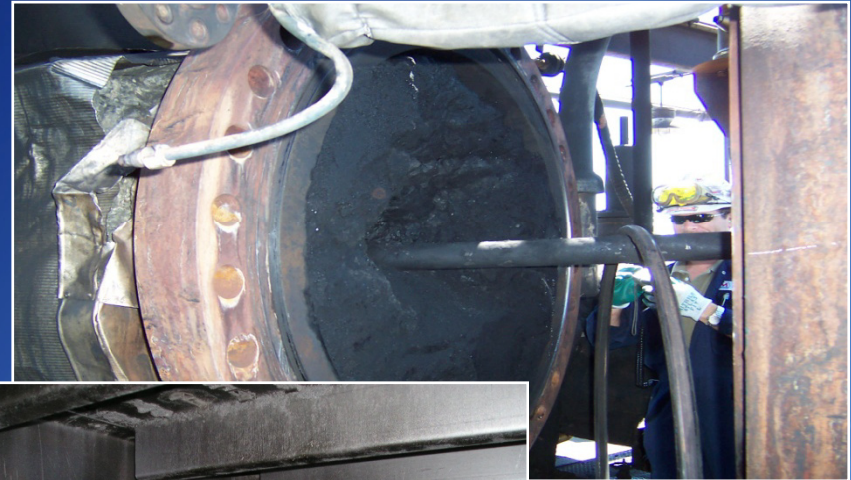
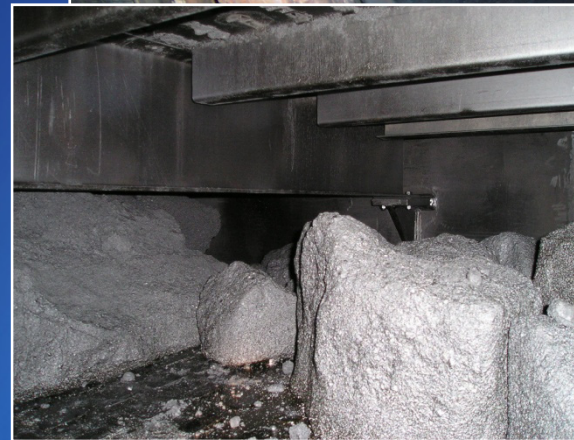
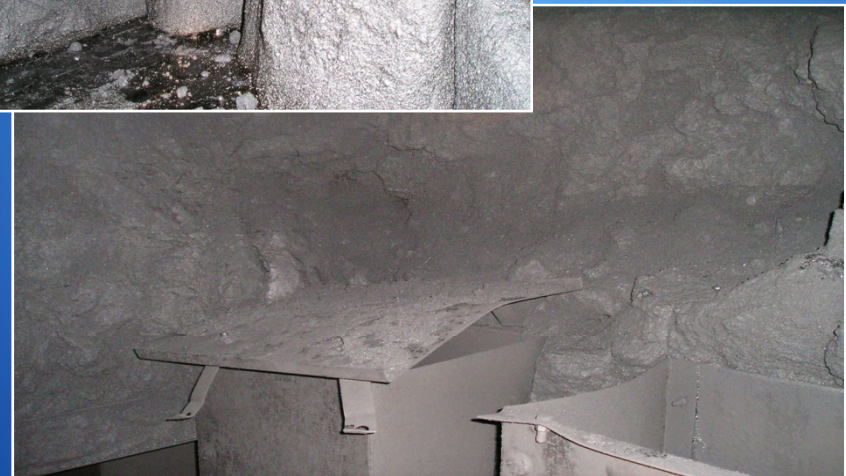
Results of the Incident

- ◆ The Coker was down for 21 days
 - Explosive charges, manual chipping, and hydroblasting used for coke removal
- ◆ Hard coke was deposited:
 - In the Coke Drum vapor outlet lines
 - In the Main Fractionator
 - Up to the gas oil pumparound return
 - Throughout the Blowdown System
- ◆ Significant tray damage
 - Including dislodging of the Flash Zone Gas Oil tray

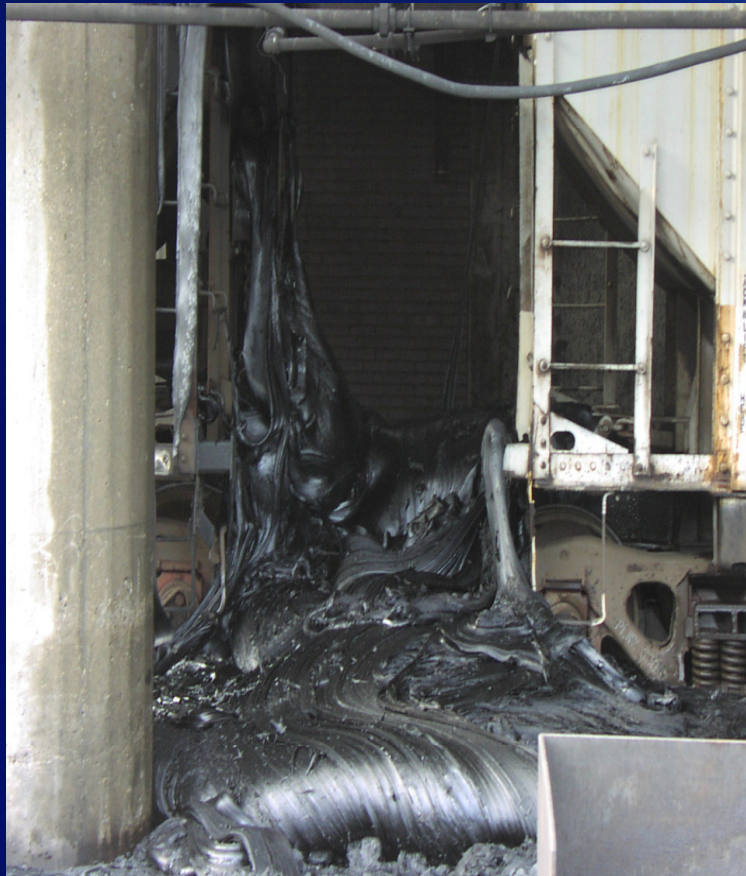
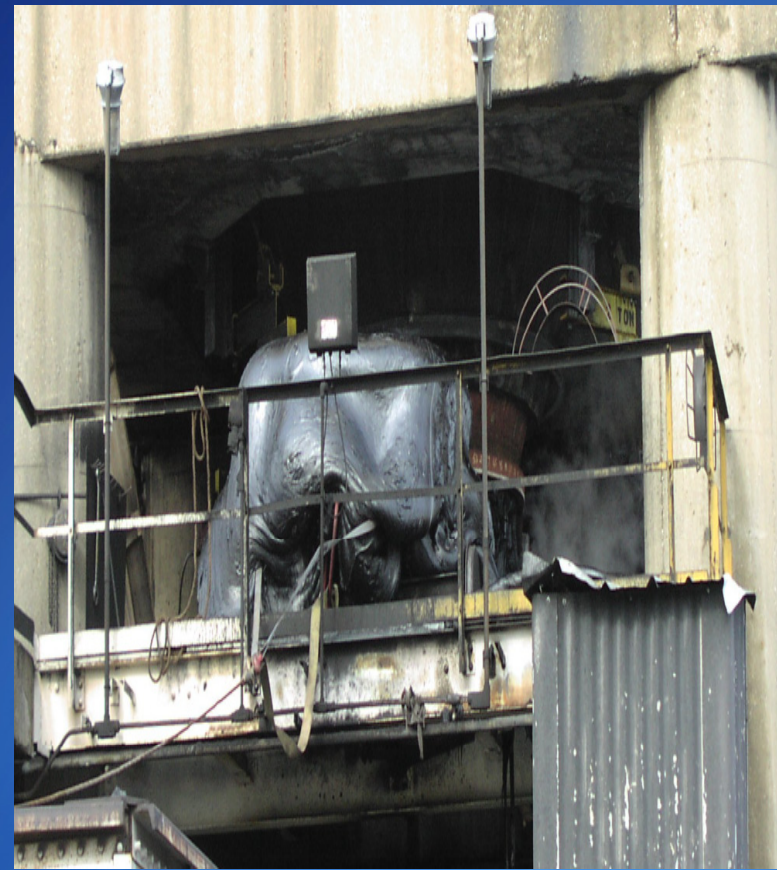
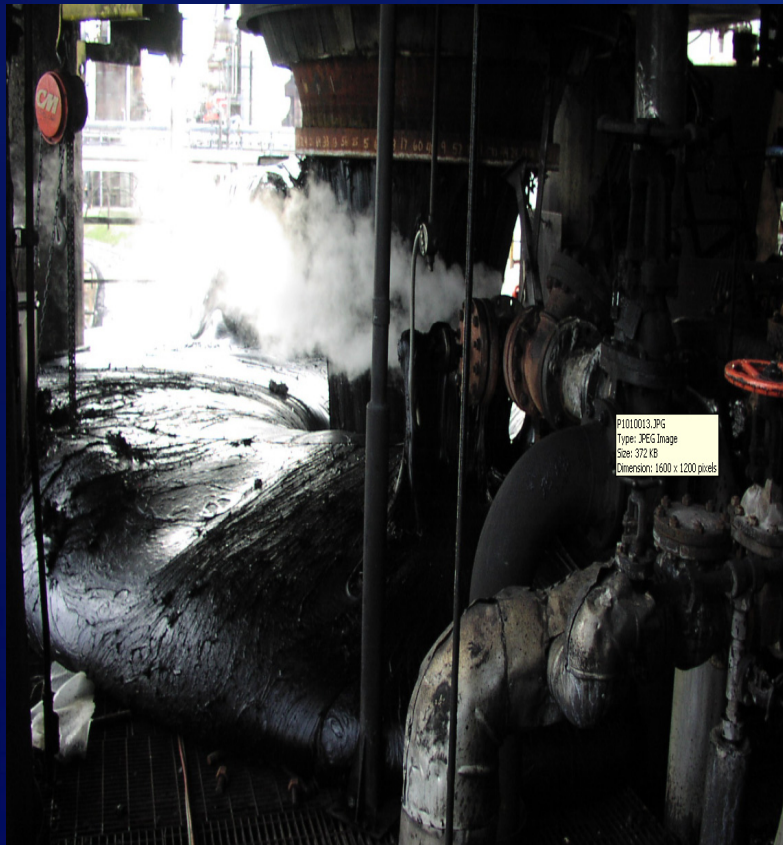
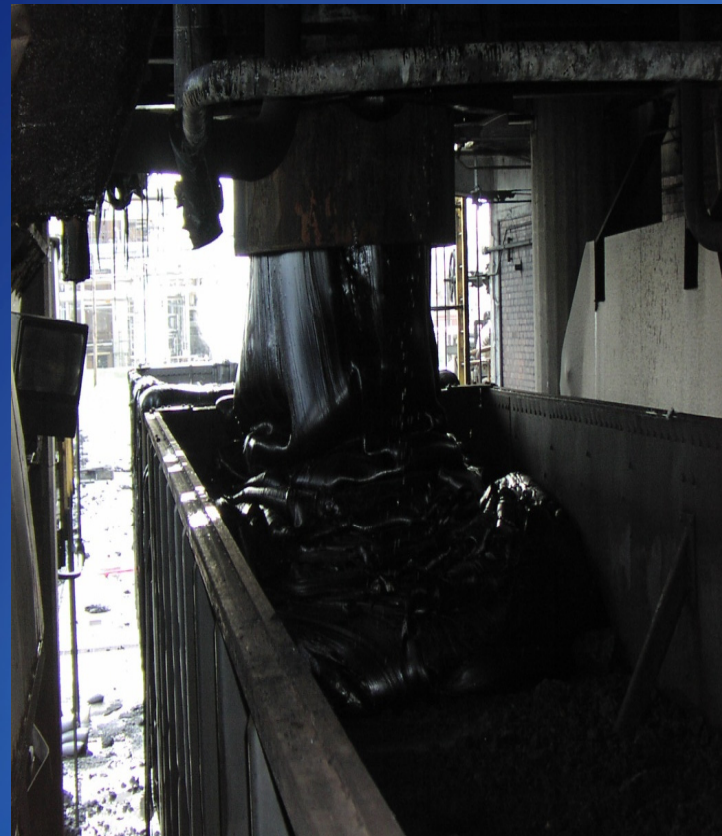
Results of the Incident

- ◆ Drum will not drain properly, potential for Tarry drum
- ◆ Remove drum insulation at the bottom cone to determine if the drum is properly quenched. The cone temperature was cool.
- ◆ Applied extra support on the bottom unheading cart in anticipation of excessive Tar/Coke on the bottom head.
- ◆ Fire trucks were mobilized as a preventative measure to suppress fire in the coke structure.
- ◆ Water was added at the top of the drum and the drum was steamed and drained for 1 ½ days.
- ◆ Loosened the bolts on the bottom head. Tar starts flowing out of the drum.
- ◆ Coker was shutdown for 3 days during this incident with 1 day to clean up the unheading deck and rail cars.

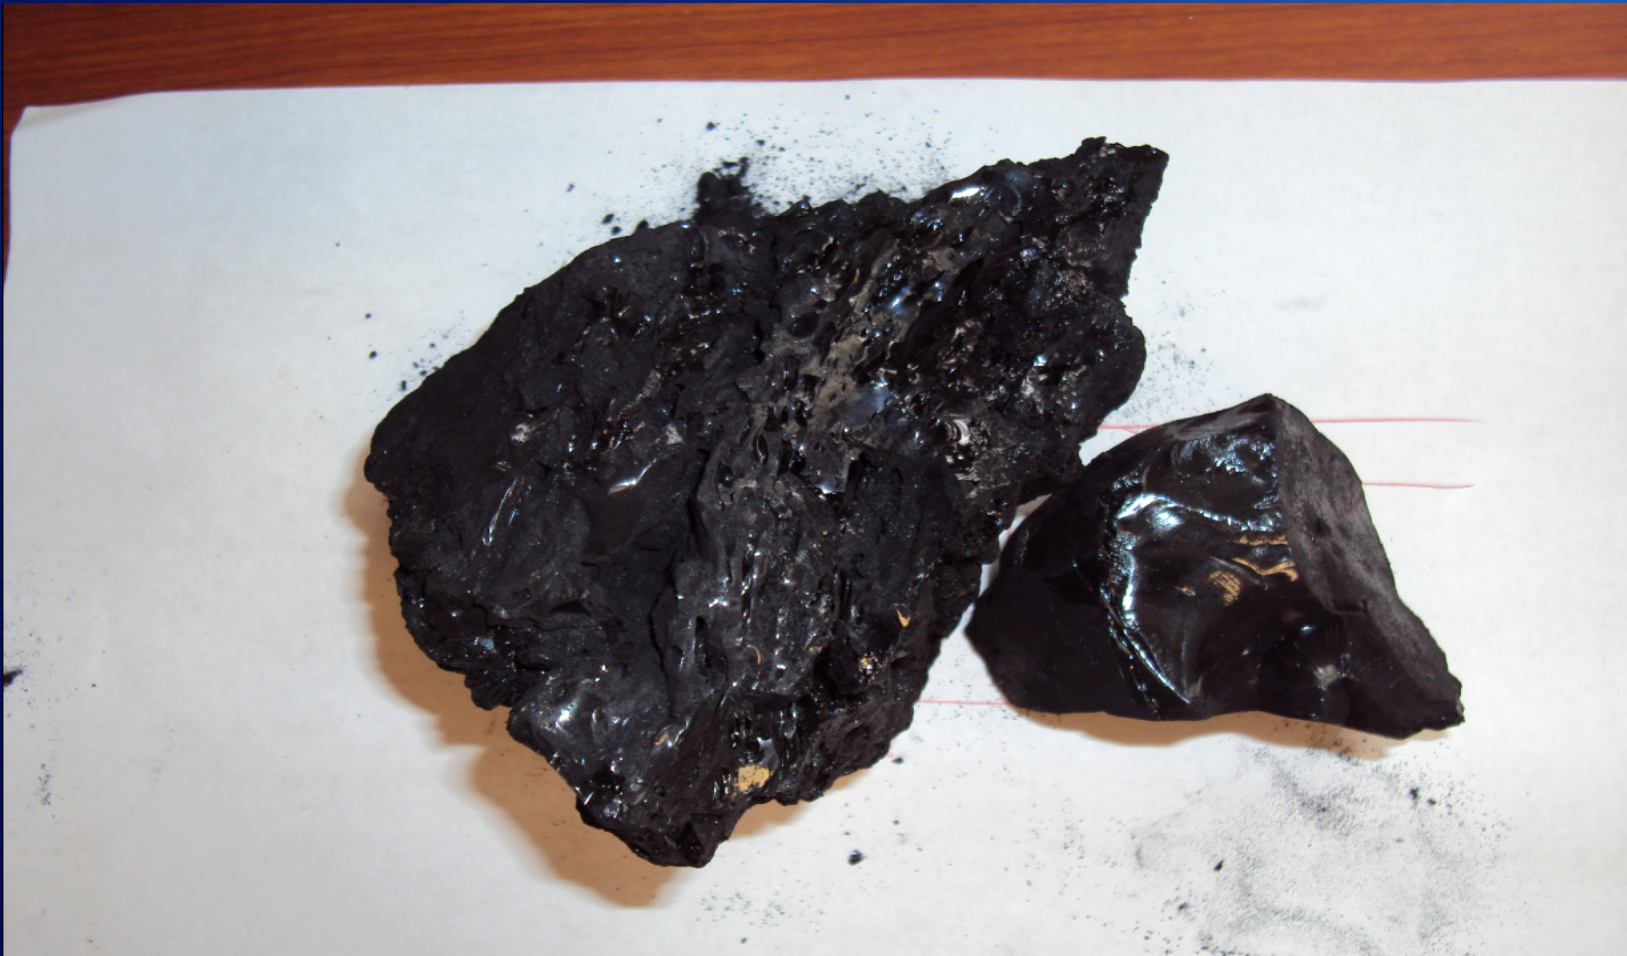
Result

- ◆ Drain per normal procedure – Water was black with coke fines floating on top.
- ◆ Cutting water was placed in pilot mode to remove material/tar sitting on top of the DeltaValve™.
- ◆ Coke was cut per normal procedure (not much coke, around 500 lbs)
- ◆ Drum outage – 138 ft (world record)
- ◆ Shortest Drum Cycle – 50 minutes
