# Field Modification of DCU Support Skirt-to-Vessel Attachment Weld Geometry

By: Pedro E. Amador – VP Business Development & Technology Darren Barborak PhD. – Director of Materials & Welding Patrick Lester BSWE CWI – Senior Welding Engineer

Unique Implementation Case Study

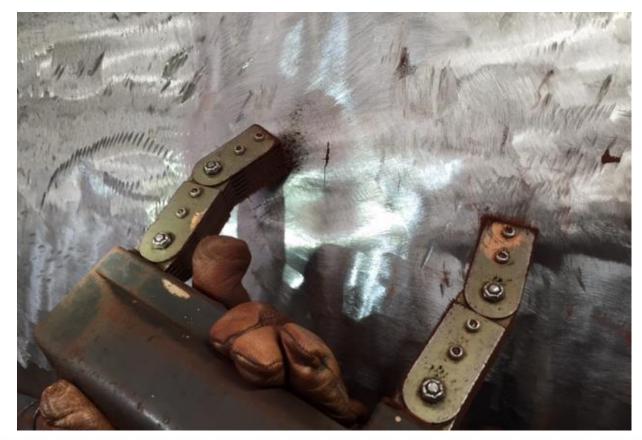
#### Step 2 – Base Metal Inspection

Magnetic Particle Inspection of Coker Vessel Base Material (Showing Vertically Aligned Crack)

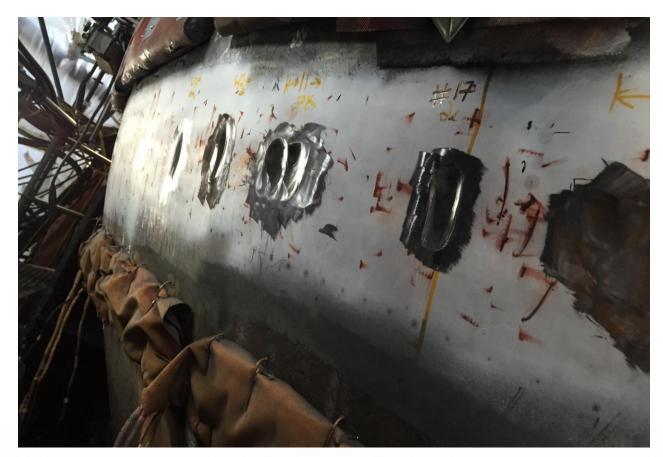
#### Step 3 – Removal of Damaged Areas

**Removal of Flaws Detected with Magnetic Particle and LPAUT**

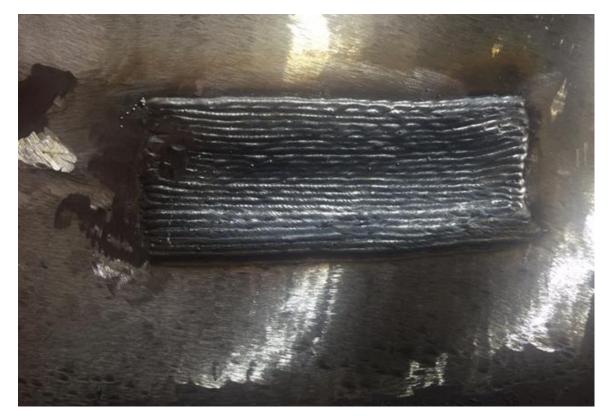
#### Step 4 – Base Material Repair Welding

Repair Welding of Cone Base Material (2 Layers Required to Achieve Tempering)

- The 2-1/4 Cr Cone Base material repaired/restored to nominal using NBIC Alternative Welding Method 2 repair (Temper Bead)
- 2-1/4 Cr filler material ER80S-B3L
- After welding, the surface of the cone was ground flush

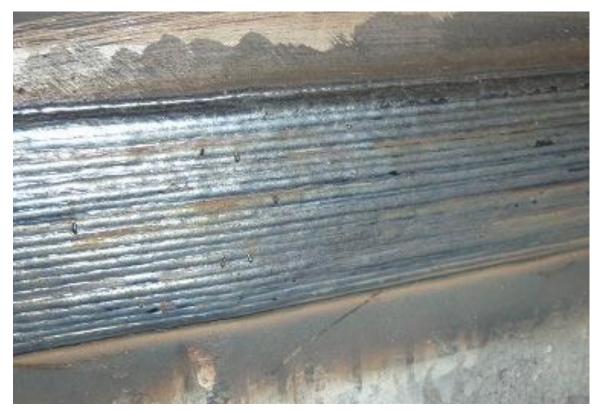
# Step 5 – Initial Knuckle Build-Up

#### Appearance of ER70S-B2L Deposit

(Two Layers)

- A build-up/structural overlay was deposited on the restored and unrestored surface of the cone using NBIC Alternative Welding Method 2
- Machine GMAW process and a 1-1/4 Cr filler material ER70S-B2L was used
- Two layers were applied to ensure proper bead placement and overlap

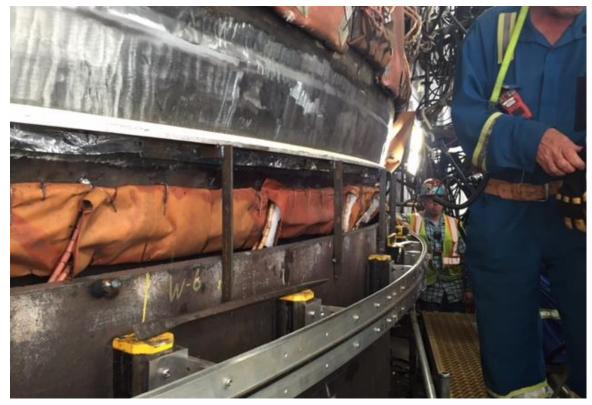
#### Step 6 – Installation of Proprietary Insert

**Casting Insert (White) and Welding Shelf**

- A Casting Insert was installed to create the desired knuckle radius
- A temporary welding shelf was installed to support the Casting Insert and provide a bottom surface for weld tie-in

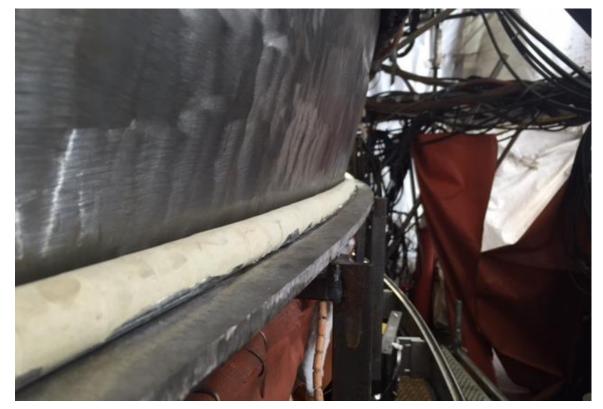
# Step 6 – Installation of Proprietary Insert

**Casting Insert (White) and Welding Shelf**

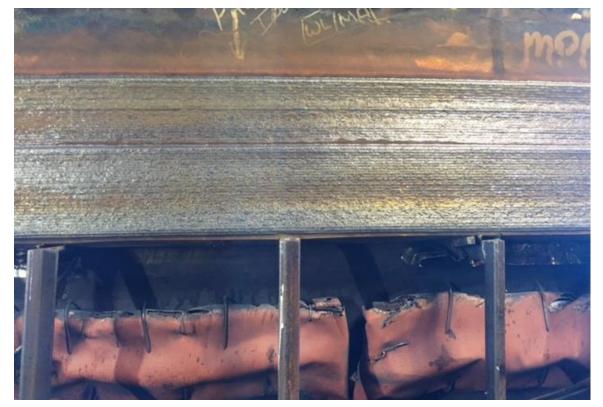
Machine Applied Knuckle Weld Deposit Completely Covering Casting Insert

- With the Casting Insert the weld build-up was completed with ER70S-B2L
- NBIC Alternative Method 2 was used for this portion of the weld
- The final deposited weld metal was considered a 1-1/4Cr, P4, base metal for the remainder of the repair

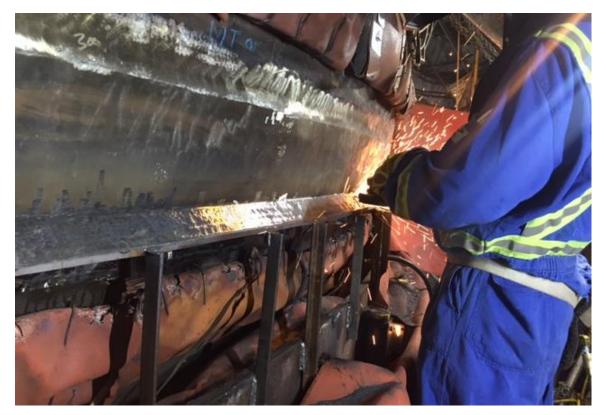
Surface Shaping of Deposited Knuckle Weld

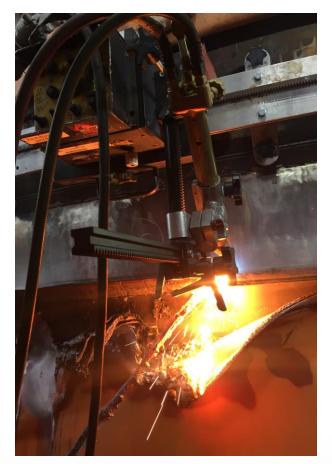
Machine Torch Cutting of the Weld Bevel

- After sufficient build-up was deposited:
  - The Welding Shelf Was Removed
  - The Casting Insert was removed
  - The bottom radius was polished by grinding
  - The front of the build-up was blended to the cone and a bevel prep was cut for the skirt attachment weld

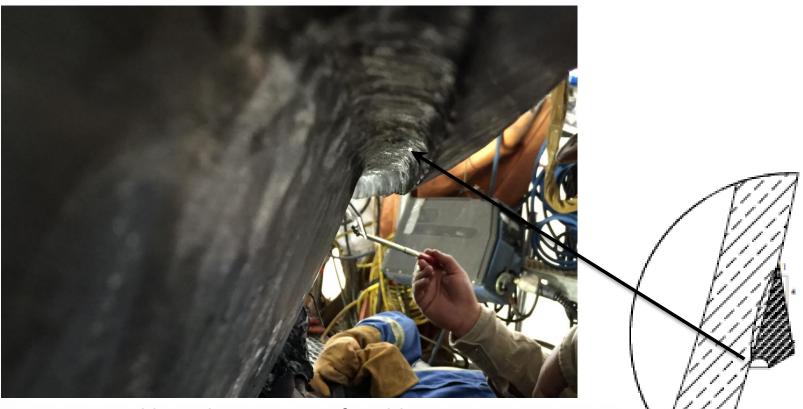
Knuckle Radius Bottom of Weld Deposit

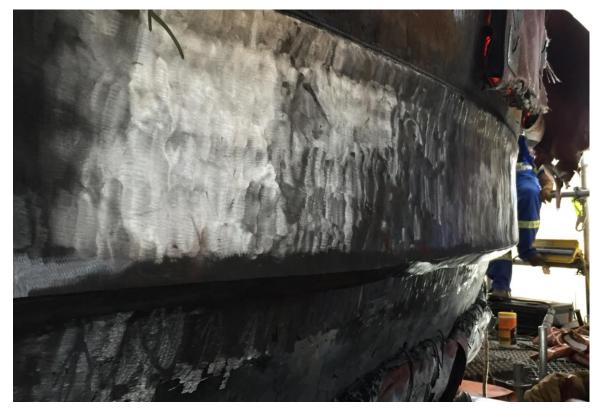
Front Surface of Knuckle Weld Deposit (After Blending and Surface Profiling)

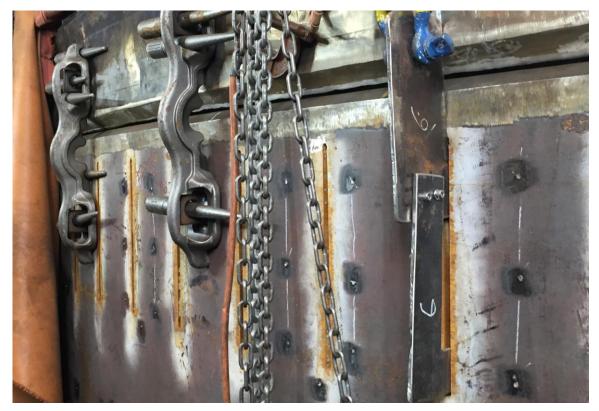
**Section Alignment Fixturing**

- Replacement skirt windows were installed and fit to achieve proper weld geometry
- The joint to be welded 1-1/4 Cr, P4 to P4

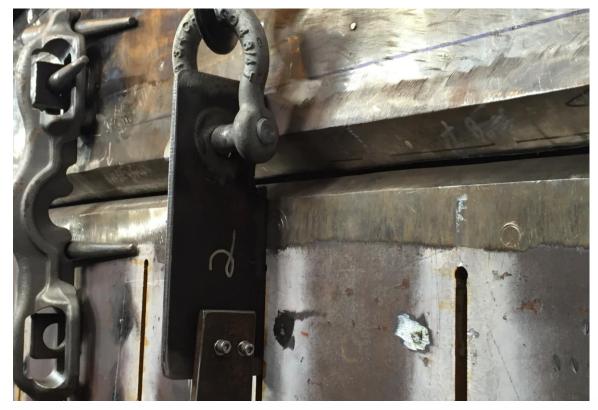
**Proper Root Opening for Welding**

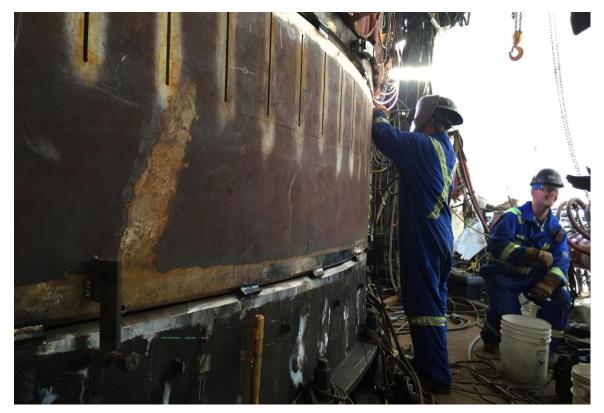
**Final Fit-Up after Tacking**

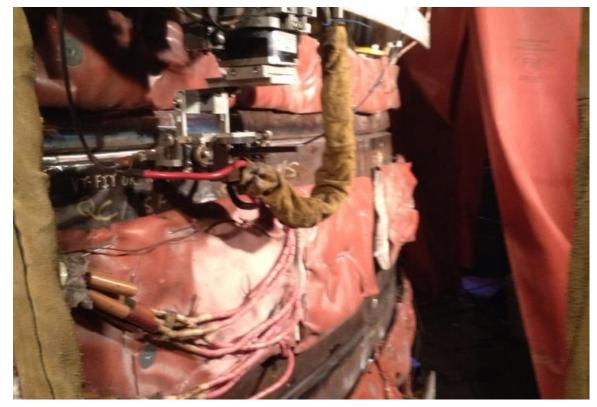
**GTAW Hot Pulse Welding System Installed**

- Weld out completed using "Controlled Deposition" which is similar to temper bead but per API-510, not NBIC
- A proprietary GTAW HotPulse process was used for this weld

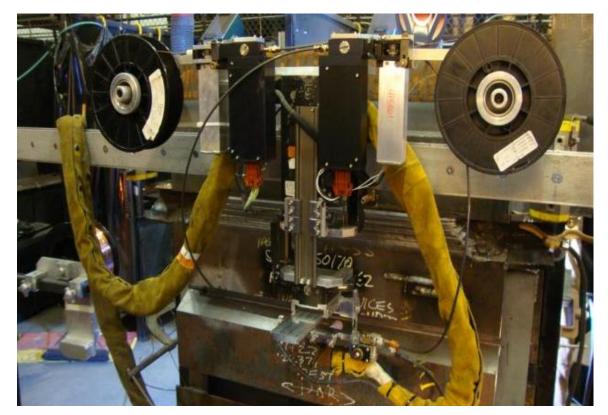
**Better Photo of GTAW Hot Pulse on Mockup**

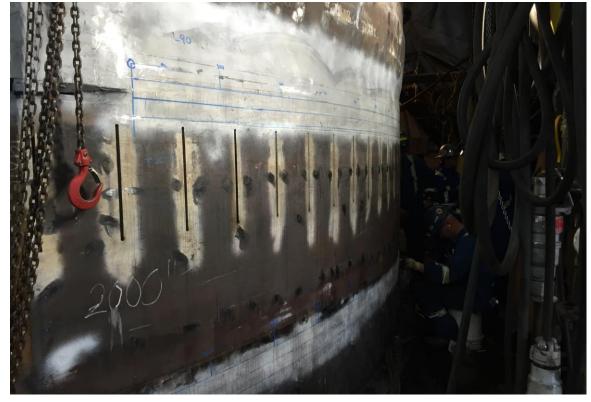
#### Step 10 – Final Assembly after Inspection

**Final Appearance after Installation**

(Inspection: Liquid Penetrant Inspection and Linear Phased Array)
