Coker Fractionator Project Review: Driving Safety and Integrity with Analytical Sophistication

Main Fractionator Vessel

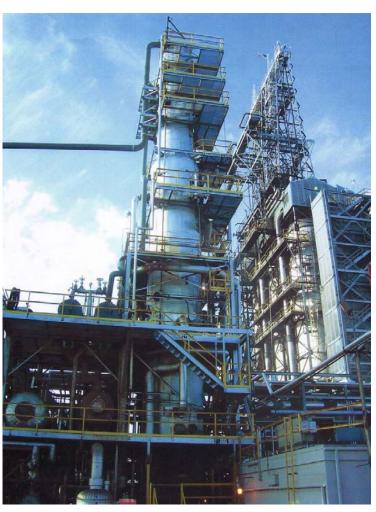
- •Significant Corrosion Thinning
- •Large Portion of the Vessel Affected (18m Height)

- •Bottom portion clad with 405 SST
- •Improved Corrosion Resistance Needed
- •Uncertainty with extent of damage

- Section Replacement
- •Component Replacement
- •Weld Metal Overlay

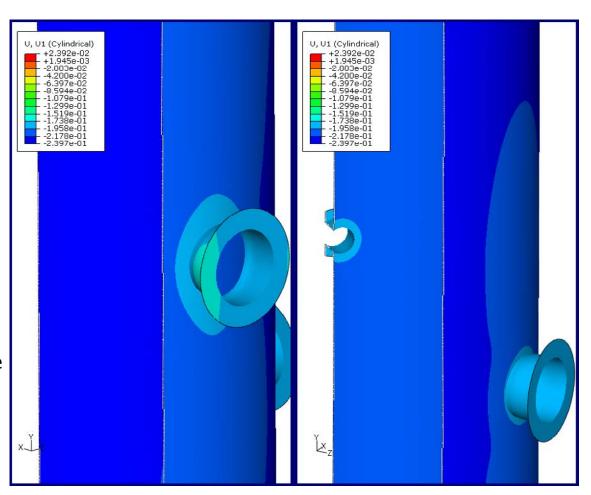
- •Improved Corrosion Performance
- •Concerns about out of roundness ASME Section VIII

•0.04% and 0.02% Deviation at Critical

- •Address structural risks
- •Model Optimum Application Order

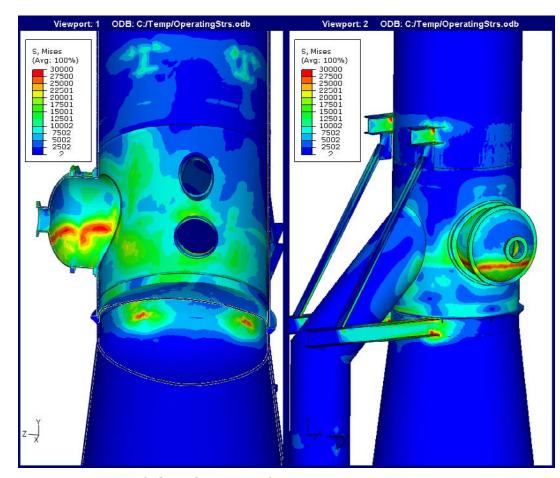
FCCU Stripper/Reactor Failure Area

- •FCCU Stripper/Reactor
- High Temperature Creep Failure
- •5 Year Life Extension Required

- •Model Existing Failure Condition
- •Develop "Engineered Design Repair" to manage stress levels below creep failure limits
- •Perform Level 3 FFS Analysis

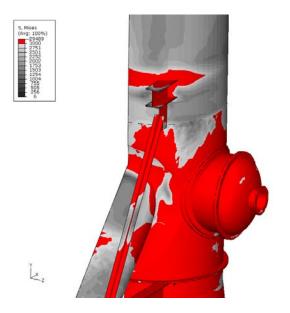
Estimated Life of Repair Well in Excess of 5 Years

Areas Exceeding Creep Stress Limit

Engineered Structural Overlay
