# Delayed Coker Cutting Derrick Collapse

Presented by Mitch Moloney of **ExxonMobil**

@ Dusseldorf DL coking.com Oktober-2011

# Delayed Coker Partial Derrick Collapse

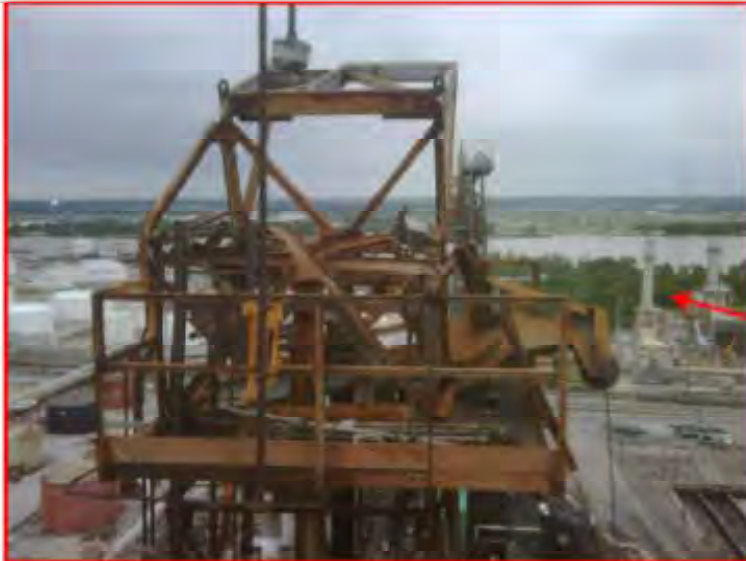
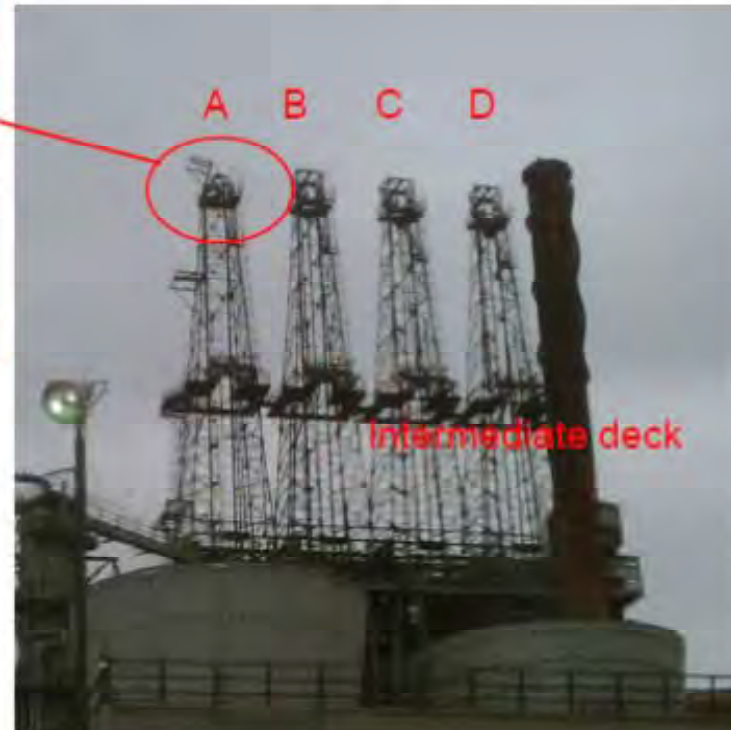
In addition to the "A" drum, "B" drum was rendered inoperable since the two drums share a common bottom un-heading system. The "A" bottom head was un-headed at the time of the derrick failure.

Sunday May 9, at approx 9:00 AM the top 8-10 feet of the Far East Coker derrick collapsed while cutting a drum and attempting to free a stuck drill stem.

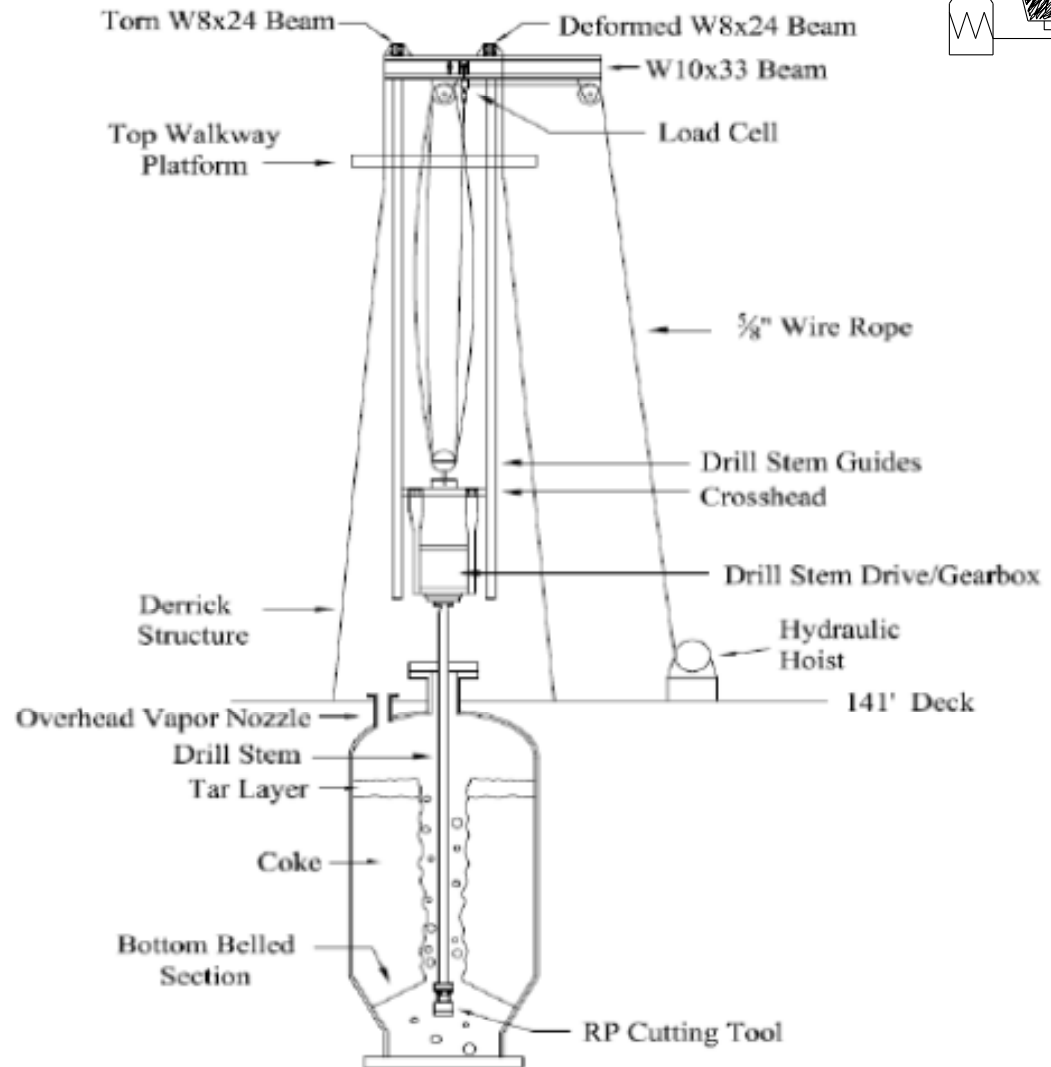
CoFlexip Cutting Hoses  
RuhrPumpen Manual Cutting Bit  
RuhrPumpen Pneumatic rotary joint  
Joy Winch 1970's version retrofit  
to hydraulics by Exxon

No Free-Fall Arrestor  
No Cable Tension Readout  
No Cutting Tool Elevation Readout

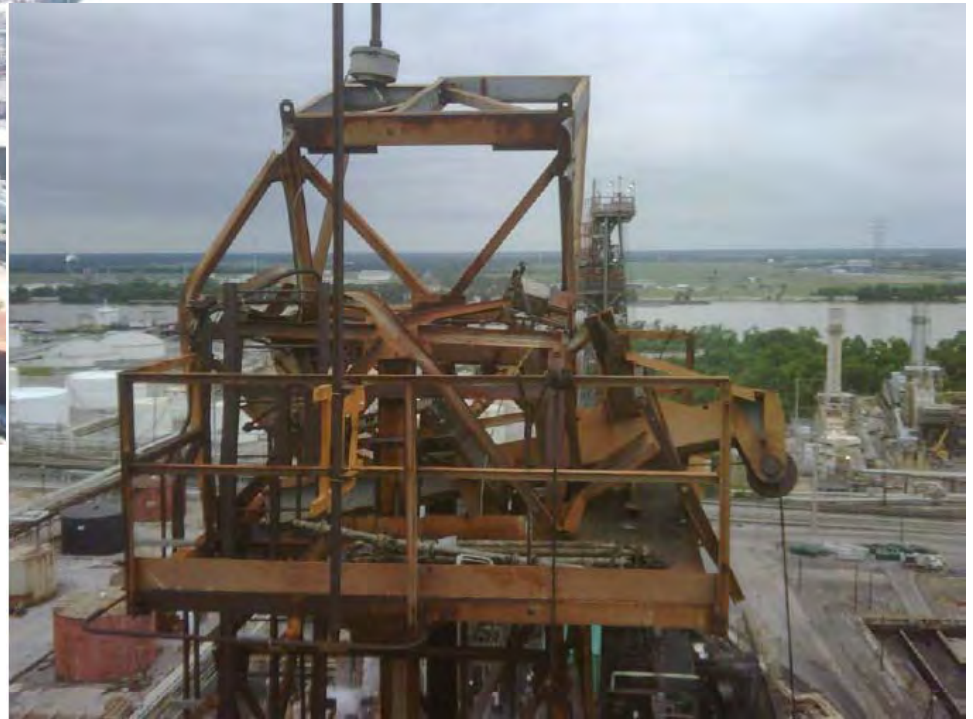
After

At approximately 7:30 AM, it was discovered that the top 8-10 feet of the Coker derrick had collapsed.

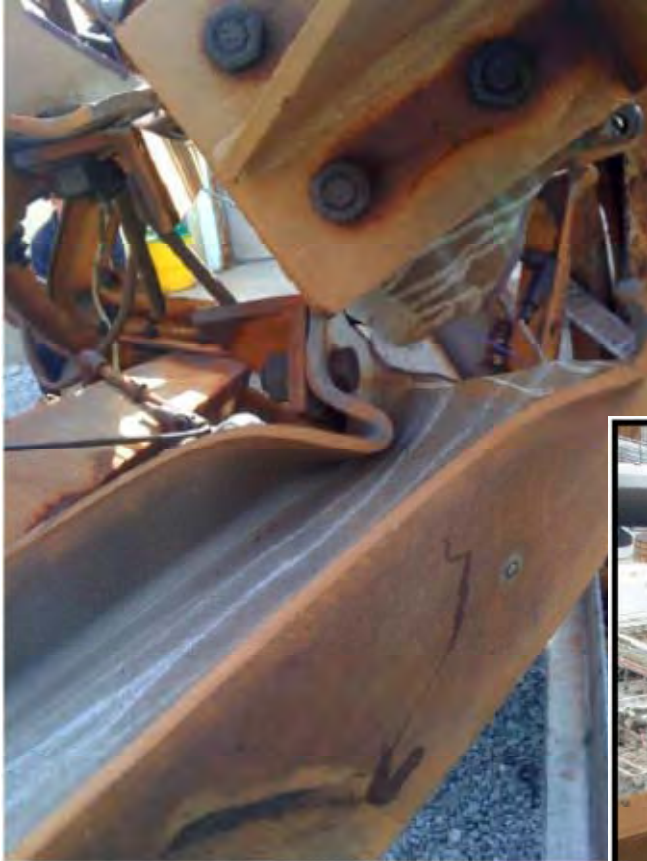
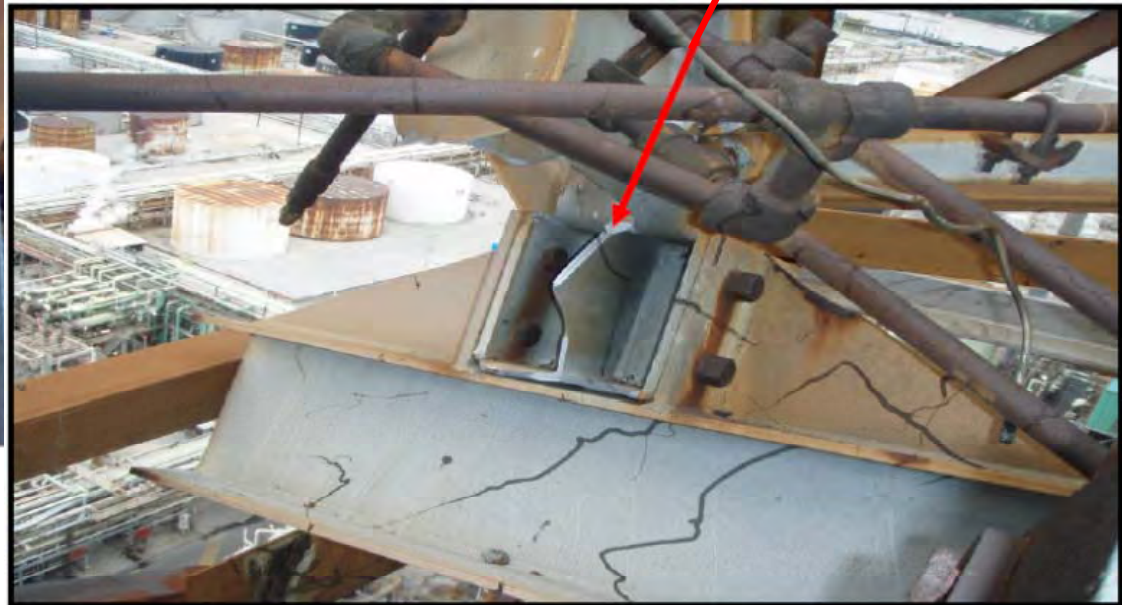
**Torn W8 x 24 Beam**

The ultimate tensile strength of the W8 x 24 beam was calculated to be on the order of 55k lbs (25k kg) of static load

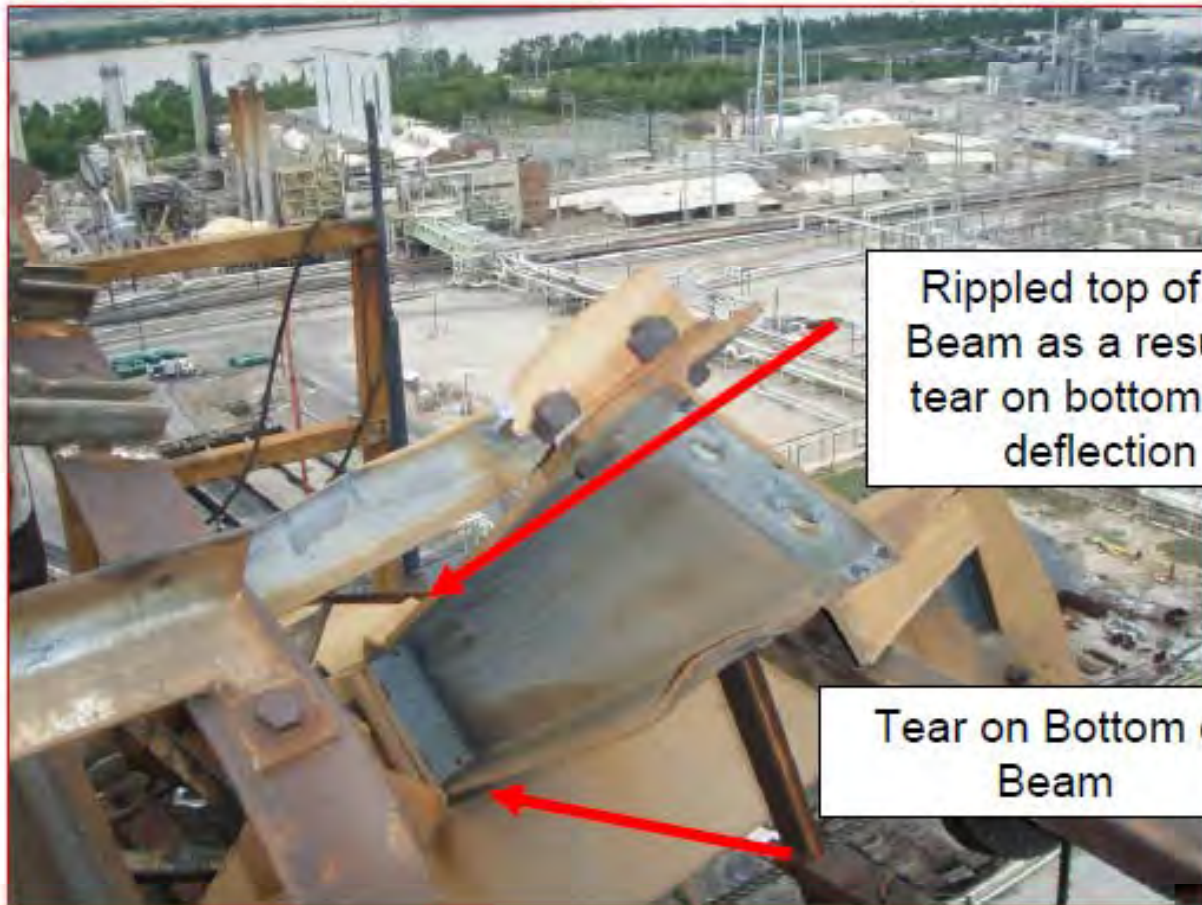
### Another Failed W8 x 24 Beam

Rippled top of W8  
Beam as a result of  
tear on bottom and  
deflection

Tear on Bottom of  
Beam

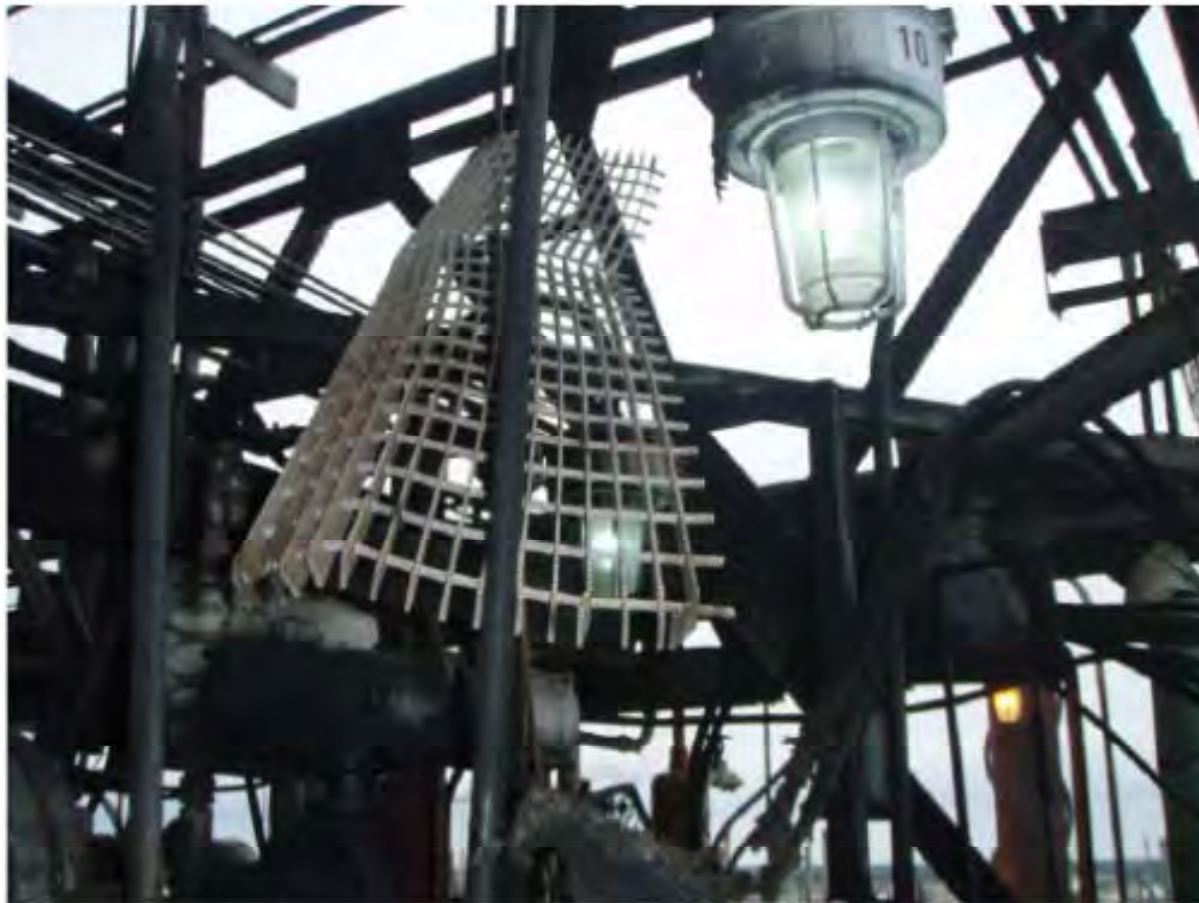
Grating fell 85 ft (26 m) to cutting deck (141 deck)

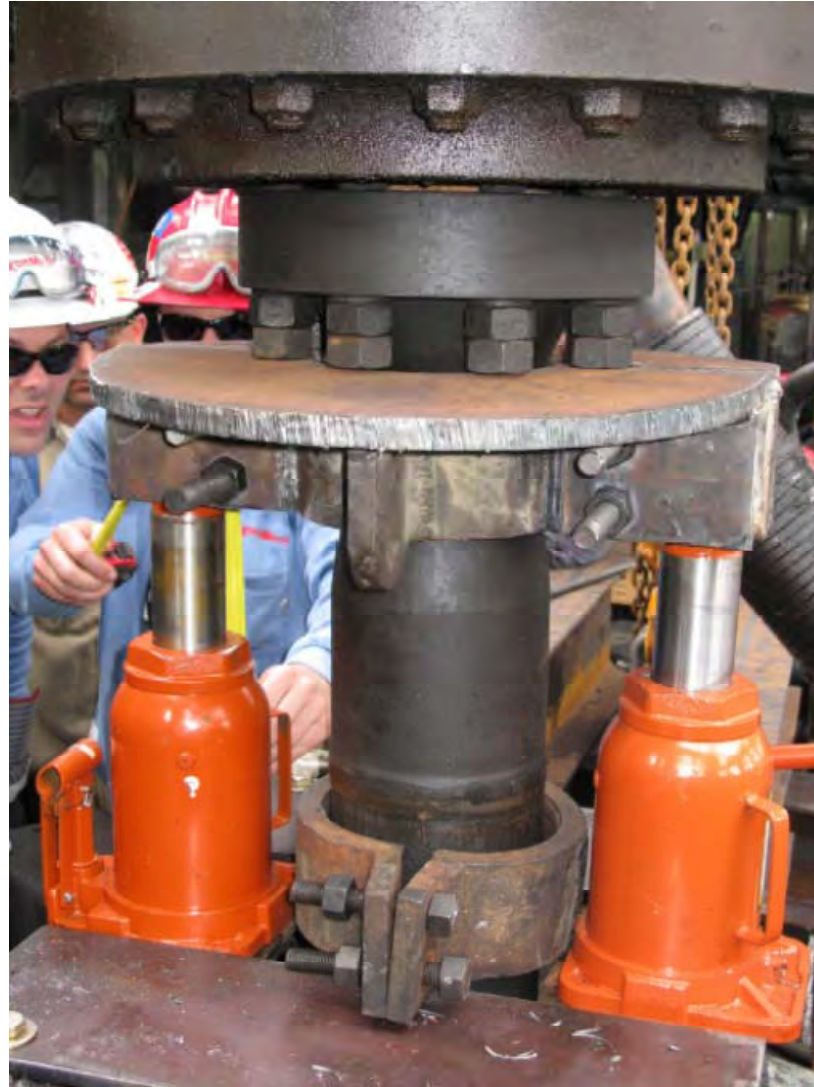
- Two 30 ton jacks installed to lift drill stem
- Effort limited by top deck beam deflection limits & inability to supplement with winch pull, since the top derrick was destroyed.

This coker (Site-1) found that 60,000 lbs (27,000 kg) was maximum load the coke drum structure beams could support. And they did detect beam deflection on the structure when that force was applied.

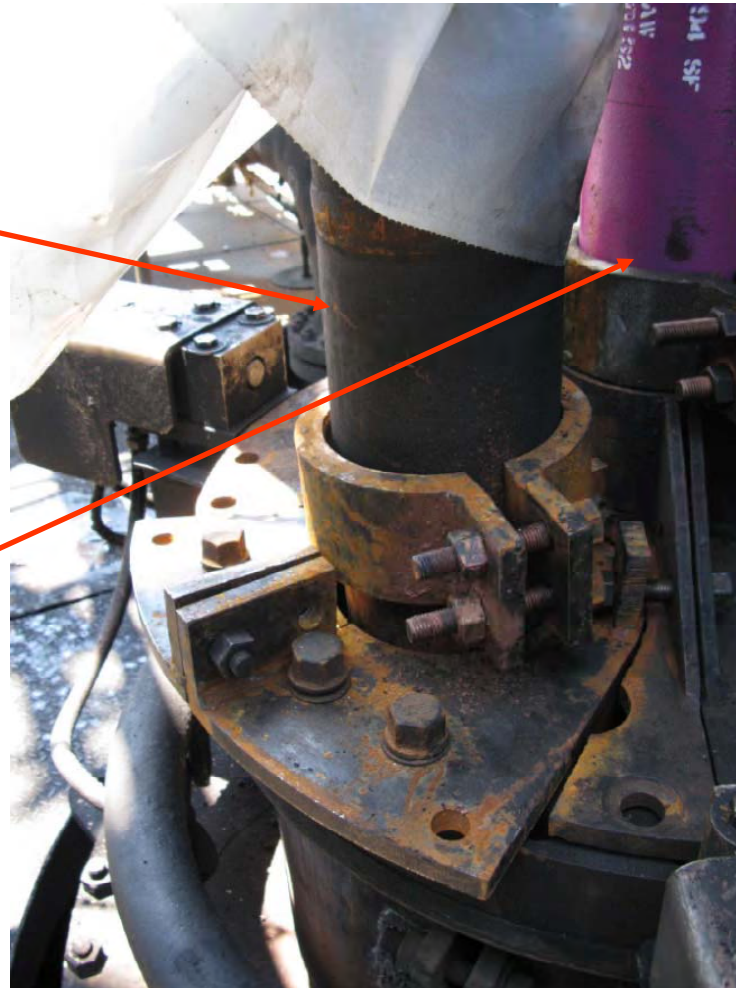
Stuck Drill Stem, after detaching from rotary joint, was clamped to Side

Second drill stem provided to cut coke from bottom.

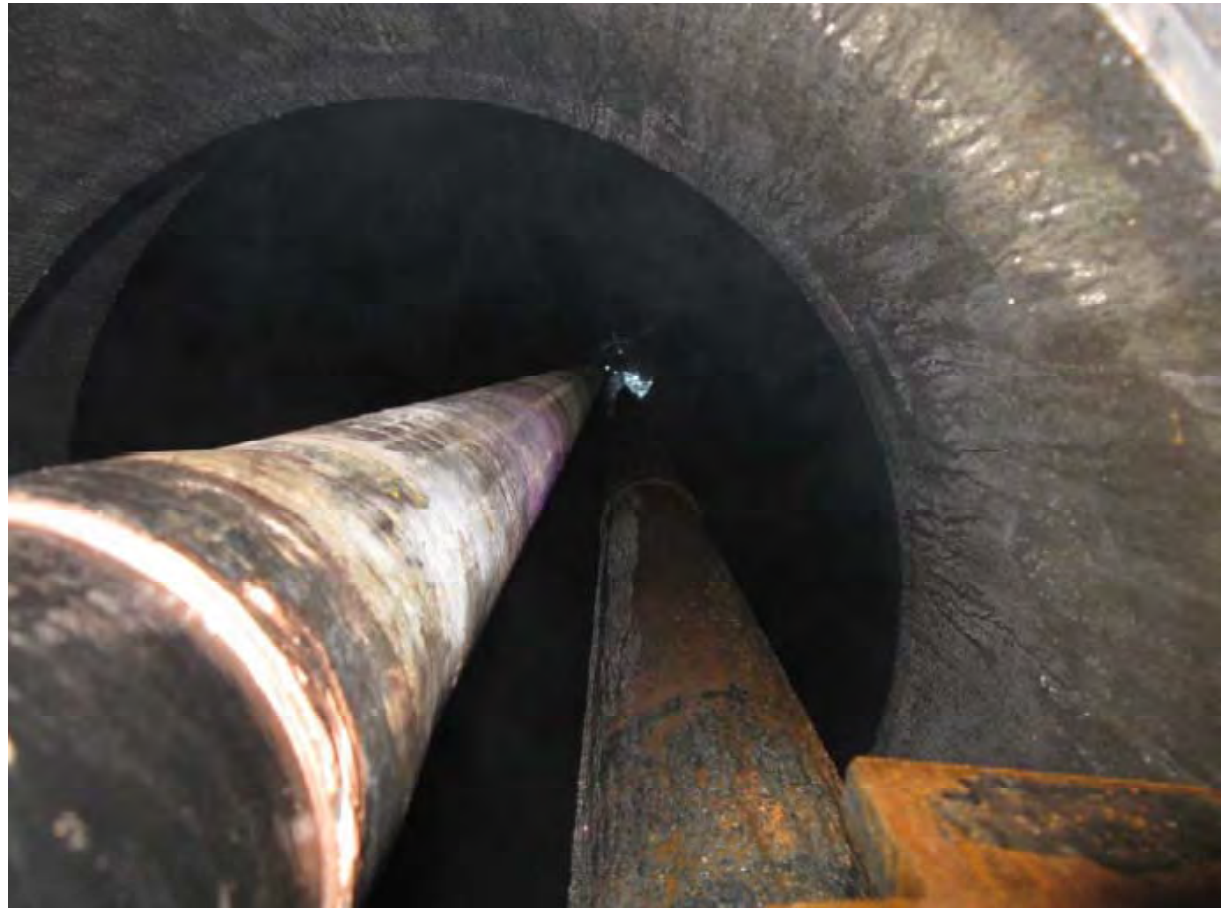
View down the hole, after 2nd drill stem cut through the coke

The majority of coke had fallen through when the cone area was being enlarged.

The partially coked resid had stuck in that lower area. The second drill stem allowed the coke to be cut into the pit.

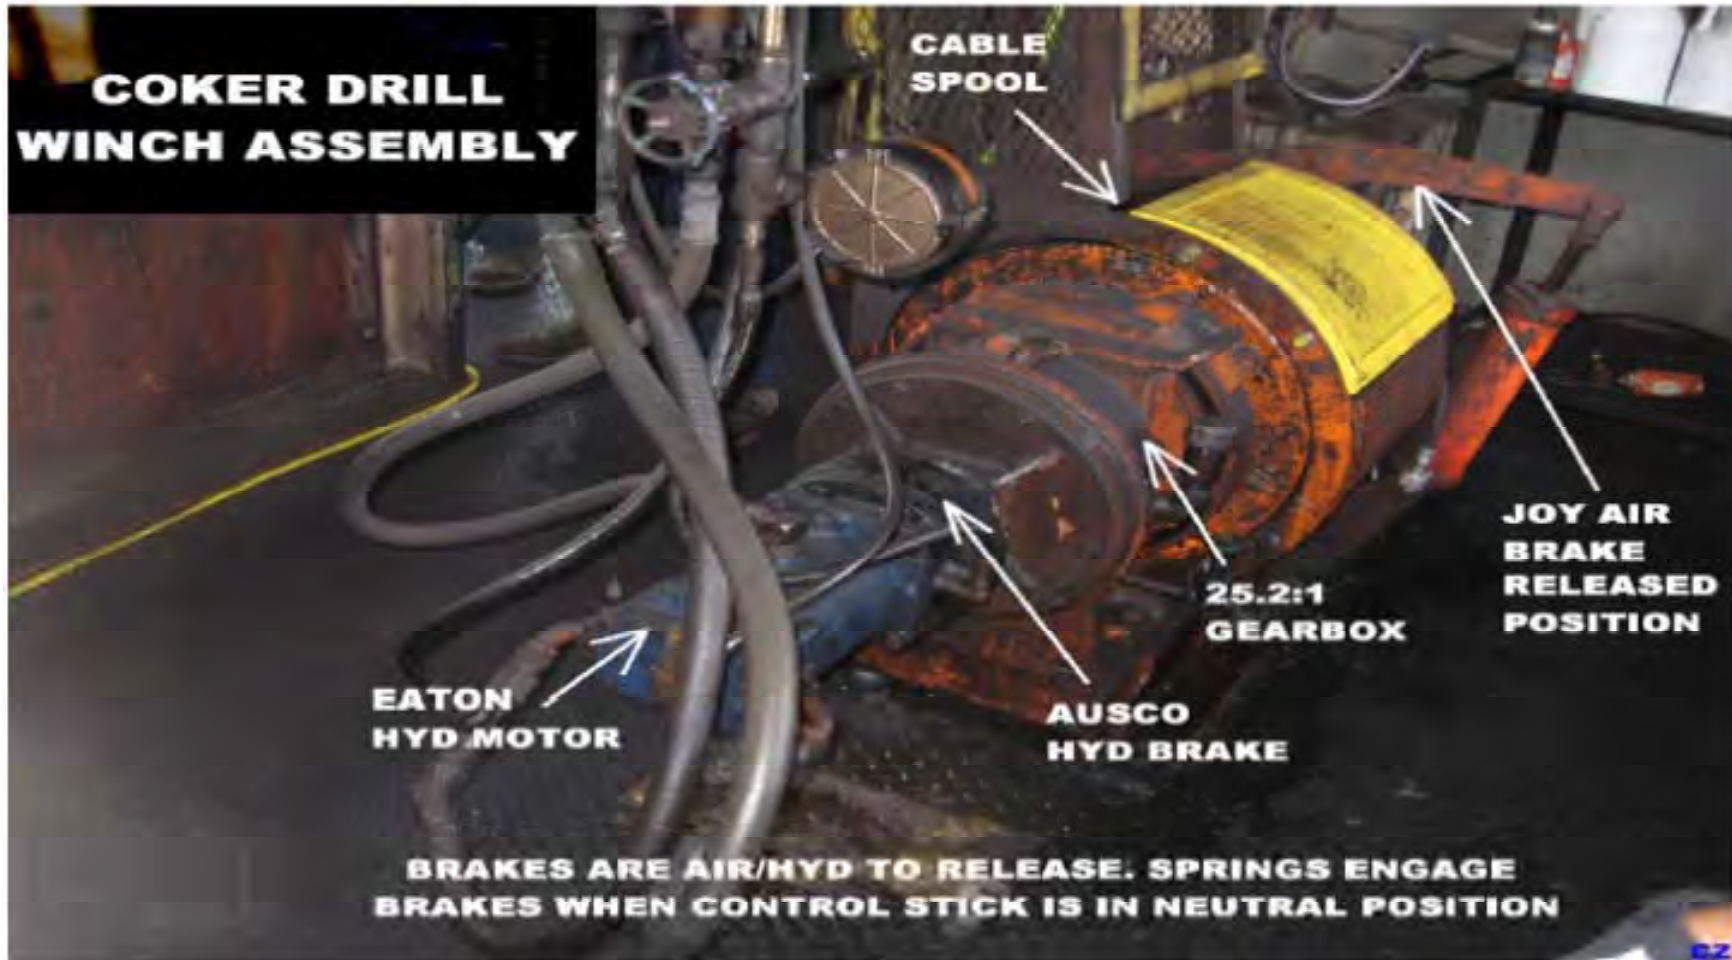
Not because of the winch.

The winch brakes worked (no disc/rotor burns). Sheaves all in proper position.

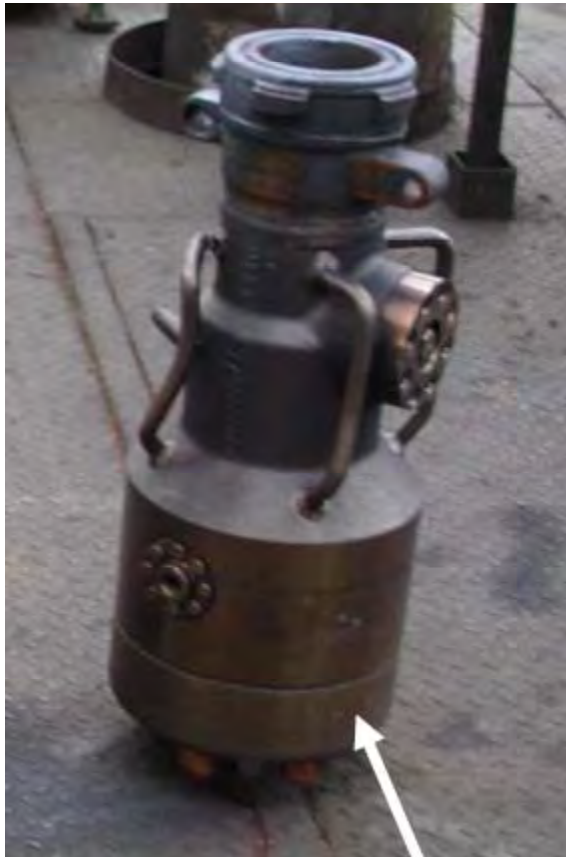
Not because of the cutting tool

The new, sleek 13-inch (33 cm) diameter RuhrPumpen tools were in place
