FCCU Regenerator Vessel Structural Repair Utilizing Automated Weld Metal Overlay

REFCOMM
RIO DE JANEIRO

29 Sept – 3 Oct 2014

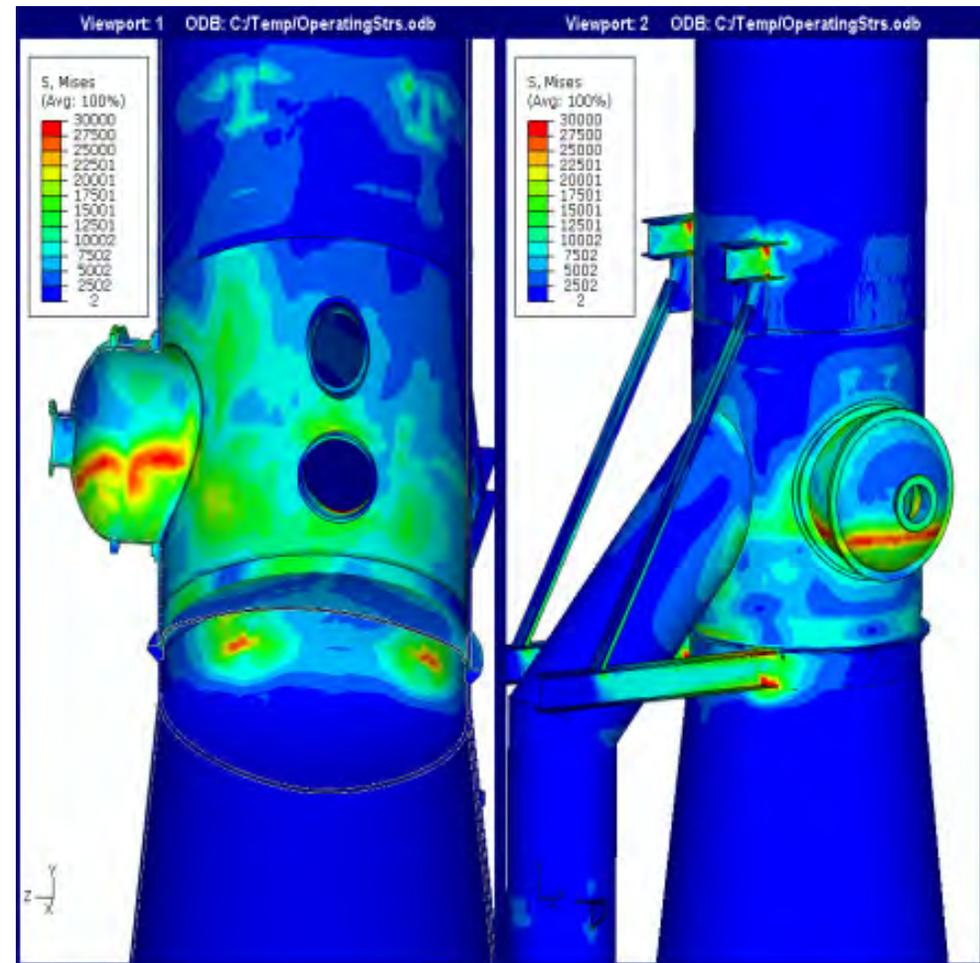
- FCCU stripper/reactor
- High temperature creep failure
- 5 Year life extension required

FCCU Stripper/Reactor failure area

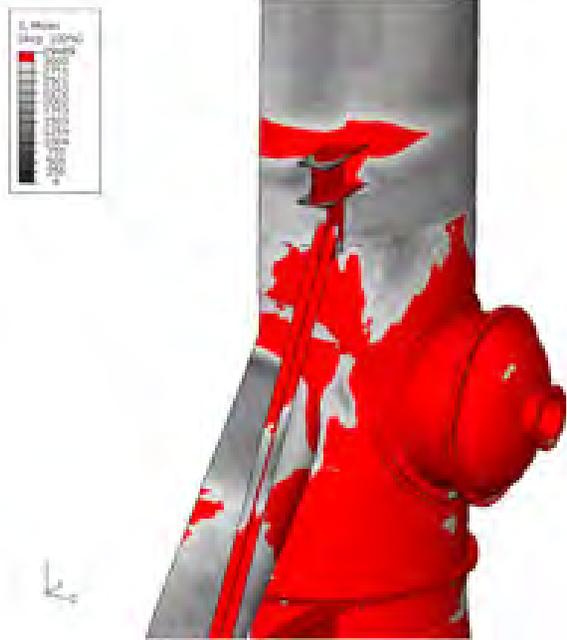
Areas Exceeding Creep Stress Limit

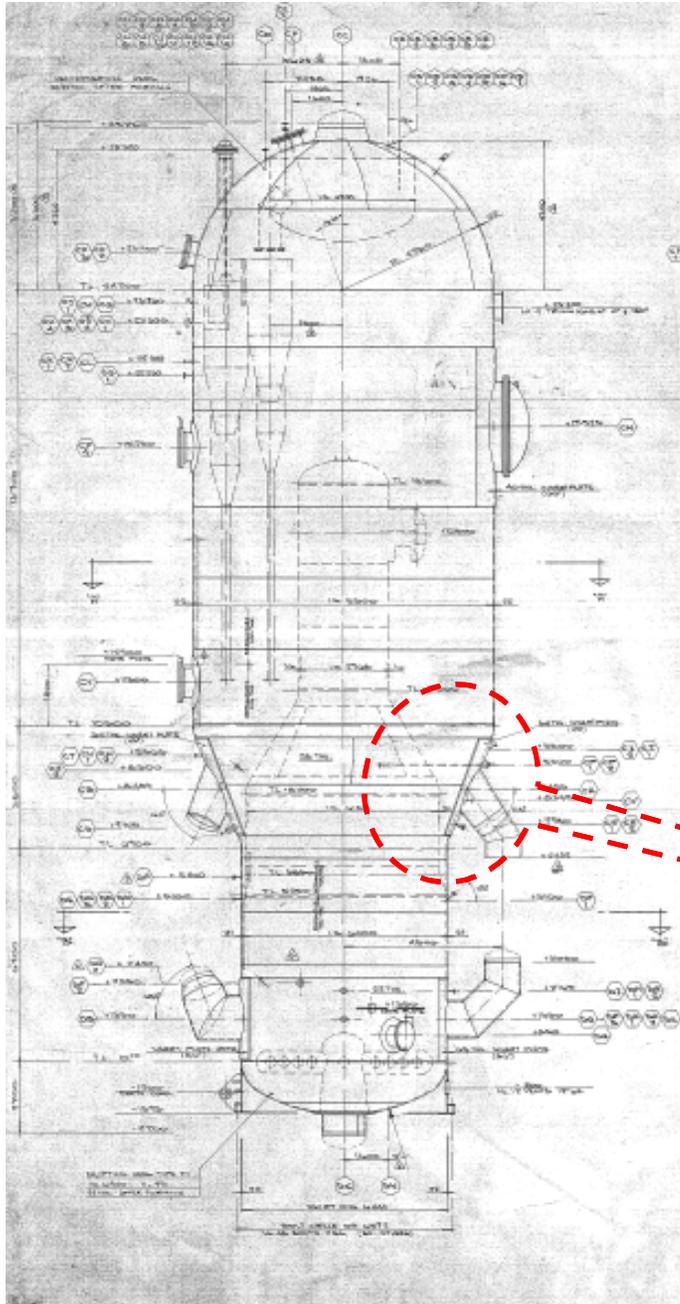
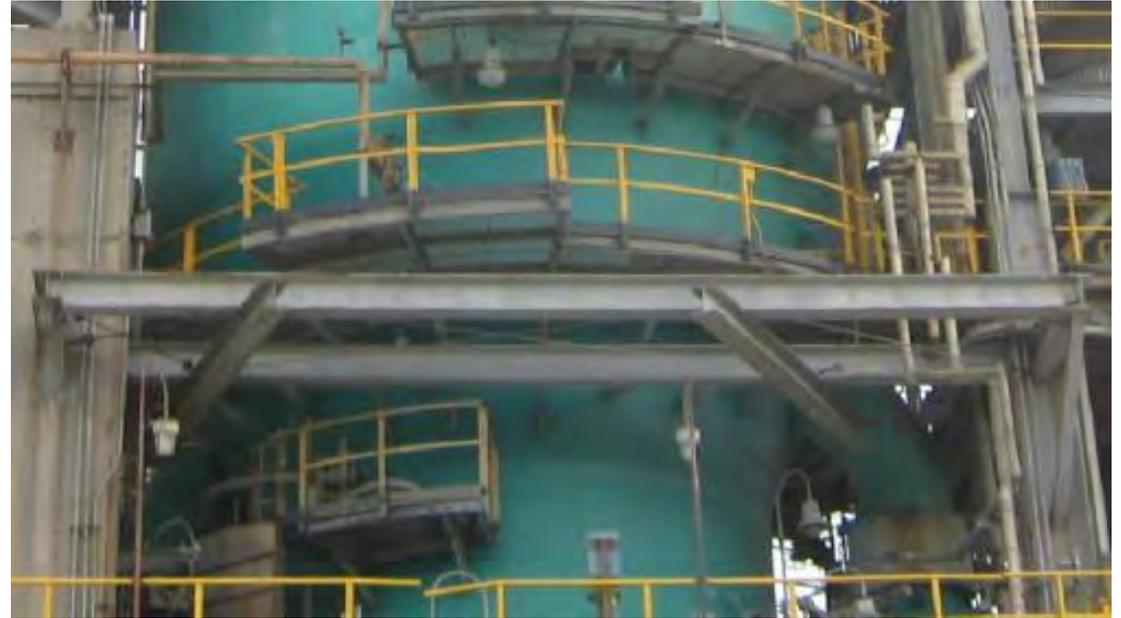
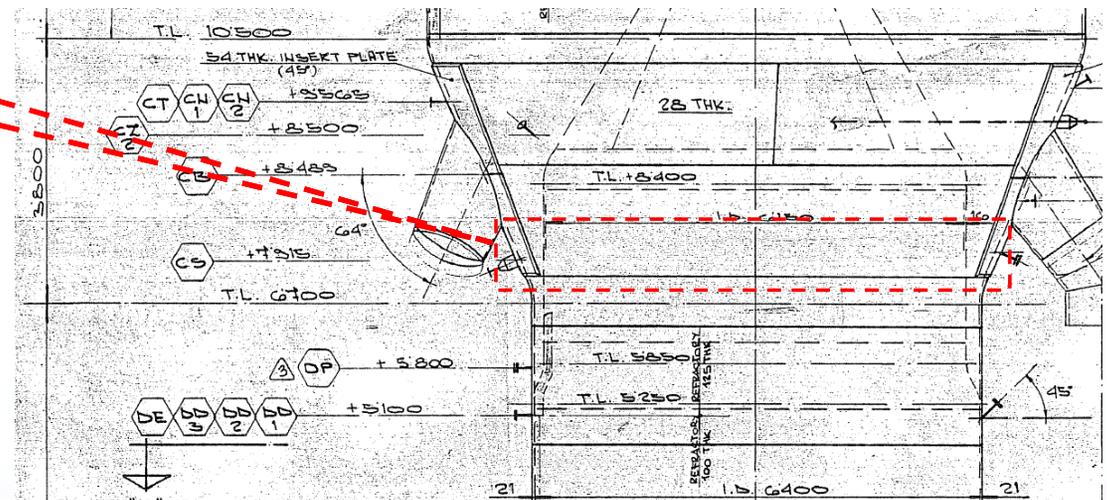
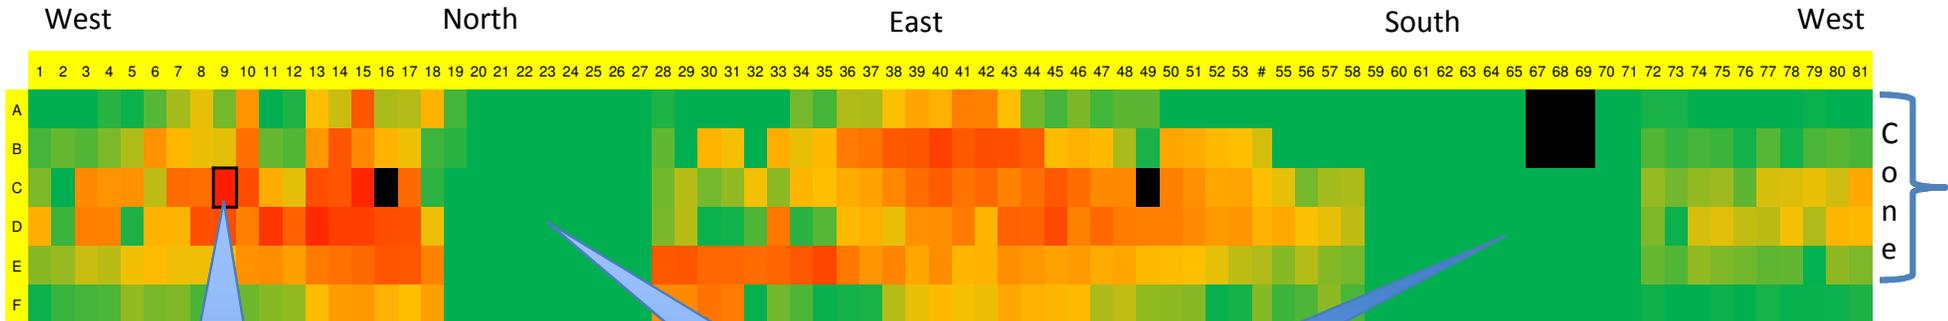
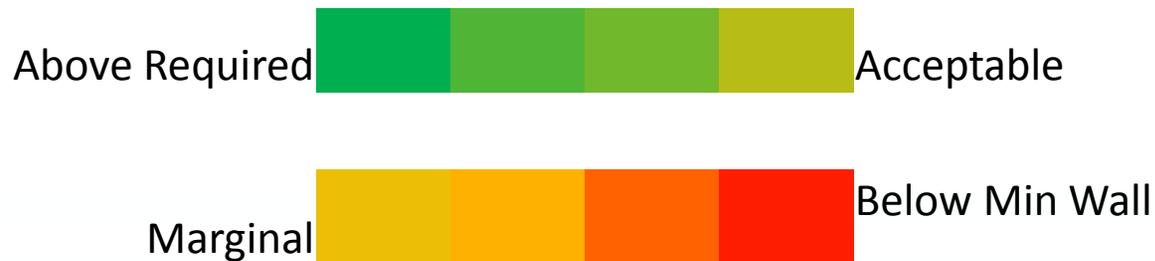
Lowest thickness location
.192" (4.9mm)

Original Thickness
Cone = Approx 1.1" (28mm)
Shell = Approx 0.8" (21mm)
Marginal Thickness
Less than 0.7" (17.8mm)

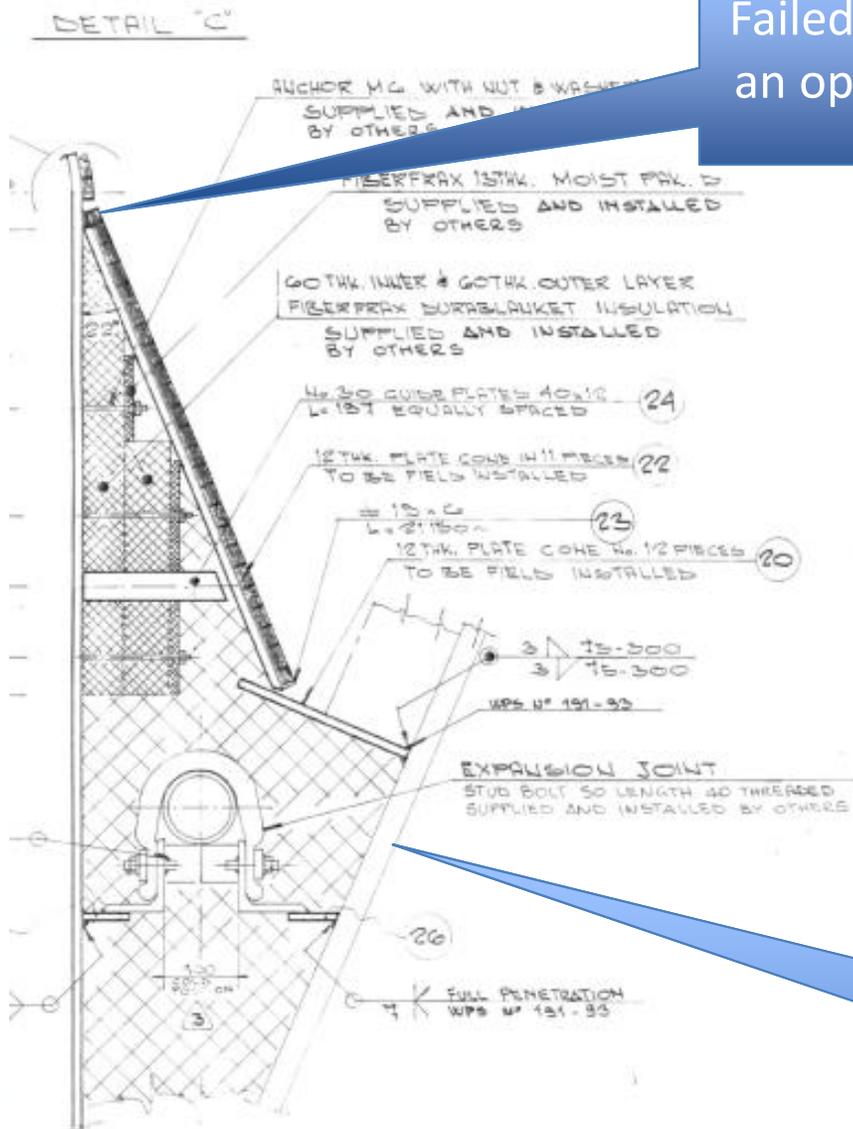
Failed weld allowed an opening to form

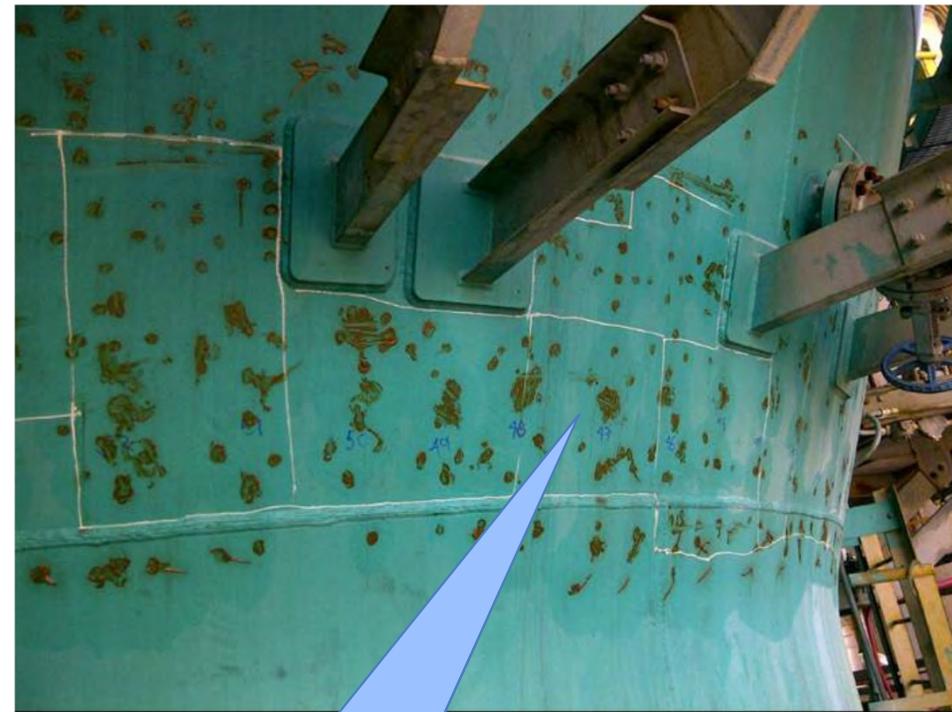
Significant ID wall thickness loss experienced

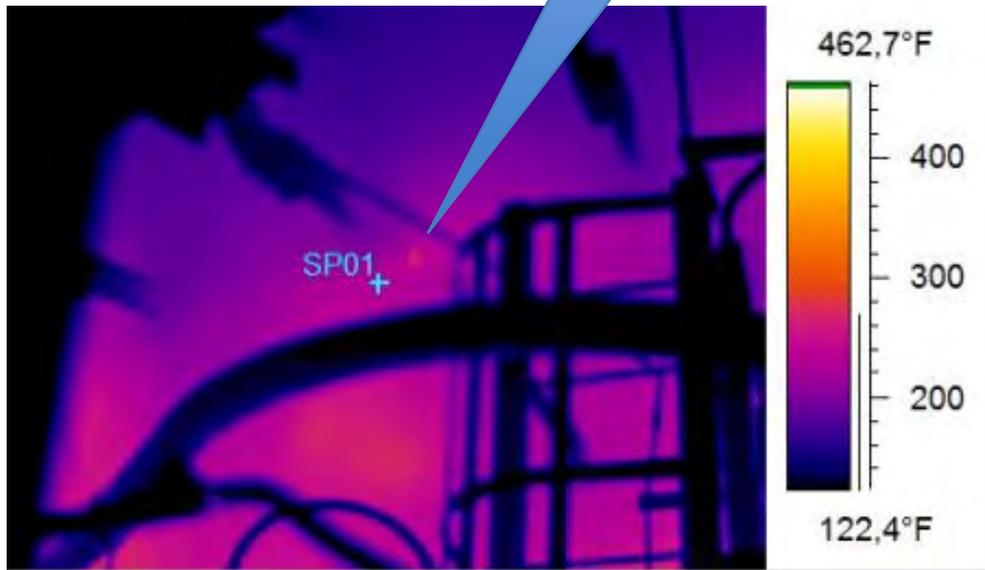
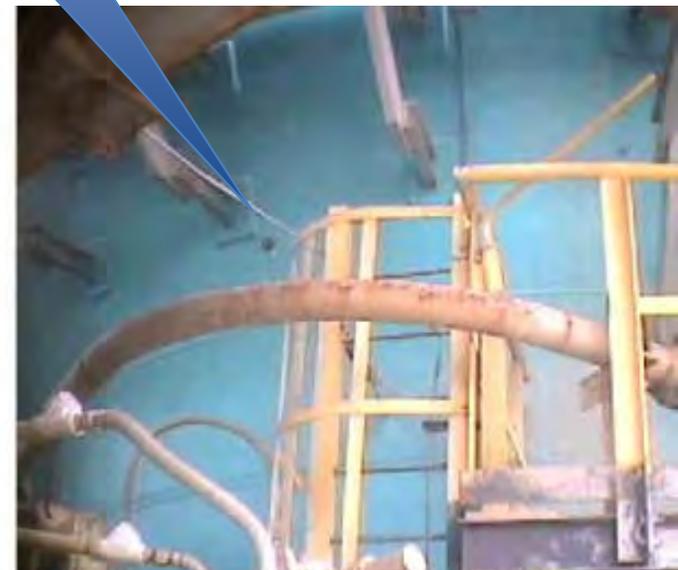
Thermal Image and
Photo of leak
location

- Refinery Located in Barrancabermeja, Colombia
- Two small leaks detected in April 2013
- Leak Areas repaired using external window patches
- May of 2013 UT mapping indicated significant loss of wall thickness in the cone to cylinder transition of the vessel
- Several repair options were evaluated:

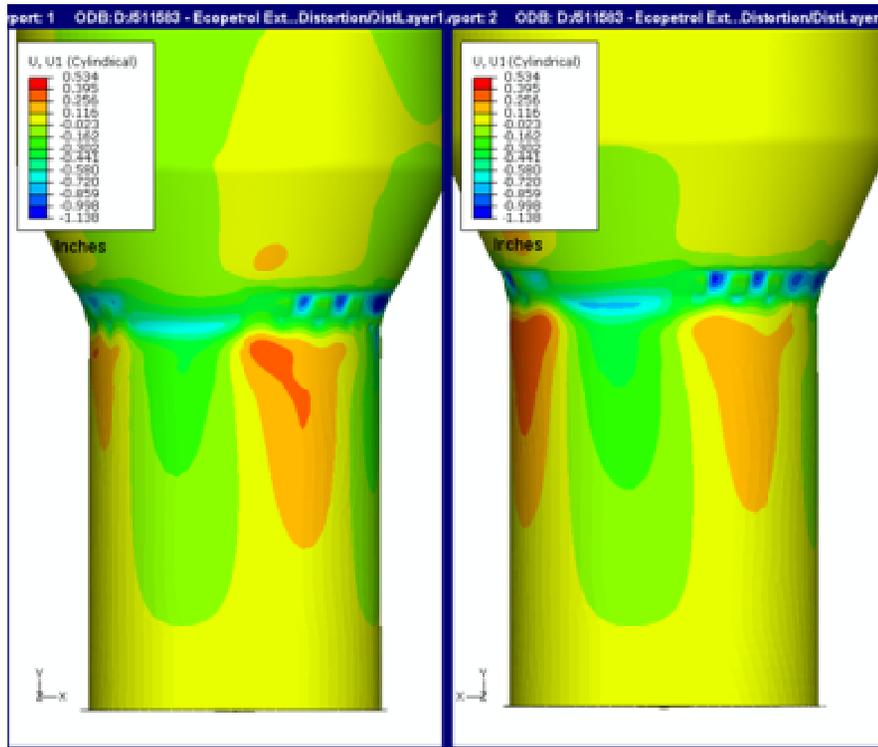
Predicted Layer 1 Distortion

- Large areas of the as-found vessel are critically thin
- Since all weld overlays cause some distortion an analysis was performed to ensure that distortion experienced would not affect the vessel internals and that the vessel would meet the code required Out-of-Roundness UG-80 criteria.

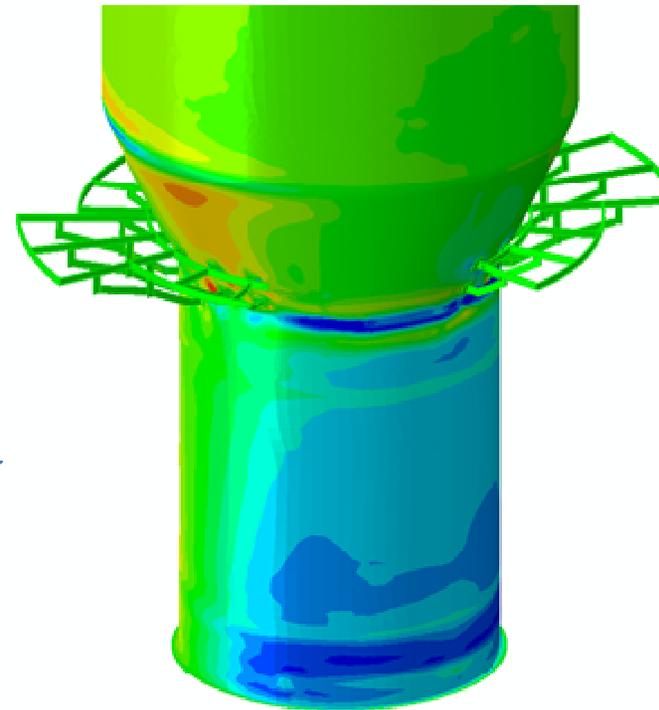
Shaded Plot of Vessel Predicted Plastic Collapse Load - Operation after Repair

No Plastic collapse of the vessel occurs from the identified load case.
Meets API 579 FFS Criteria

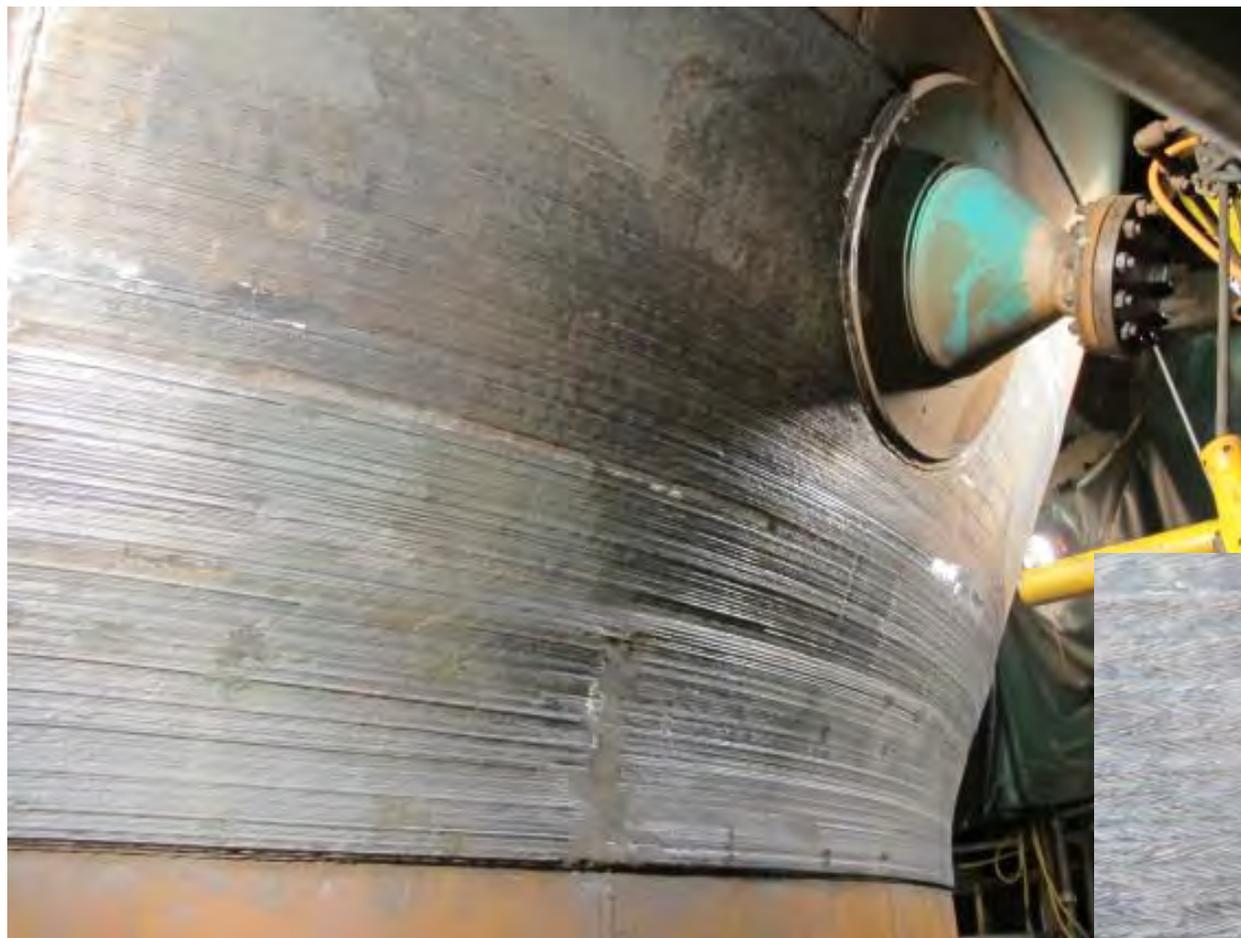
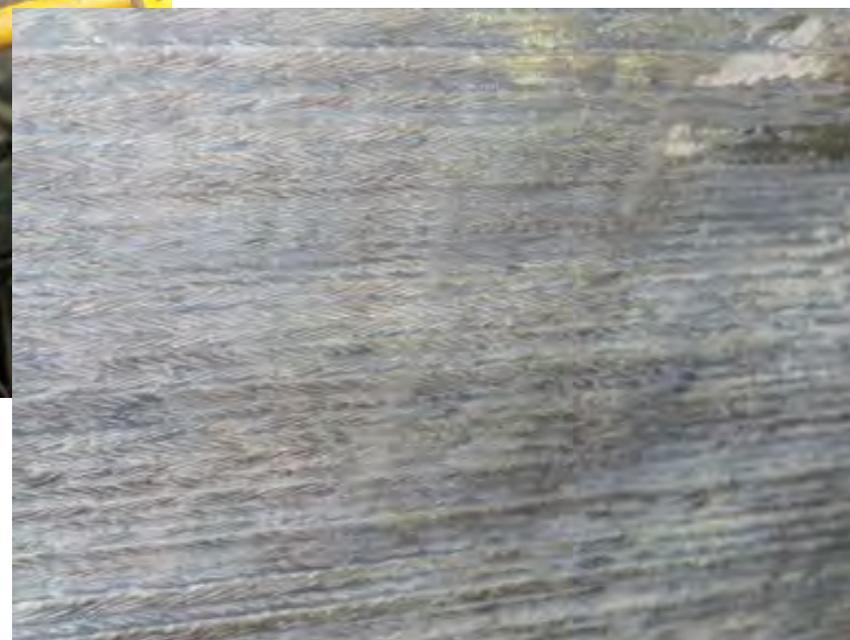
Three Layer Structural Overlay

*Finished Structural Overlay
(three layers)*

- Structural Overlay was utilized to repair significant pressure vessel wall thinning.
- A proprietary predictive numerical distortion analysis was used to determine viability of repair prior to implementation.
- A Fitness for Service analysis was performed per API 579 to qualify the repair.
- Project was performed ahead of estimated schedule with zero safety incidents.
- Project was completed below initial estimated cost.
