Coke Drum Dual Feed Issues

David Gibson – ExxonMobil Manufacturing Principle Engineer

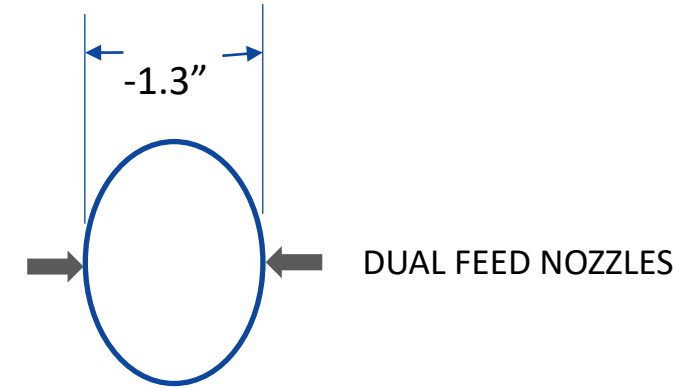
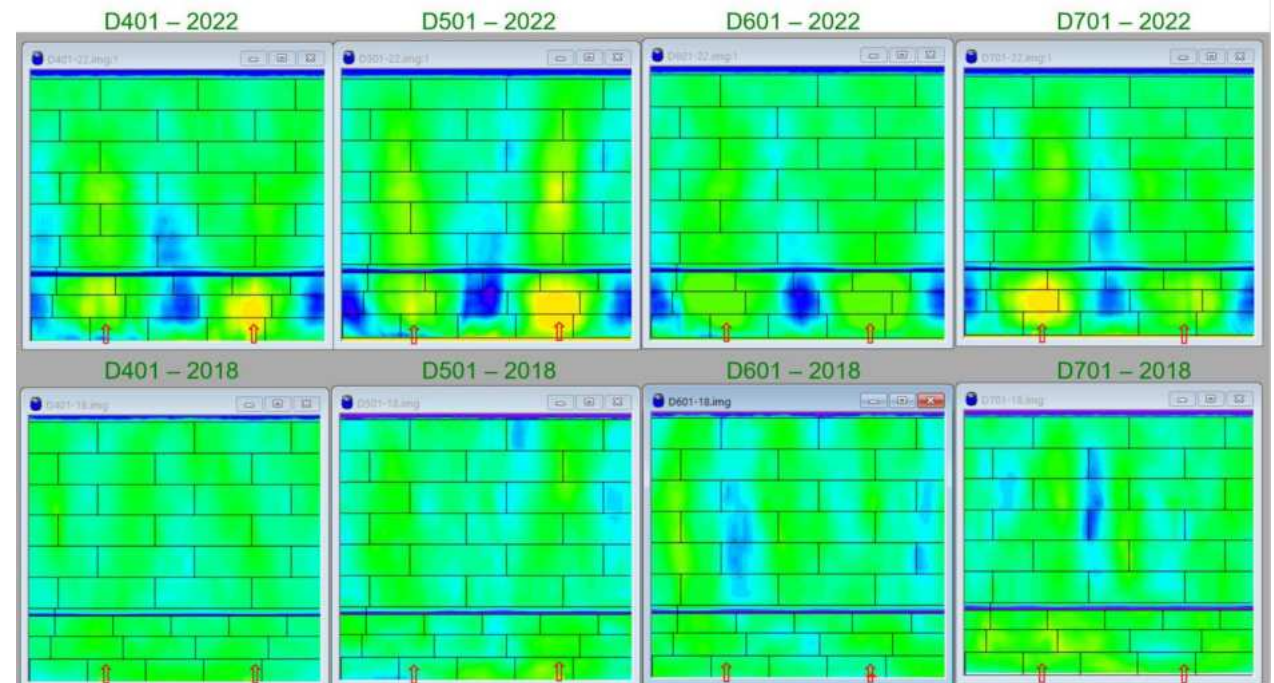
Cone/Flange Distortion Issues

- Severe flange distortion – ovalization
 - In plane of dual feed nozzles
 - 1.3” diametrical flange distortion, varies across 4 drum set
 - Worsening over time
 - May 2022 (~650 cycles) → 1.1” deformation
 - October 2023 (~750 cycles) → 1.38” deformation
 - Joint leakage
 - Gasket failure
 - BUD tapped hole thread damage
- Severe cone distortion
 - Generally ovalized, >4” difference in diameter
 - Localized areas of wrinkles
- Beginning to see anchor bolt failure

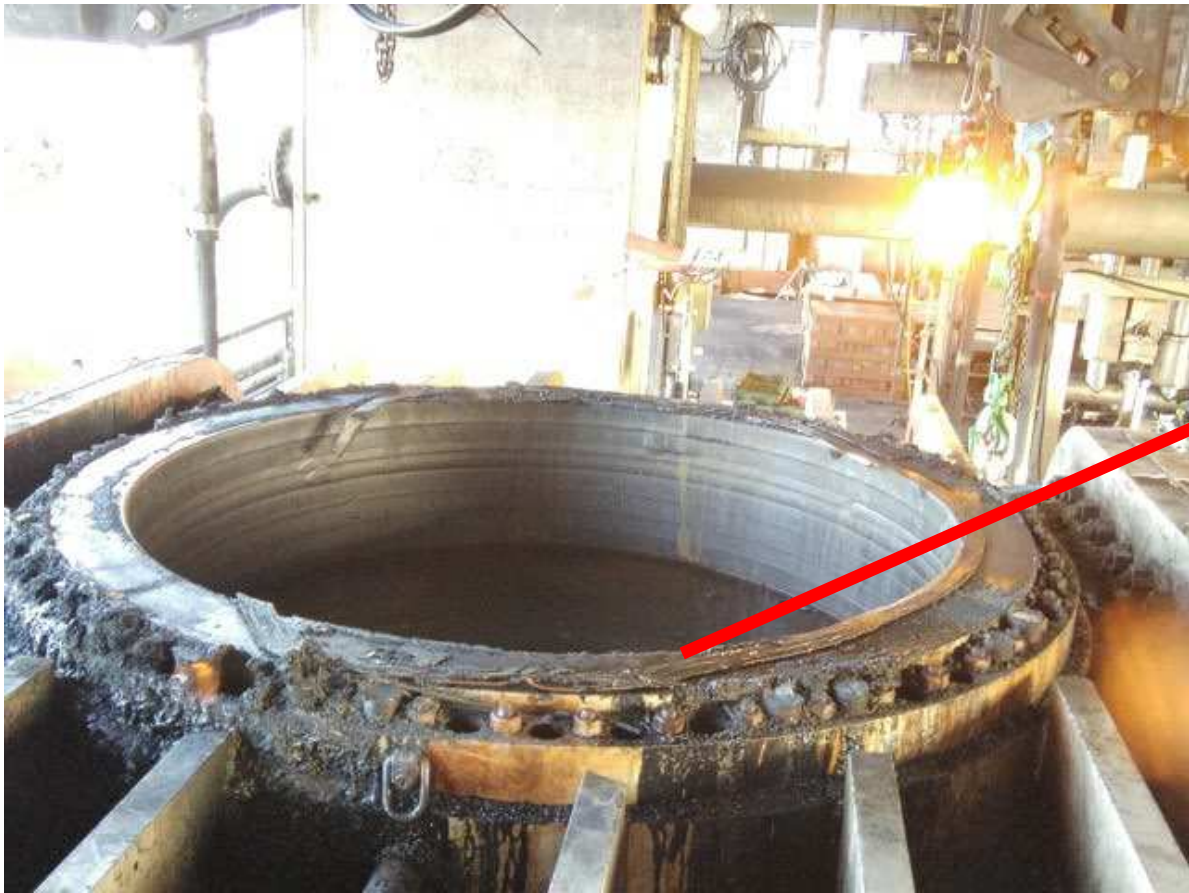
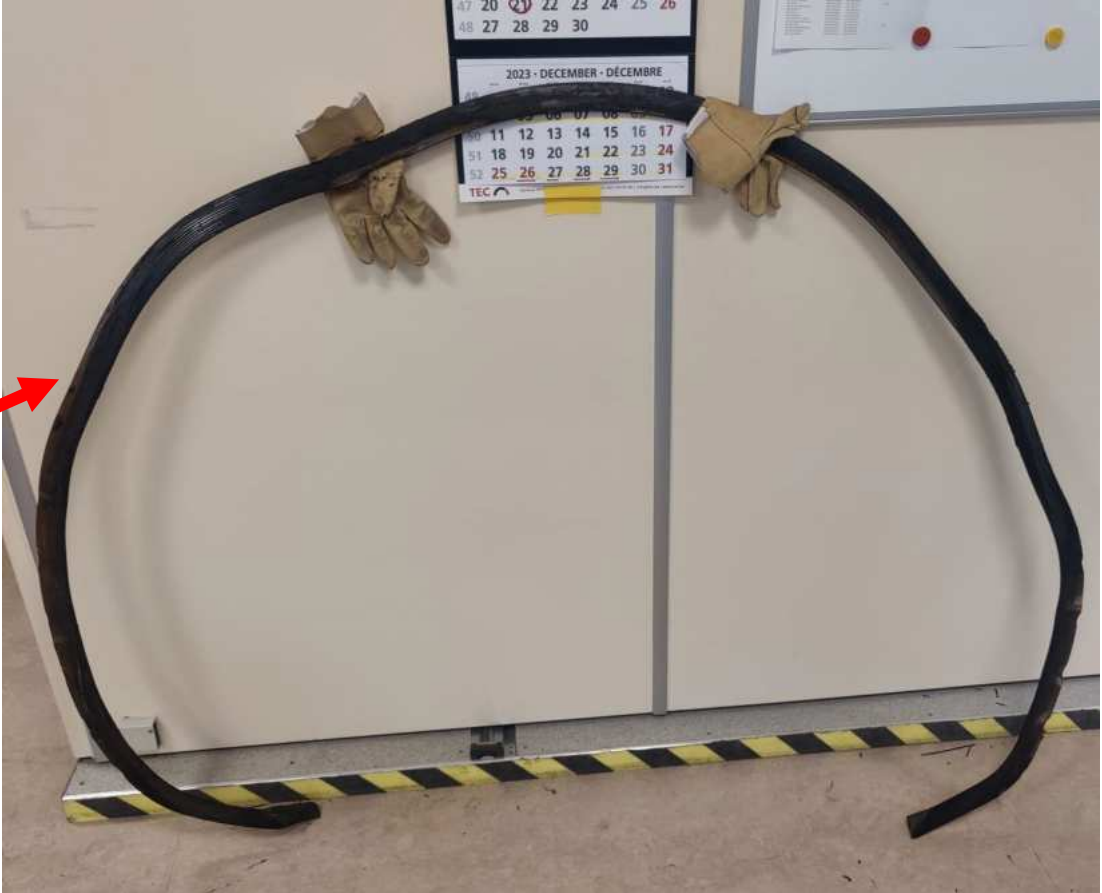
4Q23 Gasket Replacement

Missing gasket section introduces potential for larger leak vs historical flange leakage experience

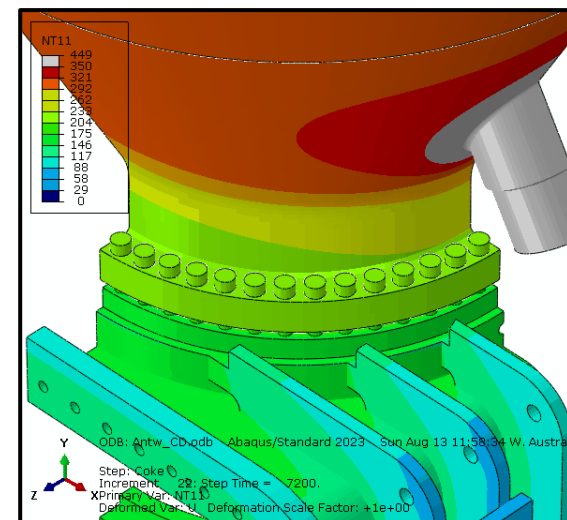
Temperature (°C) Profile During Coking

- Root cause of distortion - Thermal gradients created by the dual feed nozzles
- Valve stiffness does not appear to be a significant contributor to the ovalization.
- Insulating the flange neck to the back of the flange produces slightly less flange deformation and gasket stress variation.
- The flange bolts exceed yield during coke drum operation (bending) → thread damage in valve, extraction difficulty
- Gasket performance during operation is very sensitive to variation in bolt load.

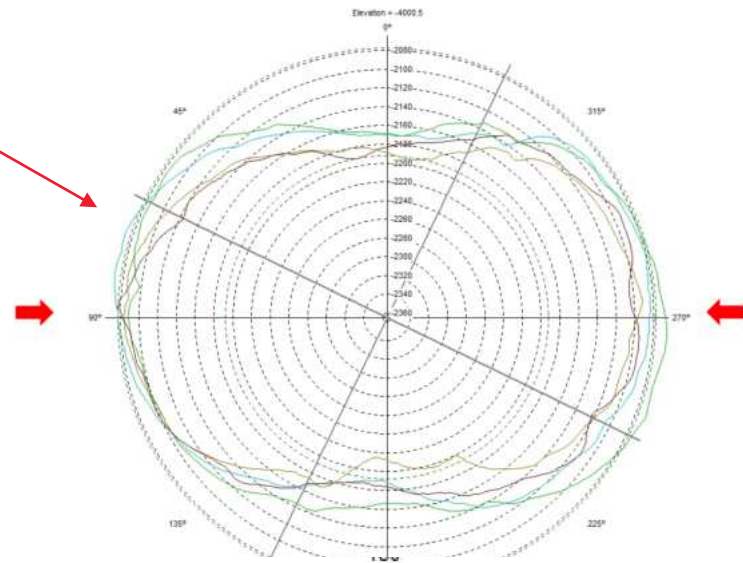
All Four (4) Drum Polar Plots:
Elevation -4000mm

Drum	Min	Max	Diff	Change
D401-22	-2192	-2077	+115	-17
D501-22	-2215	-2084	+132	+26
D701-22	-2171	-2066	+105	-16
D601-22	-2191	-2070	+121	-

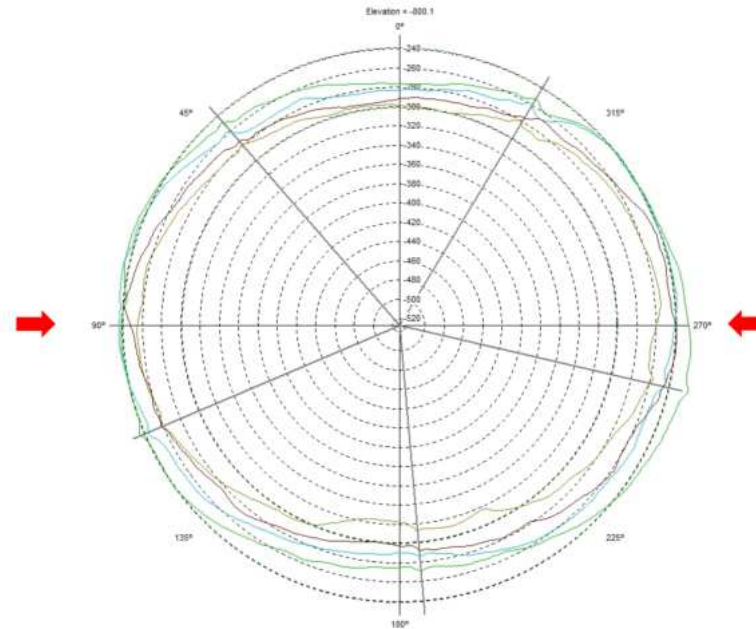
All Four (4) Drum Polar Plots:
Elevation -800mm

Drum	Min	Max	Diff	Change
D401-22	-301	-239	+62	-8
D501-22	-325	-255	+70	+13
D701-22	-277	-220	+57	-2
D601-22	-292	-234	+58	-

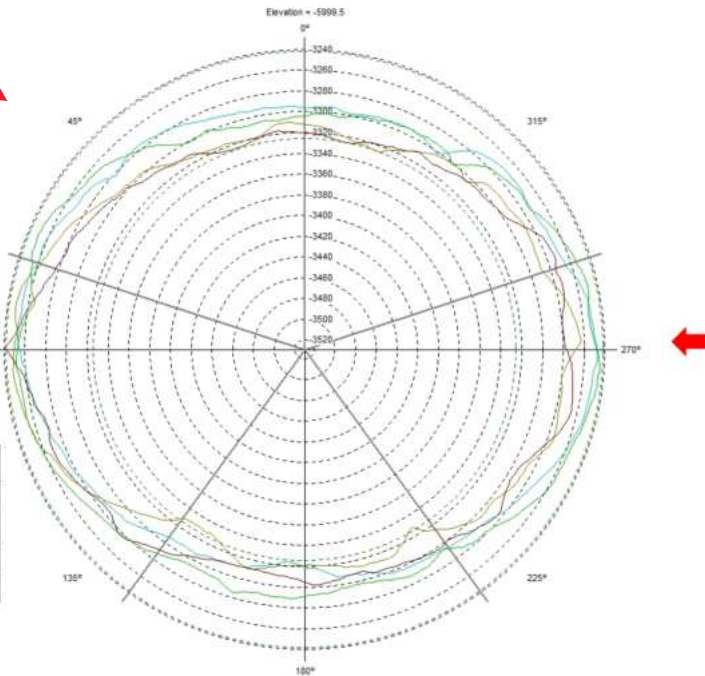
All Four (4) Drum Polar Plots:
Elevation -6000mm

Drum	Min	Max	Diff	Change
D401-22	-3326	-3242	+84	+1
D501-22	-3331	-3248	+83	+22
D701-22	-3307	-3245	+62	-15
D601-22	-3325	-3248	+77	-

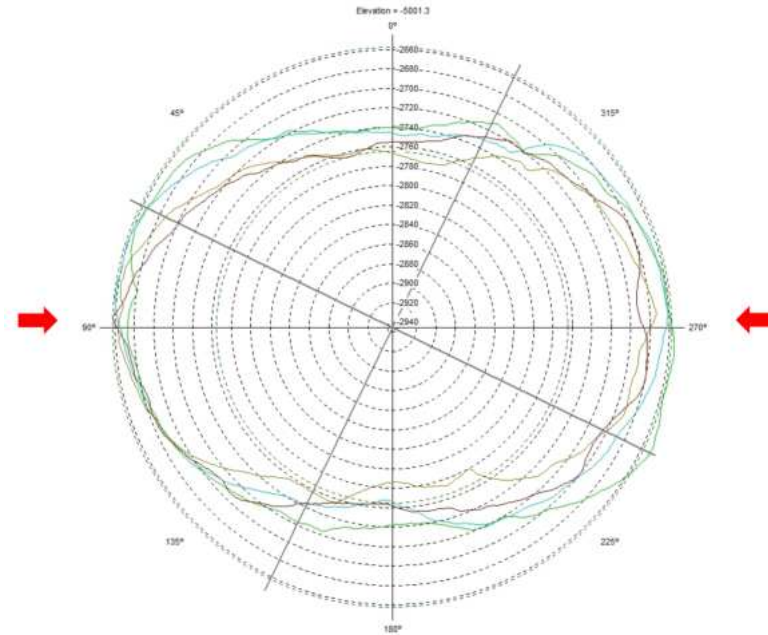
All Four (4) Drum Polar Plots:
Elevation -5000mm

Drum	Min	Max	Diff	Change
D401-22	-2765	-2658	+107	-17
D501-22	-2787	-2663	+124	+31
D701-22	-2744	-2651	+93	-17
D601-22	-2769	-2659	+110	-
