# CASE STUDY DISTRIBUTION TRANSFORMER AND PD DETECTION

Charlie Smith, IAE Subject Matter Expert  
[Charlie@refiningcommunity.com](mailto:Charlie@refiningcommunity.com)

1 MVA oil-filled transformer

Sole power supply for refinery Nitrogen production plant

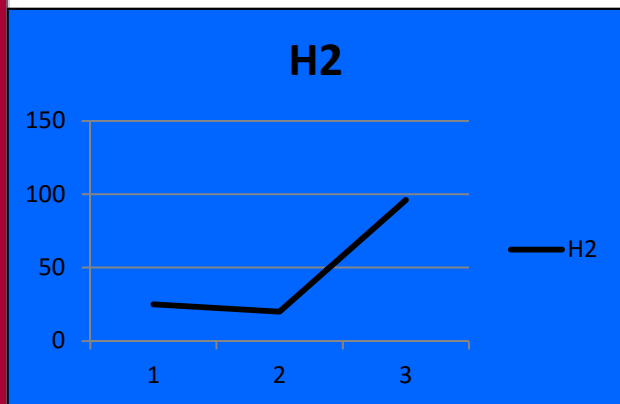
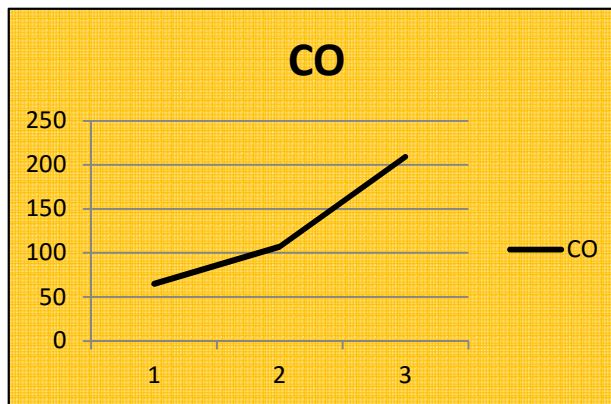
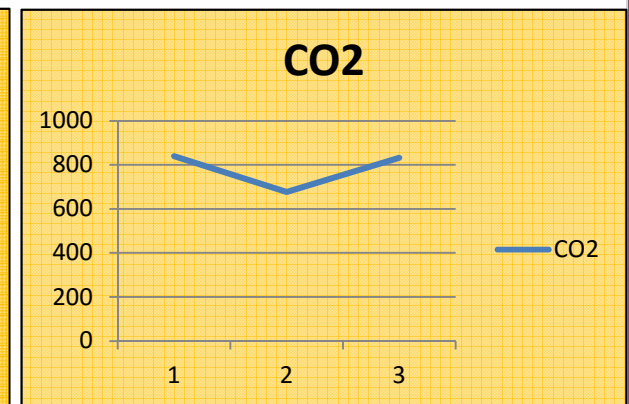
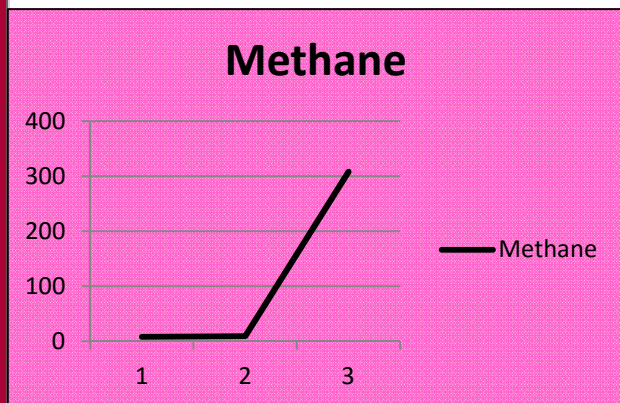
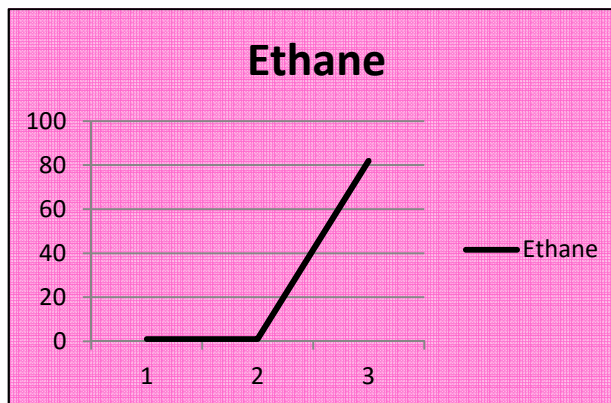
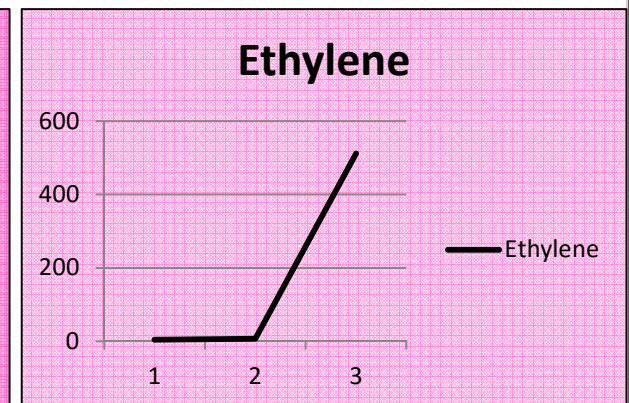
JUNE 2010 DGA RESULTS

First indication of problem June 2010 in DGA

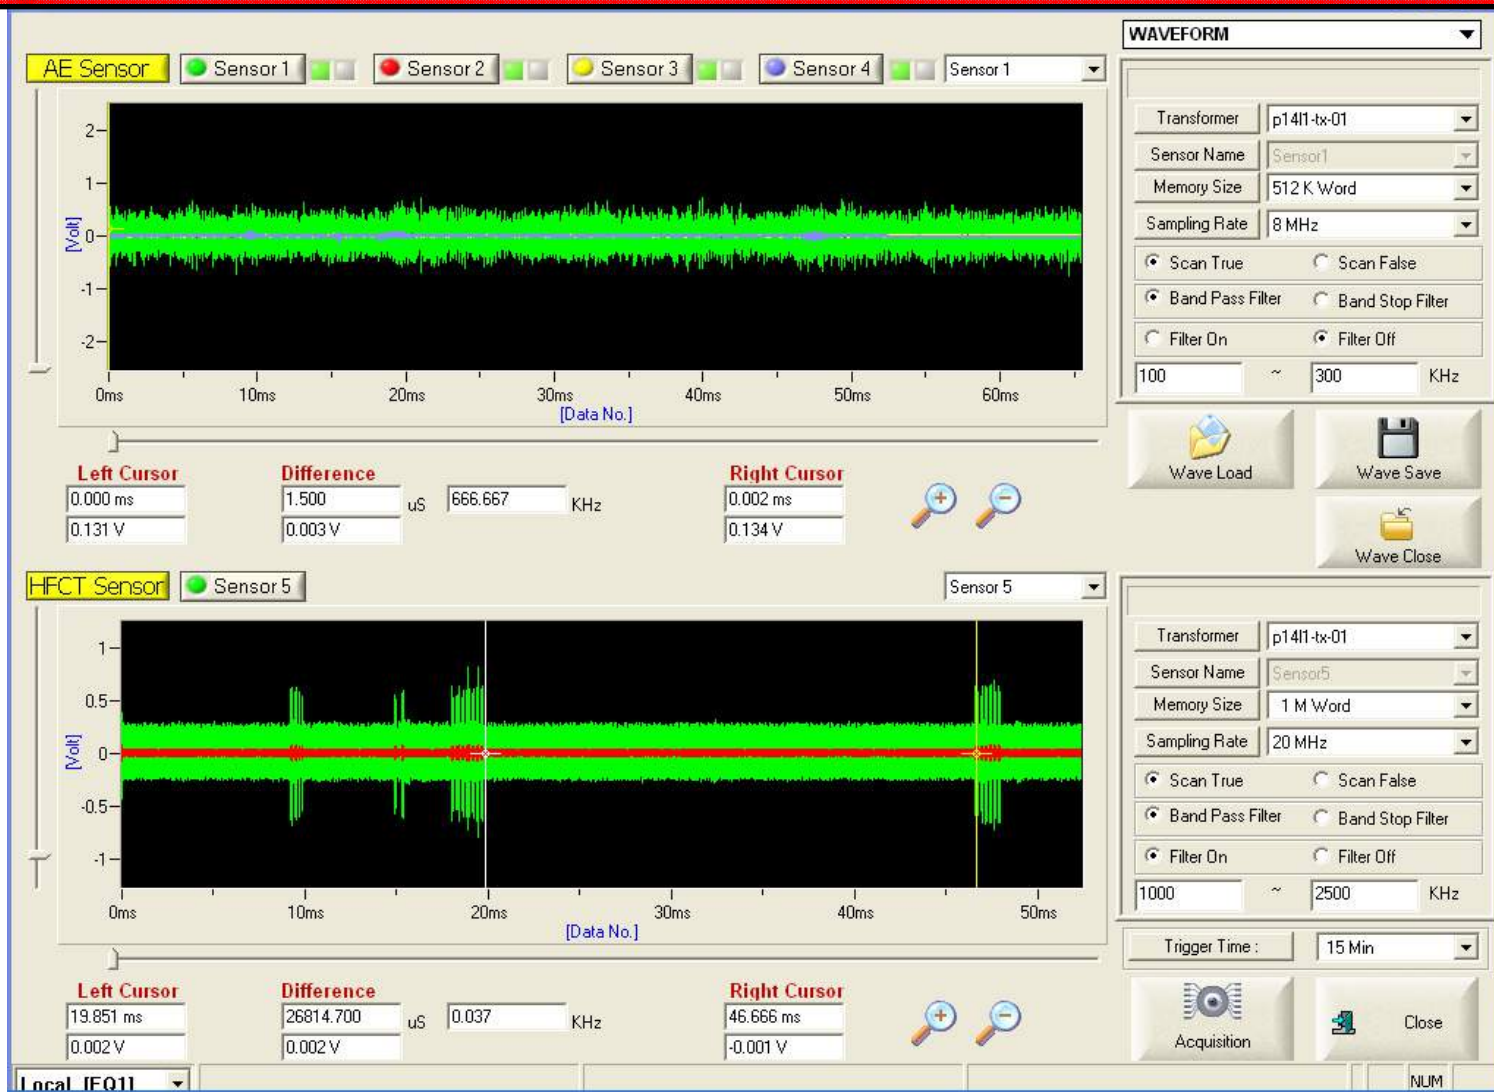
Immediately detected a waveform indicating arcing, not PD

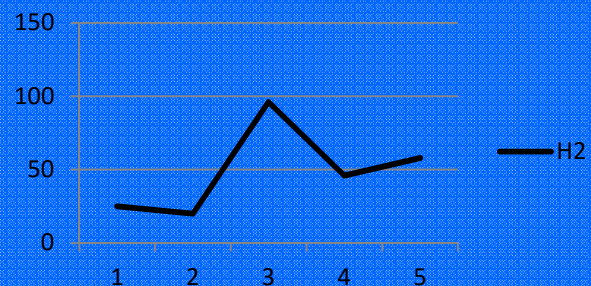
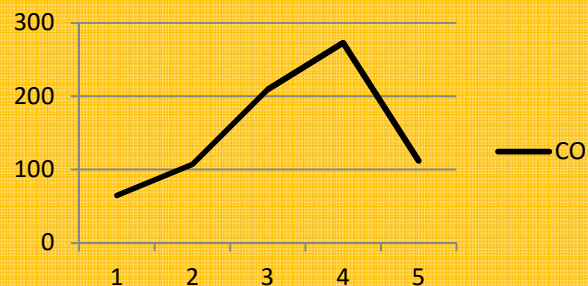
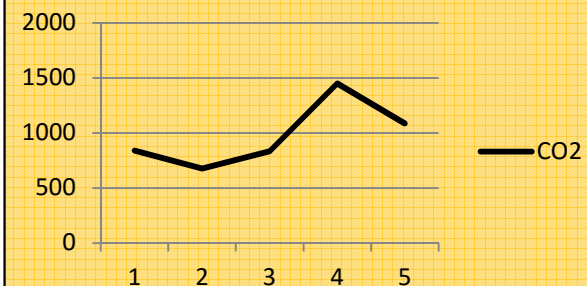
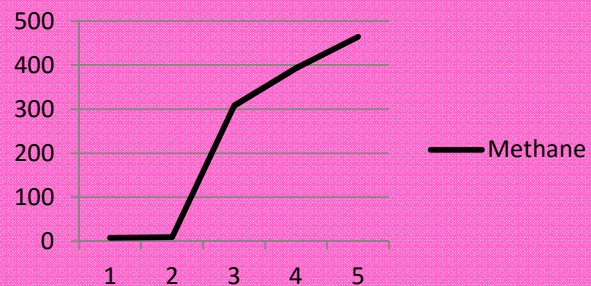
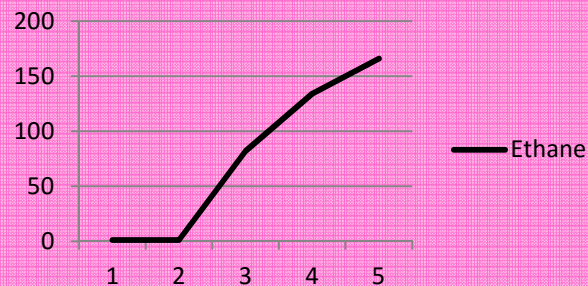
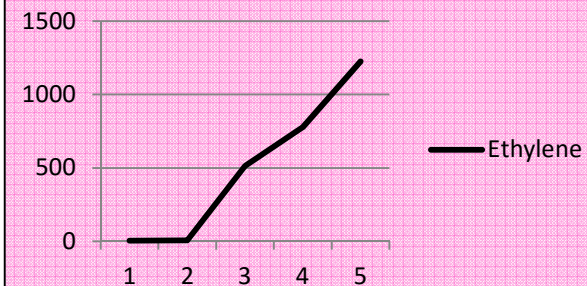
DEC 2011 DGA RESULTS

December DGA testing results were inconsistent

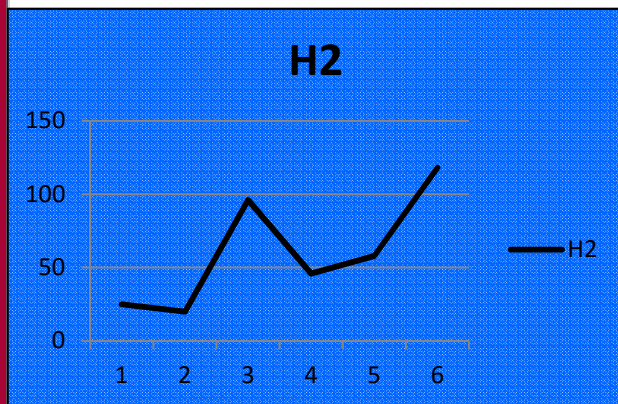
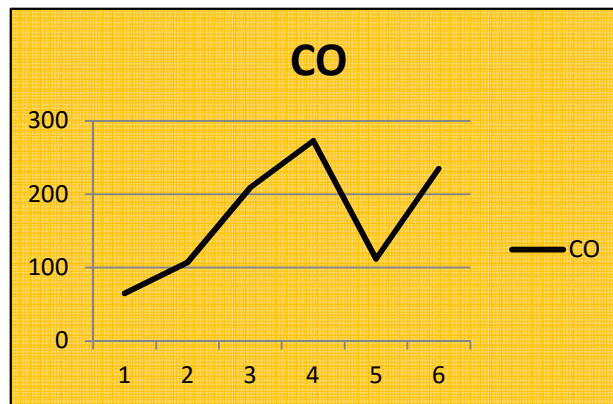
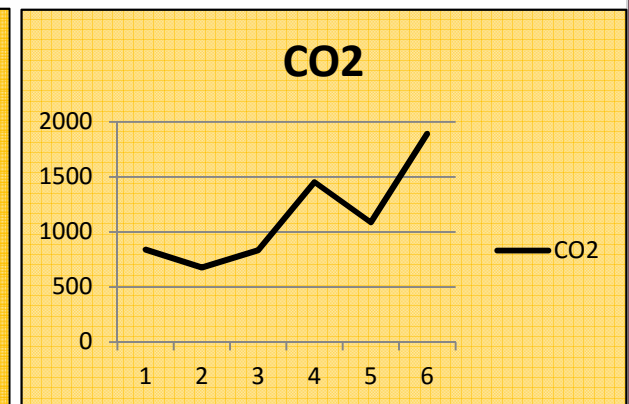
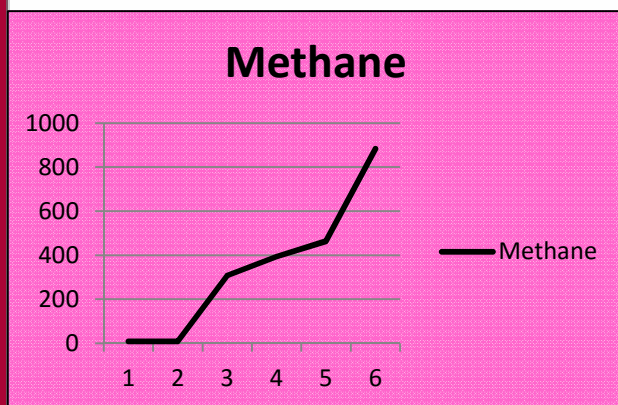
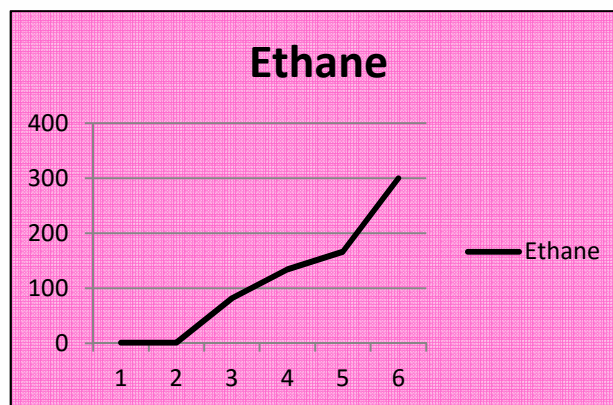
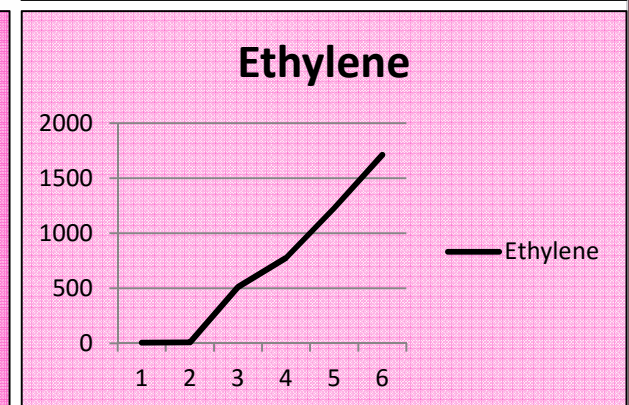
JUNE 2012 DGA RESULTS

Subsequent DGA testing several months later also indicated the problem was still present.

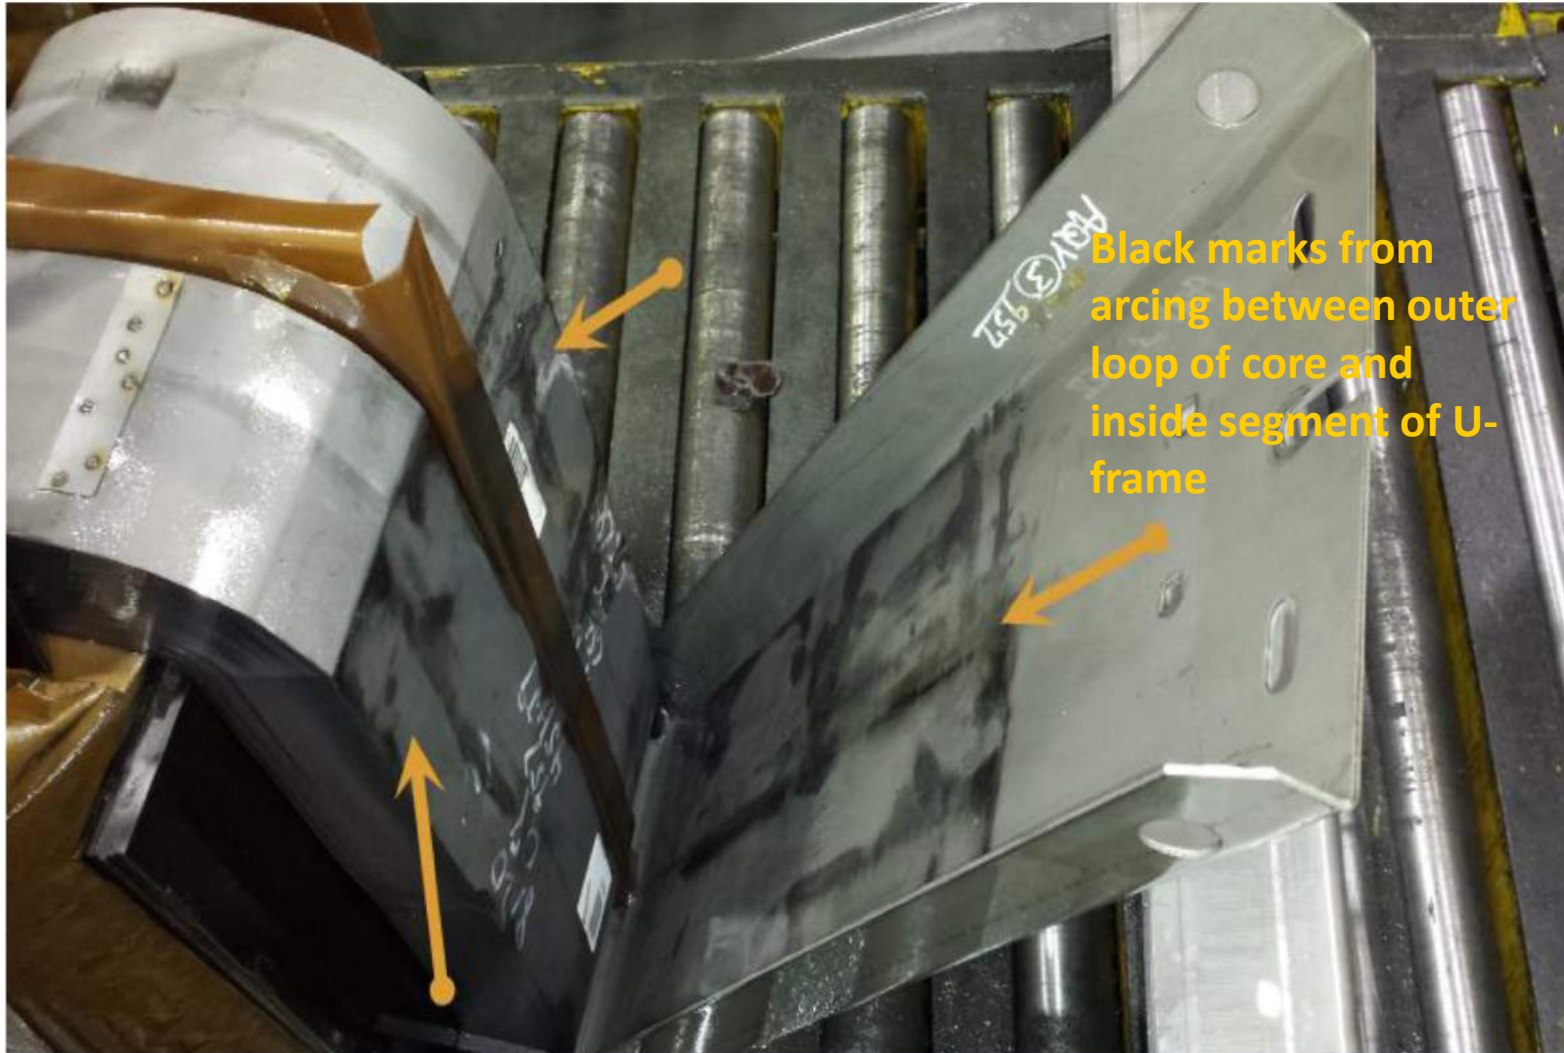
“multiple core ground points created different potentials, resulting in arcing between the core and frame, and from core to core across its insulation”
