# Sulfur Unit Equipment Problems and Low Silicon Carbon Steel Corrosion

Gerald W. Wilks  
Lemont Refinery  
CITGO Petroleum

# Weld Cracking in Piping Connecting Two Vessels

# Reaction Furnace Refractory Failure and Corrosion

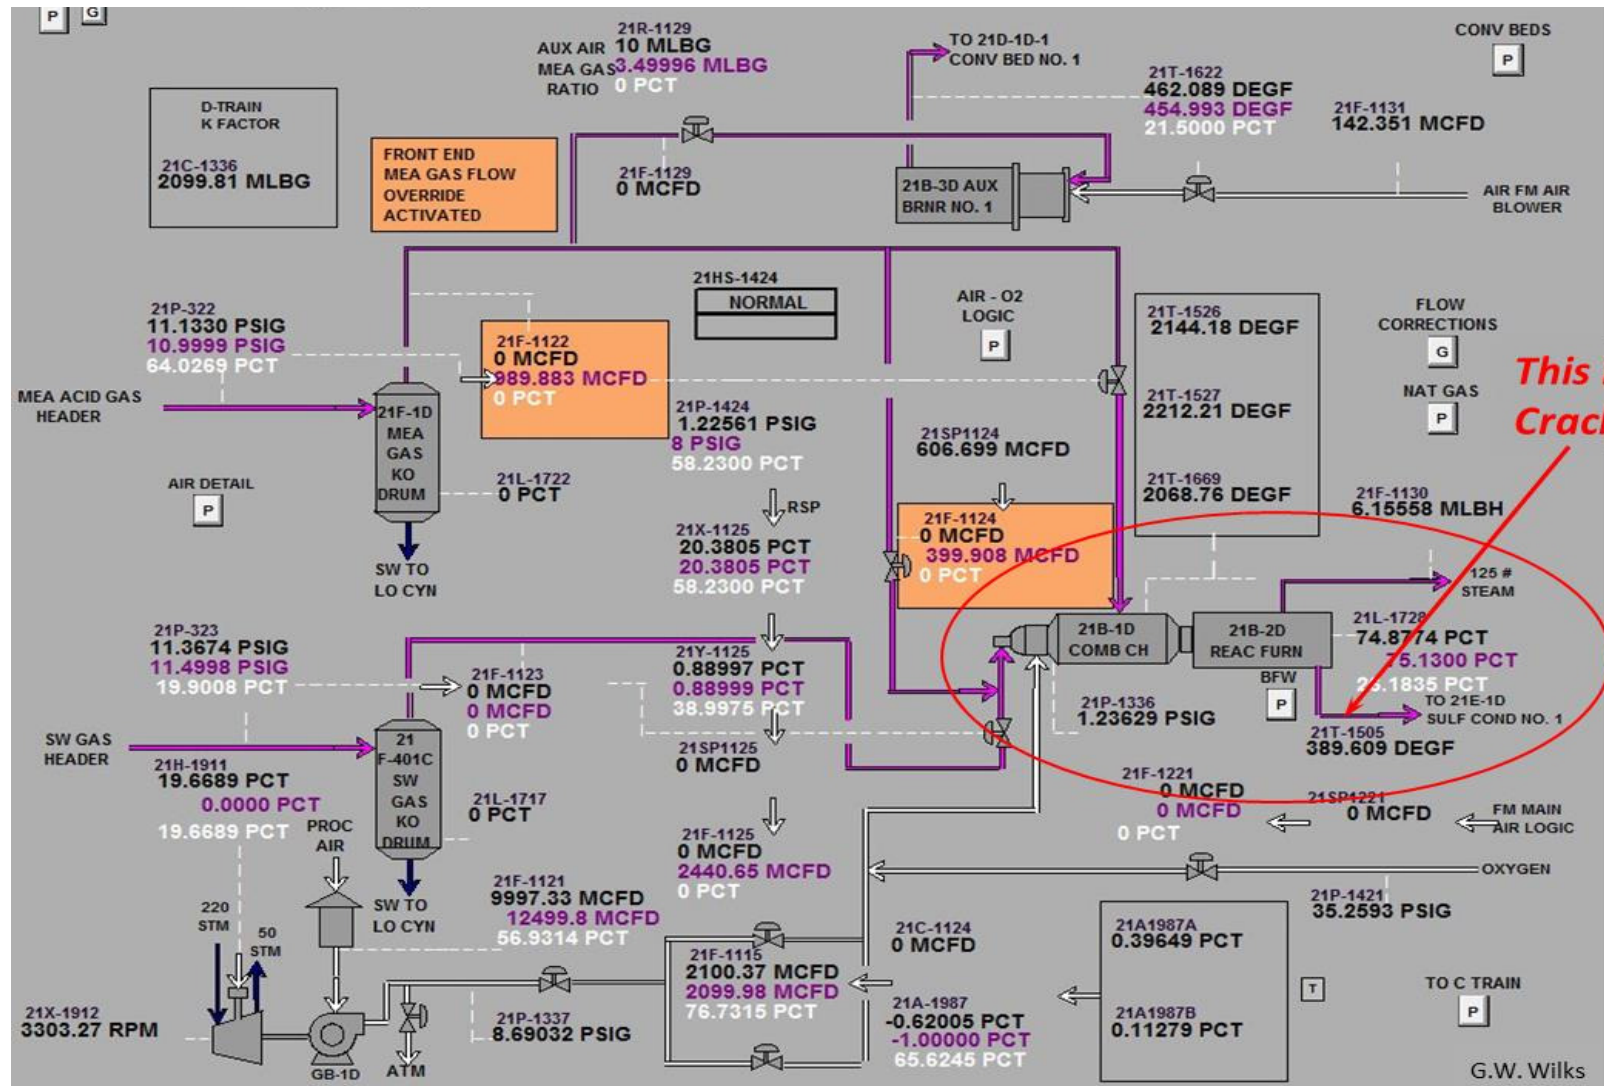
# Where the Failure Occurred – In a Reaction Furnace

- Failure occurred in November, 2012 in piping connecting 21B-2D and 21E-1D on D-Train of the Sulfur Unit
- 21B-2D is a reaction furnace and 21E-1D is a sulfur condenser
- The leak caused D-Train to shut down
- The vessel was cooled, purged, filled with nitrogen, and repairs were made externally using alloys that would not corrode in-service
- The repair was done safely and the vessel remained fit-for-service until the next turnaround when a permanent repair was made
- Other reactor–condenser connections with similar designs were analyzed and modified to prevent fatigue failures.

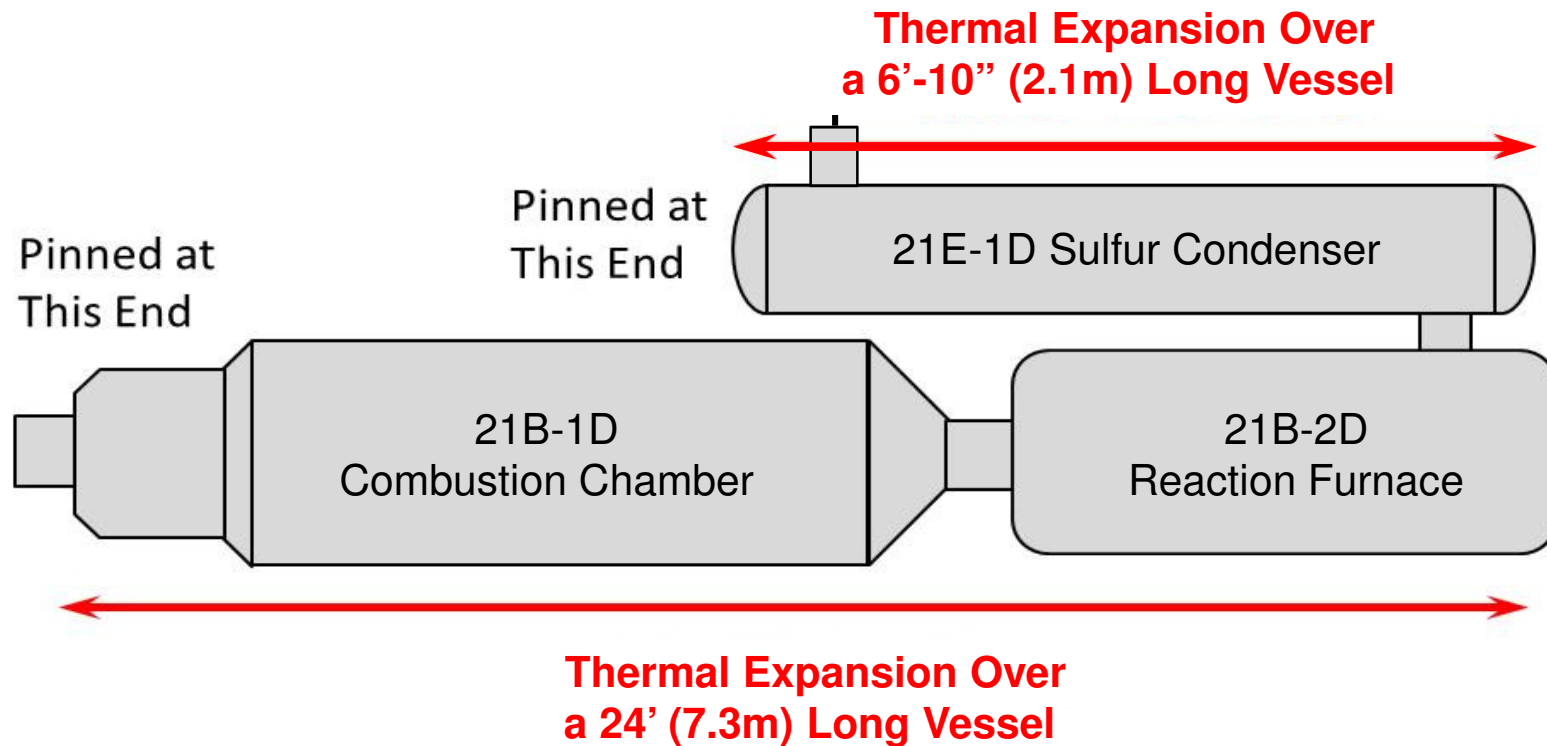
## **What Caused the Cracking**

*The relative motion due to the different amounts of expansion resulted in high bending stresses at the pipe attachment welds.*

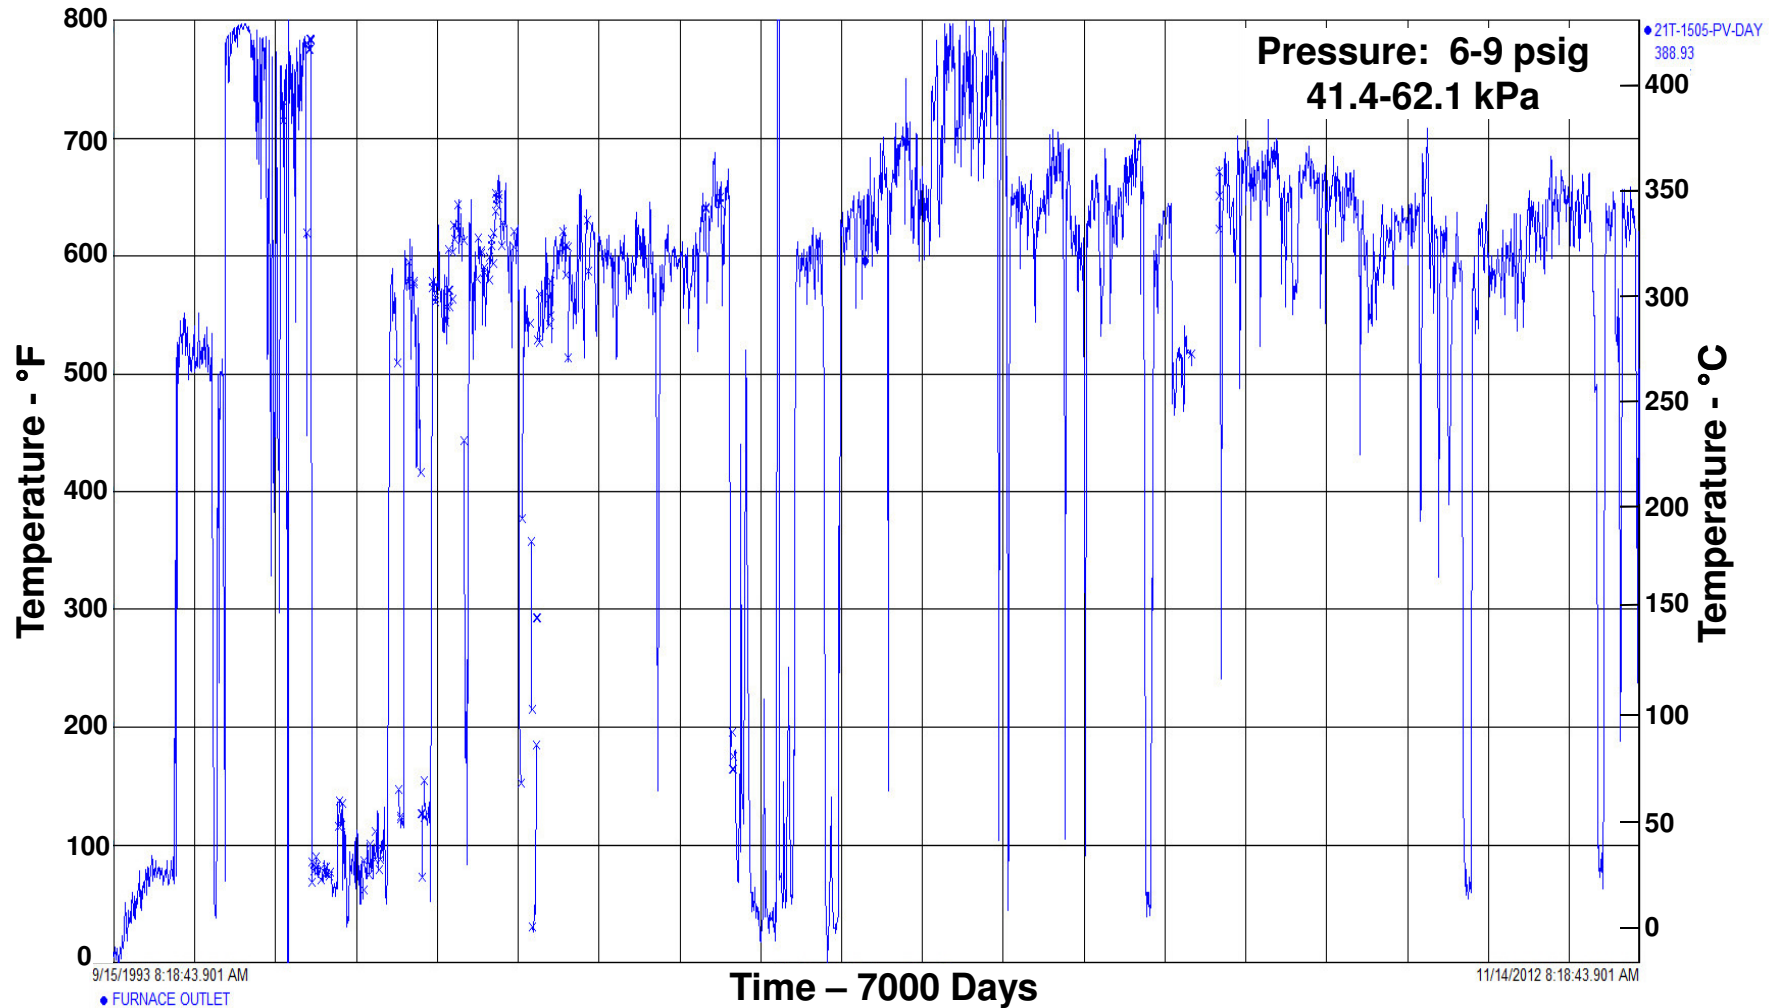
# Pipe ID Temperature and Pressure

*The thermal stresses at the weld are high and there are enough cycles to start fatigue cracks.  
The small cycles also contribute to fatigue cracking if a high constant tensile stress is present.*

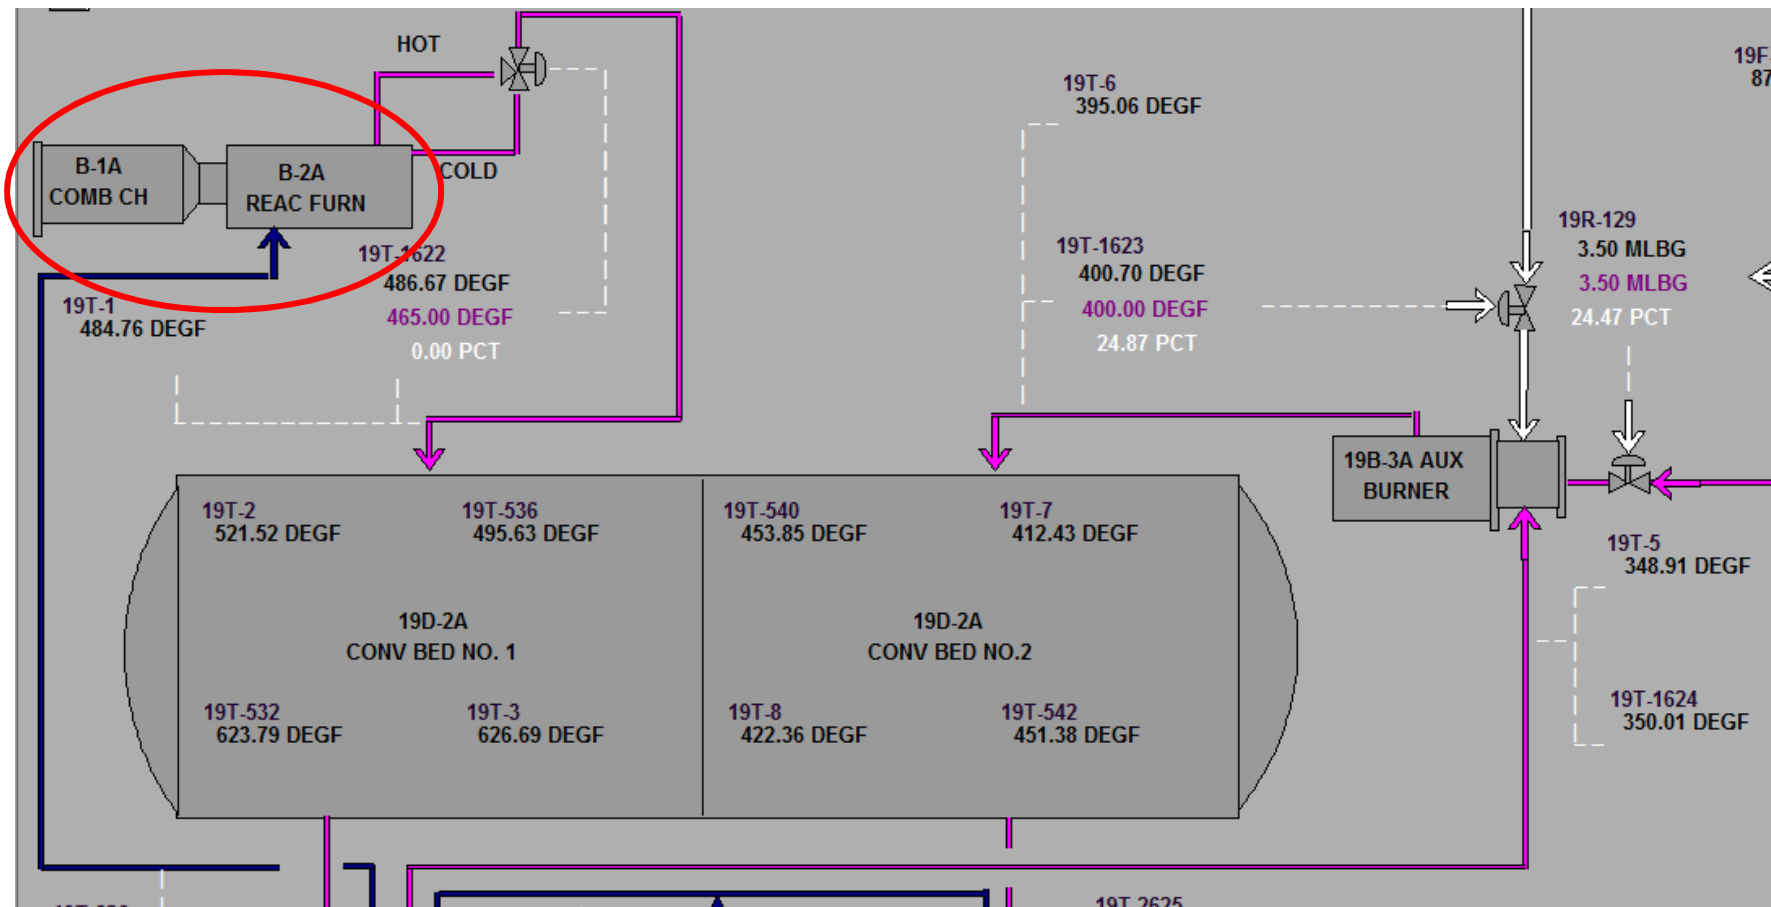
# Problem Description – Hot Reaction Furnace Shell

The hot reaction furnace shell was noticed by Operators when it rained and infrared monitoring was used to determine the temperatures.

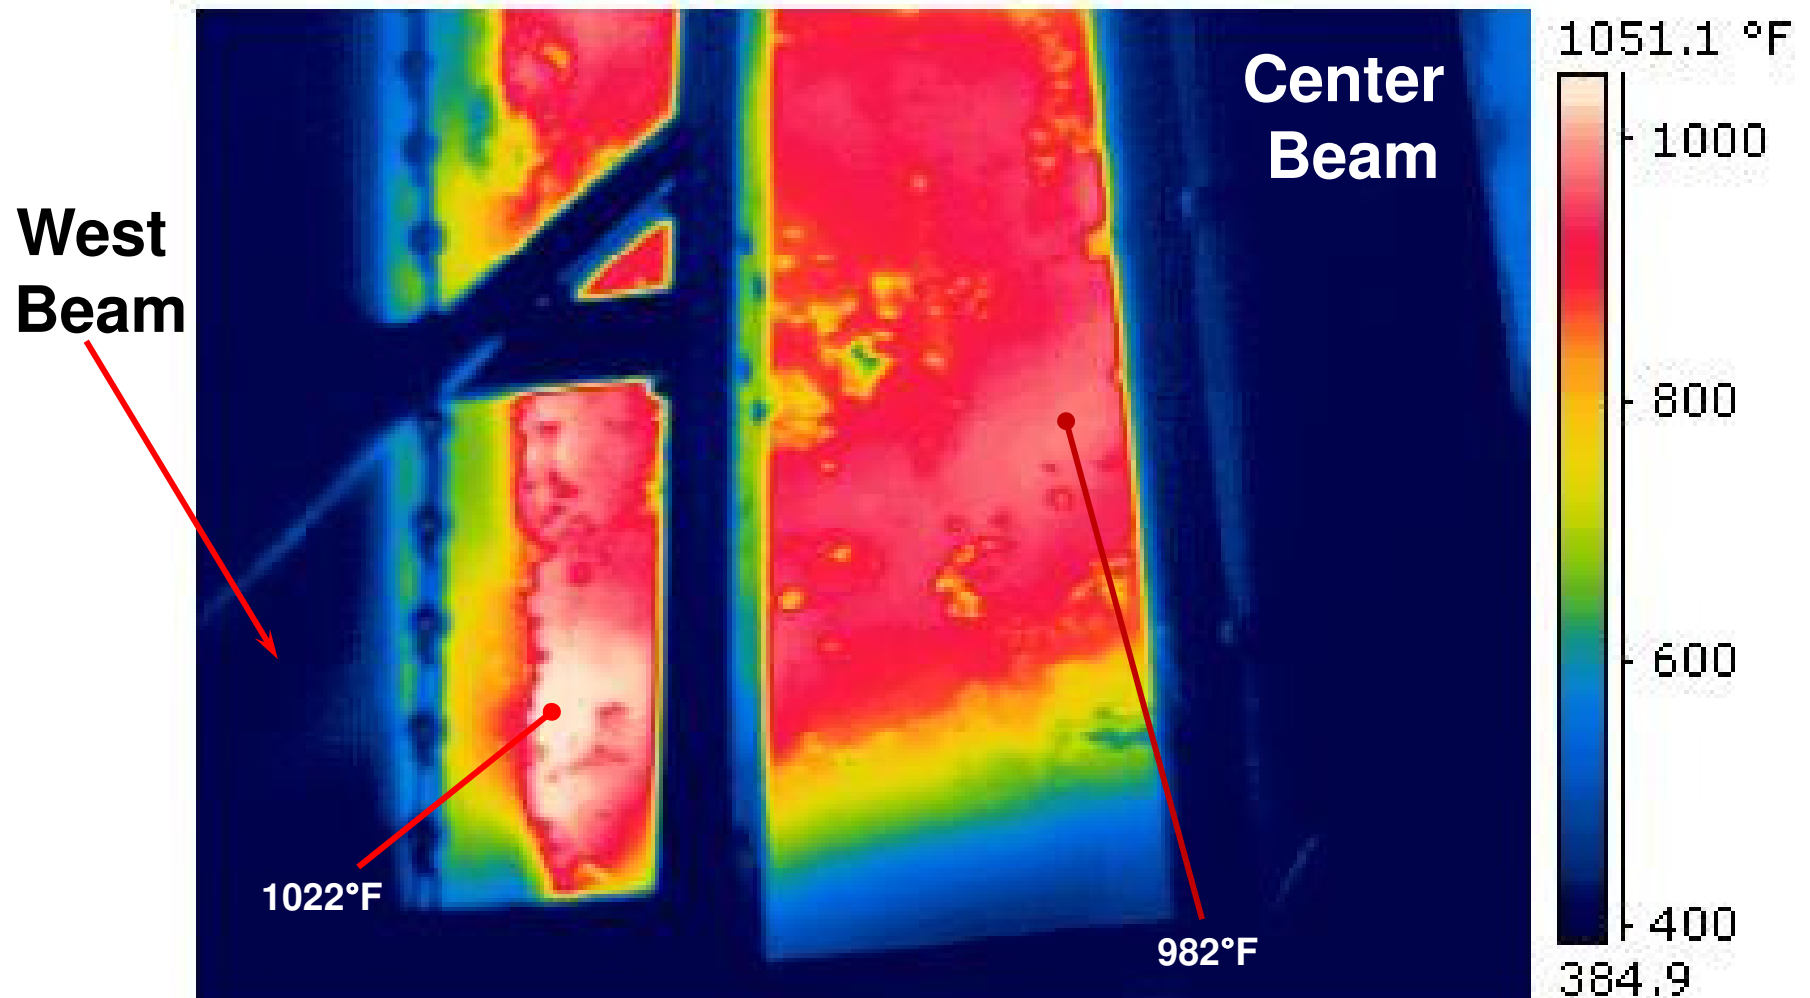
# IR Scan of the OD of 19B-2A Furnace

Steam lances were used to keep the wall temperature down, but unit shut down was eventually necessary.

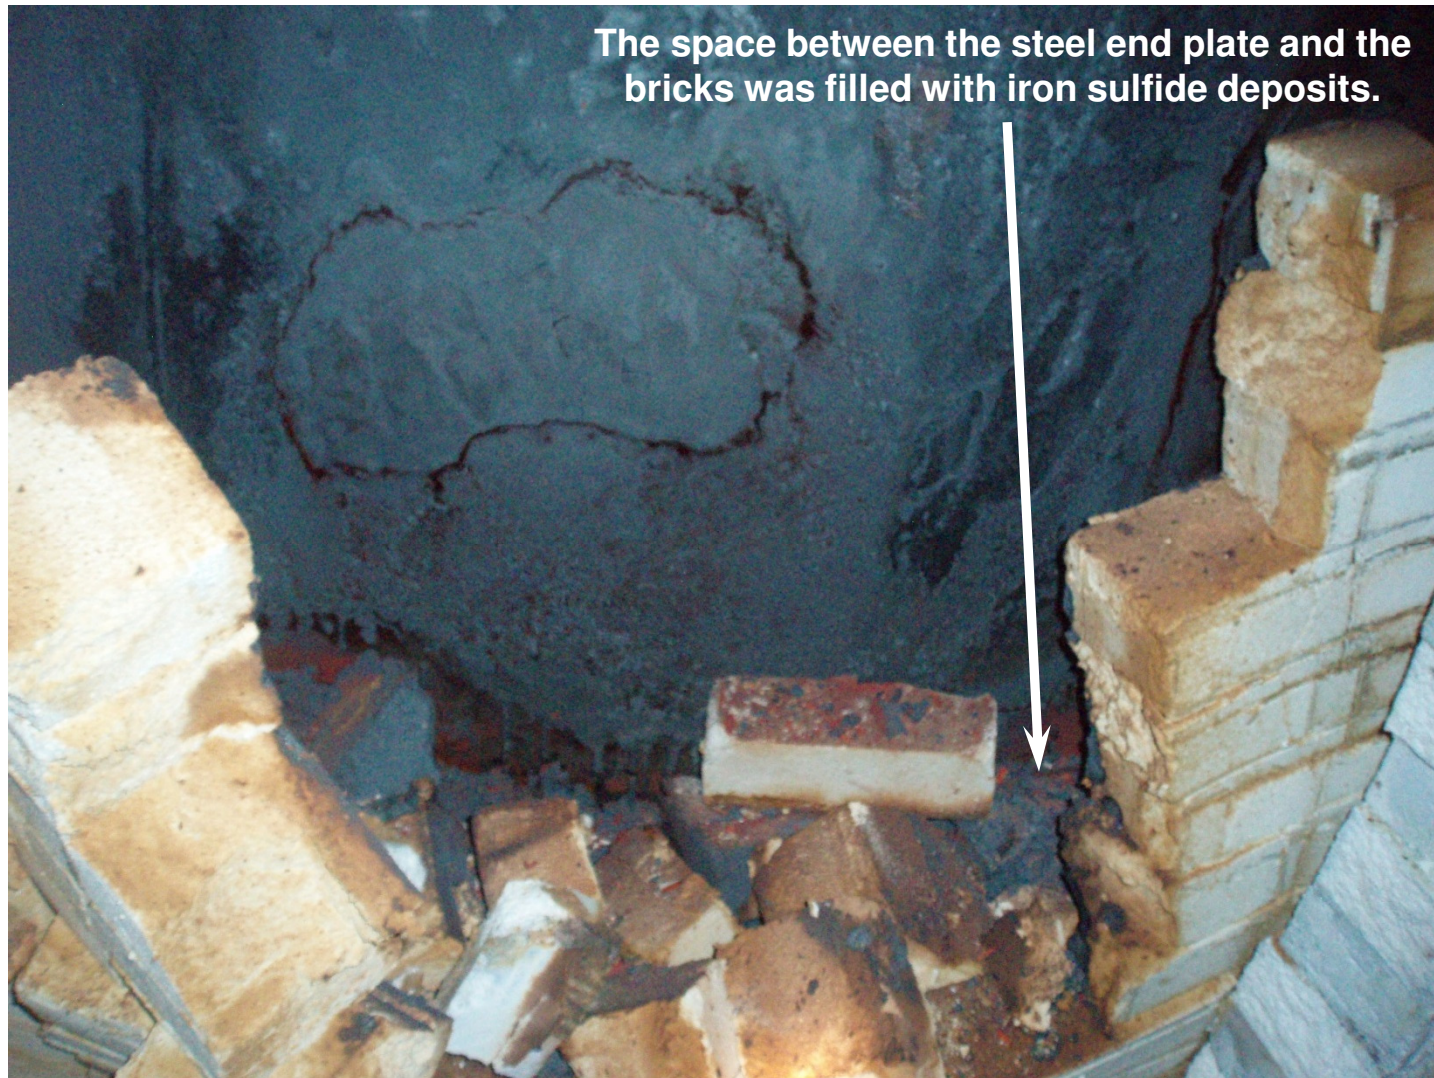
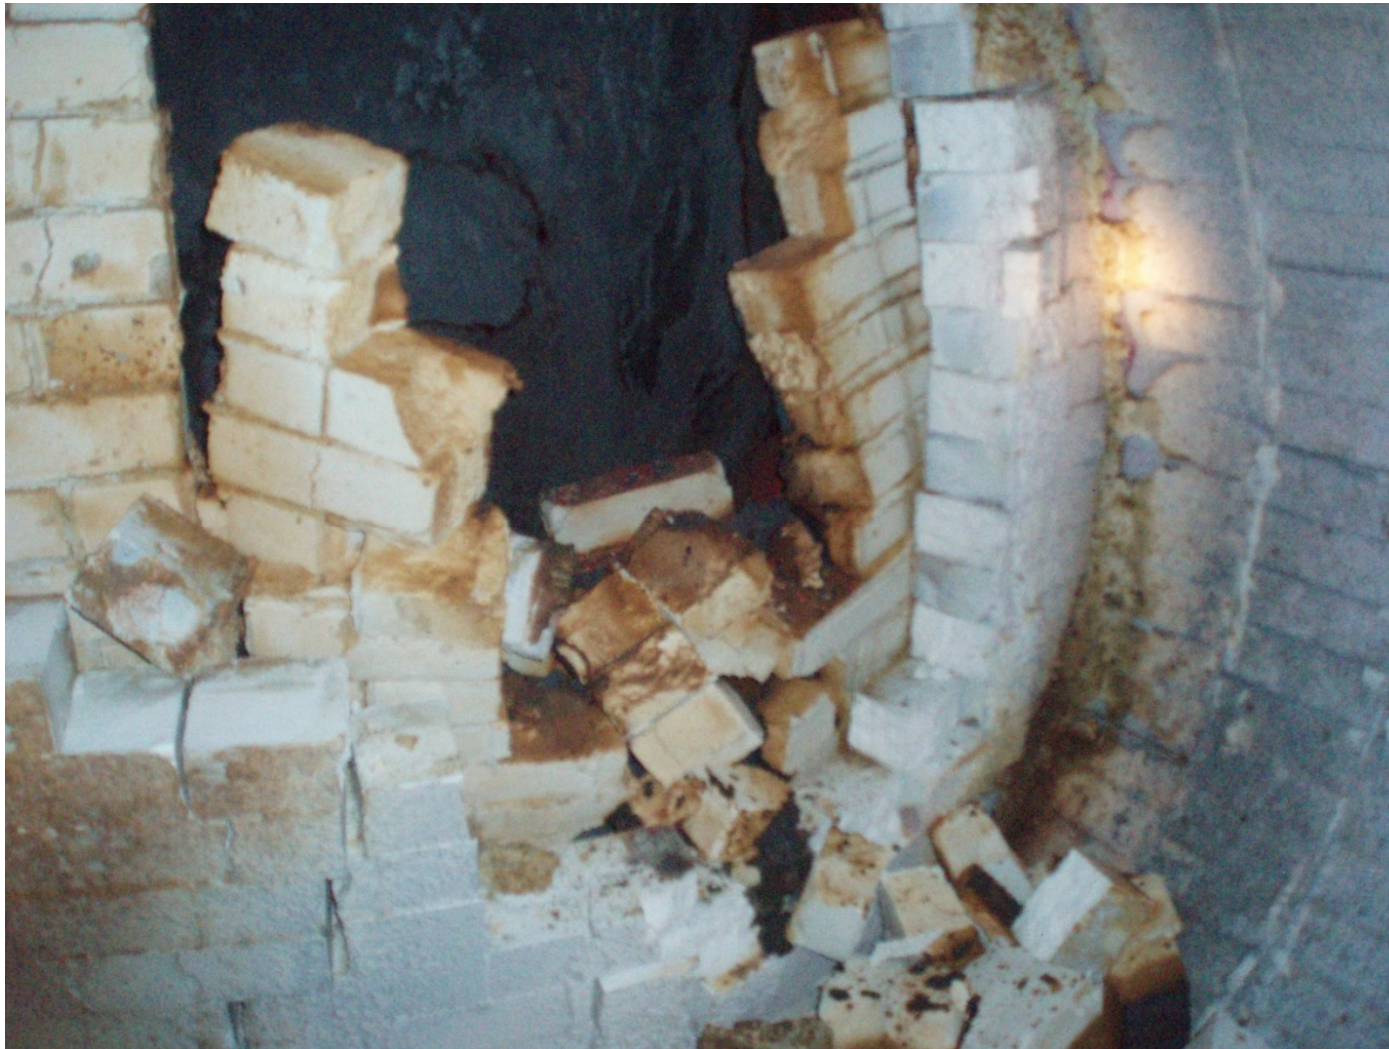
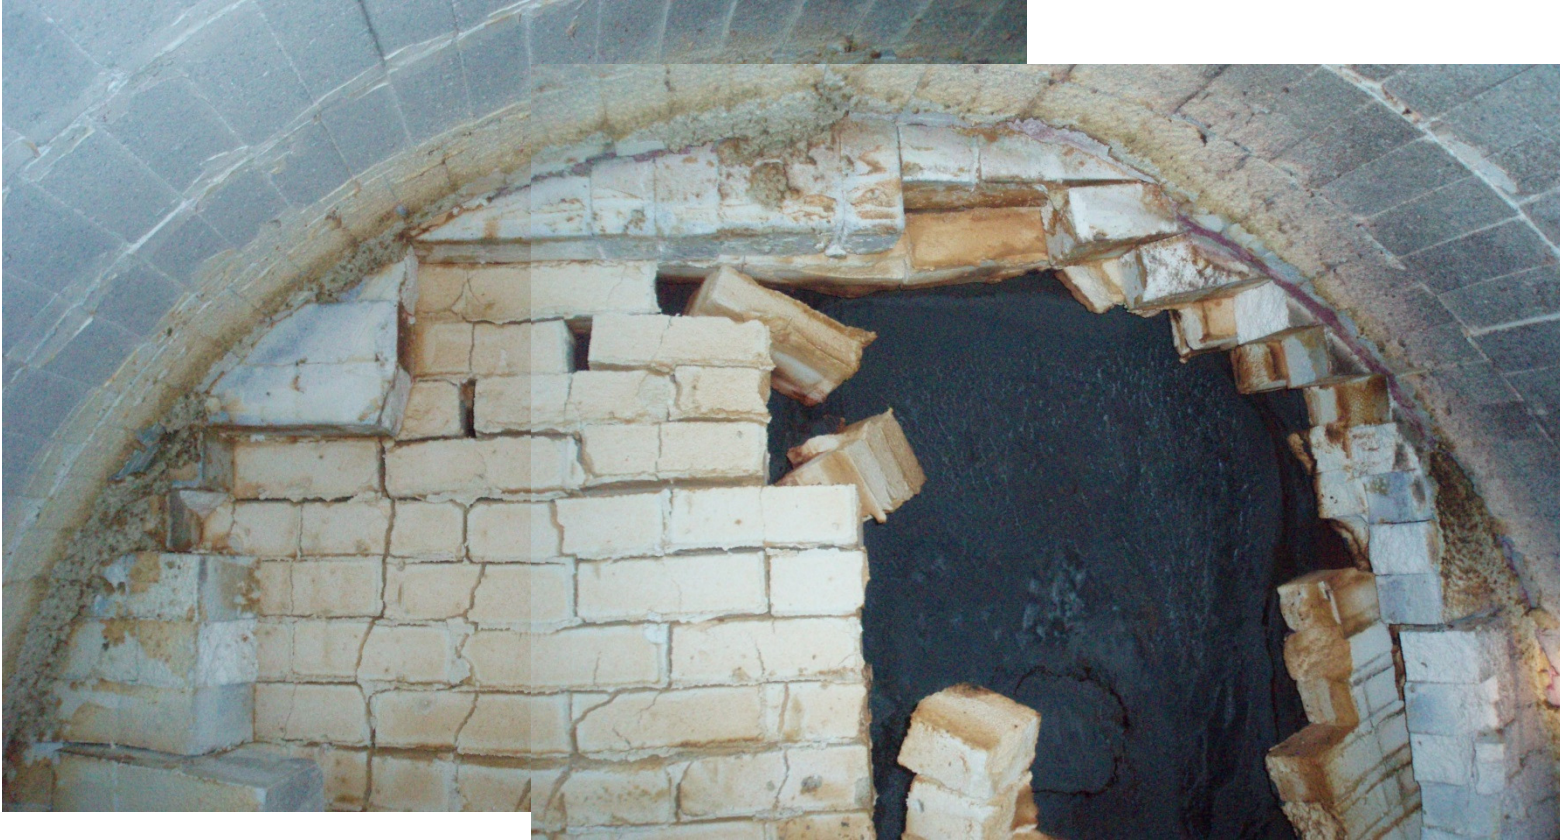
# Refractory and Wall Damage on the ID

Failure occurred because the refractory bricks were set with castable refractory. This reduced the ability of the wall to expand so it bulged into the Reaction Furnace and cracked. Then resulting corrosion deposits pushed the wall inward causing the refractory to completely separate from the steel end plate.

- The 1½-Inch end plate was replaced.
- All refractory bricks installed with castable were removed
- New refractory was installed with gaps between the bricks to accommodate expansion.
- Infrared surveys were conducted on similar high temperature Sulfur Unit equipment
- UT thickness measurements were taken on similar Sulfur Unit equipment

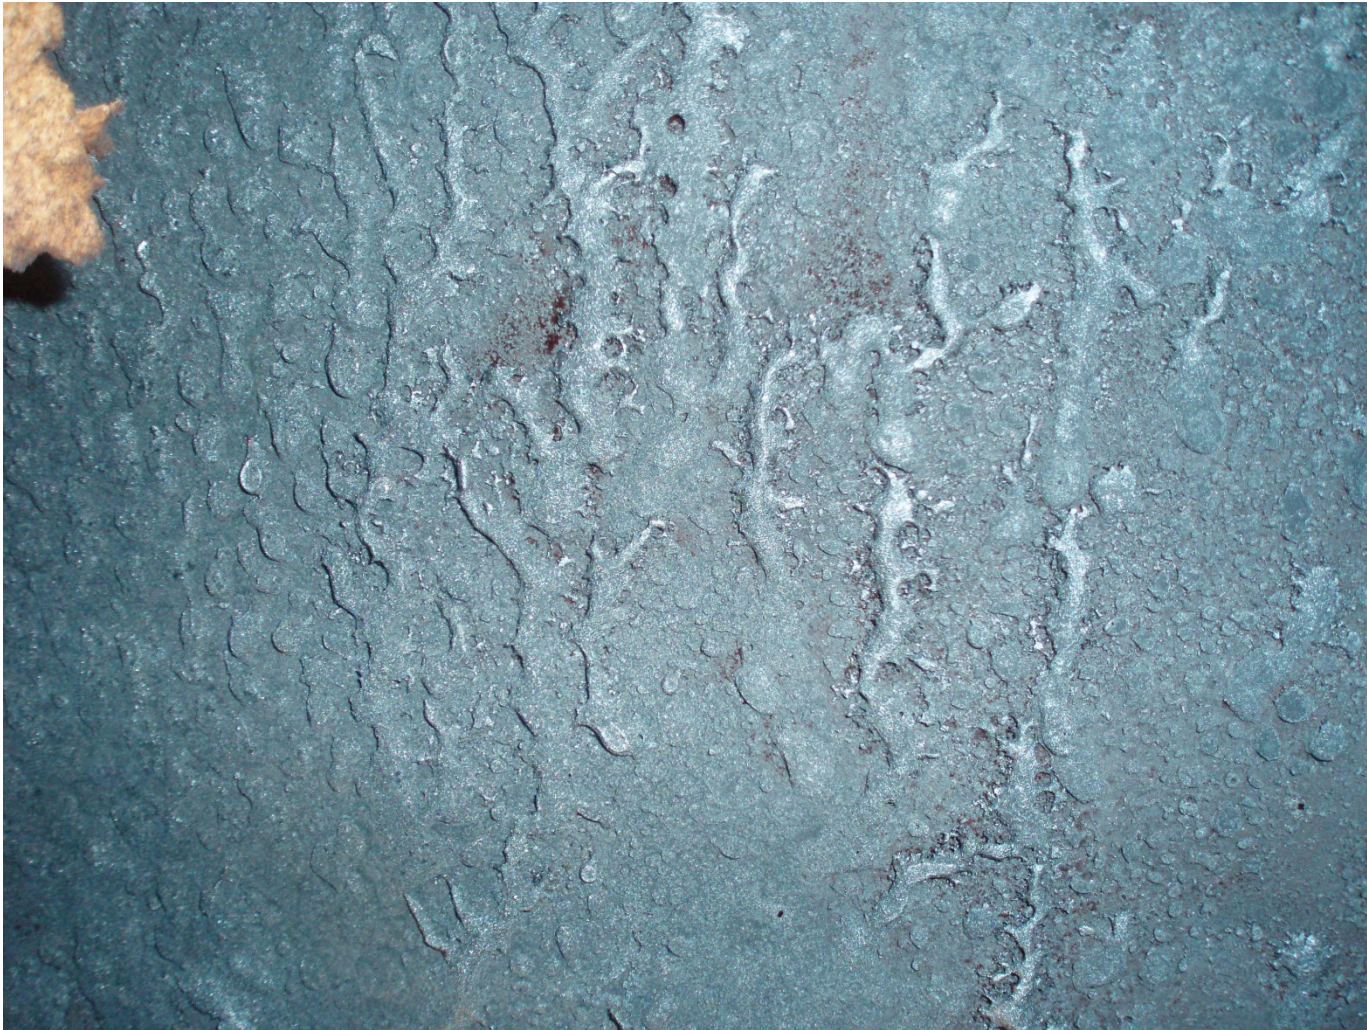
## Close-Up of the Corrosion on the Wall

Corrosion deposits were a mixture of iron oxides and iron sulfides.

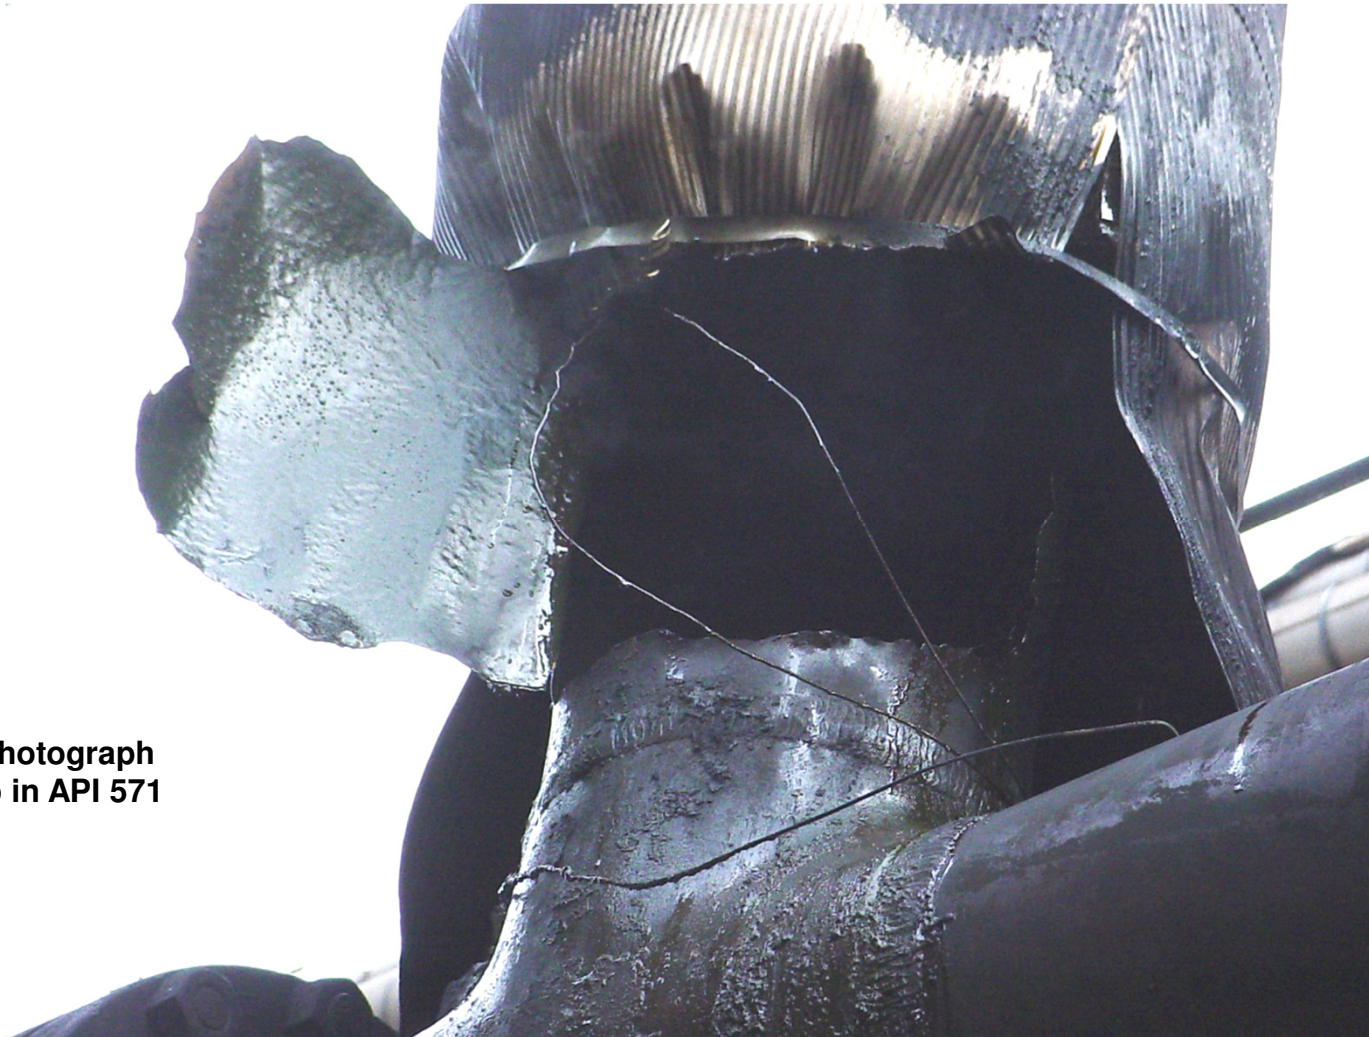
# Surprise Failure – Inspection Data Indicated No Problems

Fractionator Bottoms @ ~150 psig (1035 kPa) & 650-700°F (345-370°C)

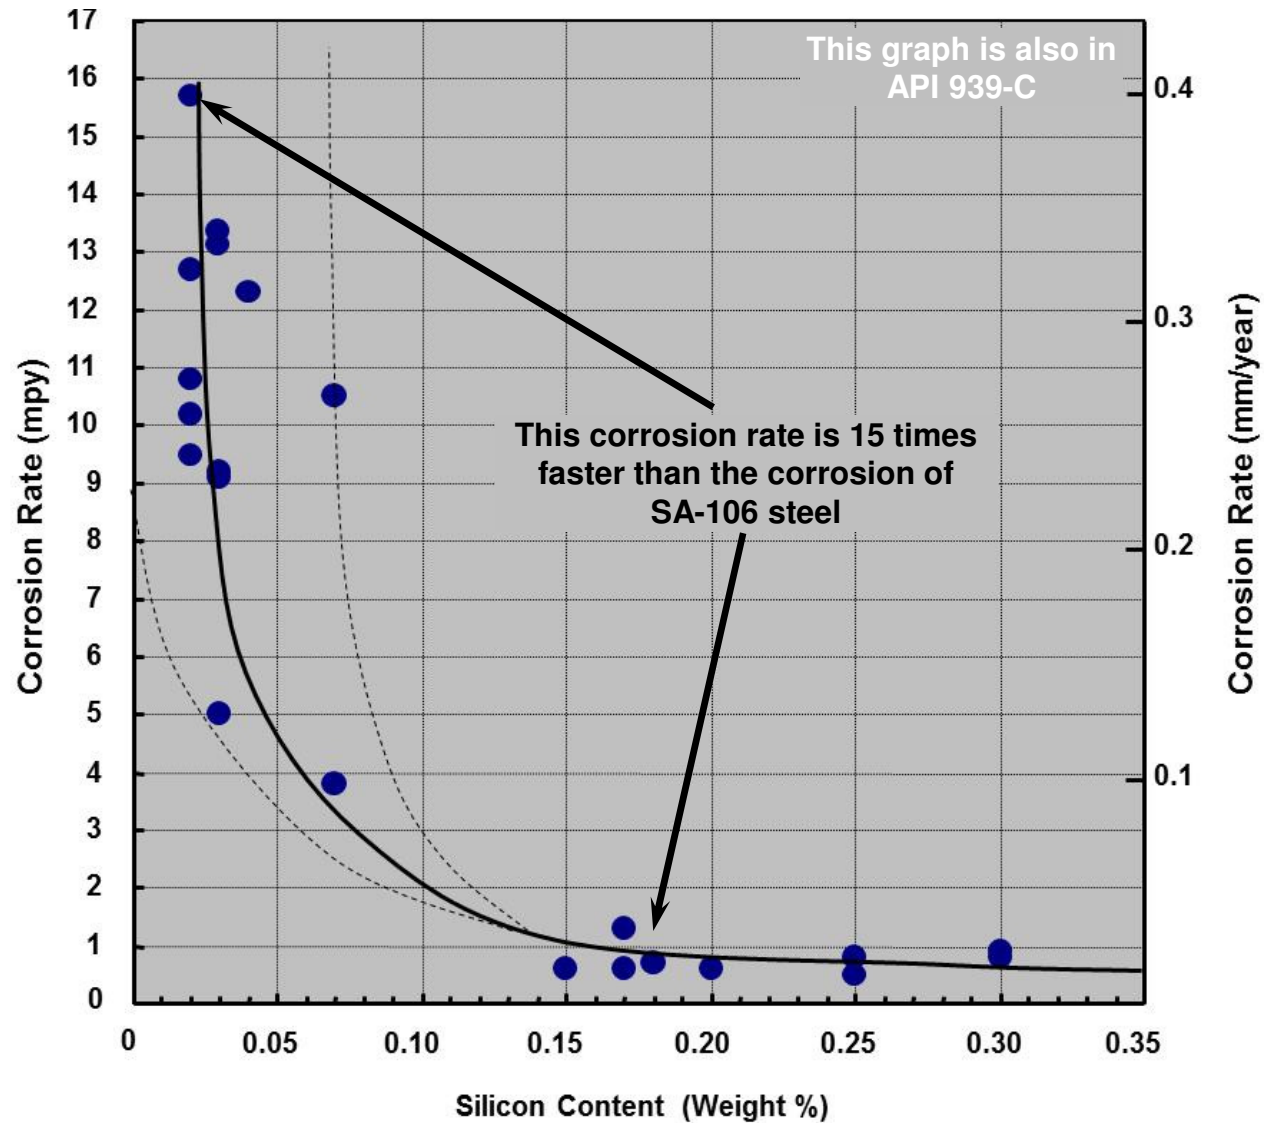
# Corrosion Rate vs. Silicon Content for Piping

- Low silicon carbon steel (SA-53) can corrode at a rate that could be 15 times the rate that normal silicon carbon steel (SA-106) corrodes.
- Not all SA-53 pipe has low silicon content. Also silicon content isn't always present in the steel – some Si is present in silicate inclusions.
