TROUBLE SHOOTING IN **DELAYED COKER UNIT**- INSPECTION EXPERIENCE

TROUBLE SHOOTING IN **DELAYED COKER UNIT**

MRPL's DCU DETAILS

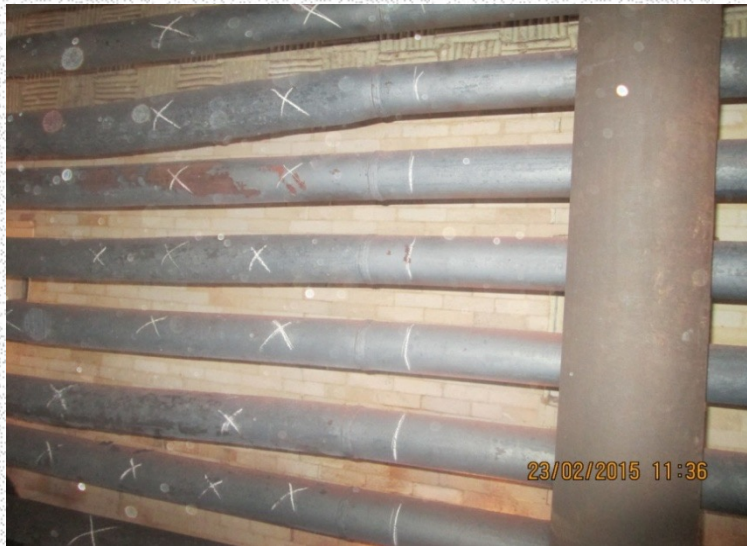
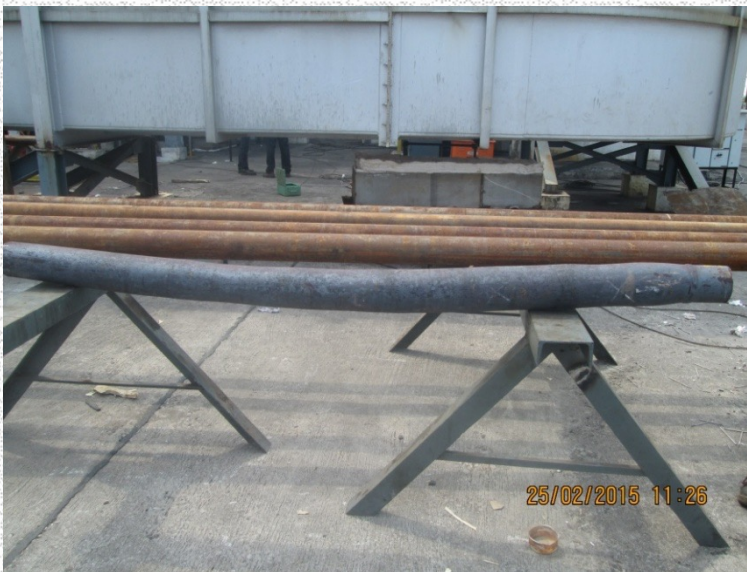
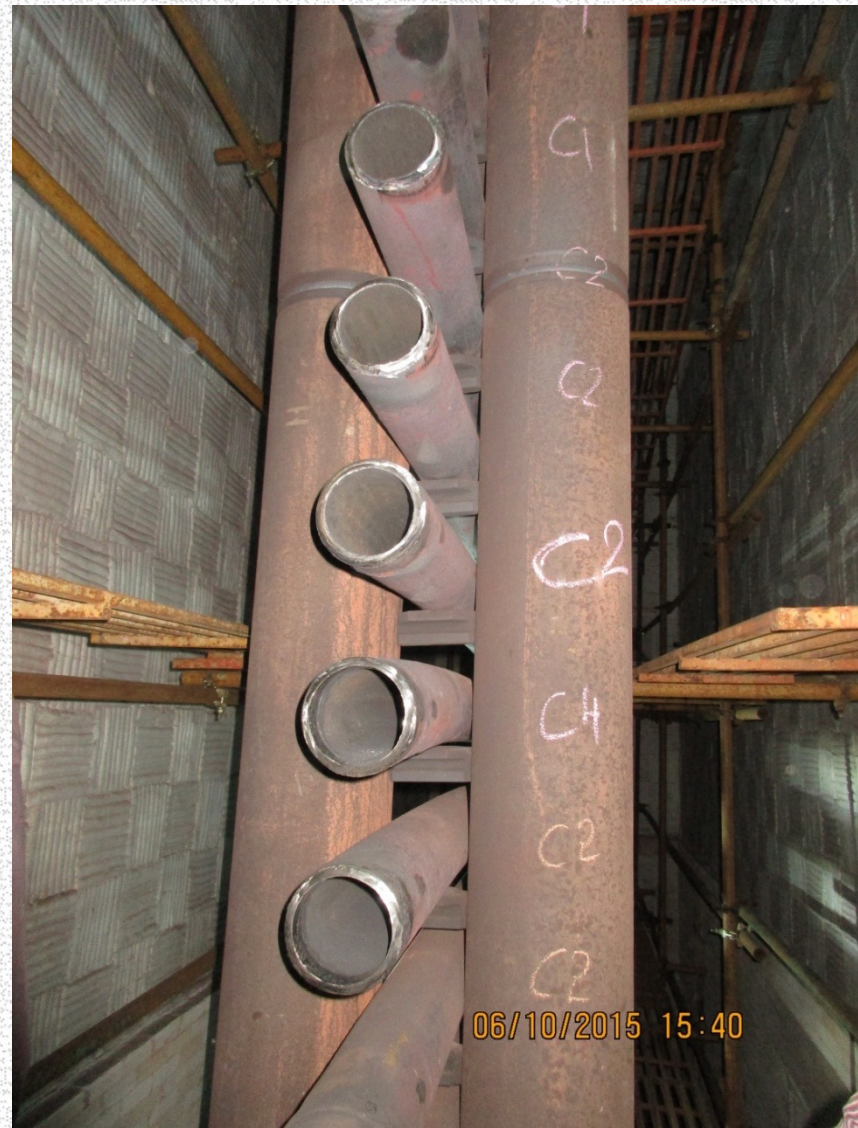
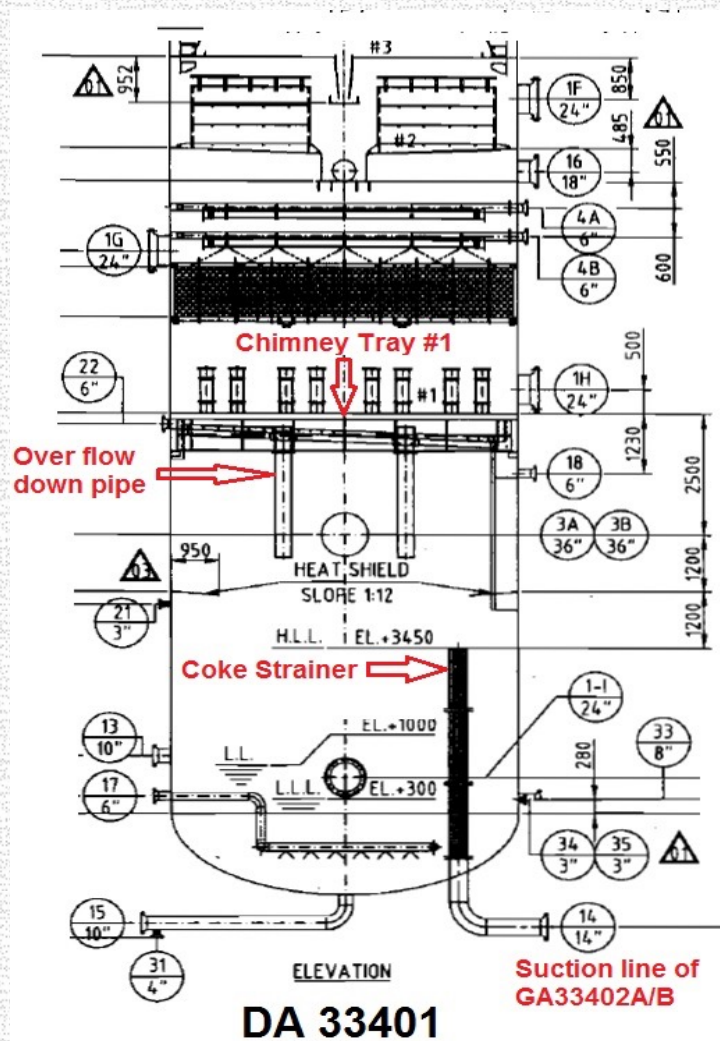
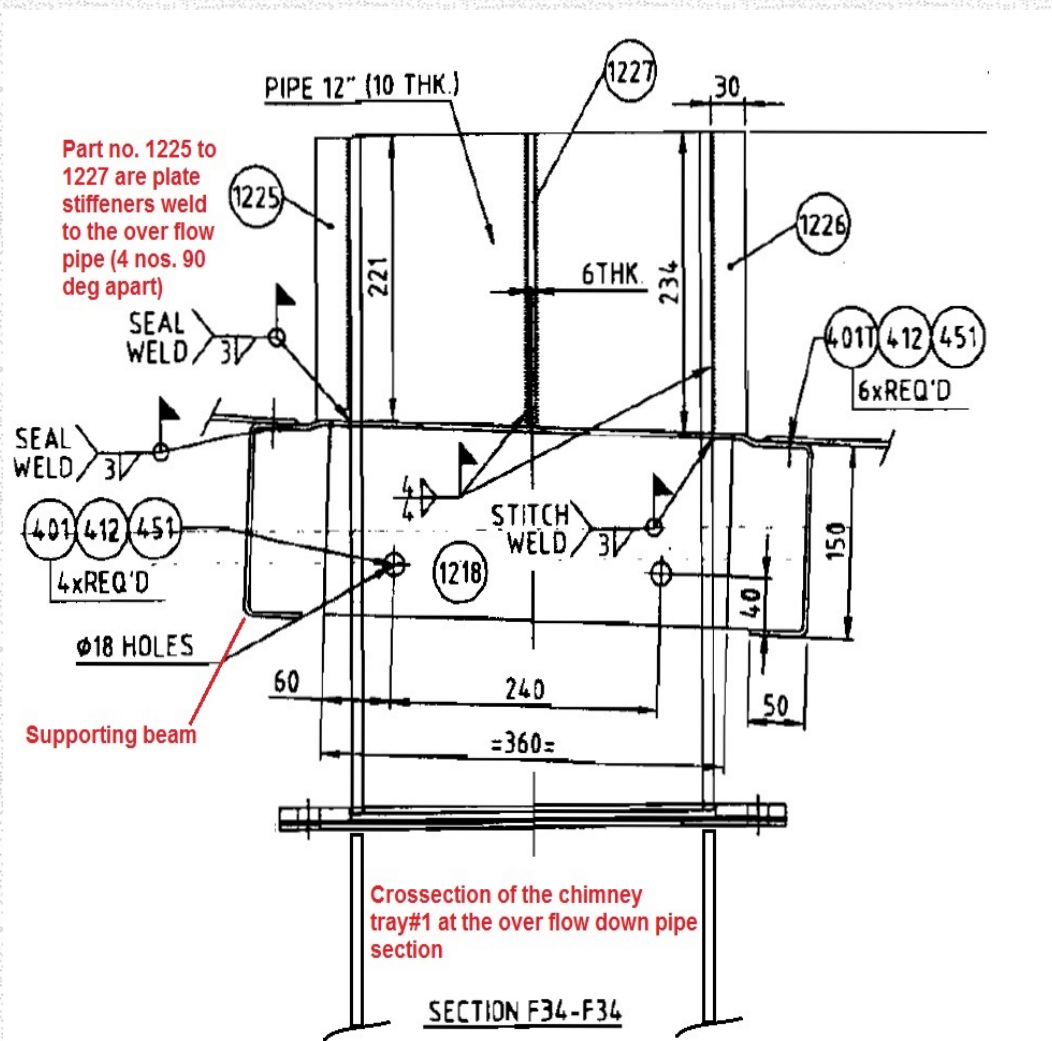
Learning from Coker Heater

Observations /analysis	Corrective measures	Feedback
<ul style="list-style-type: none"> 02 instances of Bulging and sagging of radiation section tubes Size: 114.3mm OD X 11.13mm Thk , MOC: 9Cr-1Mo (SA 335 Gr P9) Dimensional measurement revealed bulging–Photo Bulging and sagging due to coking and localised heating . Metallurgical analysis of Samples of failed tubes Results indicate comparable metallurgical damage in bulged tubes with 5% and more. 	<ul style="list-style-type: none"> Replacement of tube sections beyond 5% enlargement in OD. RT carried out to check the extent of coke deposition at random locations Thickness measurement, Hardness check, visual and dimensional inspection 	<ul style="list-style-type: none"> Online inspection is limited to Visual inspection Off line inspection includes visual and dimensional check, thickness & hardness measurements and RT for checking coke deposition. Additional no. of skin thermocouples.

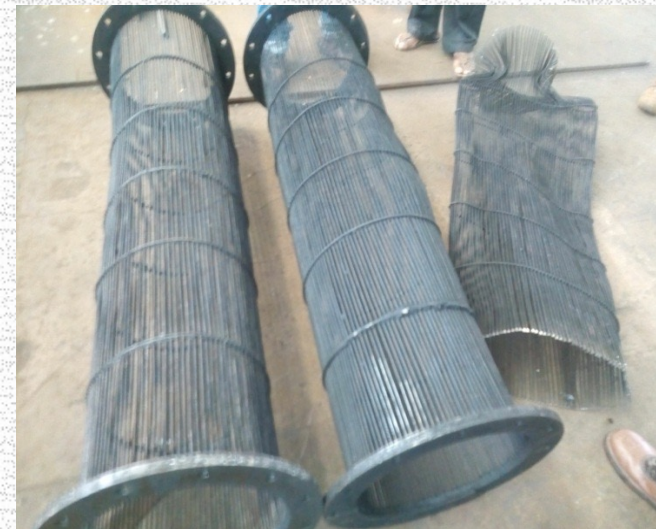
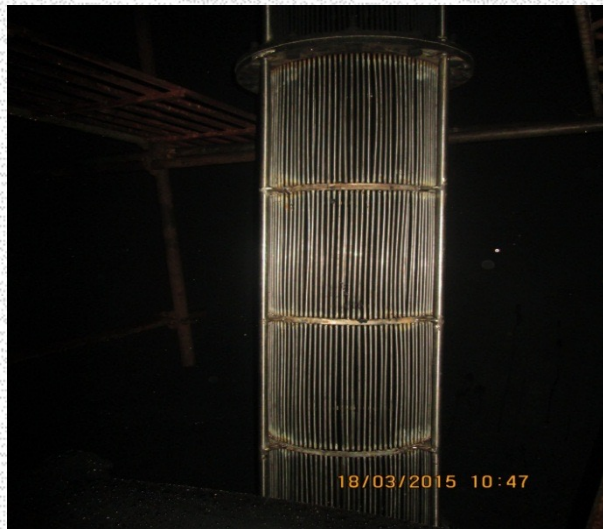
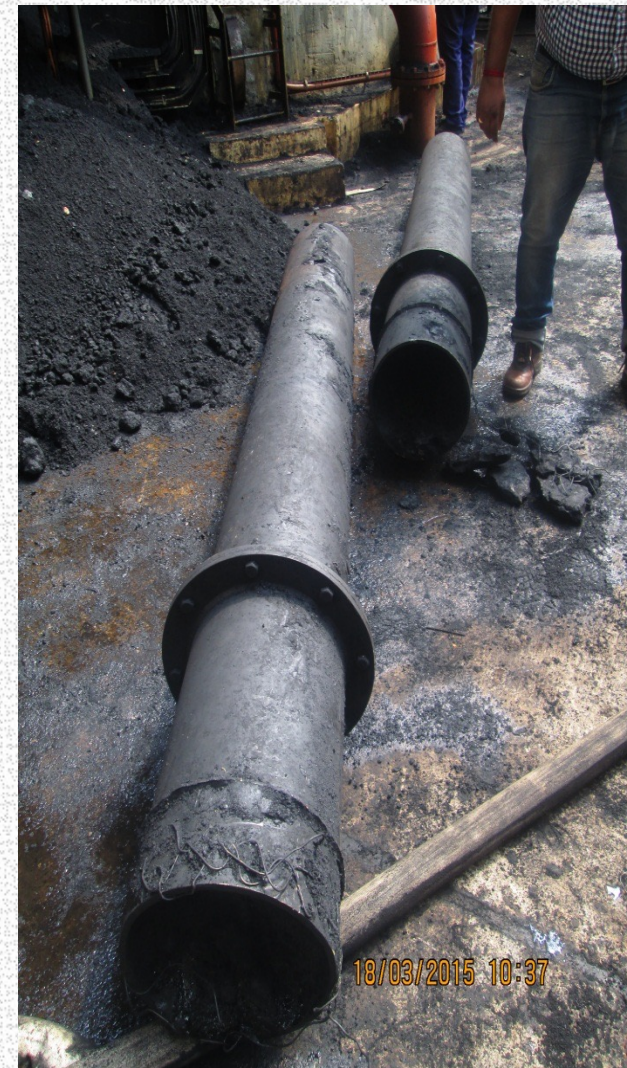
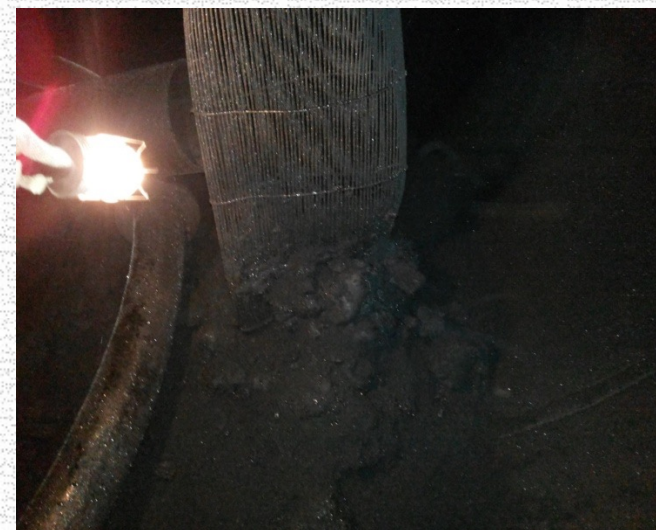
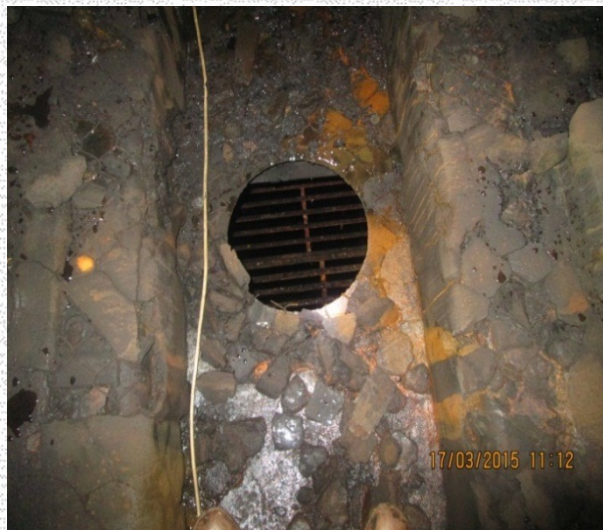
Learning from Coker Fractionator

Observations	Corrective measures	Analysis/Feedback
<ul style="list-style-type: none"> Column opened for internal inspection subsequent to heater charge pump flow issue. Blockage suspected. Sketch Coke deposits on bottom dish end. Coke strainer observed damaged and partially blocked Overflow down pipes connected to chimney tray #1 sheared and were lying on the bottom dish end. Refractory damage approx 50% of the area on top of chimney tray#1. KAST-O-LITE 20 Photos 	<ul style="list-style-type: none"> Coke deposits were removed and Strainer assembly was repaired Overflow down pipes were fixed back as per the modified supporting arrangement recommended by tray vendor. Refractory repair work was carried out along with dry out -Photos 	<ul style="list-style-type: none"> Damage to Coke strainer caused by damage to overflow down pipes which aggravated the coke deposition. Also, over flow down pipe damaged due to self weight and insufficient supporting. Efficient dry out procedures and special castable if any for use during shutdown ?

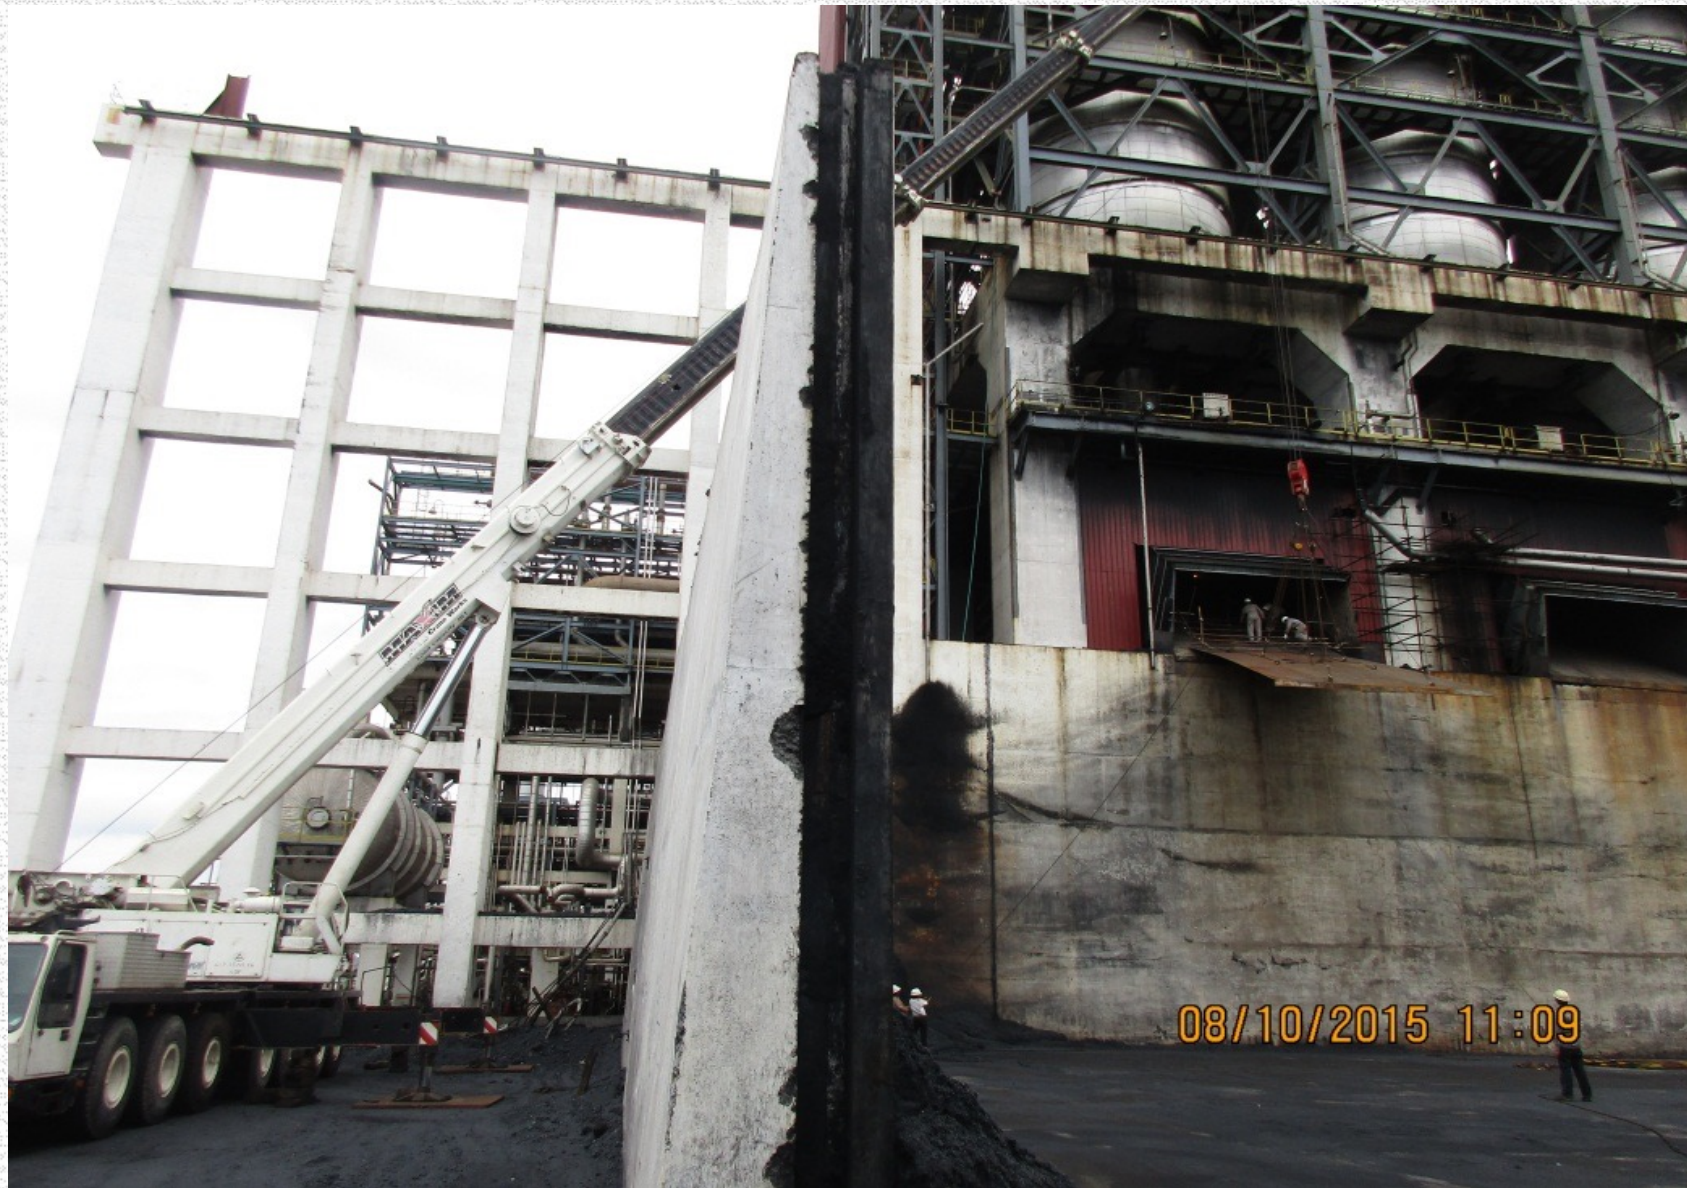
Learning from drum Chute area

Observations	Corrective measures	Analysis/Feedback
<ul style="list-style-type: none"> Coke drum chute is provided with a 19 mm thk abrasion resistant plate on top of concrete. Photo Failure of Chute plates of 2 nos. drums Plate material ABRAZO 400 by TATA Steel UK (Carbon steel with hard facing). 	<ul style="list-style-type: none"> Restoration of damaged chute plates and welding capping with hard facing electrodes. Inspection and repair of balance drums Chute plates. 	<ul style="list-style-type: none"> Failure due to Improper welding consumable / procedure No hard facing was performed on site fabrication welds.

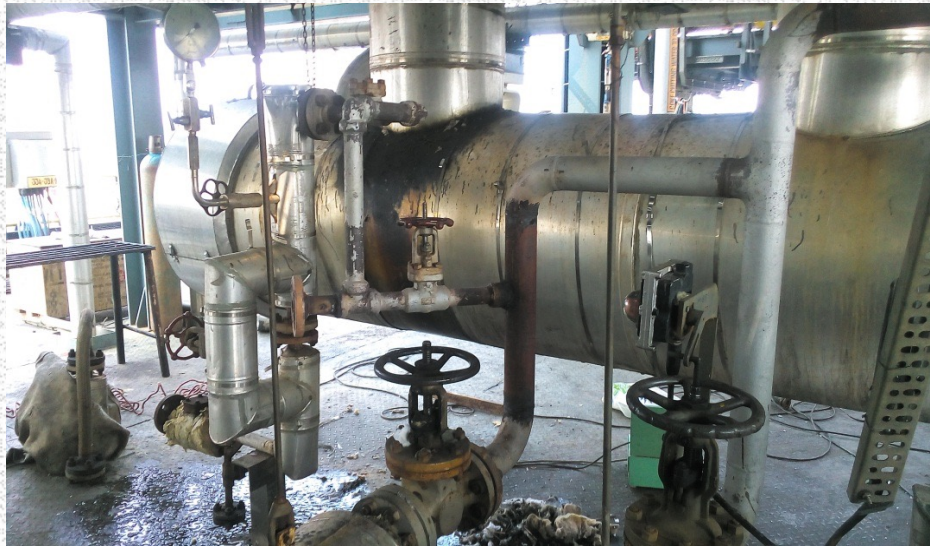
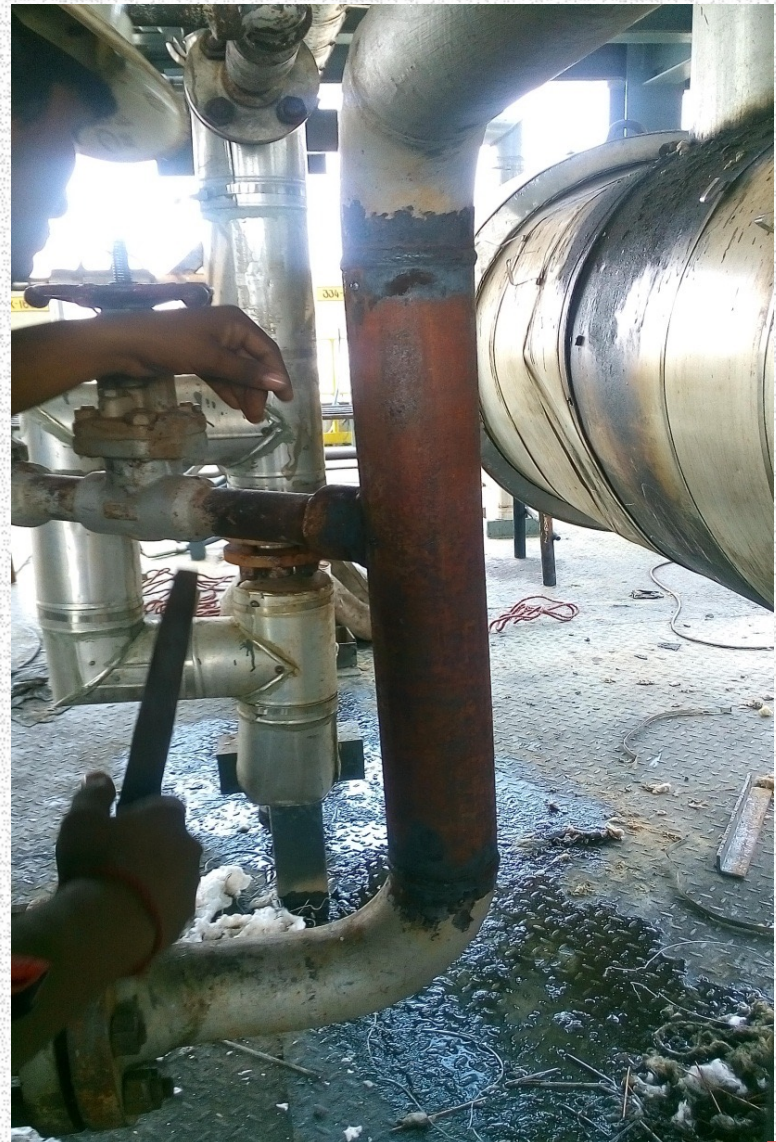
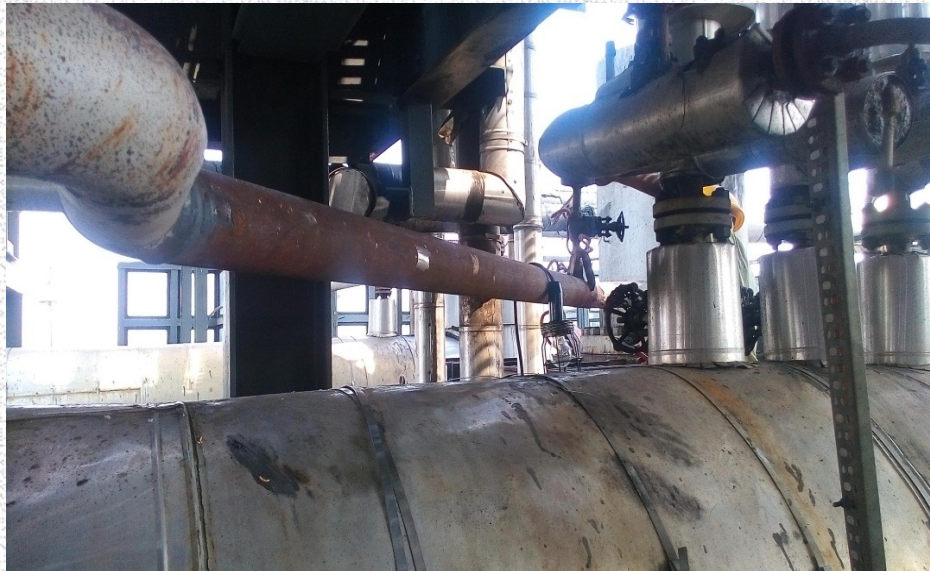
Learning from Antifoam lines

Observations	Corrective measures	Analysis/Feedback Sort
<ul style="list-style-type: none"> Repeated failures observed in Antifoam line connected to Coke drum. Line size 3" and MOC 9Cr-1Mo (SA335 Gr P9) Failures were limited to common portion of the line used for supply of Antifoam and top cooling water. During hydrotest after repair, leaks detected at multiple locations. All leaks were from cracks in the weld HAZ. Higher hardness values were recorded at certain locations Normal values also observed for few failed portions. Photo 	<ul style="list-style-type: none"> Replacement of the failed portions of the line. Minor pitting noticed Hardness check carried out for site welds. Radiography & re-PWHT Re-examination of the joints was carried out after PWHT. 	<ul style="list-style-type: none"> Analysis of failed pieces indicate that failures were due to combined effect of corrosion and vibration. Corrosion part is being studied further. Few cases of improper PWHT also contributed to failures in presence of vibration. Modification for providing isolation valves on the drum nozzles for ease of maintenance in case of failure.

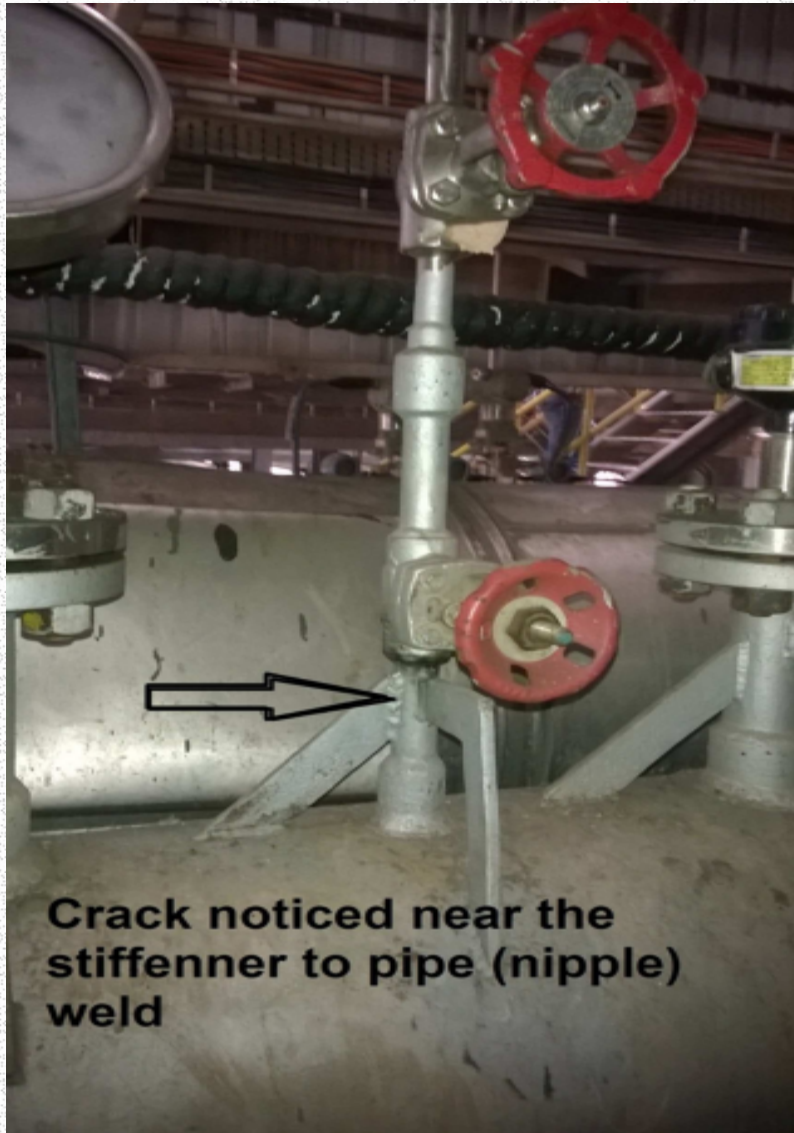
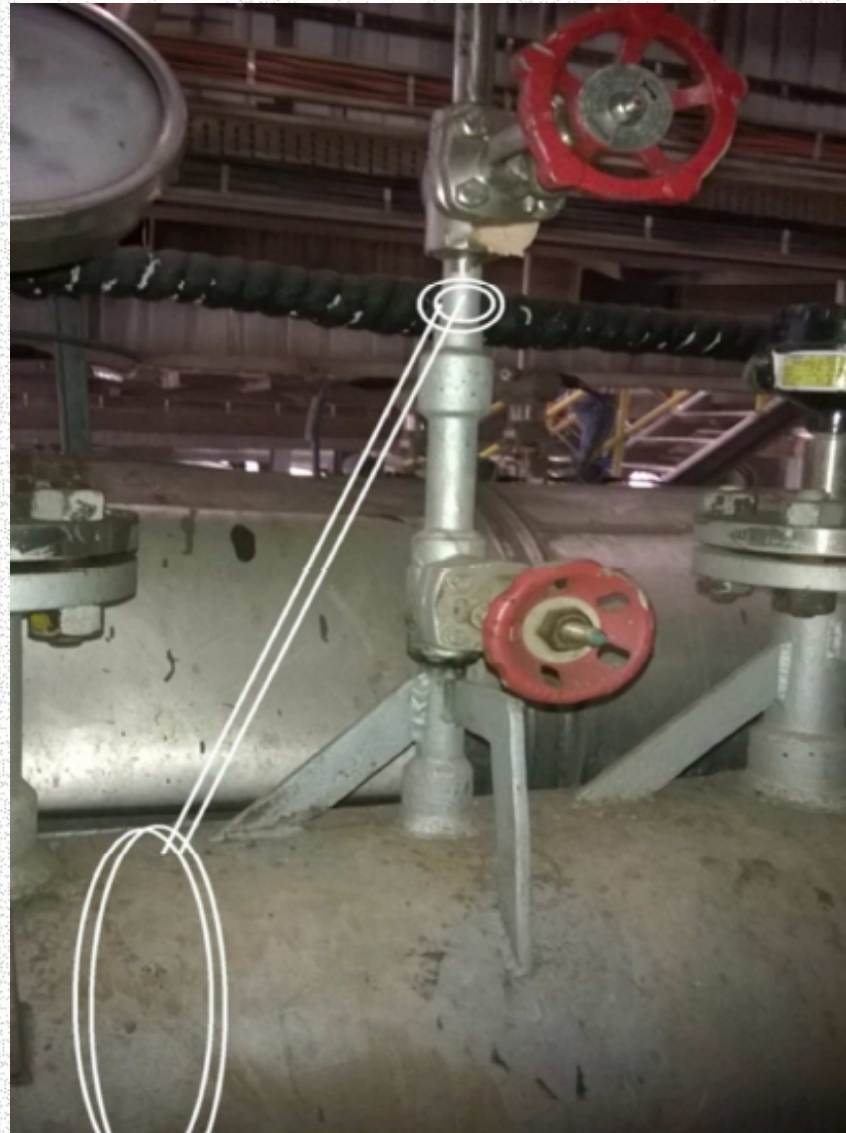
Learning from Small bore tapping's

Observations	Corrective measures	Analysis/Feedback Sort
<p>(1) Failure in Wet gas compressor 2nd Stage discharge 0.75" PG tapping Photo</p> <ul style="list-style-type: none"> Crack observed near the stiffener support to 0.75" pipe weld upstream of isolation valve. MOC Carbon steel with PWHT 	<ul style="list-style-type: none"> Replacement of the failed assemblies and modification of the existing supporting arrangement. Hardness values of failed sections were checked and found within acceptable limits. 	<ul style="list-style-type: none"> Cause of failure is mechanical fatigue due vibration
<p>(2) Stripper overhead line connected 0.75" PT tapping shear. MOC Carbon steel with PWHT. Photo</p> <ul style="list-style-type: none"> Circumferential through thickness crack all around the periphery resulting in shearing. 	<ul style="list-style-type: none"> No sign of internal or external corrosion in visual inspection and thickness survey Inspection of balance tappings and corrective action

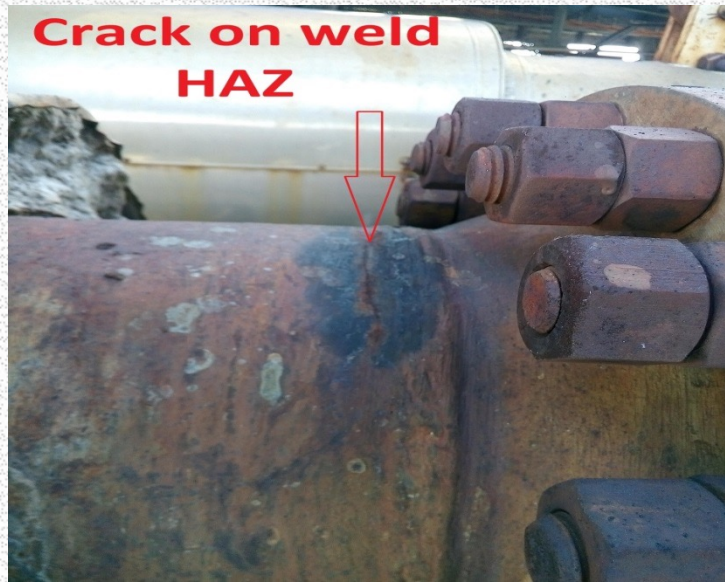
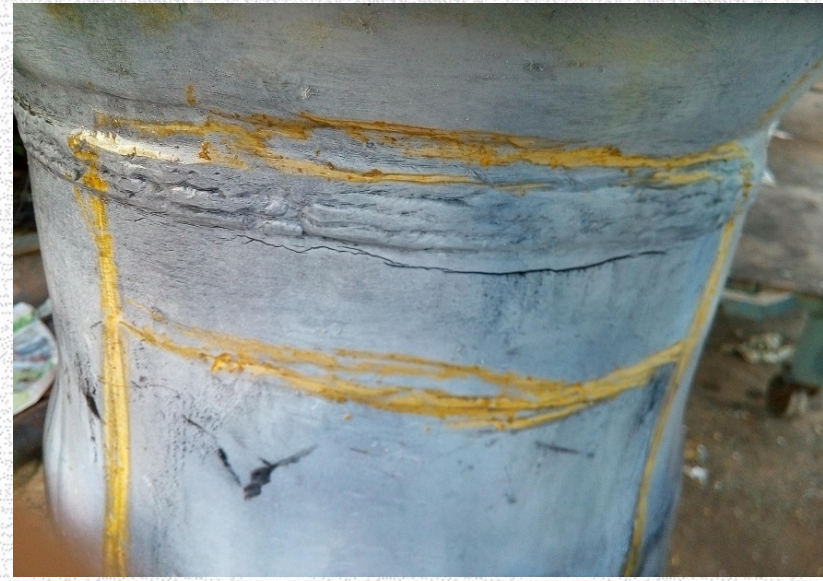
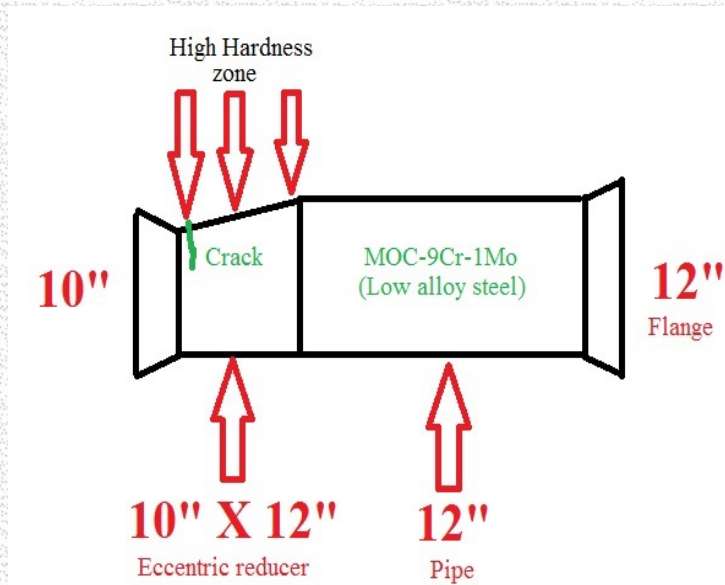
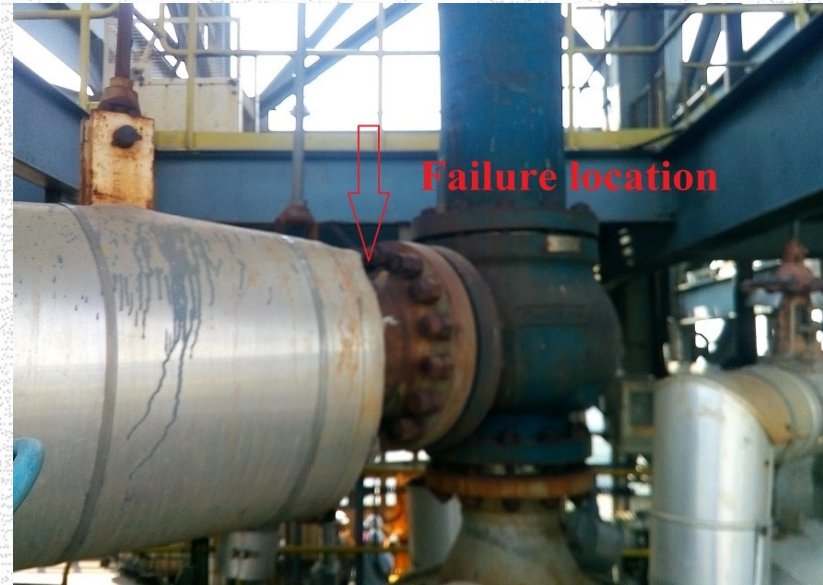
Learning from coke drum PSV line

Observations	Corrective measures	Analysis/Feedback Sort
<ul style="list-style-type: none"> Coke drum connected 24" PSV header has 2 nos. PSV's mounted for individual drums. Crack observed on weld HAZ of Eccentric reducer (10"X12" SA 234 Gr WP9) connected to PSV outlet line. Circumferential through thickness crack from 12 O'clock to 1 O'clock position on the 10" side of the reducer in HAZ of the reducer to flange weld. No sign of external or internal corrosion. Higher hardness recorded on the reducer and both welds of the reducer - Photo 	<ul style="list-style-type: none"> Replacement of the failed section of the piping. Identification of reducers having similar heat nos. 	<ul style="list-style-type: none"> Probable cause of failure:- <ul style="list-style-type: none"> ➤ higher hardness of the fitting ➤ Higher hardness of weld ➤ Vibration related. Feedback required on similar issues
