# 2017 CHEVRON COKER SAFETY & RELIABILITY

- Presentation for REFCOM Conference – DELAYED COKER
- May 2017

- Bottom unheading injury
- Furnace transfer line loss of containment
- Furnace transfer line cleaning – coke ignition
- Furnace tube thinning investigation

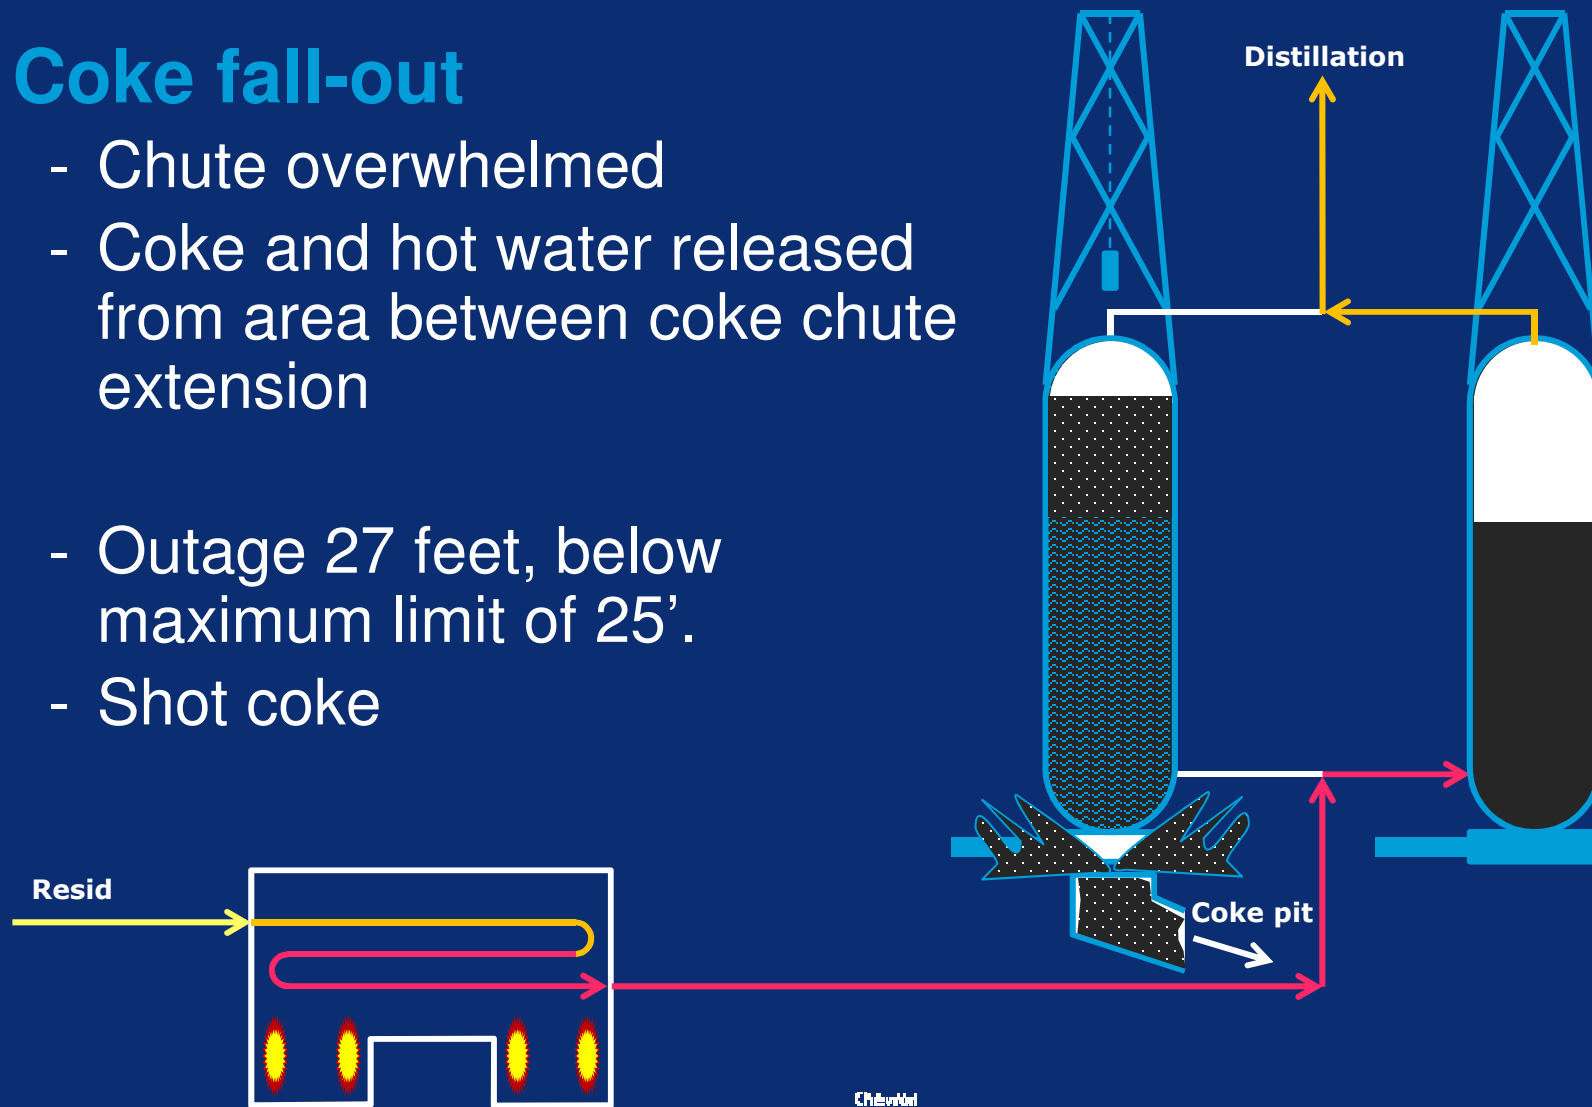
# Coke fall-out

- Chute overwhelmed
- Coke and hot water released from area between coke chute extension
- Outage 27 feet, below maximum limit of 25'.
- Shot coke

1. IMMEDIATELY STOP Re-INSERTING locking pin after opening BUD until after the energy source (coke & water) has been removed from coke drum. Recommend inserting after coke has been cut to verify that the BUD limit switch is in correct position, fully opening the gate. Verifies an edge of the gate will not be in path of falling coke and experience erosion during coke drilling operation.
2. Continue and complete the fixed chute replacement. Monitor new design performance; has it stopped coke back-up onto bottom unheading deck?

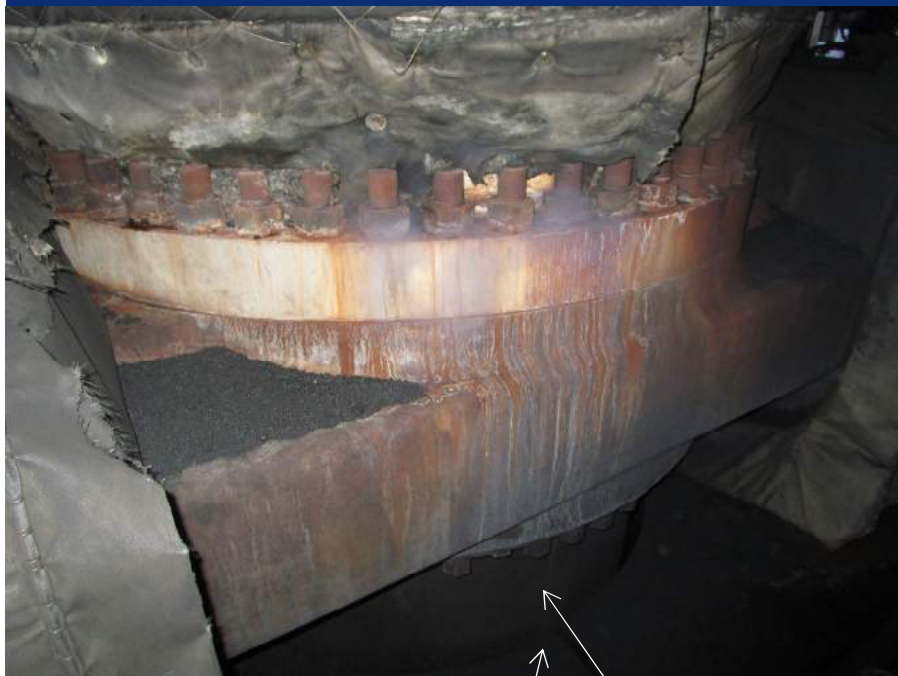
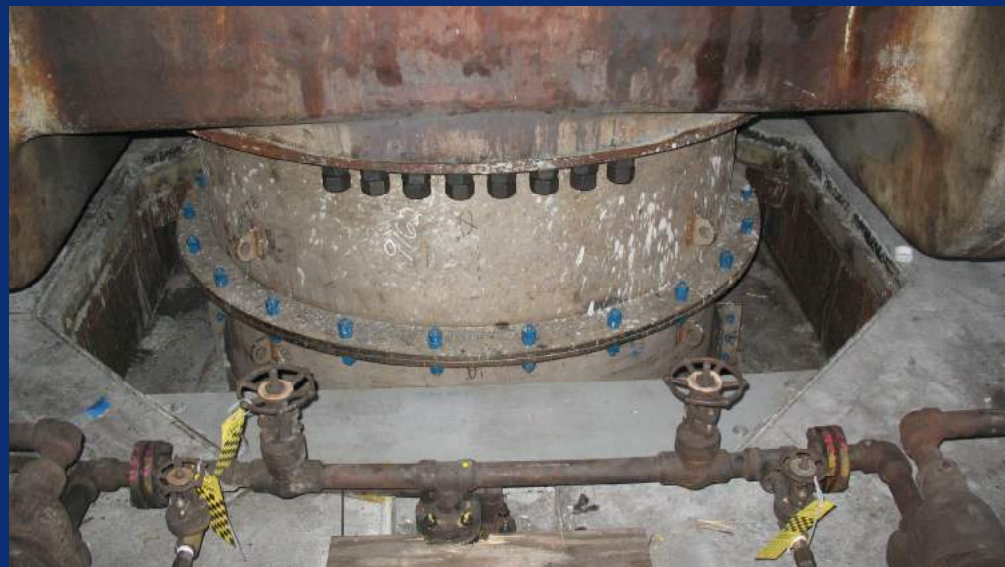
Original design: CS fixed chute to bottom flange of BUD. There were plates used to fill gap between bottom (feed) deck (72" opening).

New design ( right picture) is stainless, two pieces with the intent to have a seal to prevent coke and water onto deck. New design developed and being implemented prior to incident.

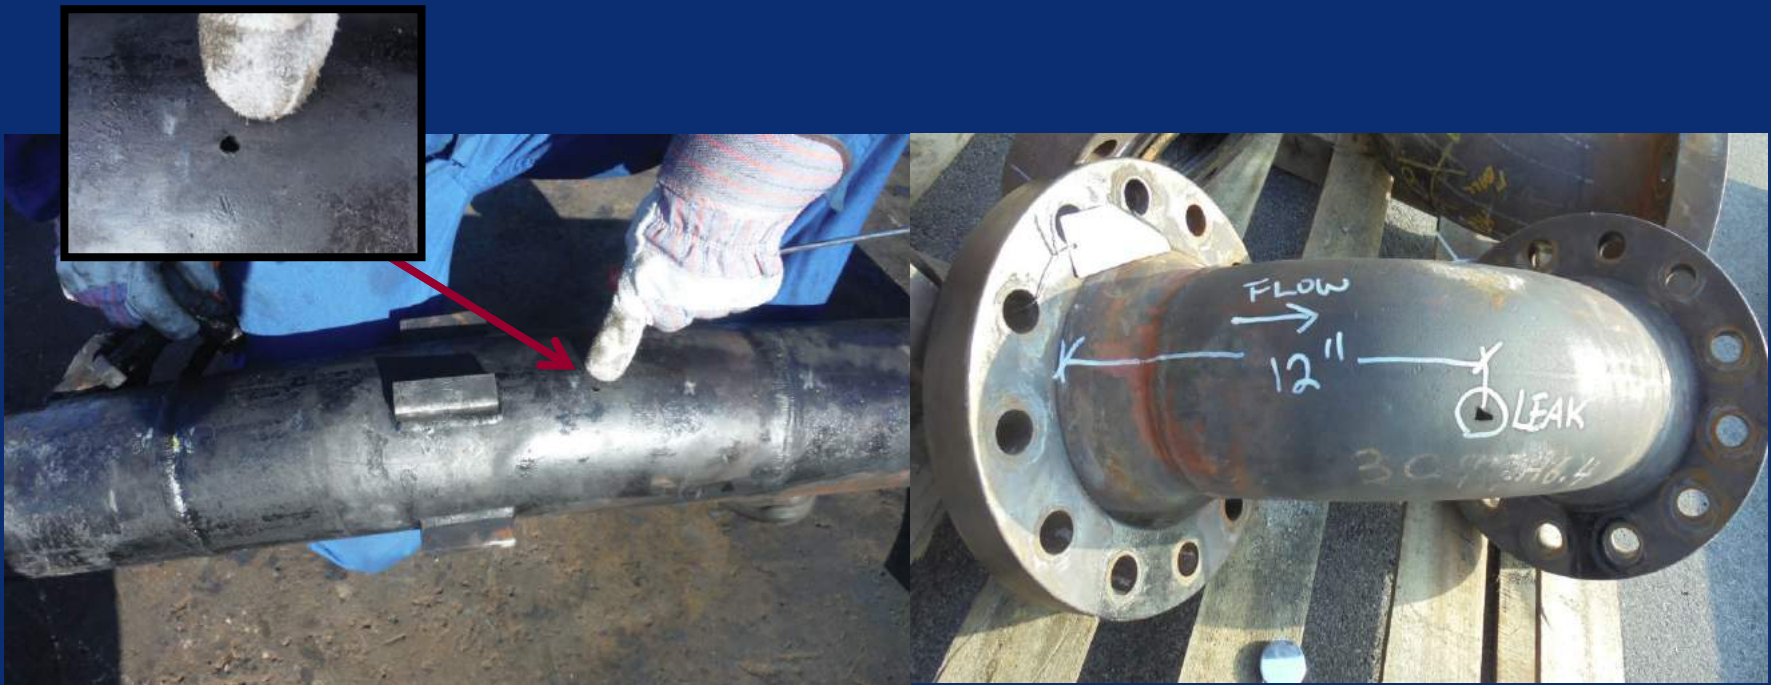
- Initial leak on A furnace transfer line discovered after a spall.
- Second leak on C furnace transfer line discovered during spall.

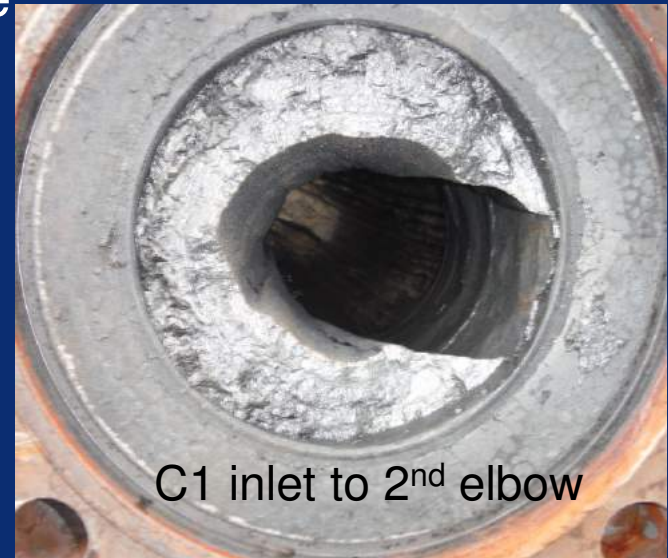
C1 inlet to 2<sup>nd</sup> elbow

- Channeling in the coke due to a change in direction of the flow which targeted locations for erosion.
  - Apex of 90°s.
  - Quench steam introduced perpendicular to flow.

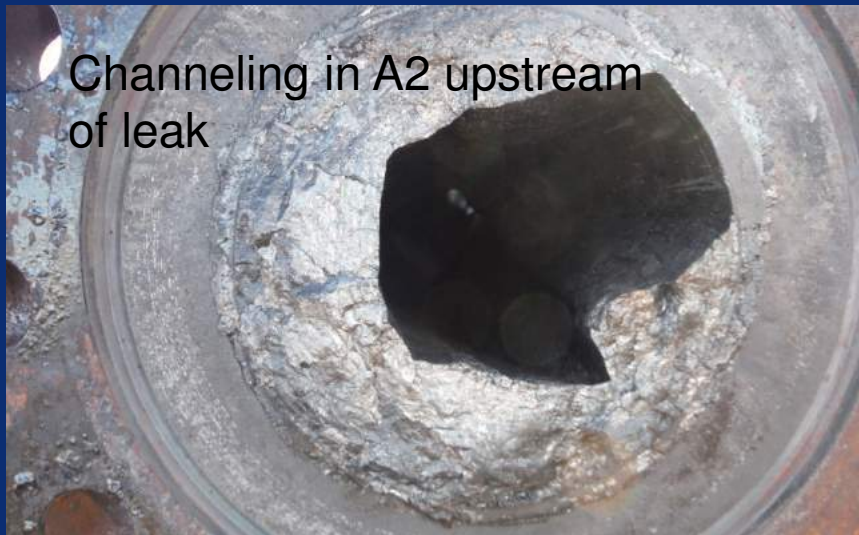
Channeling in A2 upstream of leak

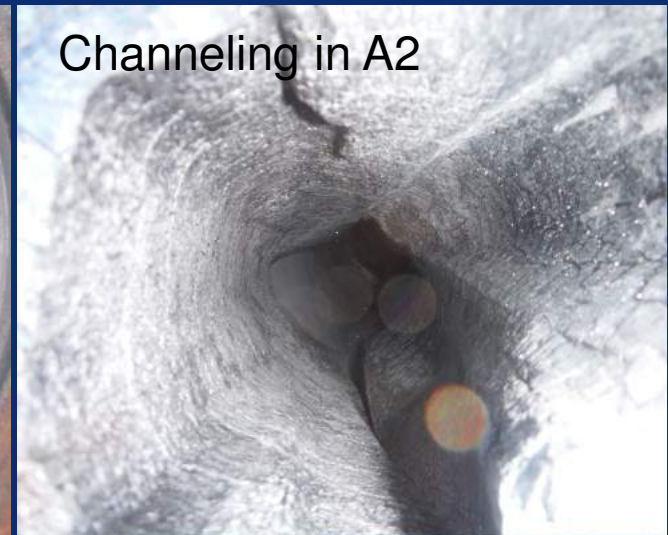
Channeling in A2

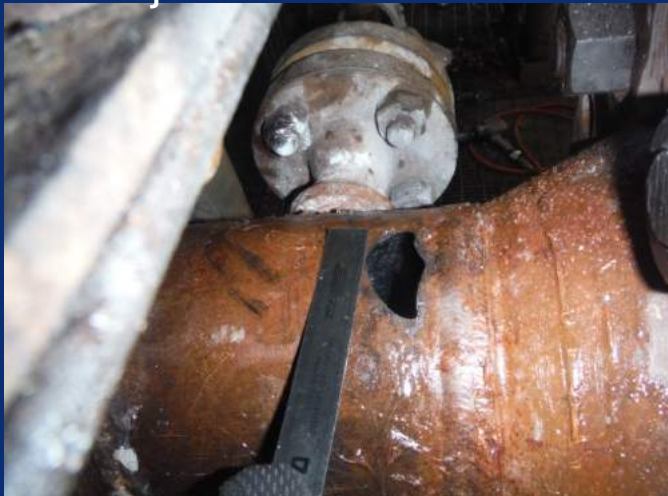
2015 B1 leak during spall.  
Leak is opposite quench  
steam injection.

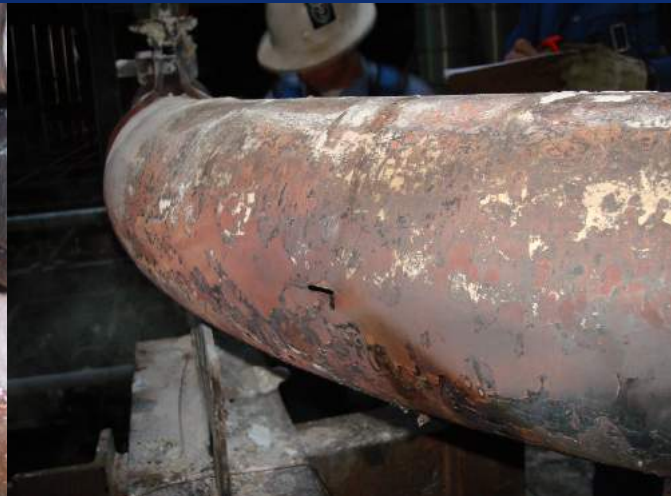
2011 B1 leak during spall

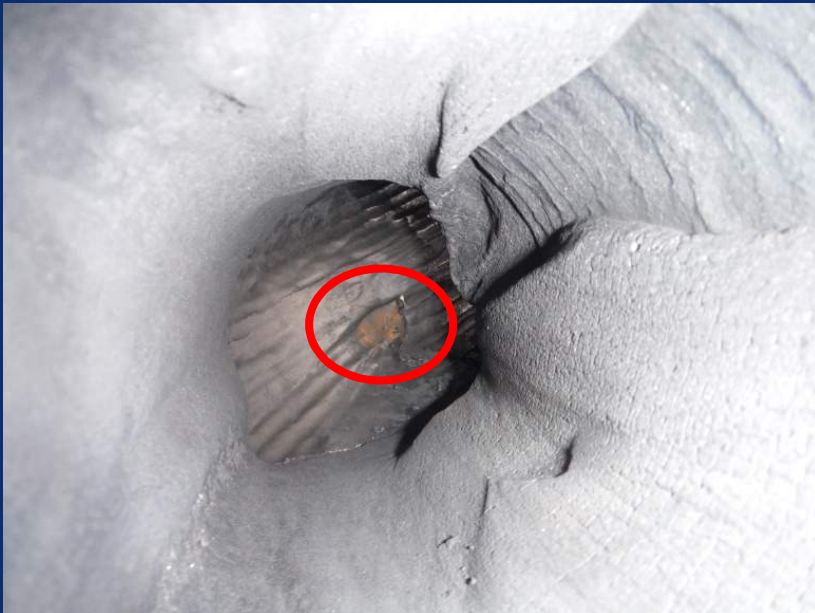
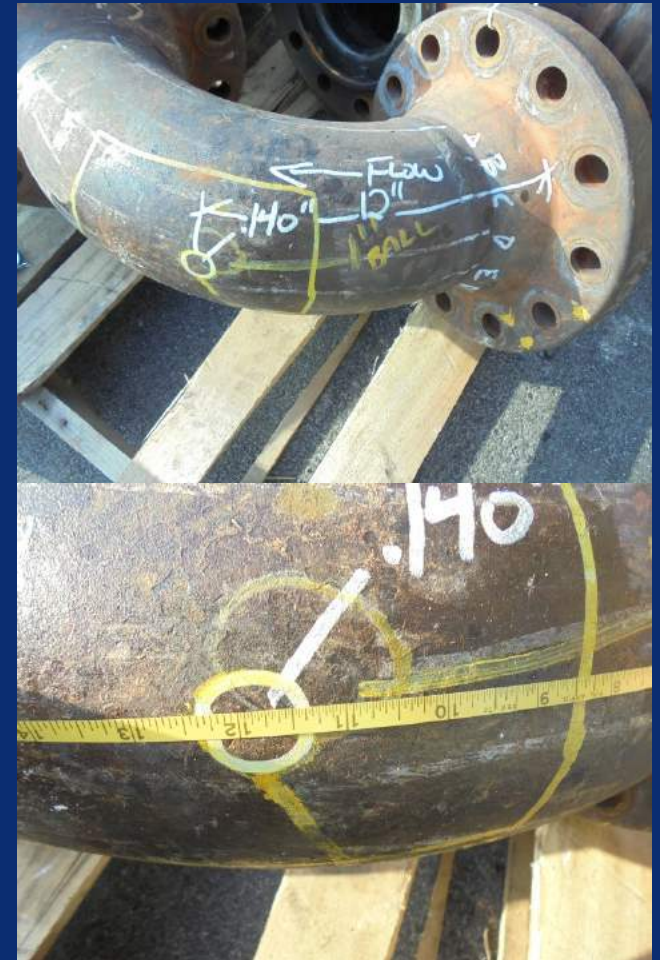
- Found the erosion on the elbows to be ~12" away from top of flange.
- Pictures: C Furnace pass 1 - 1<sup>st</sup> elbow
  - Stellite/Inco breach
  - Thinned from ~ 0.5" to 0.140"

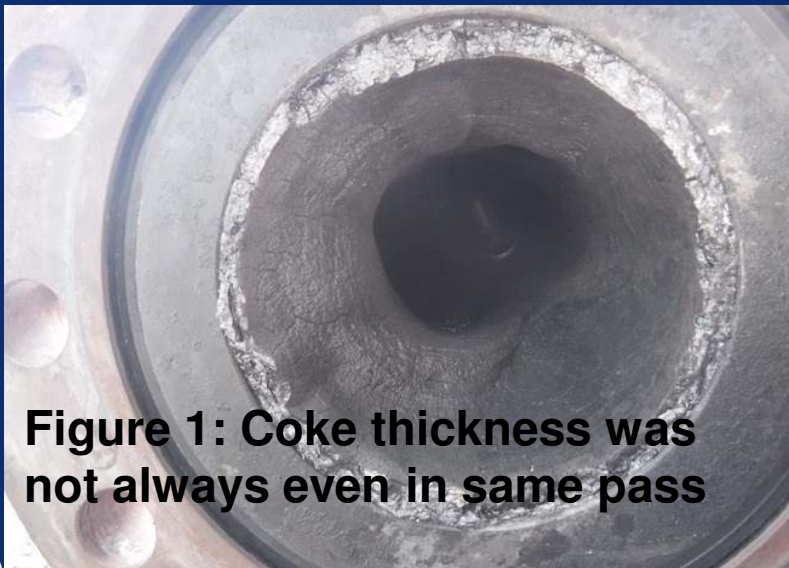
**Figure 1: Coke thickness was not always even in same pass**

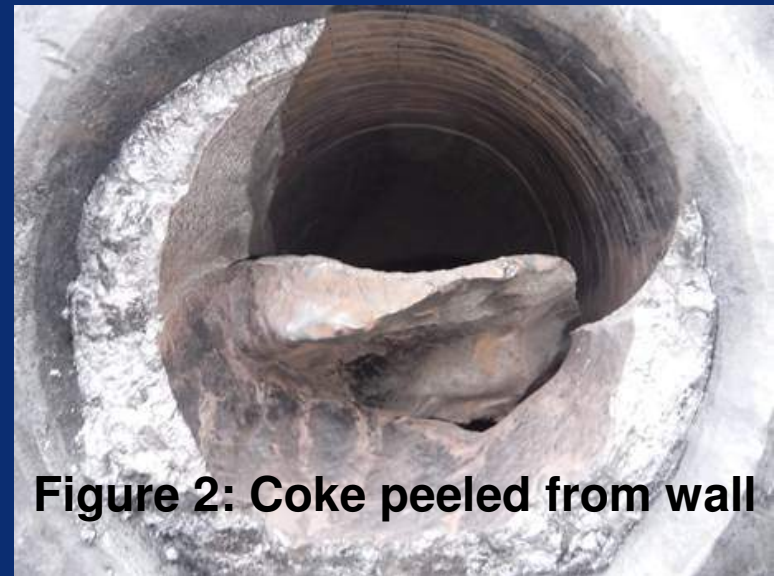
**Figure 2: Coke peeled from wall**

- Set a limit on furnace transfer line dP which will trigger Operations to open, clean, and inspect the transfer line.
- Develop and implement an asset strategy plan on the Furnace transfer line.
- Eliminate and/or minimize the affect of quench steam in order to reduce channeling.
  - Install Cushion Tee's which avoid the 90 degree mixing point and impingement of coke fines during spall on first elbow.
  - Consider increasing transfer line temperature limit during spalls in order to eliminate quench steam.

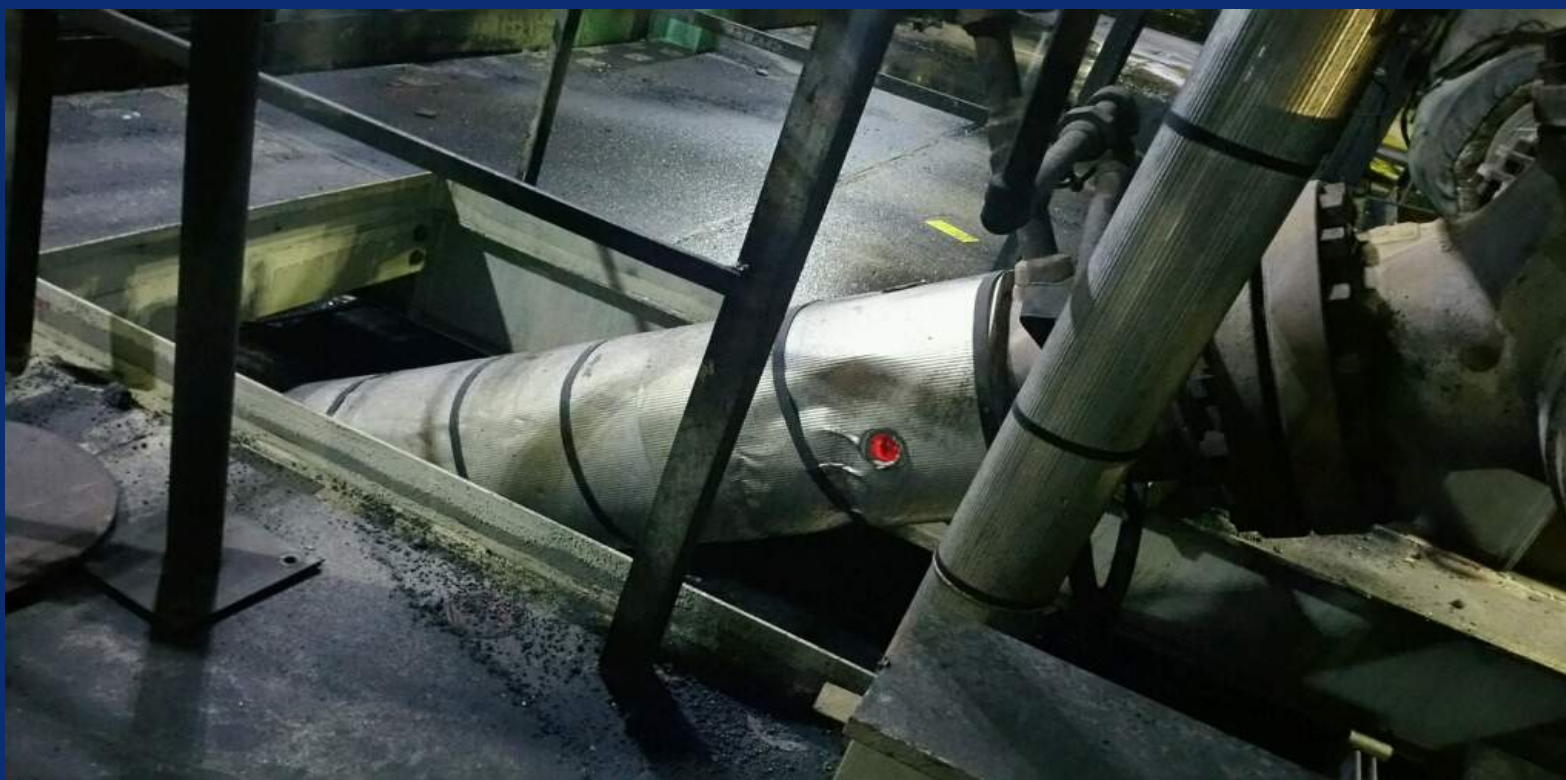
**Coke combusting inside transfer line.**

**Response:** Introduced 150# steam to cool the line.

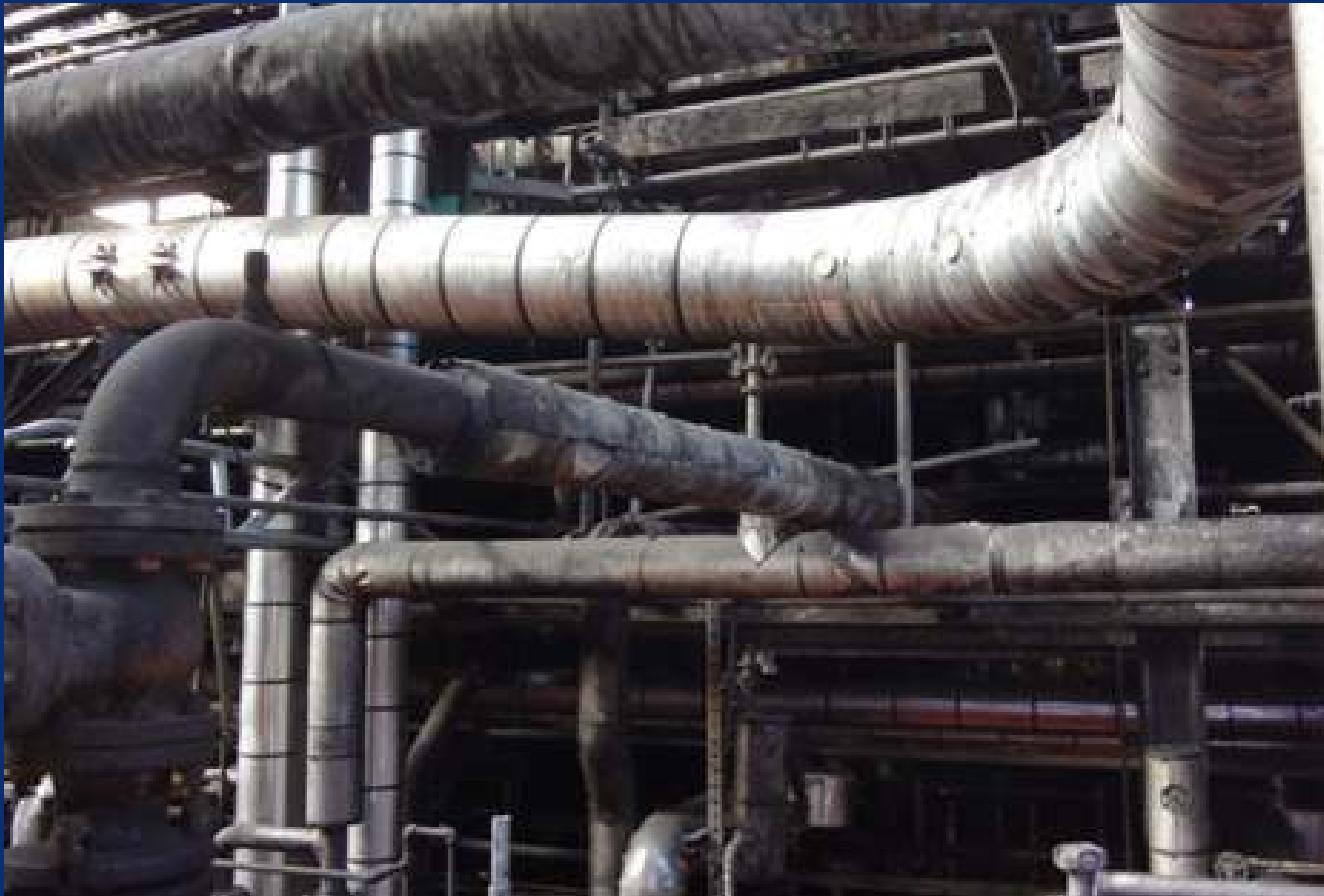
Observed sagging elbow.

- Performed hardness testing
  - Showed tensile strength slightly above 60-85 ksi (ASTM A387 spec for 5Cr class 1 plate)
  - Concluded no considerable damage re: mechanical properties. Line deemed fit for service.
- Stress Calcs:
  - Caesar modeling showed 2-3 ksi max stress.
  - API 579 calcs - exposure temp was ~1500-1600F to yield/creep at 2-4 ksi
  - Recommended a new pipe support to eliminate potential for future damage due to creep/yield.

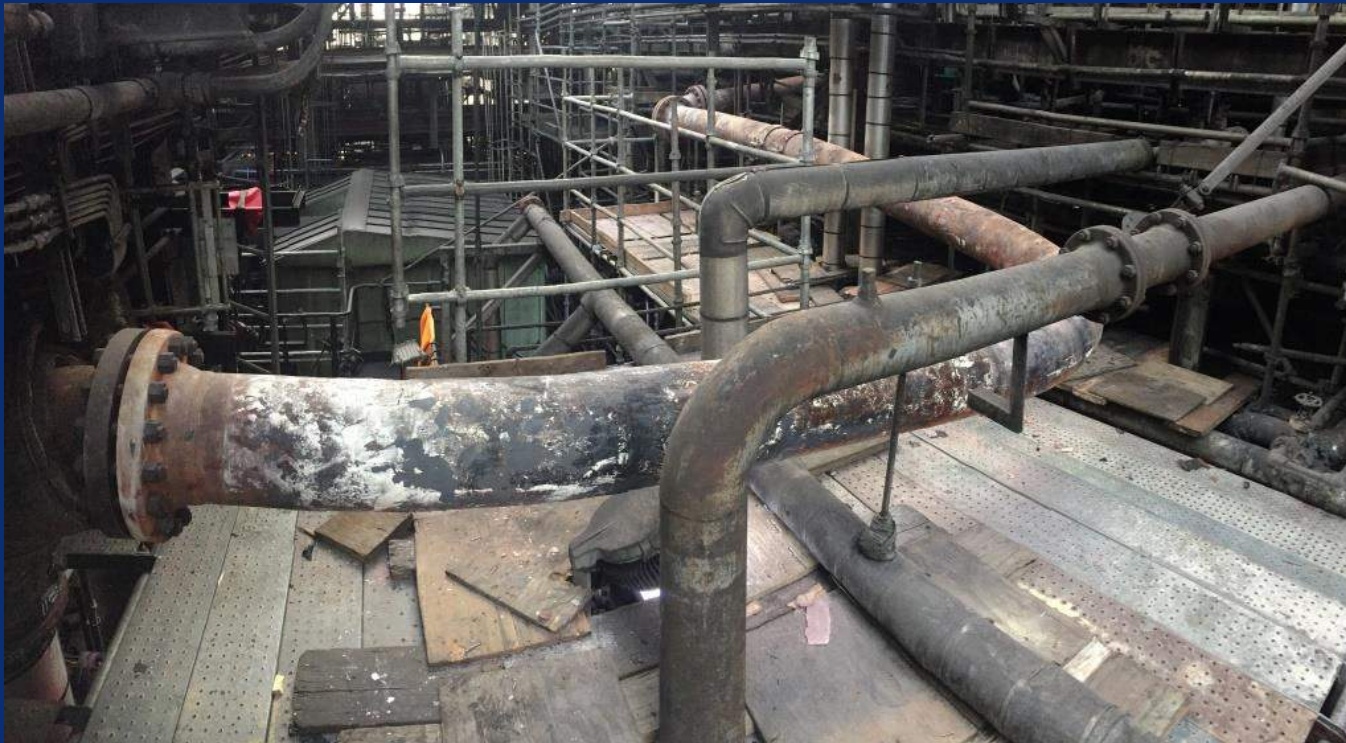
Stripped insulation for inspection and fitness for service evaluation.

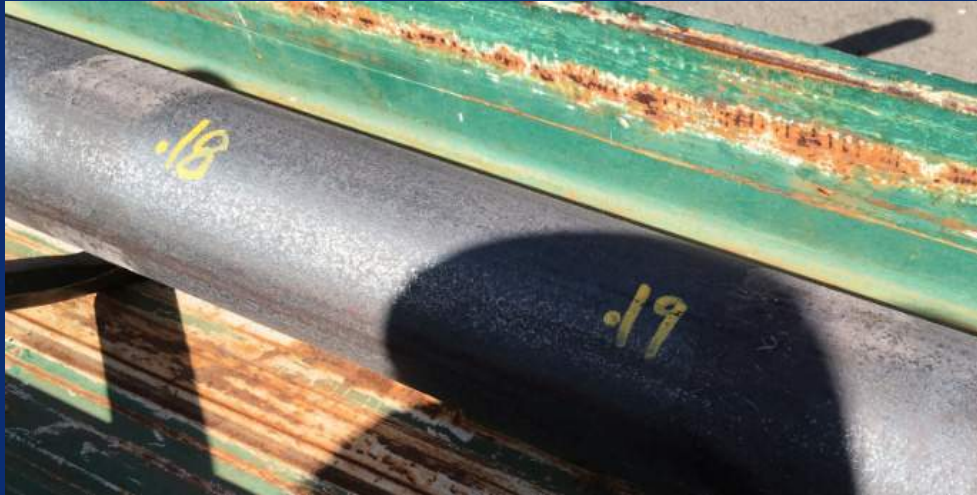
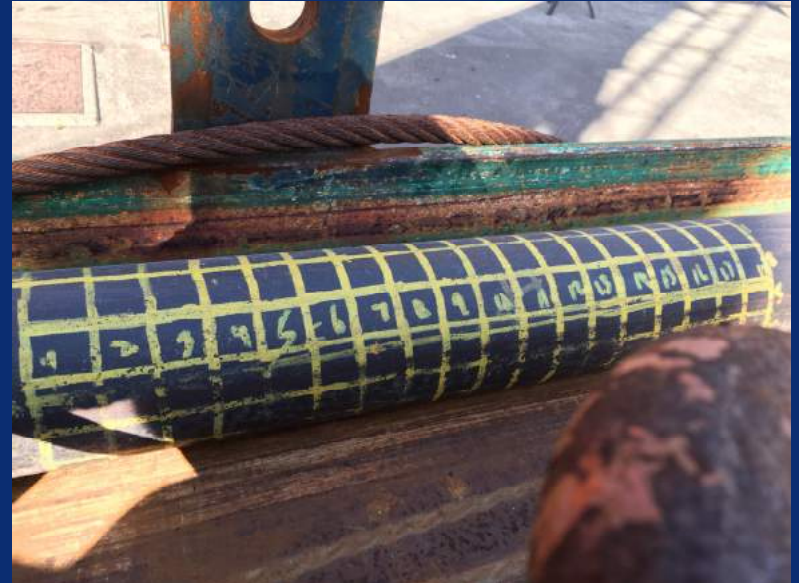
## F-501B Pass 3 Tube 30

Tube 30 : Removed for metallurgical analysis.  
Very localized, maybe 6 feet in length, down to 0.14".

Length wise, thin section is in the middle. Both ends had some loss in thickness, from 0.226 down to 0.180. Limited spot UT data.

Circumferentially, damage is only 4:00 – 7:00, the tube side that “sees flame reflected from wall”. Back side of tube is nominal, 0.226".

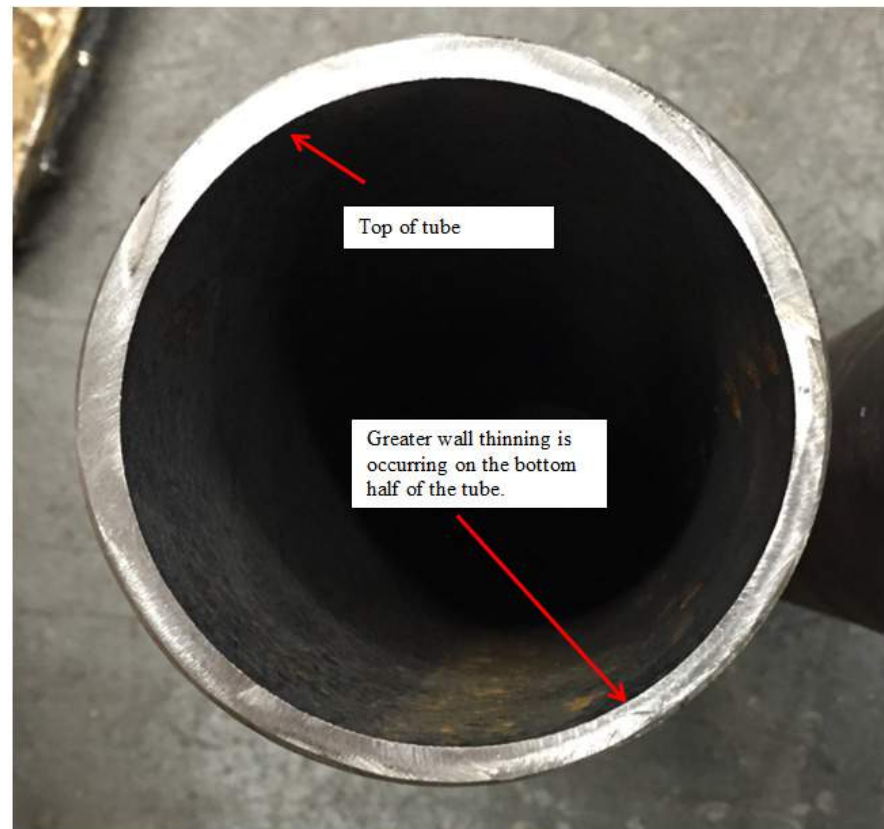
**Figure 2:** Thinning tube cross section

The thinner side corresponds to the bottom half of the tube, roughly the 4 to 7 o'clock position. The thinnest area is at the 7 o'clock position on the fire side, also known as the "sunny side" (Figure 3).

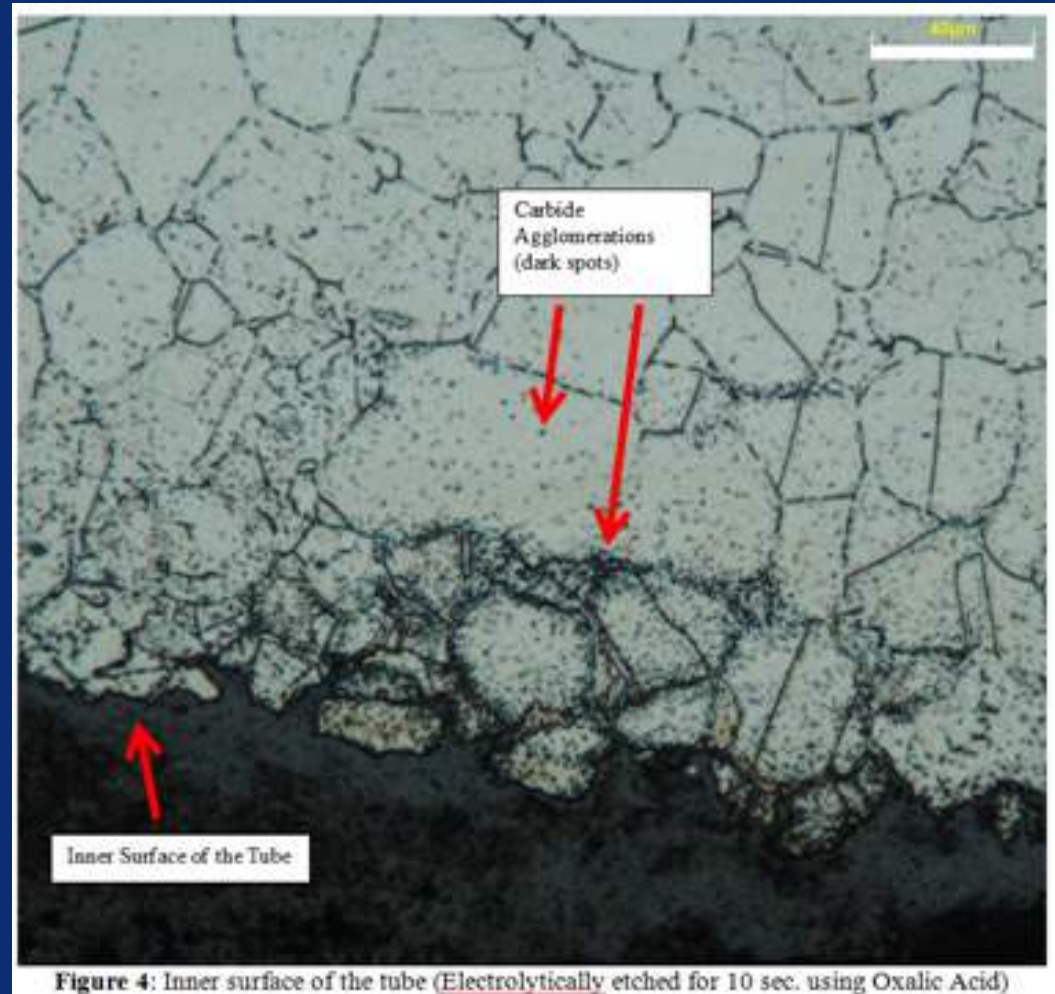
- Confirmed 347 SS tubes.
- The H for high carbon grade was not confirmed.
- Dark spots indicate higher presence of carbides.
- Carbides forming within individual grains towards the inner surface.
- CARBURIZATION damage is occurring toward the inner surface during normal operation.
- THINNING occurs by spalling off carburized metal during temperature cycling in coke removal process.

Tube wall loss from inside of tube

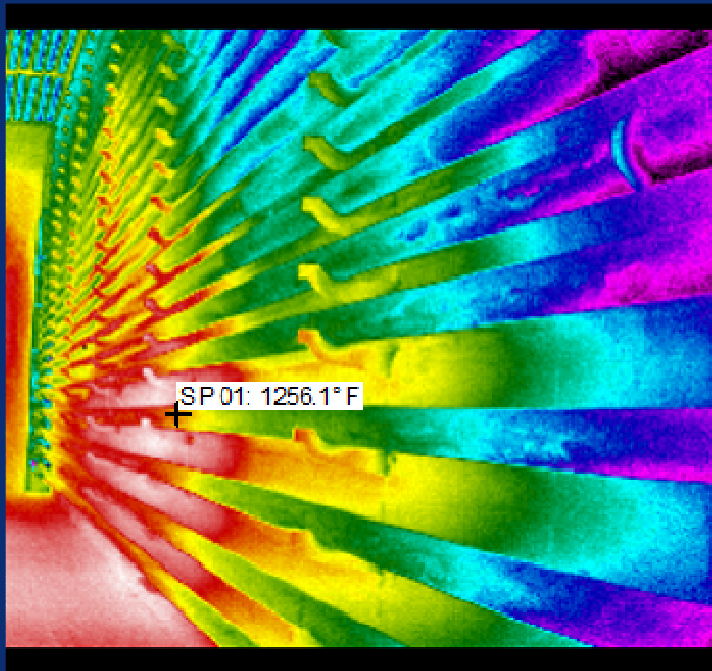
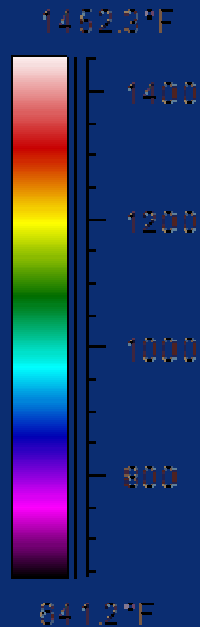
+ is on refractory, supposed to be on tube. Initial report of 1300 F revised to 1256 F. Visibly tubes 45, 46, 47, 48 for a section of tube are much hotter than rest of same tubes.

F-501C pass 1, July 7, 2016. Burner 12 was out of service. Tube and refractory across from burner 8, 9, 10 was extremely hot, about 15 foot width. Tube skin TI for same tube was 1120 F. The 136 F difference does not mean the skin was incorrect; **it means the heat release in the firebox was not uniform.** Burner 8, 9, 10 could have had higher fuel rates due to other burners plugged or out of service.

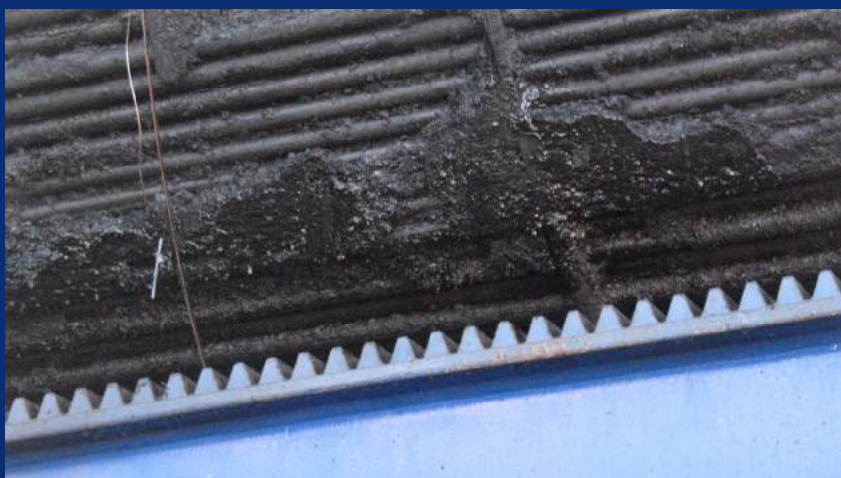
Asphaltene  
material at bottoms

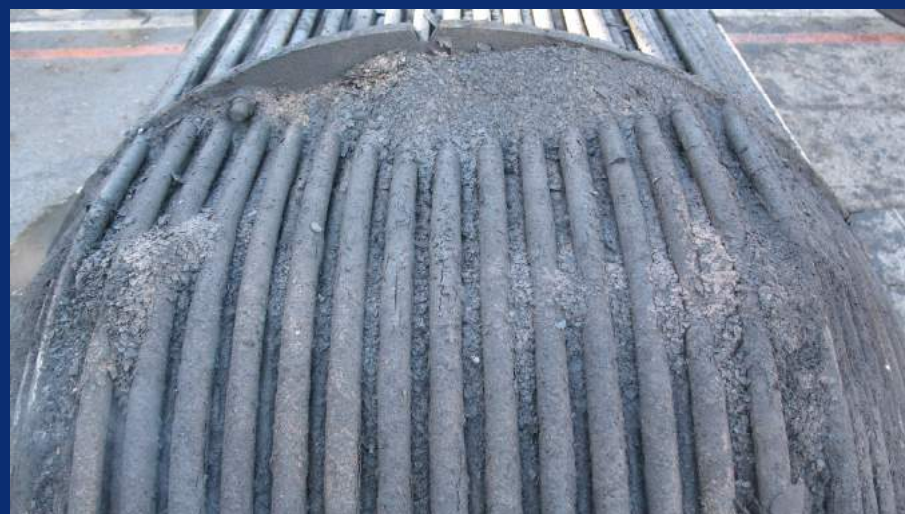
Packed with of Iron sulfide scale  
at top of bundle (E-535B)

Coker HCGO – resid exchangers use to achieve a 3 year run before cleaning was required. Cleaning frequency has been every year recently. Exchanger acting as a filter for iron sulfide scale collection.

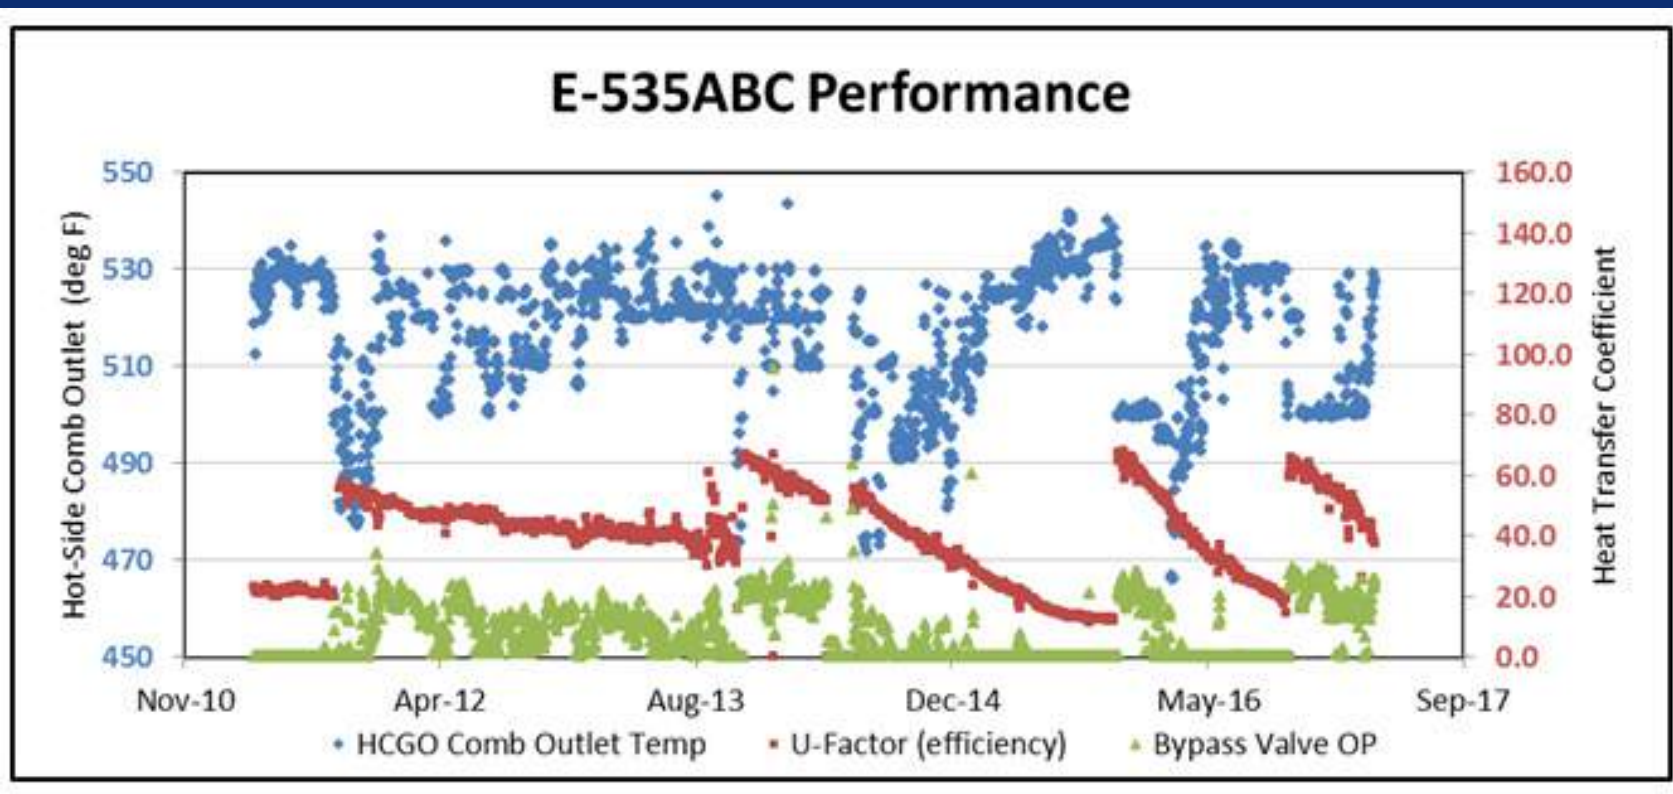
Coker HCGO – Resid exchanger heat transfer U-factor has had step change since 2013, dramatic increase in fouling rate.

Lower heat transfer causes lower furnace feed temperature, higher furnace fired duty.

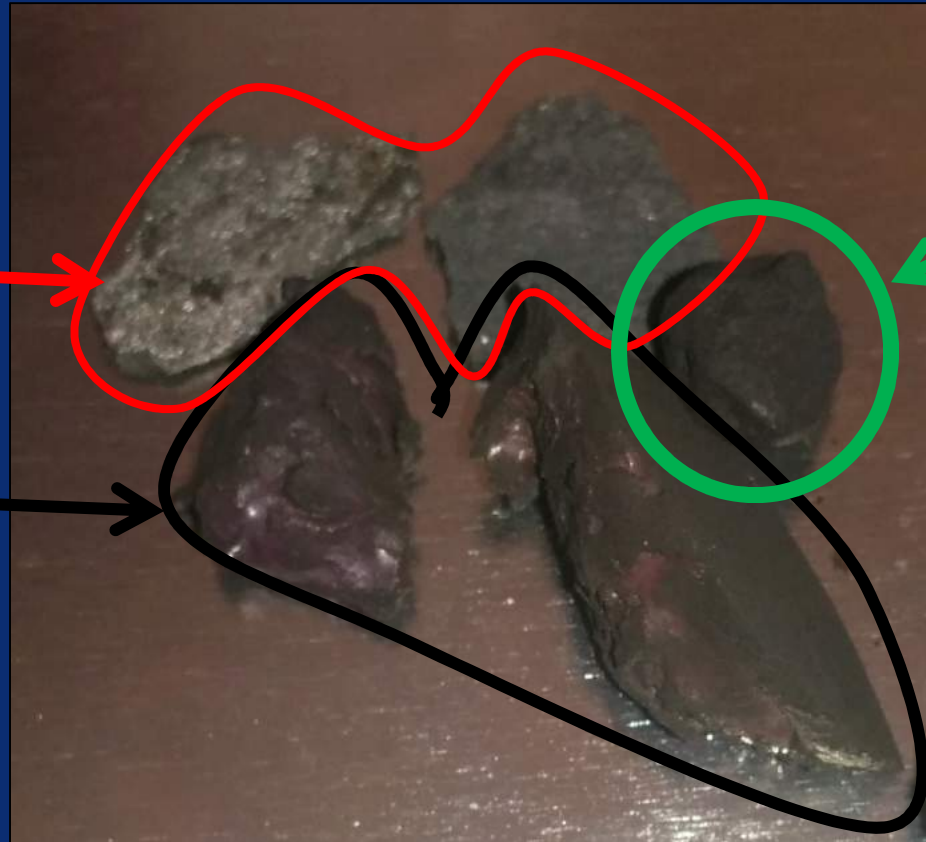
Grayish  
rock-like  
material

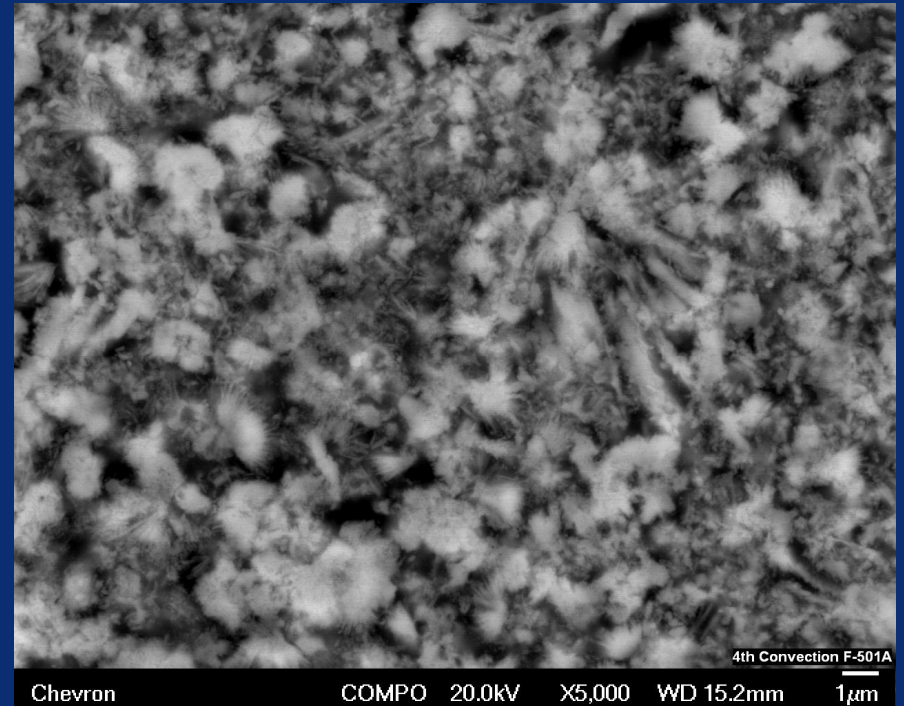
Lighter areas have  
high calcium content

Fuzzy crystals, inorganic deposit,

- ETC: "Hard deposit, rich in Si-Ca." "Very hard."
  - Calcium from difficult to desalt crudes, maybe Napo, Ecuador?
  - Silicon used in crude (antifoam?). Why is it in convection deposit?

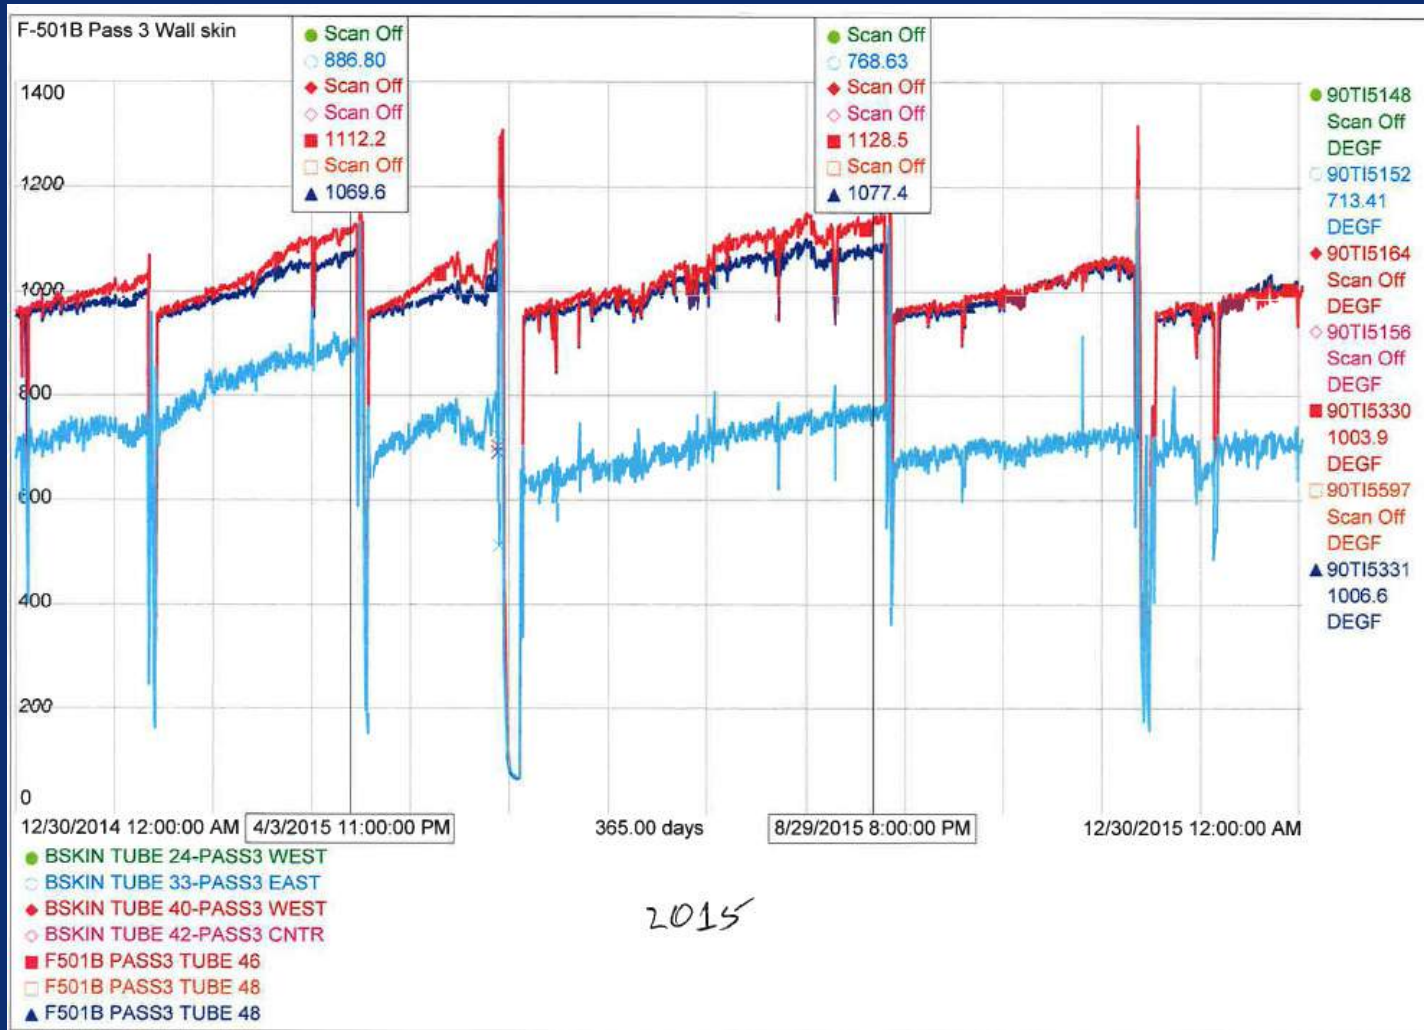
Fouling rate 3-5 Deg F per day. Lower radiant wall triggers coke removal.
