## **Coker Unit Pascagoula Refinery Coke Drum Vent Near Miss**

**Robert Bell  
Coker Process Expert**

**May, 2007  
Coking.com Seminar  
League City, Texas**

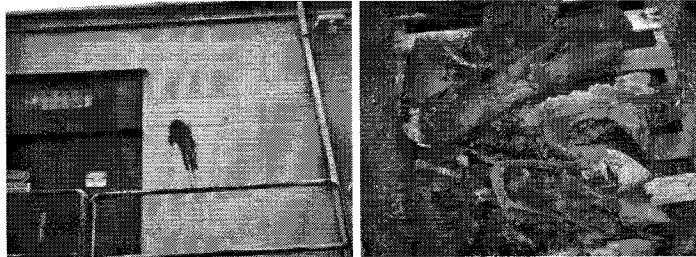
- Drum Pressure began to increase
- Driller noted that no steam was coming from vent
- Plug ejected from vent when drum reached 20 psig

## Material Ejected From The Vent

- Mufflers were installed on the vents. Muffler internals increase potential for accumulation of plugging materials
- Mufflers were 24 years old. Inspection limited to external integrity.
- Risk of vent plugging missed during HAZOP reviews
- Normal venting carries coke dust, moisture and oil into vent
- Blowbacks can deposit large quantities of coke in the vent
- Muffler does not have instrumentation to monitor pressure drop. Material can accumulate and then shift into a complete plug

- Near Miss Incident investigation underway
- Interim procedure created to define actions for a plugged vent
- Add this incident to HAZOP review sheet
- Communicate to Chevron and Industry.
- Muffler now designated with a 15 year end of life.
- Consider routing vent discharge to a more contained location
