## Innovative Coke Drum Repairs

Coking.Com Workshop  
Galveston, TX  
03/24/2009

Welding Services Inc.

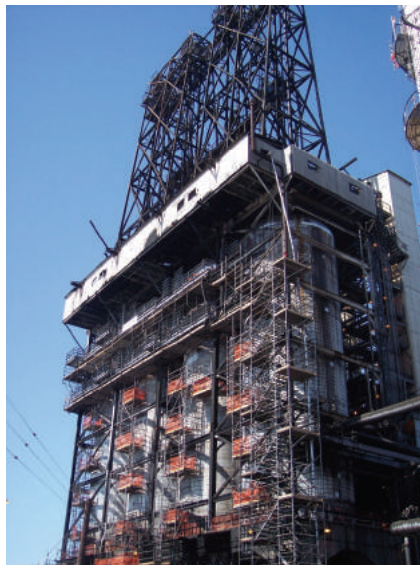
- T/A to Retro fit (4) four Coke Drums to accept new Delta Valves
- Coke Drum Material: SA387, Grade C, 1 ¼ Cr ½ Mo, 25mm thick
- Perform repairs to existing 410 explosion bonded cladding by applying over 115sq.m. of Inconel 82 Overlay in cone section above bottom nozzle
- Schedule: 10 days for all four drums total completion

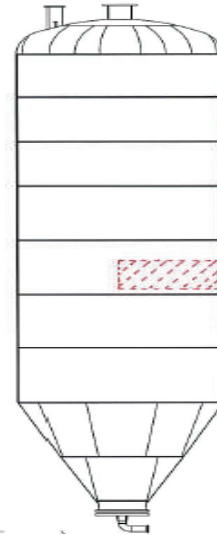
- 8 Coke Drums
- Material: SA 263 Grade C
- Wall Thickness: 22.3mm
- Diameter: Ranging from 7925mm to 9755mm.
- Size: Ranging from 20m to 29m.
- One of the Cokers was experiencing bulging due to fire in drum

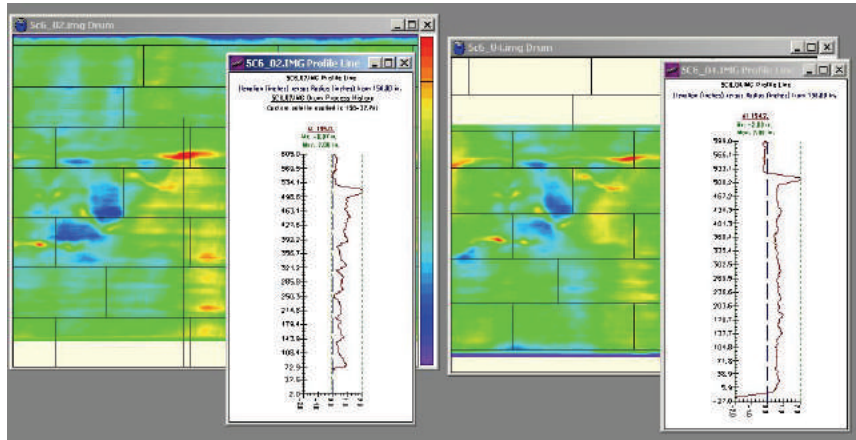
## Compare 2002 and 2004 Bulges

- Of the eight drums reviewed, 1 Drum was identified with the most severe bulging at 2 Locations. We name them Bulge A & Bulge B.

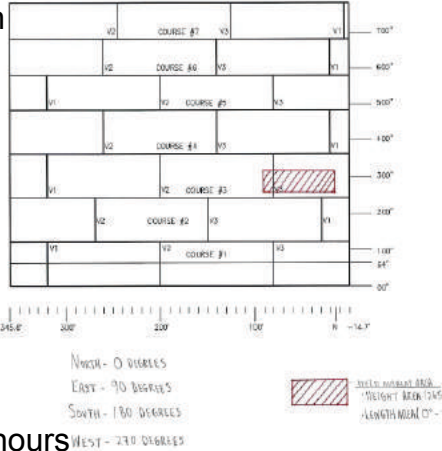
- Bulged area overlaid: 6.5m x 2m

- Applied Alloy 625, 955mm thick (2 layers), overlay utilizing temperbead utilizing (2) PLC controlled Unifuse Weld Systems

- Temperbead eliminated the need for PWHT

- Post Soak of 450° F(233C) for 2 hours to eliminate any potential for hydrogen

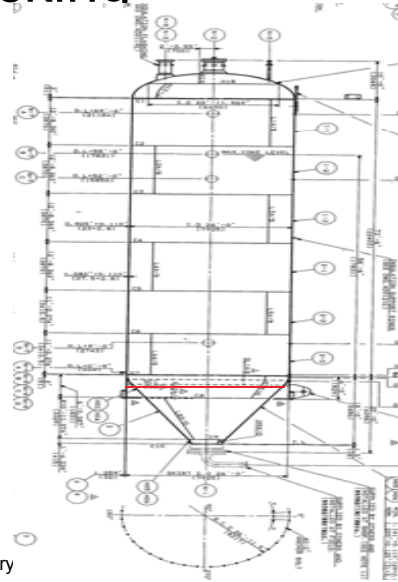
- 2 - Coke Drums
- Tower details:
  - SA-387-Grade 11 material
  - 31.7m tall
  - 8m ID
  - Original wall thickness 31.75mm
- Turnaround inspection:
  - 2003 T/A repaired weld seams in Coker # 2
  - May 2006 found many indications approximately 5mm deep, 25mm long, throughout the entire circumference of the weld seam in both drums

- Utilizing 8 Automated Weld Systems
- Machined and Re-Welded Circ Seam using Temperbead WPS
- Post Soak used, eliminated PWHT
- UT Shear Wave acceptable
- 5 day Schedule for the welding of both Coke Drums
- Savings \$\$\$
  - Customer avoided 10 days of Downtime
- ***Recently inspected after 660 cycles no cracks***

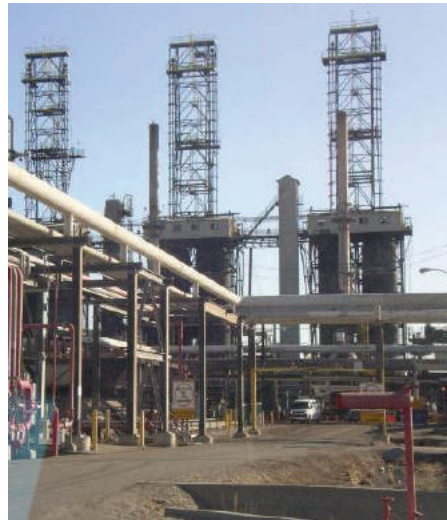
- 12 Drums
- Material: SA 387-12-CL2
- Drum Thickness: 1.377"
- Height: 90' Tan - Tan
- Diameter: 18'5" ID
- Customer was experiencing cracking below skirt to shell weld. Changed the skirt design (key hole slot) to reduce stress on skirt to shell weld.

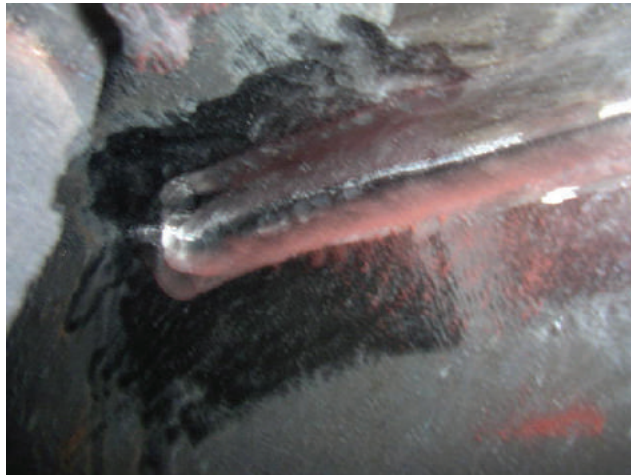
## Shell Crack Removal

- The crack was excavated with the carbon arc gouge process.
- The cracks ranged in depth from approximately 0.188" to 0.75"
- The cracks were removed to a minimum of 0.380" to ensure that the entire crack was removed.
- If the crack still existed at 0.380" then more excavation was done.
- MT was performed to ensure cracks removed

- 1<sup>st</sup> and 2<sup>nd</sup> layer of temper bead welded then in process MT performed
- After all of the welding and the 2 hour heat soak was completed a UT shear wave was done to check the area for flaws.
- If no flaws were found the area set for 24 hours to look for delayed cracking. After the 24 hour wait, another UTSW was done.
- If this UTSW was good then the window repairs started in this section of the skirt.
