Inspection Utilizing “Intelligent Pigging” of Coker Heater Coils

Author: Rich Roberts

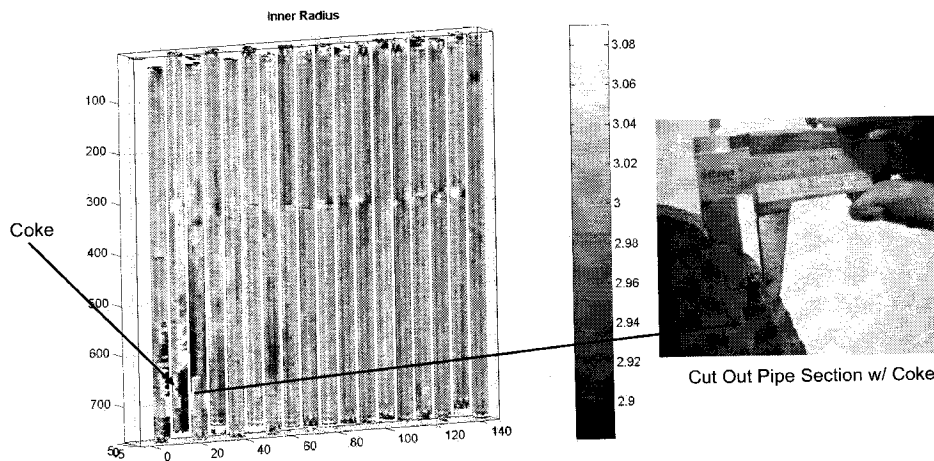
Process Heater
Tube Rupture

Naphtha Hydrotreater

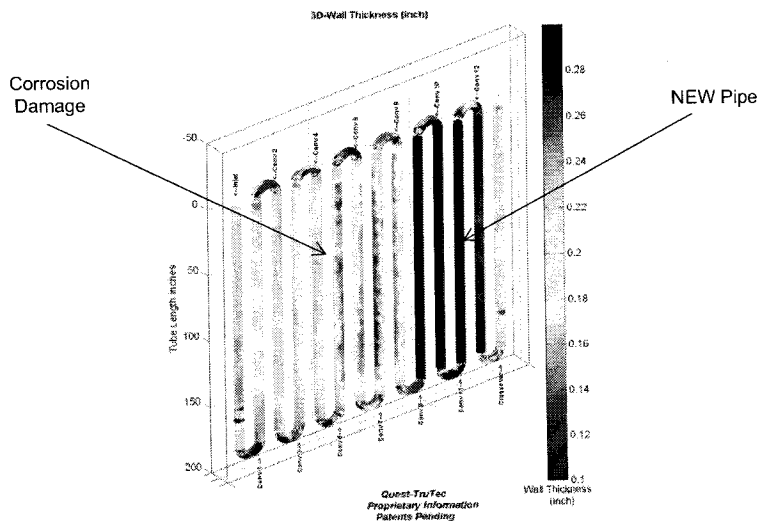
Corrosion (Convection Section Corrosion)

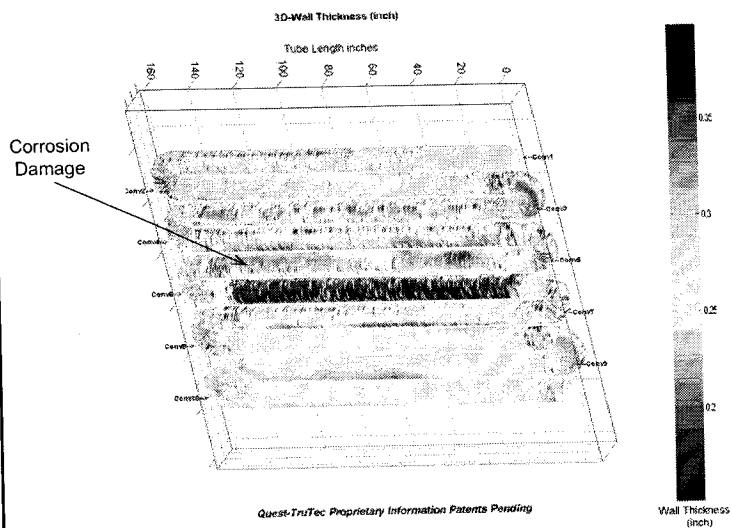
Corrosion (Convection Section Corrosion)

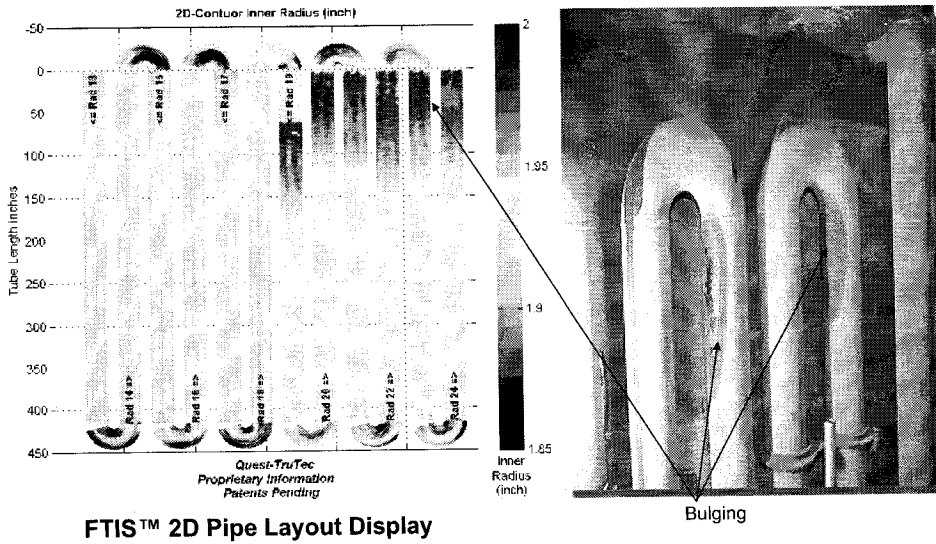
Flame Impingement Damage (Bulging / Swelling)

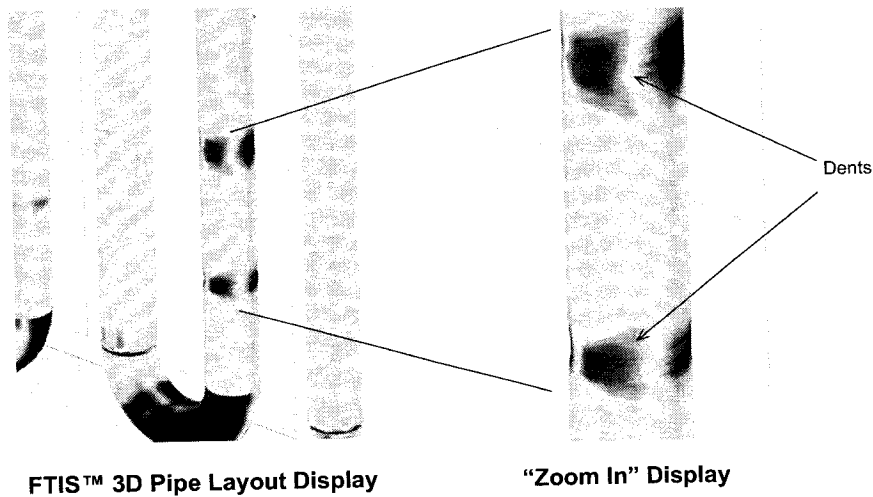
Dents In Pipe

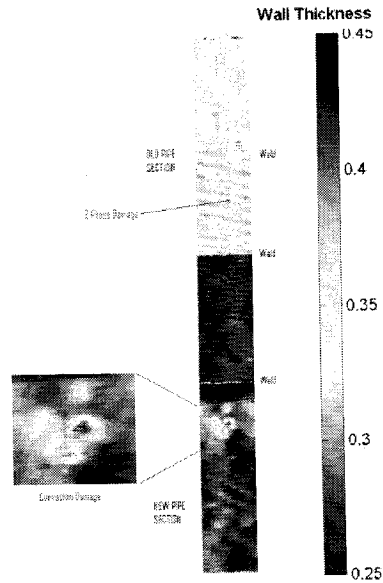
- Number of Coils / Passes = 12
- Pipe Material = 9Cr – MO (A335-P9) (6” x Sch-80)
- Plant had several sections in which partial sections of piping coil had been replaced with new material.
- Plant Engineers did not expect any damage in new coil sections, however were concerned with older coil sections.
- Manual Ultrasonic inspection had not found any damage in previous years’ inspections (inspection limited to “only” Radiant section).
- A FTIS™ Inspection was carried out on all 12 coils/passses (Inspection encompassed “both” Radiant and Convection sections).
- FTIS™ data showed severe corrosion damage in “both” new and old coil sections.
- Plant has reconsidered use of conventional NDE inspection methods.

Case Study #1 Isolated Corrosion Damage

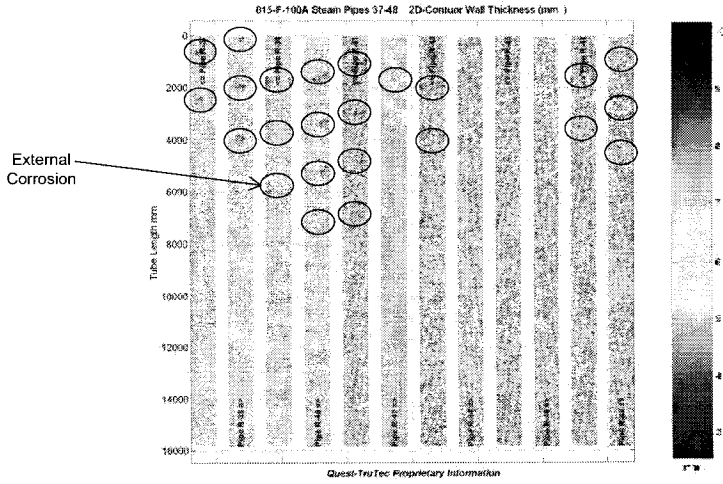
- Number of Coils / Passes = 8
- Pipe Material = 5Cr (5", 6" & 8" x Sch-80)
- Plant had modified heater convection section. (*Installed soot blower*)
- During mechanical pig cleaning process water was observed coming from Convection Section.
- Plant then elected to have FTIS™ inspection performed, rather than start cutting off return bends to find damage.
- A FTIS™ Inspection was carried out on all 8 coils/passes (Inspection encompassed "both" Radiant and Convection sections)
- FTIS™ Intelligent Pig revealed only 8 pipe sections were damaged and localized to one end. All damage was "external".
- Plant stated that FTIS™ saved them over \$1M in coil replacement costs.

Case Study #2 FTIS™ Data Showing External Damage

Obvious Patterns Developing in Damage Distribution

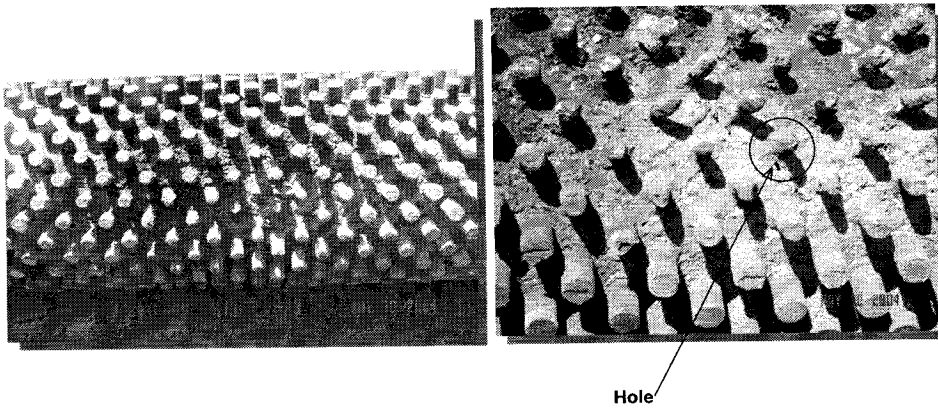
Case Study #2 "Externally" Corroded Convection Piping

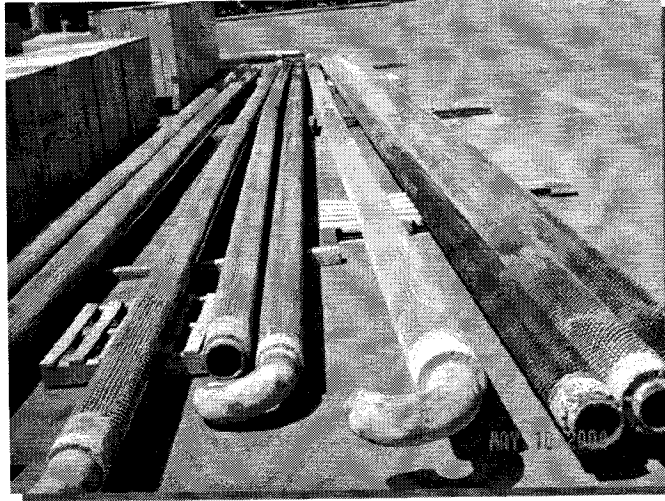
Case Study #2 Removed Piping From Convection Section

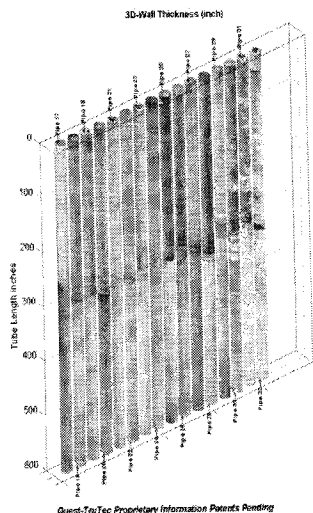
- Number of Coils / Passes = 4
- Pipe Material = 347Stainless (4", 5" & 6" x Sch-40/80)
- Plant anticipated damage, however nothing severe.
- FTIS™ Inspection revealed substantial damage in both Radiant and Convection sections of the coil.
- Plant cut out sections to confirm data. When the results matched perfectly, plant then elected to expand scope of work and inspect a total of three (3) heaters.
- FTIS™ data clearly showed two types of damage patterns.
- Plant cut out all damaged areas above threshold and confirmed accuracy of FTIS™. FTIS™ data matched destructive testing perfectly.
- Plant is now using FTIS™ data to better understand why damage is occurring.

Case Study #3 (3D Plot) Corrosion in Radiant Section Piping

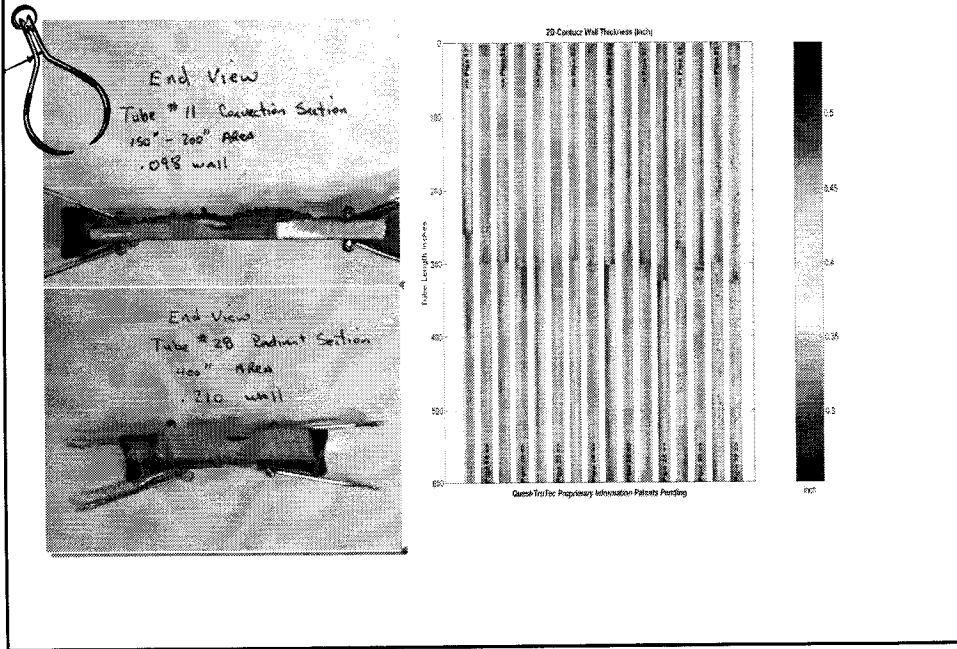
Case Study #3 (2D Plot) Corrosion in Radiant Section Piping

- THICKNESS CHECKS WERE INITIALLY PERFORMED BY FTIS™
- MANUAL UT THICKNESS WERE TAKEN ON EXTERIOR AFTER REMOVAL
- SAMPLES WERE CUT OUT / HOLE DRILLED AND MEASURED WITH A MICROMETER
ALL FTIS REMAINING READINGS WERE VERY CLOSE TO MICROMETER READINGS (+/- 0.002").
- THE AREAS SHOWING LOCALIZED THINNING IN THE FTIS REPORT HAVE EROSION AREAS THROUGHOUT ENTIRE PIPE LENGTH, WITH SCATTERED DEEPER PITTING.

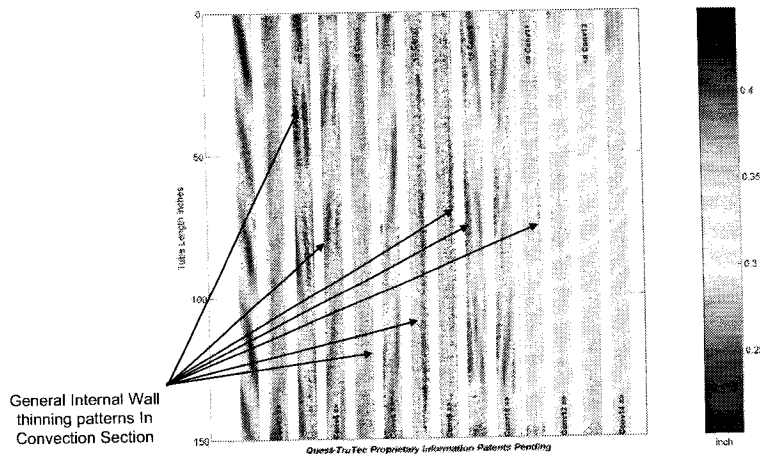
- Number of Coils / Passes = 2
- Pipe Material = ASTM A-106, Grade B (6-inch x Sch.40)
- Plant did not anticipate any “serious” problems with heater prior to FTIS™ Inspection.
- FTIS™ was primarily being used to test technology and satisfy internal routine inspection.
- FTIS™ data results showed coil was exceptionally cleaned by “mechanical pigging” contractor.
- FTIS™ inspection results clearly showed extensive corrosion damage in the convection section.
- FTIS™ pointed out to plant that 6” x Schedule-20 piping was installed in the cross-over regions of the coil. “No” Schedule-40 as originally thought.
- Plant engineers later informed Quest TruTec that based upon the FTIS™ results they replaced coil.
- FTIS™ inspection potentially saved furnace failure.

Case Study #4 (2D Plot) Corrosion in Convection Section Piping

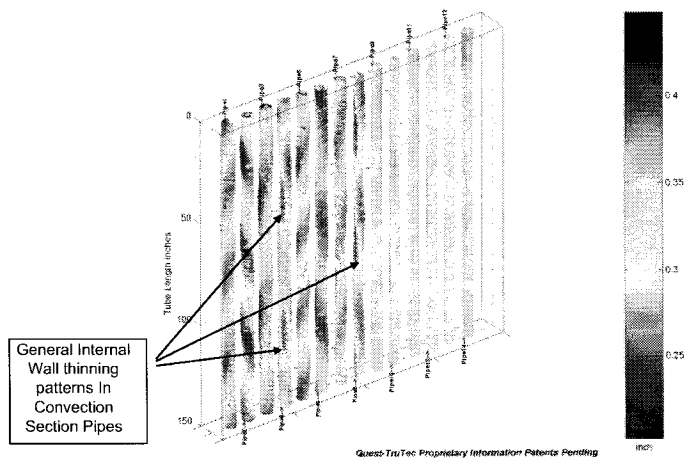
Case Study #4 (3D Plot) Corrosion in Convection Section Piping

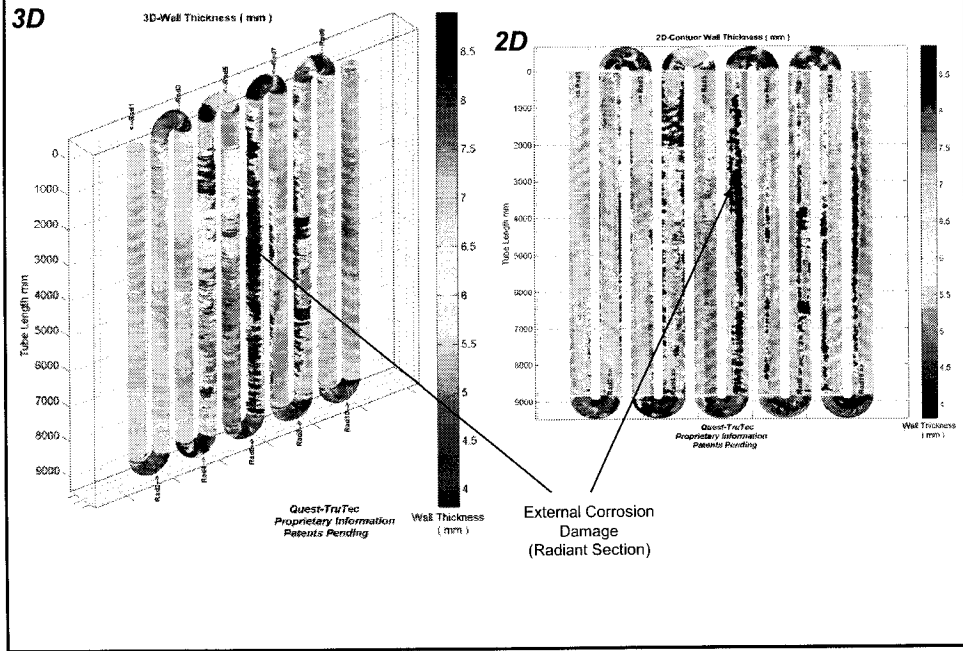
- Number of Coils / Passes = 2
- Pipe Material = ASTM A335 – P5 (6-inch x Sch.40)
- Heater Vintage = 1976
- FTIS™ was applied to inspect both process coils.
- FTIS™ inspection results detected extensive “external” corrosion damage in the radiant section.
- Visual inspection found tightly adhered scale on piping exterior surface.
- FTIS™ results were not impacted by tightly-adhered scale.
- Large broad areas with 56% “external” wall loss were noted.
- Plant engineers utilized FTIS™ test results to make decision for replacement of several pipe sections.

Case Study #5 Corrosion in Convection Section Piping

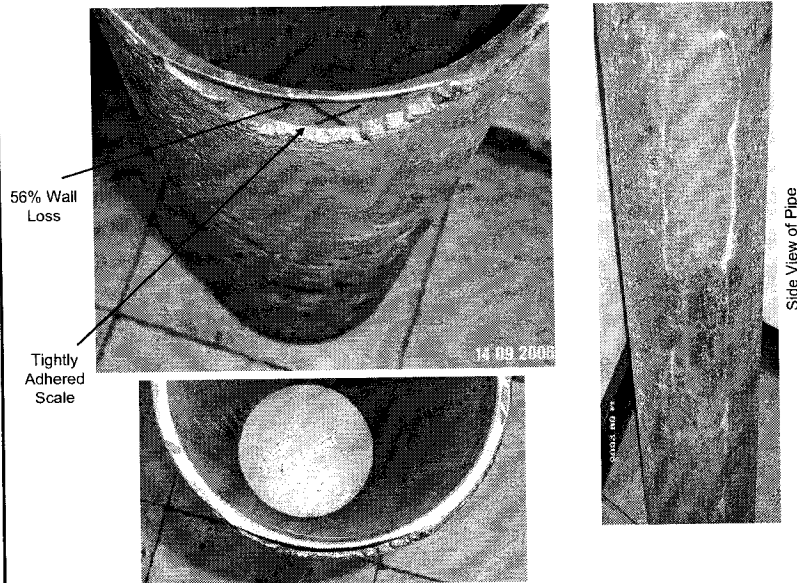
Case Study #5 (3D Plot) Corrosion in Convection Section Piping
