A DIFFERENT APPROACH TO ARREST THROUGH WALL CRACKS ON A COKE DRUM USING WELD OVERLAY

YURIK LEON
APPLICATION ENGINEER
WELD O LATINOAMÉRICA

REFCOMM[®]
BUDAPEST
2-5 Oct 2017

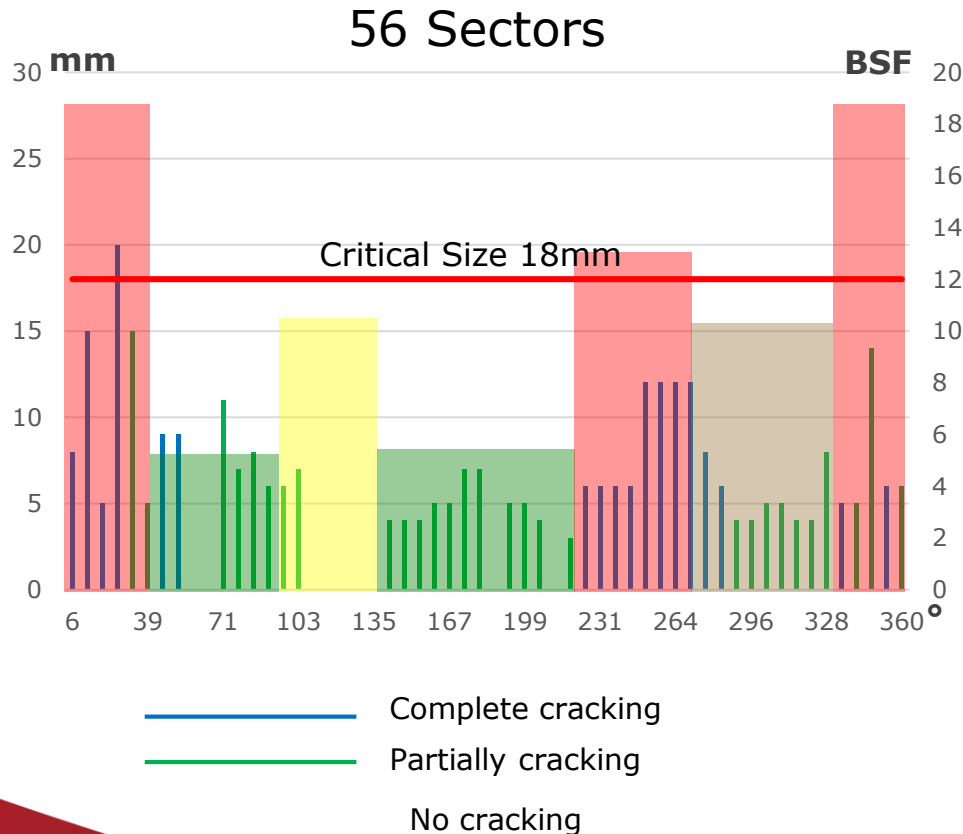
UT Phased Array Inspection C4 Drum 4

June 2016

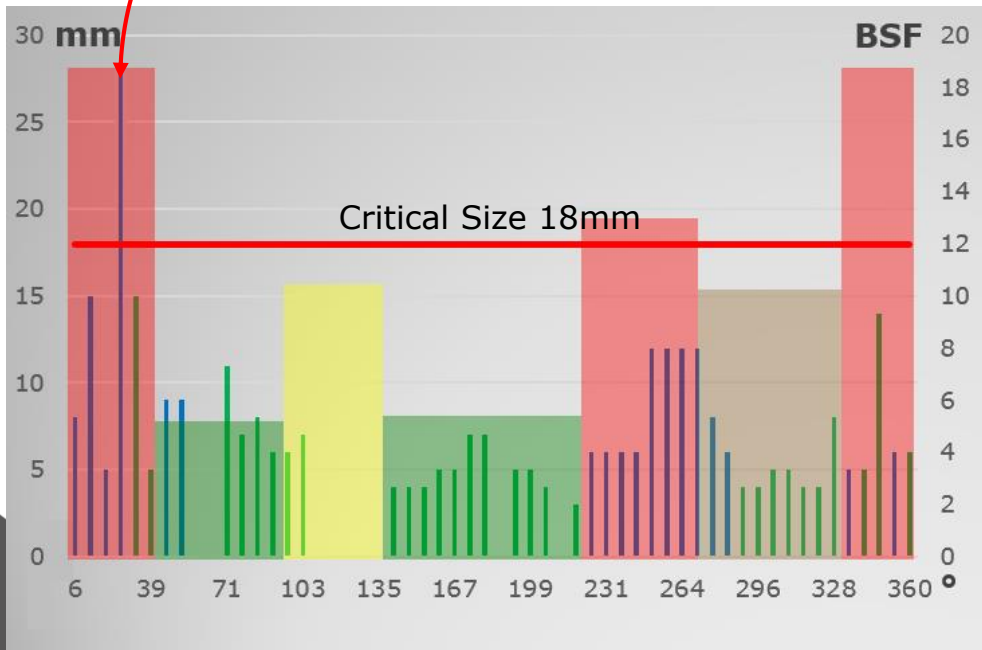
UT Phased Array Re-Inspection C4 Drum 4

Lenght = 500 mm / 19.69 in
Depth = 27 mm / 1.06 in

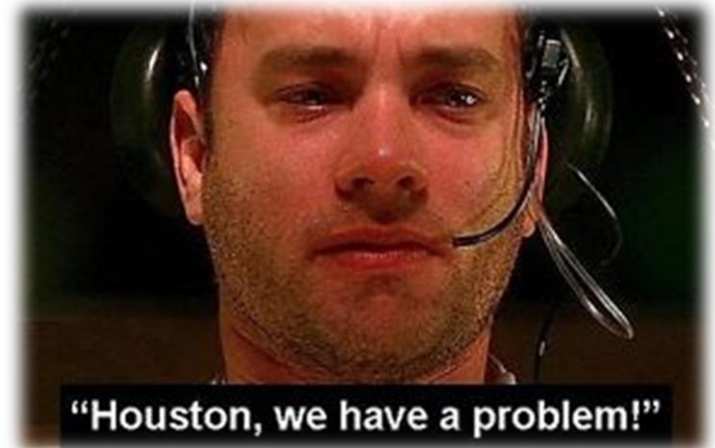
Few days later after
Drum 's 2 Failure...

Remaining Thickness = 0.12 in
