Managing Weld Stresses for Advantage in
Coker Engineered Repairs
Pedro Amador (VP&Chief Technology Officer WSI)

Coking and Cat Cracking Conference ←

Bulge Repair of Delayed Coker Unit
Karlsruhe Germany, March 2012

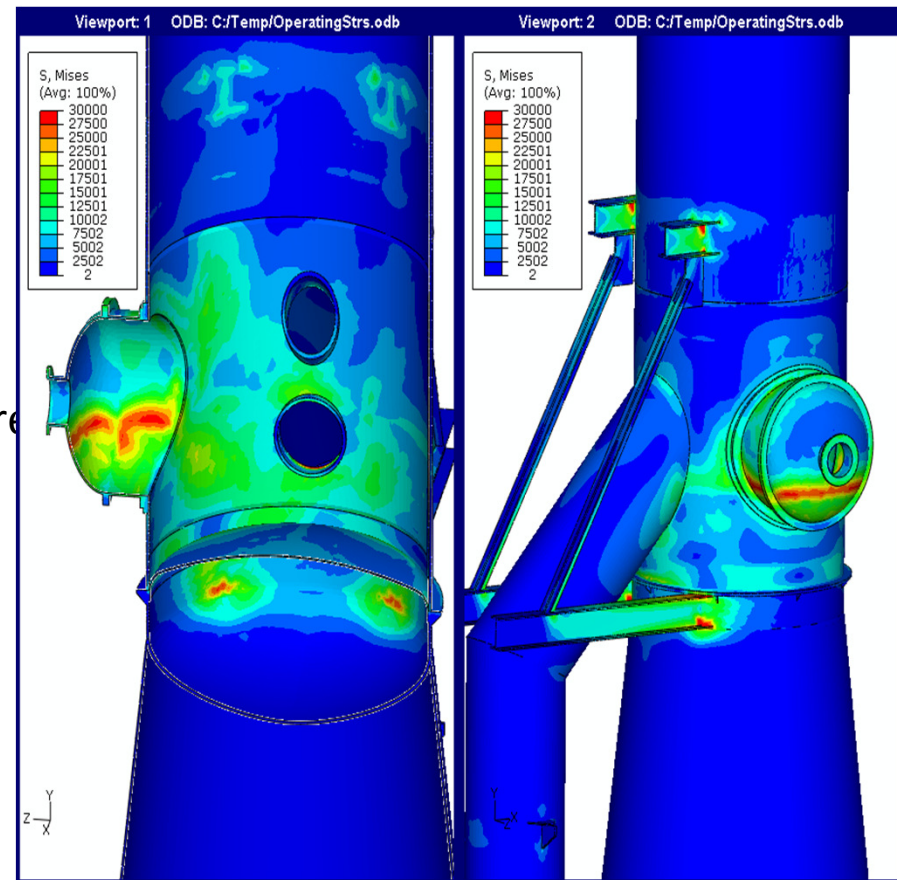
- FCCU stripper/reactor
- High temperature creep failure
- 5 Year life extension required

FCCU Stripper/Reactor failure area

Engineered repair cycle using NPA

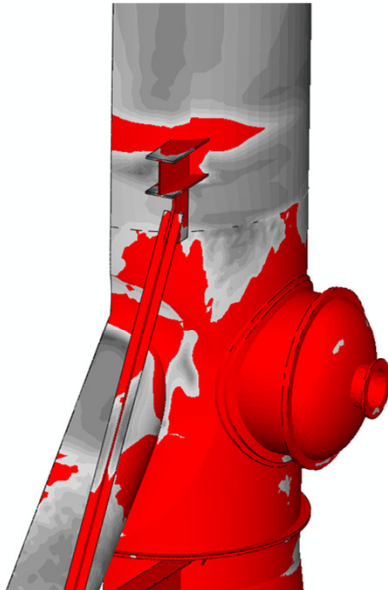
Areas exceeding creep stress limit

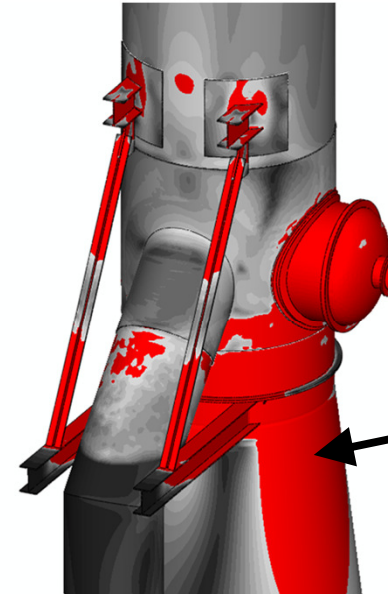
Regions below
temperature
threshold for
creep

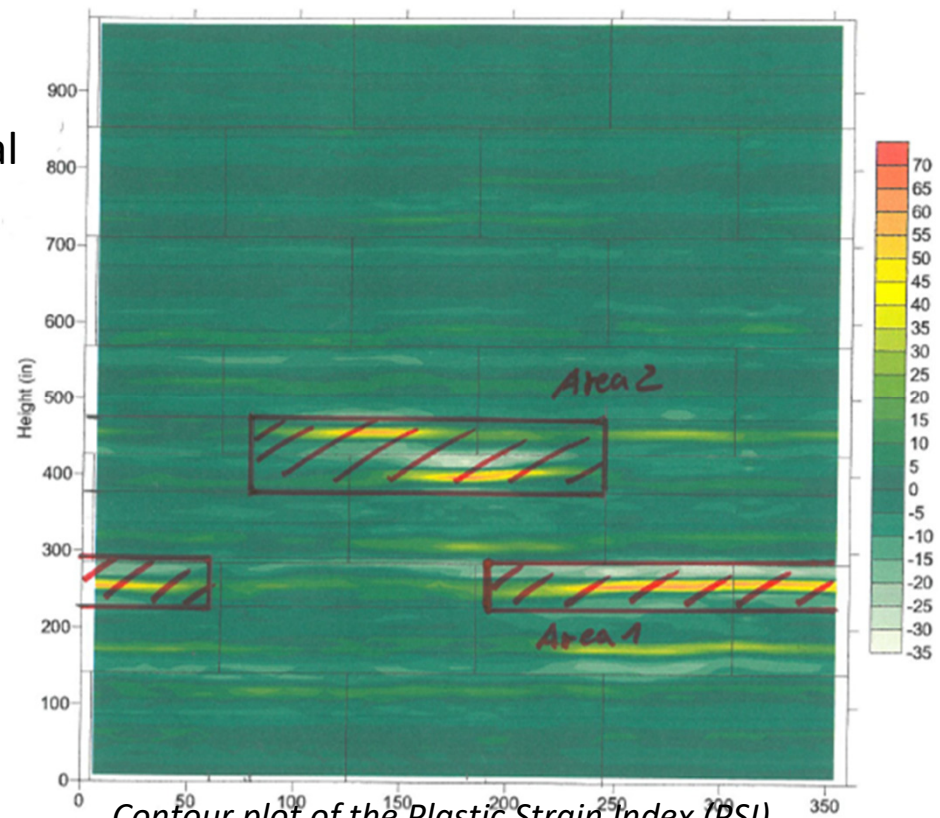
- Plastic Strain Index Study performed
- 2 bulge repair areas defined
 - #1 23m²
 - #2 27m²
- Design required additional structural thickness:
 - 0.56" (14.3mm)

Contour plot of the Plastic Strain Index (PSI)
looking from the outside of the drum

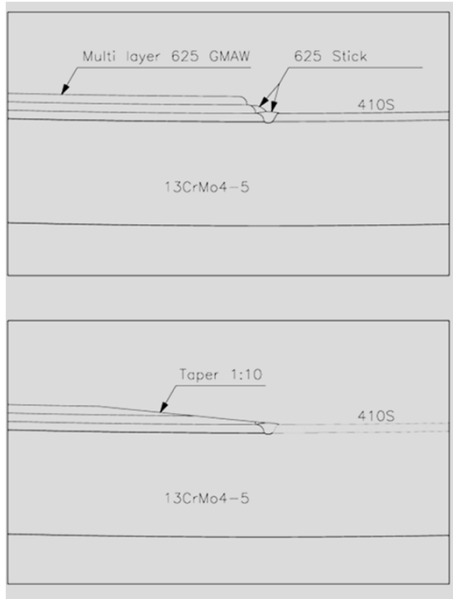
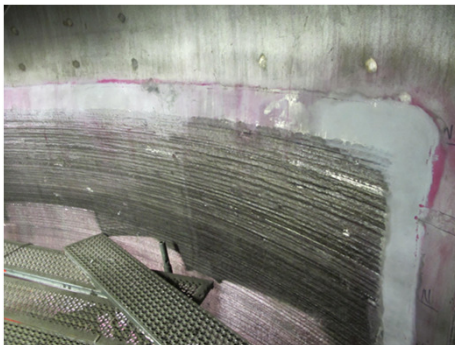
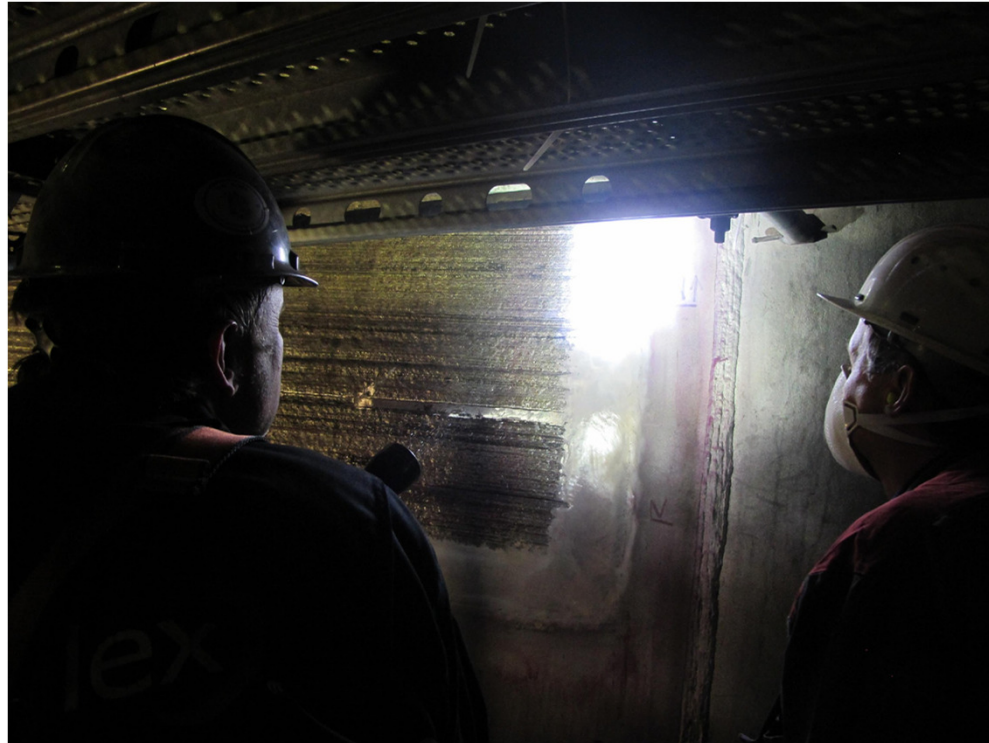
- Hardness / layer
- Liquid penetrant inspection

Deposit edge transition
