# MATERIAL TESTING AND CORROSION EXPERIENCE IN CRUDE UPGRADER ATMOSPHERIC DISTILLATION UNIT

Tore Arnesen<sup>1</sup>, María Specht<sup>2</sup>, Henry Tovar<sup>2</sup>, Erik Rodriguez<sup>2</sup>  
Statoil, Research Center, Norway<sup>1</sup>  
PDVSA Intevep, Research Center and Technical Assistance, Venezuela<sup>2</sup>

**REFCOMM**  
RIO DE JANEIRO

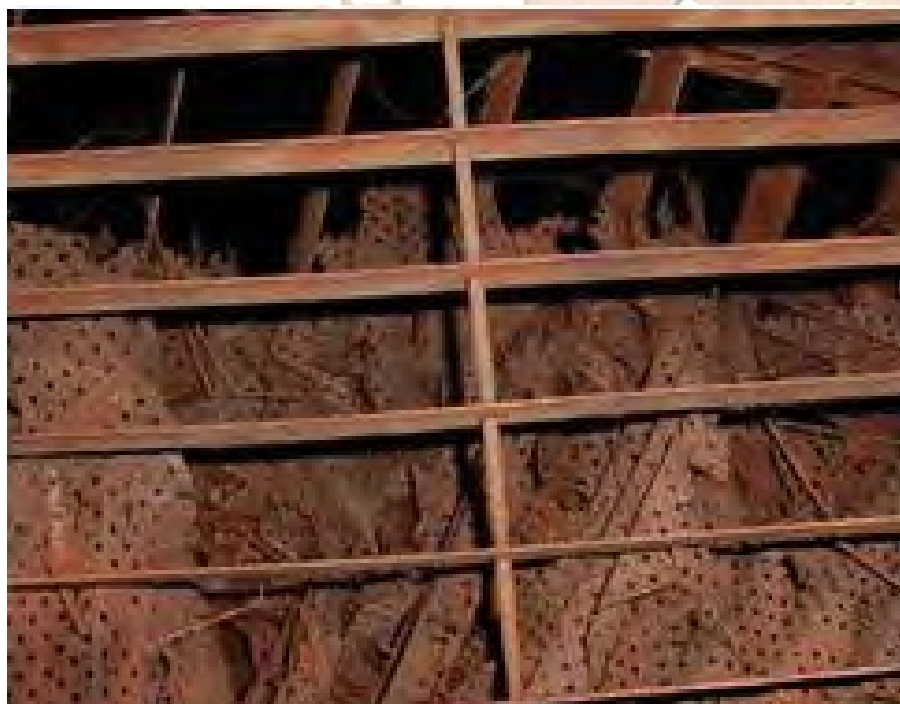
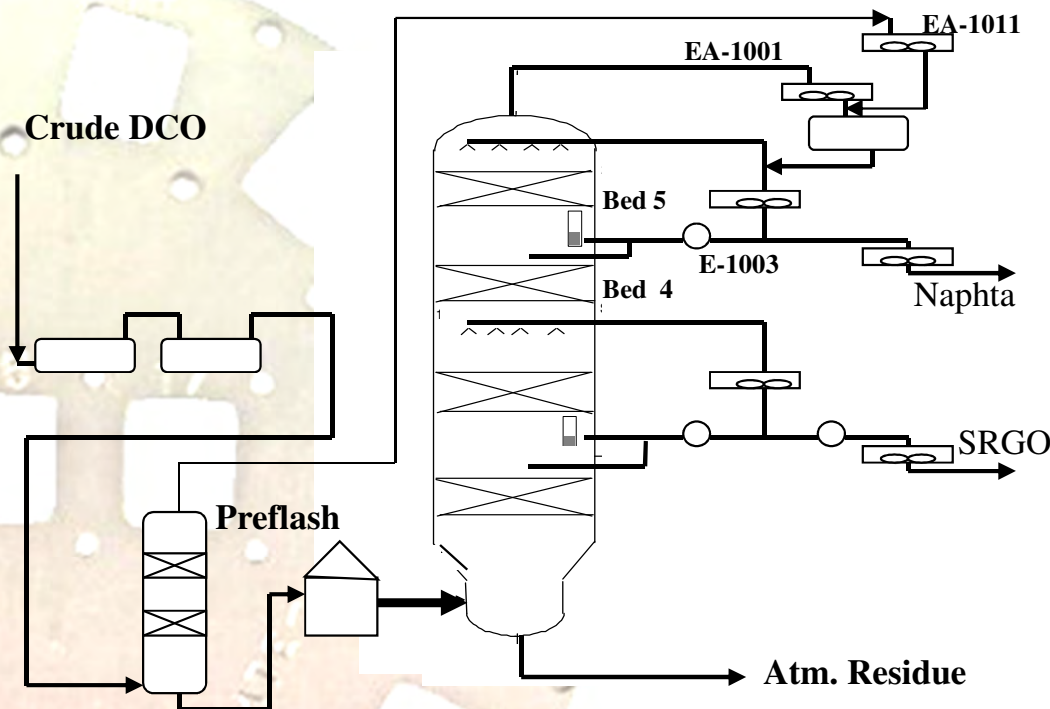
Two main damage mechanisms were found in the main column: Hydrogen Chloride corrosion, and corrosion due to Wet H<sub>2</sub>S and Light Organic Acids in as a consequence of salt deposition

Top packing of the column lost several times after start up.

Tower internals were originally 410 SS. They failed twice.

Internals upgraded to AL6XN failed shortly after installation.

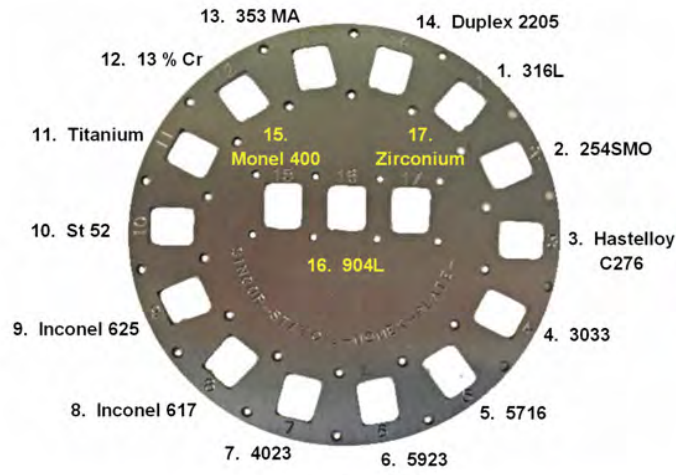
- a) Distribution of the coupons or probes before being exposed to operation conditions.
- b) Test plate 1 after being exposed showing 4 missing coupons.
- c) Test plate 2 after exposition. No missing probes.
- d) Test plate 3 after being exposed showing 1 probe lost.

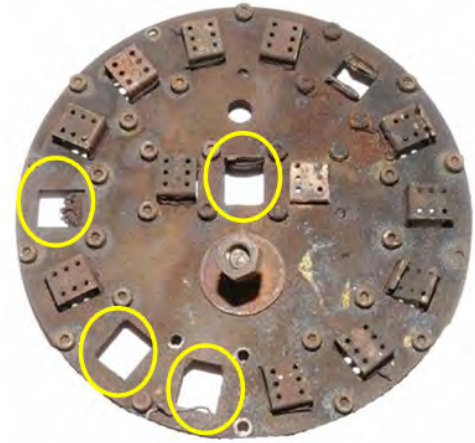
Test plate 1, several coupons were lost (4023W, Inconel 617, Carbon Steel and 904L) perhaps due to the corrosion conditions prevailing nearby the overhead section of the column. Test plate 3, only carbon steel coupon was lost.

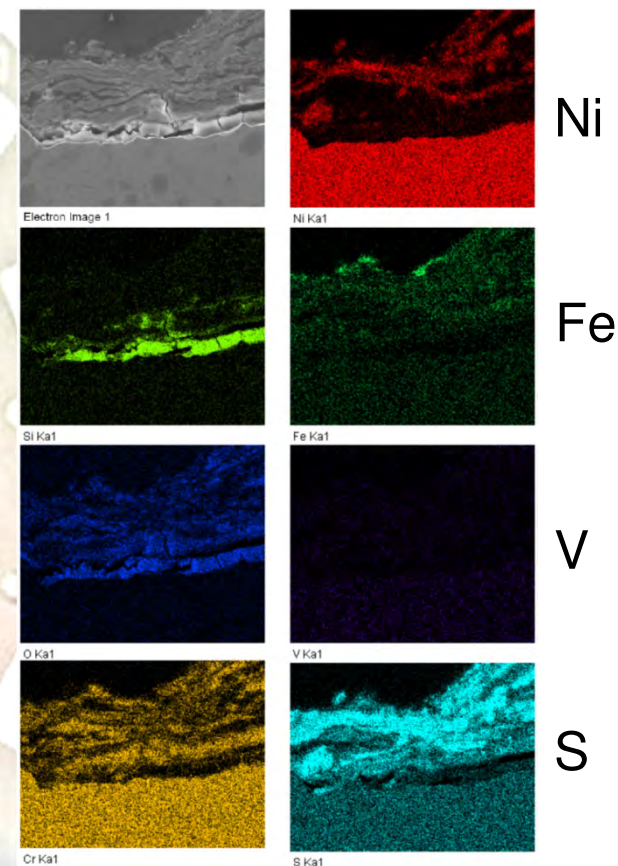
Example: Electron image and X ray dot maps of the corrosion product formed on 5923 alloy located in test plate 1
