Repair and Retrofit of a Coke Drum Skirt Attachment Weld

CHS Inc

Houston Engineering Solutions

Coking.com Conference

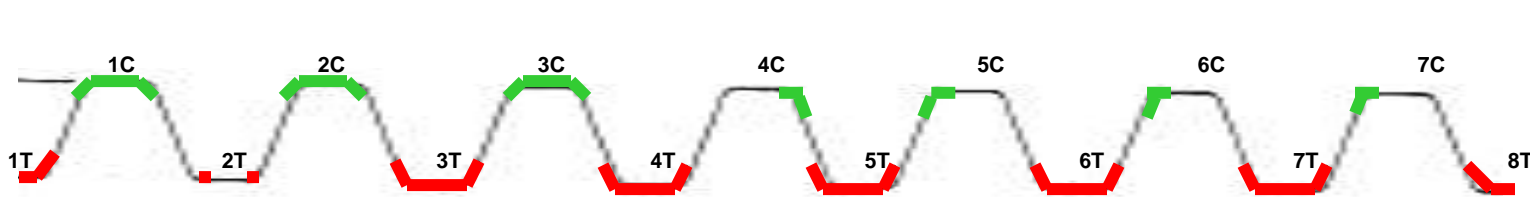
Skirt weld cracks

Peak cracks were at the toe of the fillet weld and in the base metal. Cracks were determined to be less than 0.10" deep.

Trough cracks were in the fillet weld throat. Cracks which did not extend through the full weld thickness appeared to originate at the weld root.

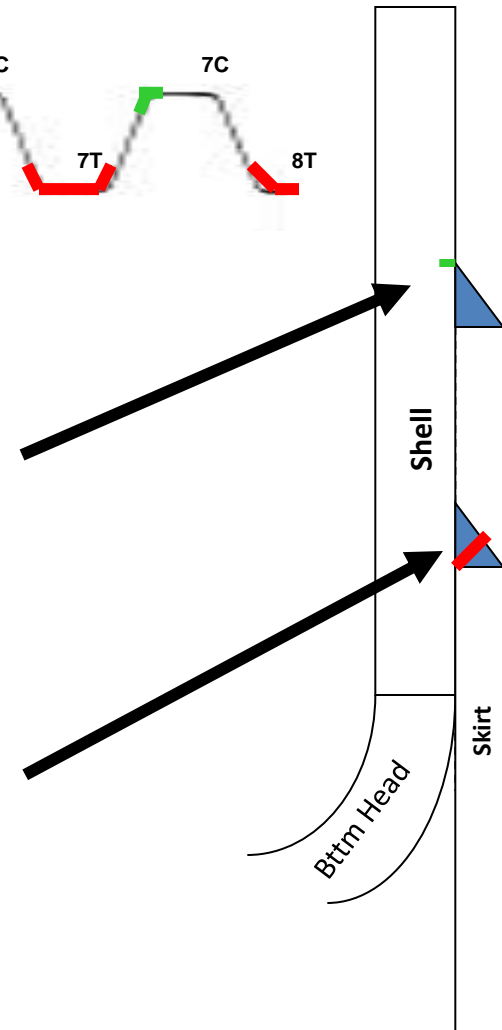
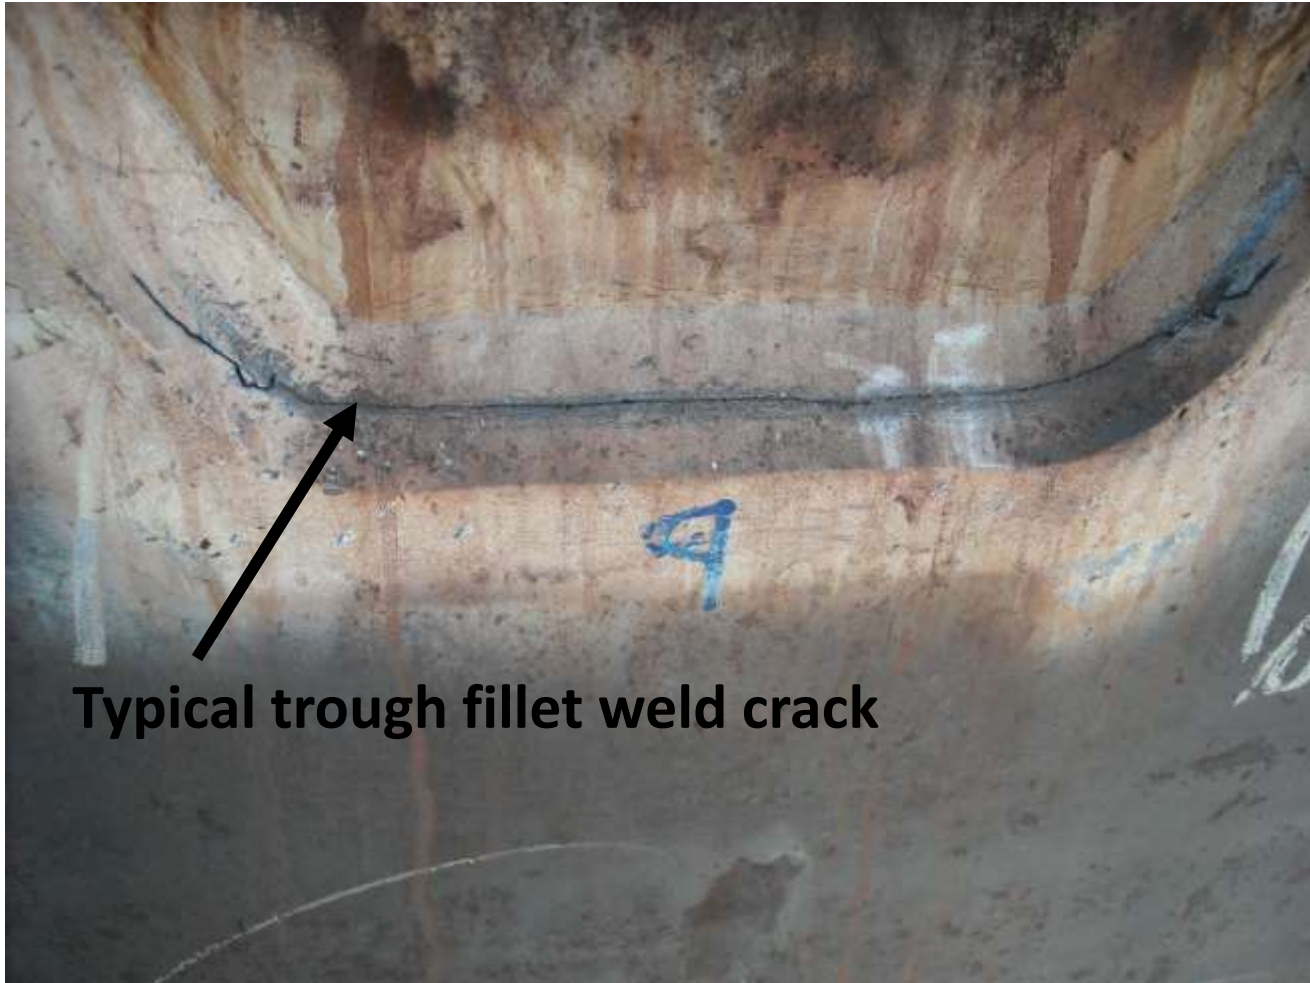
Trough Cracks

Typical trough fillet weld crack

- Install sliding brackets for load transfer
- Allow through-throat cracks in scallop troughs to continue to propagate
- Manage crack propagation at scallop peaks by crack removal and addition of planned notches

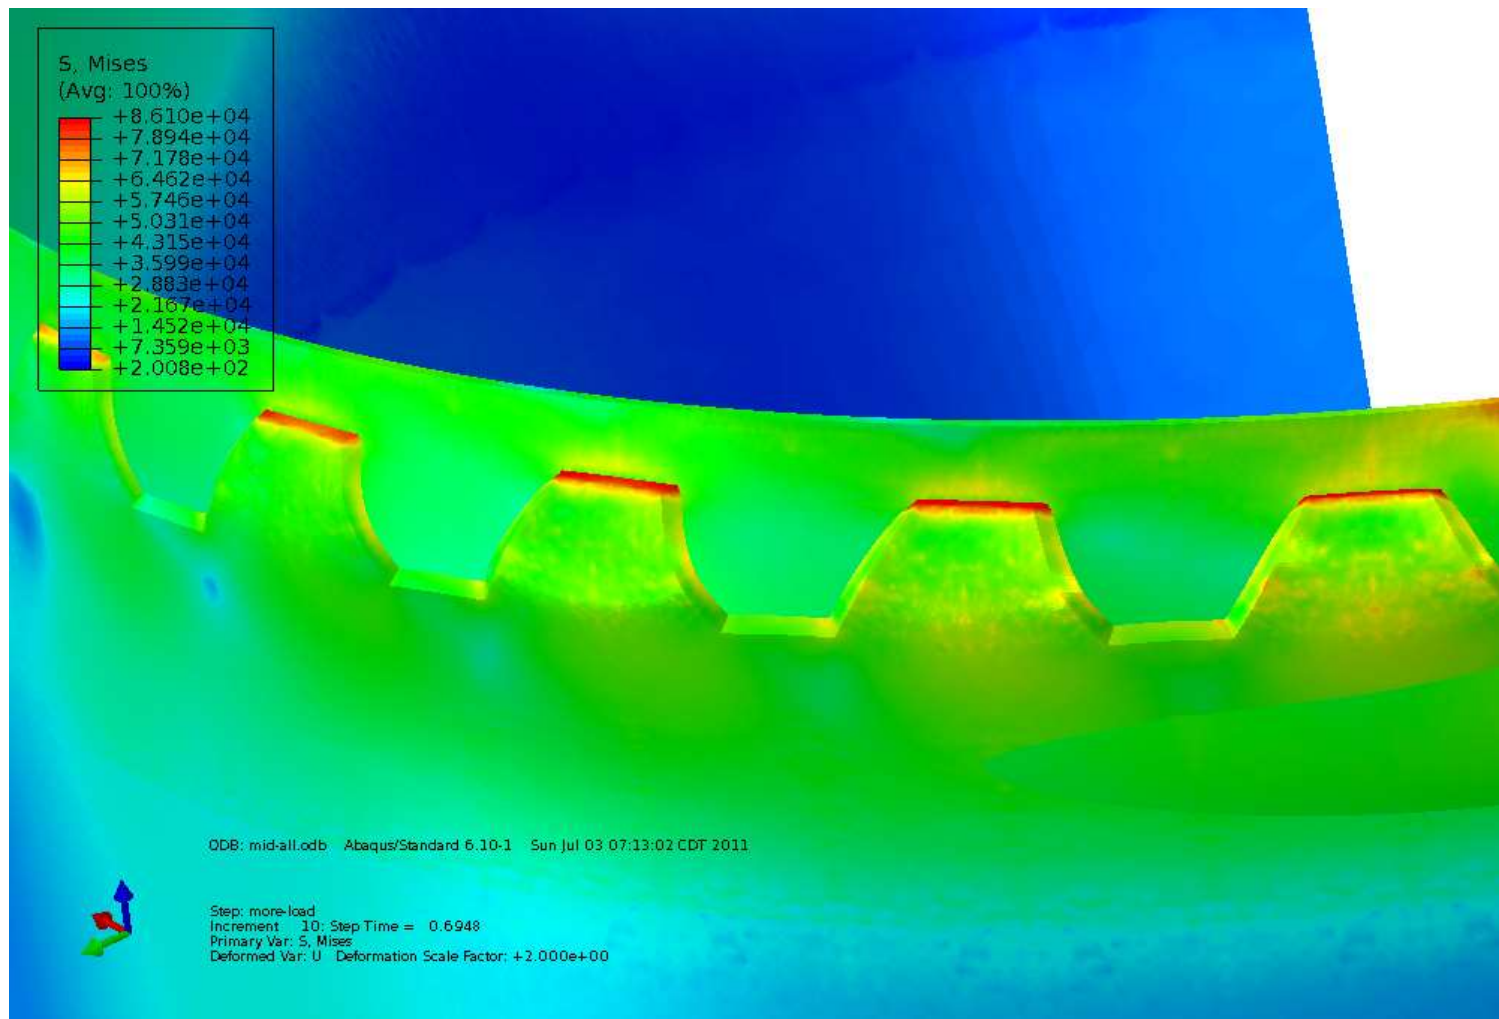
Von Mises Stress @ Collapse (Case 4)

- For the longest crack of 37.05", the minimum load multiplier was 1.23. This means that the remaining ligament of the weld (half of the top weld attachment) had 23% more strength than that required by API-579/ ASME-FFS.
- The combination of drum weight and filling temperature profile was the worst load case.
- Skirt should remain stable with sufficient margin as long as one half of the peak of the scallop remains intact.
- Frequent inspections used to monitor crack propagation until TA.

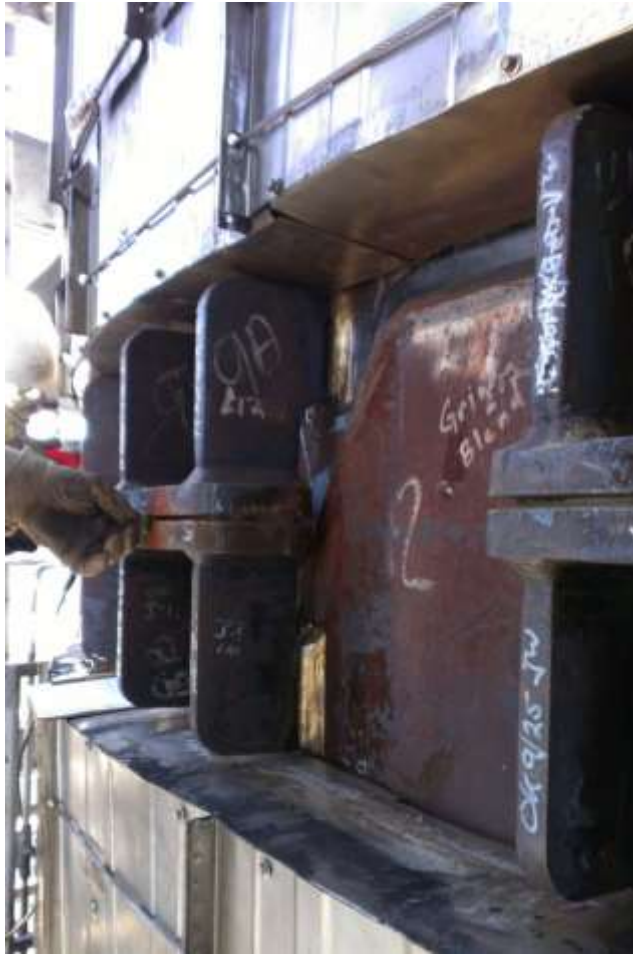
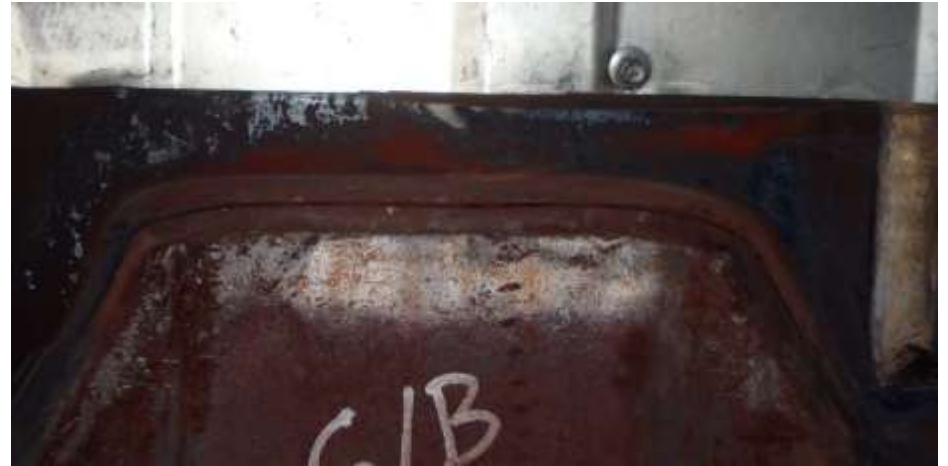
Inspection Photos of Retrofit Skirt

- A re-inspection of sliding brackets and skirt attachment weld cracking was completed in August 2012.
- Inspection Results
 - No cracking noted in attachment fillet weld connections using dry MT
 - Brackets had no distortion or notable movement
 - Fillet welds in scallop valleys are continuing to propagate
 - Repaired cracking at the toe of the scallop peak fillet attachments have not re-initiated in this area.
 - No cracks found in slotted and un-slotted scallop peaks
