Root cause analysis and successful modifications to eliminate hot spots in SRU at MOL's Danube Refinery

Ákos Németh
Residue Processing Area
Danube Refinery, MOL

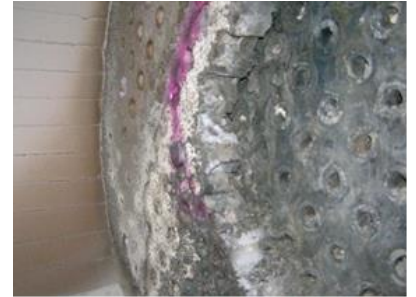
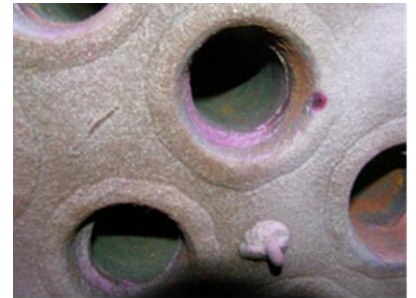
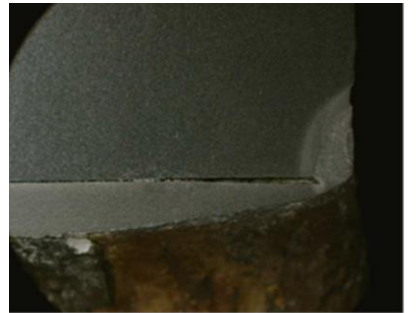
Damage details: SRU5 unit

Refractory wall separated from bundle wall

Large percentage of ceramic ferrules were broken or cracked

Outlet bundle wall intact

Refractory wall support pins corroded away

Bundle wall and tube weldings corroded

Tube endings funnelled in, thinned around the ending

More than 57 leaking welding

Bundle lining was replaced according original design

Inlet side bundle wall was replaced

Ceramic ferrules and refractory wall were replaced according original design

Refractory wall support pins were modified

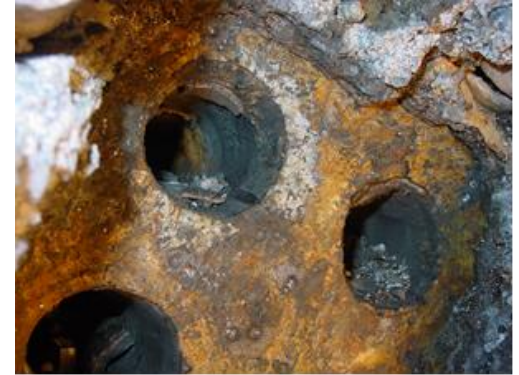
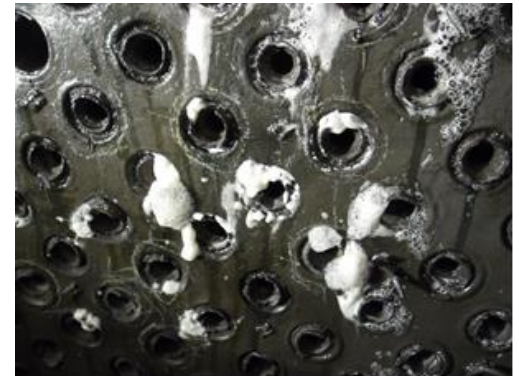
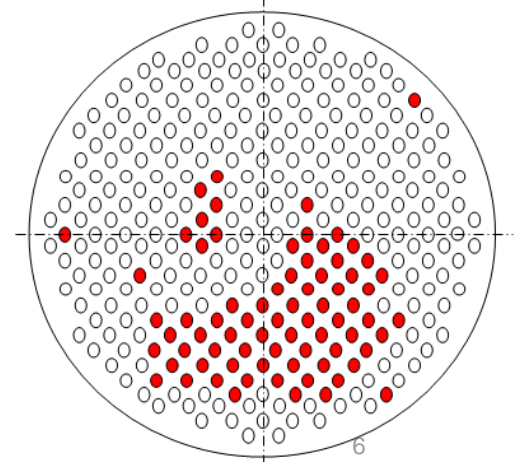
Damage details: SRU6 unit (2011)

Refractory wall separated from bundle wall

Large percentage of ceramic ferrules were broken or cracked

Refractory wall support pins burned away

Outlet bundle wall was intact

Bundle wall and line endings were corroded

Tube inlets were funnelled, thinned around the weldings

More than 75 inlets leaked at low pressure testing, replacement needed

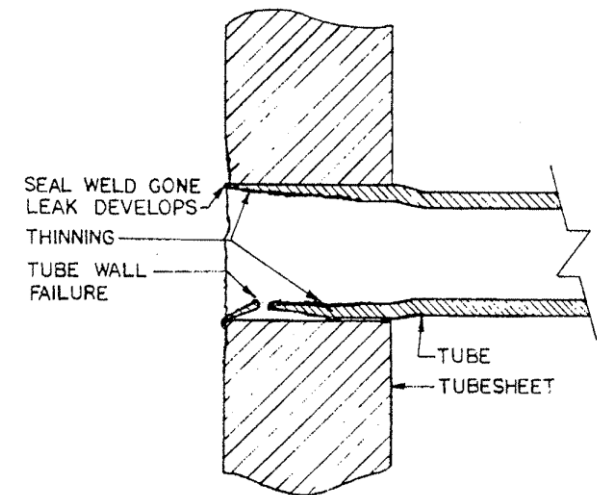
FIGURE 2

- High temperature S-corrosion damages overheated areas like bundle wall and tube inlets and weldings (high prob.)
- Acid dew corrosion during S/U and S/D. (low prob.)

TYPICAL TUBE END DETERIORATION AND FAILURES

- Cr alloy materials instead of carbon steel
- Reducing surface temperature
 - Lower bundle wall thickness
 - Reduced welding distance from feed water
- Prevent ferrule and refractory wall cracks, protecting the less cooled areas from high S gases

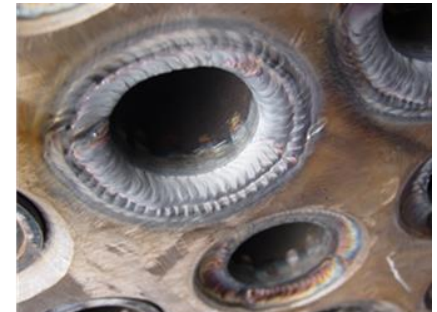
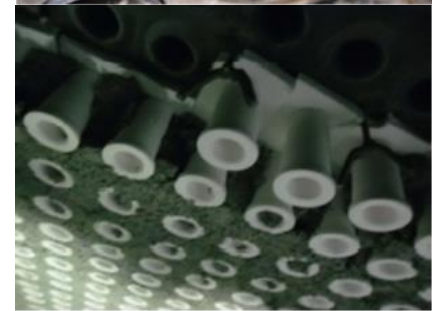
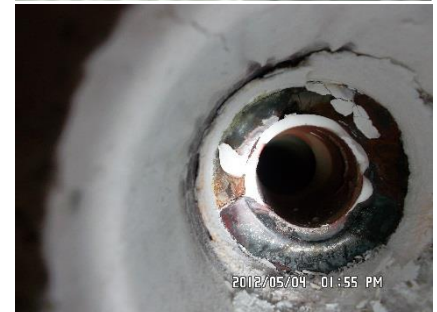
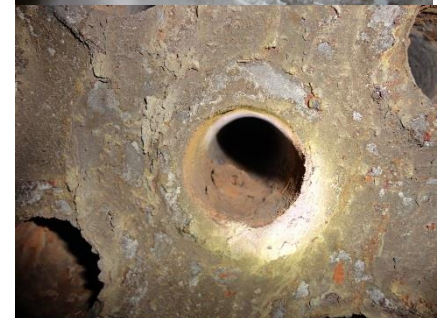
Internal benchmark: Ferrule+Refractory types

- Inlet side bundle wall thickness

- Cracked ferrules within a few years of operation
- Beginning or leaking corrosion and funneling

- Additional 5 mm fibre insulation between bundle and refractory walls
- Stronger ferrules and wall support pins, weldings

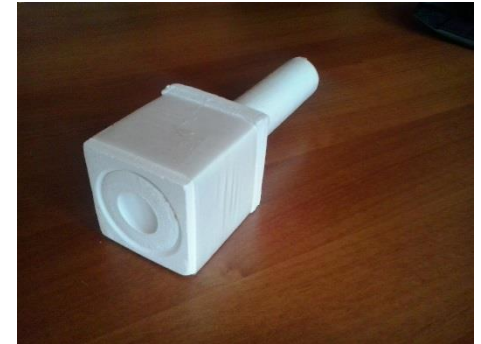
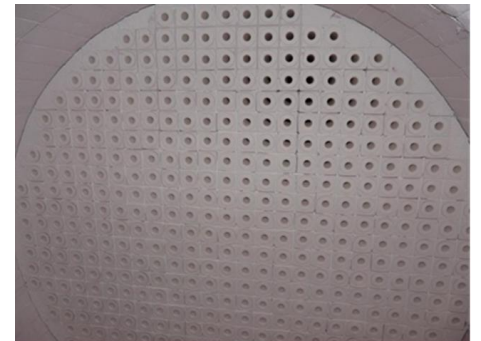
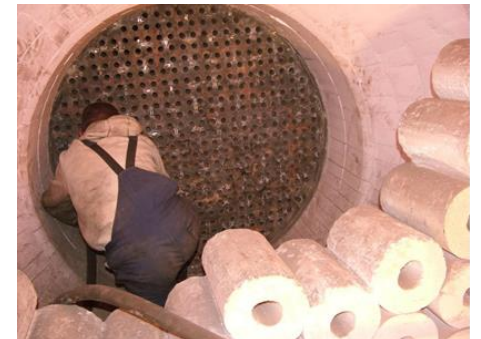
Internal Benchmark: Block ferrules and Other protections

- Tube size and number
- Waterside pressure
- Heat distributor wall

- No breaking or corrosion

- Replacements of ferrules to block type in 2 units

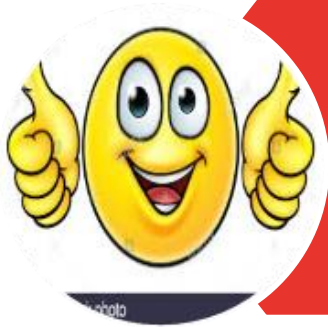
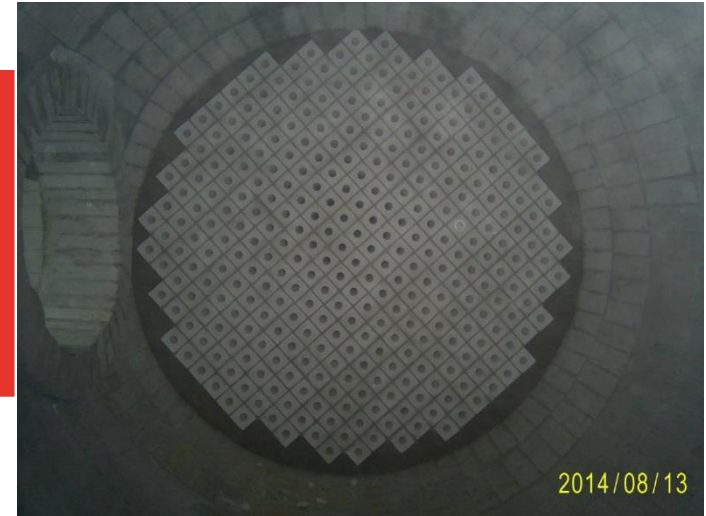
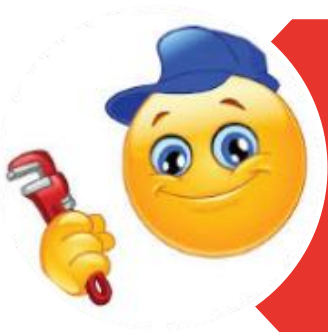
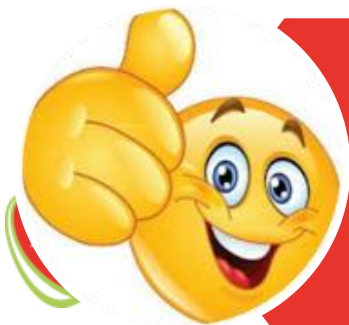
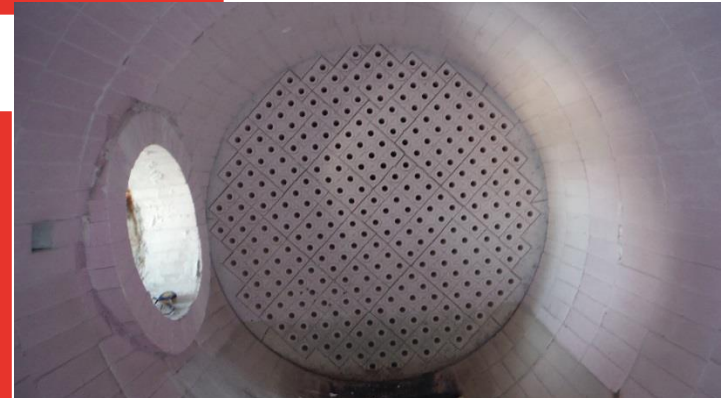
Results

- 2017 check-up found 2 cracked ferrule after extreme testing

- Bundle wall replaced (35 mm)
- Bundle lines replaced
- Tube weldings: corner welds
- Refractory+ferrules replaced by block type ferrules
- Heat distributor wall deemed unnecessary.
