PERFORMANCE OF WELD OVERLAY REPAIRED COKE DRUMS

Mahmod Samman, Ph.D., P.E.

Houston Engineering Solutions, LLC

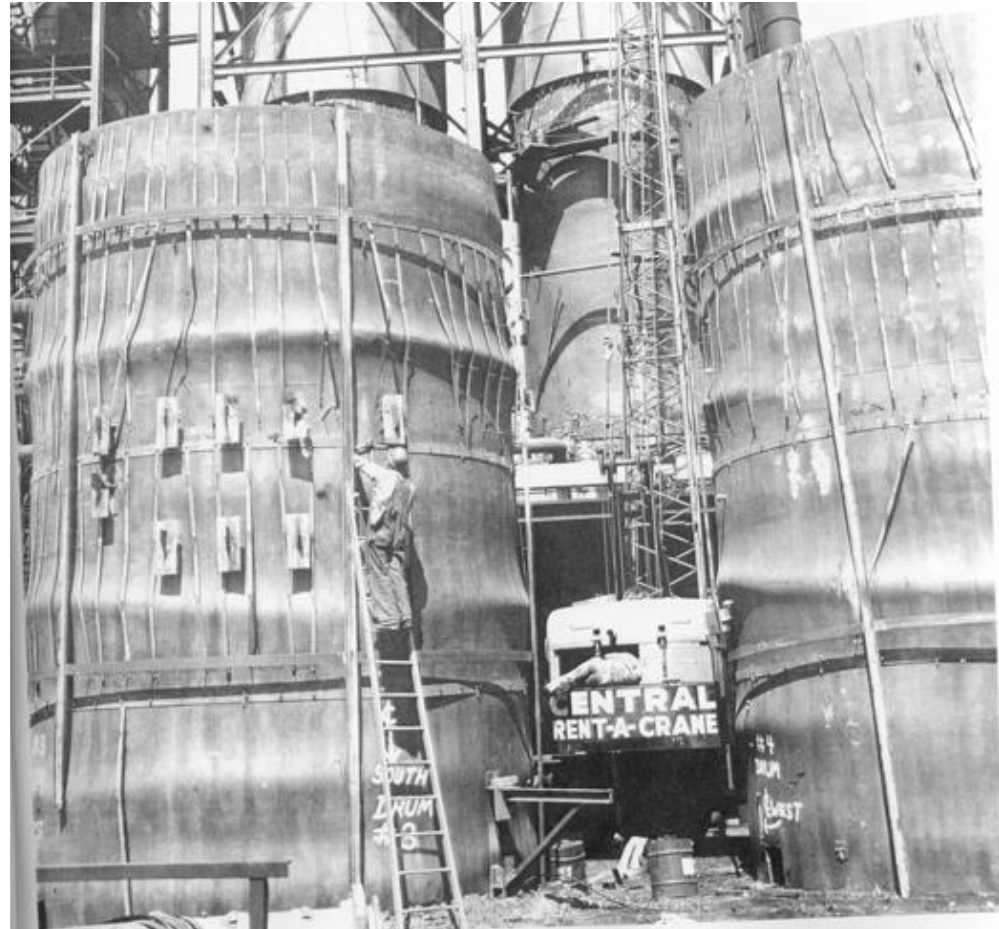
Shell Bulging

- Known problem for decades.
- Can lead to cracks and leaks
- Cause for drum replacement

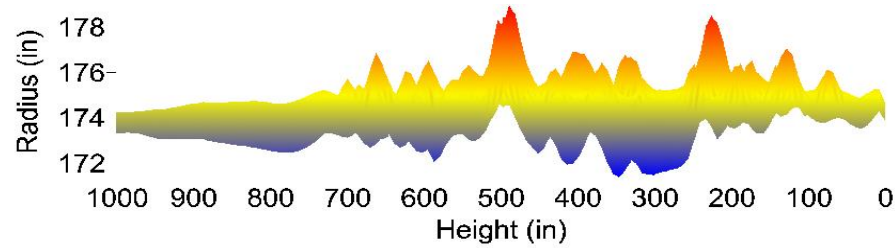
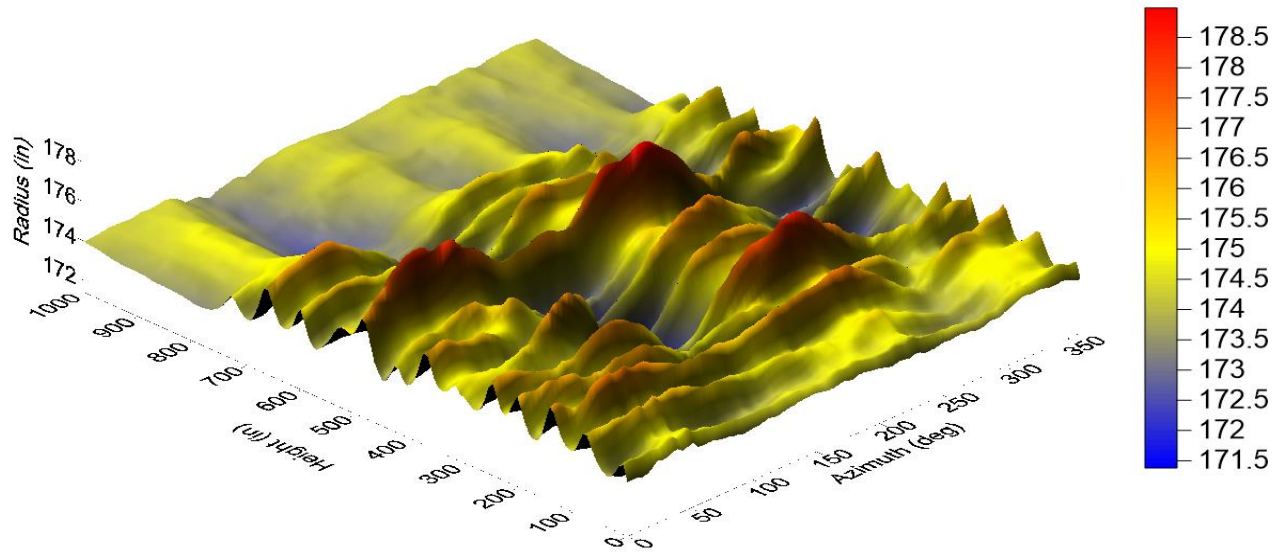
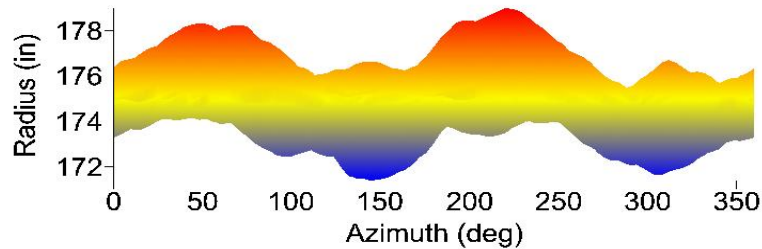
Bulging

Developed
severe
bulges after
seven years
in service.

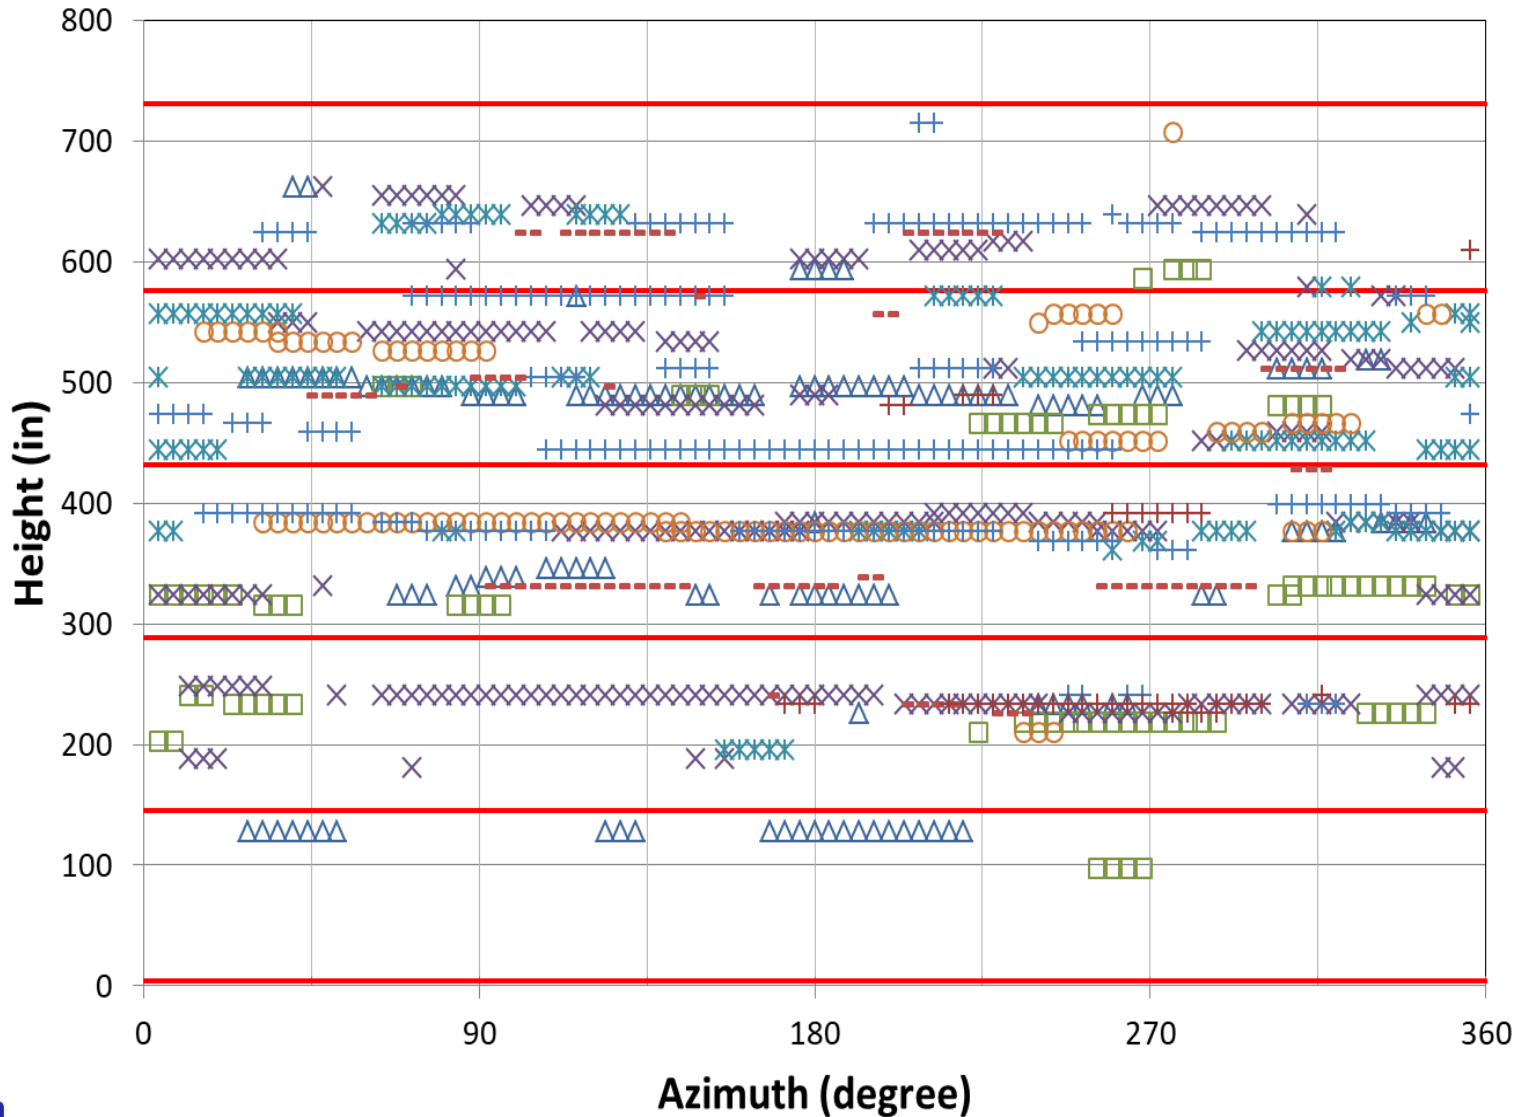
Severe Bulge Indications

(Locations of PSI exceeding “Design” level in all drums)
