May 1, 2019

ExxonMobil Baton Rouge Refinery Coke Bed Combustion Incident

Sarah Whitaker – Resid Conversion Specialist
David Gibson – Fixed Equipment Specialist

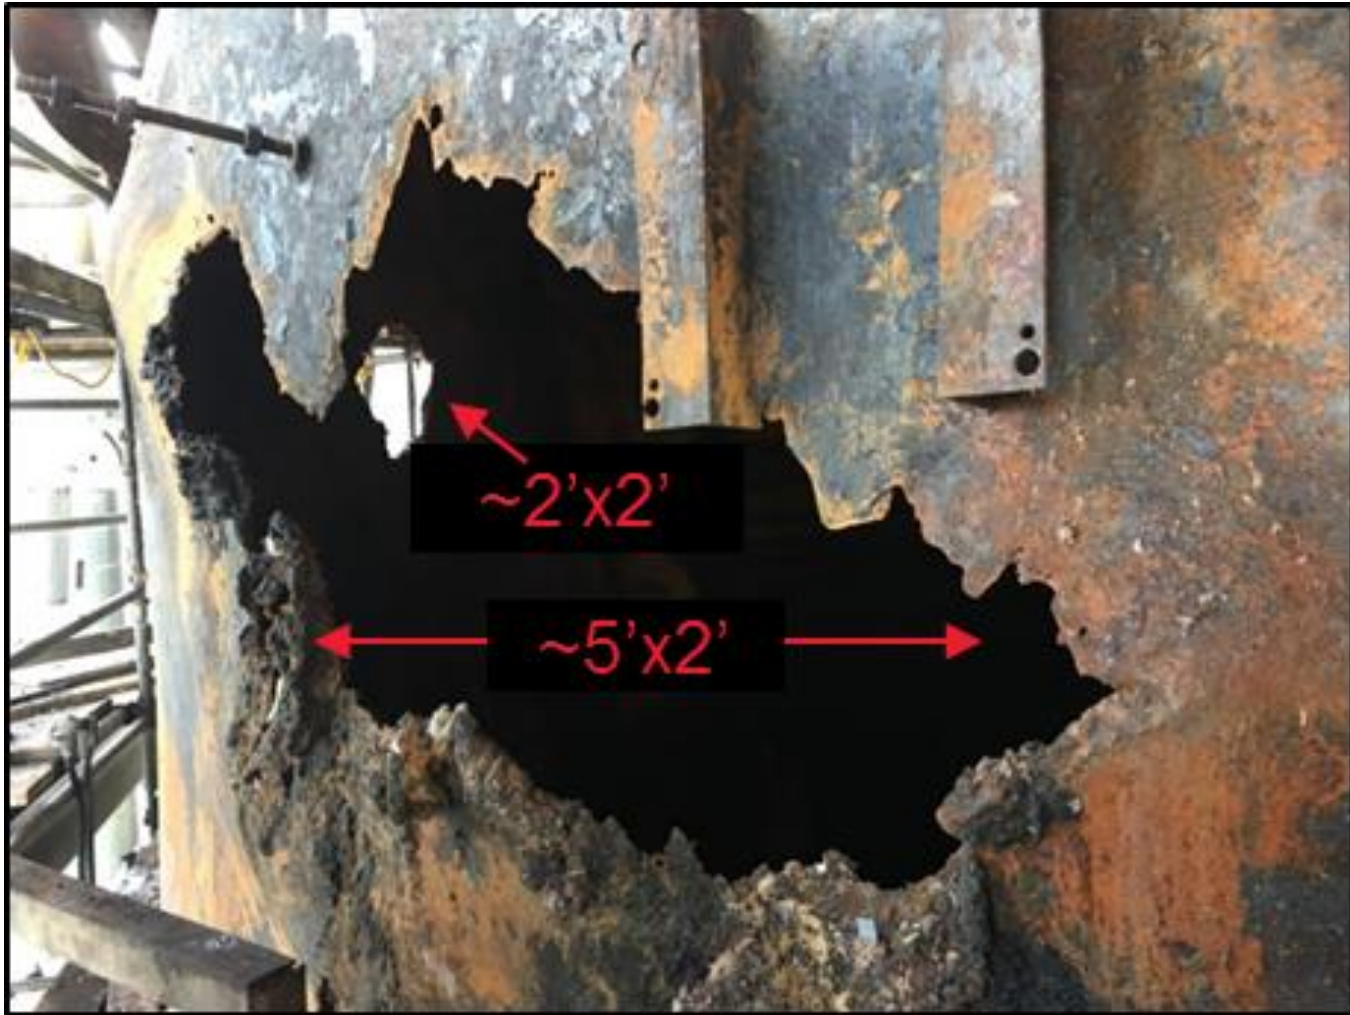
Drum Damage

- No personnel injured or exposed
- Two through-wall holes formed near outage level
- Damage localized to drum
- Extended downtime to repair
