REFCOMM
GALVESTON
APRIL 29 - MAY 3 2019

CITGO Lake Charles Coker 1 Skirt Replacement

CITGO Lake Charles - Coker 1 Drum Details

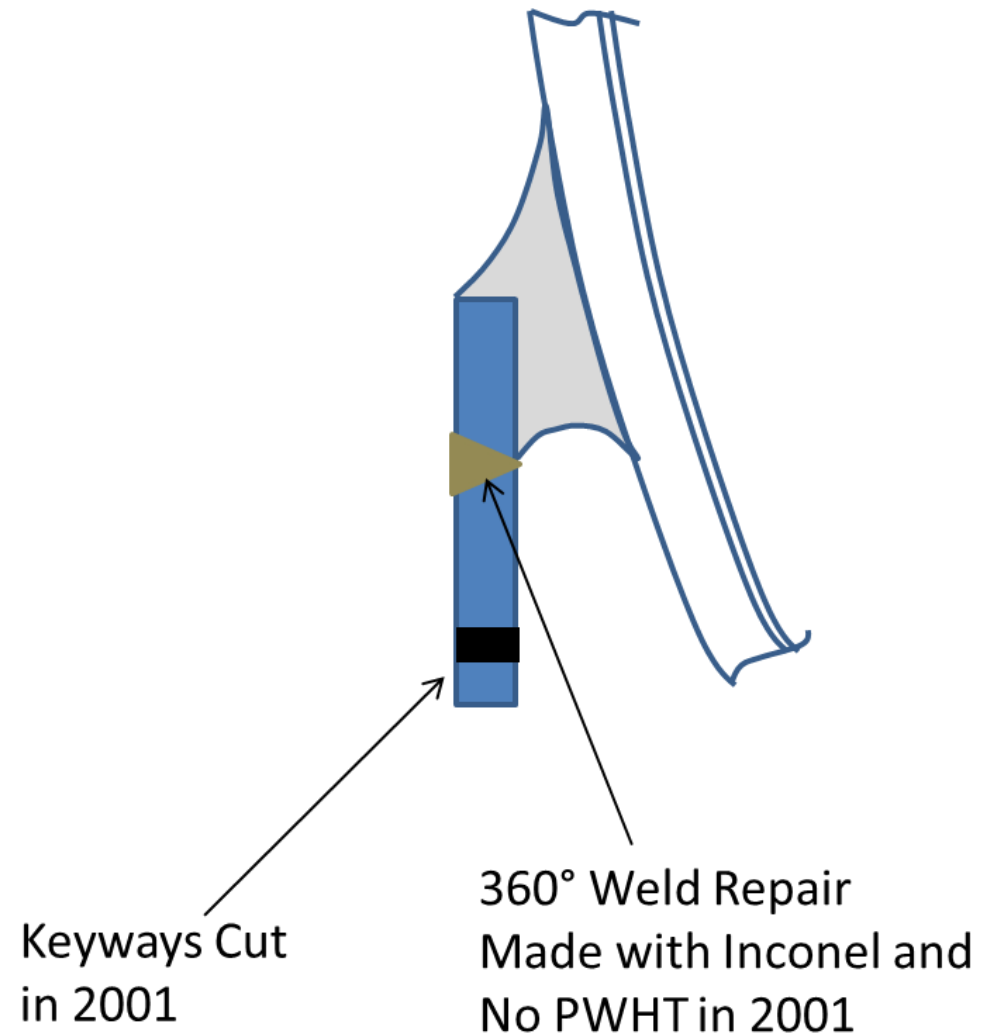
- 2001 First skirt inspection took place during a scheduled Turnaround
 - Cracking found 360° around skirts (through-wall in many locations)
 - Welds were entirely repaired from OD with pre-heat and Inconel filler (no PWHT)
 - Keyways added to reduce stresses

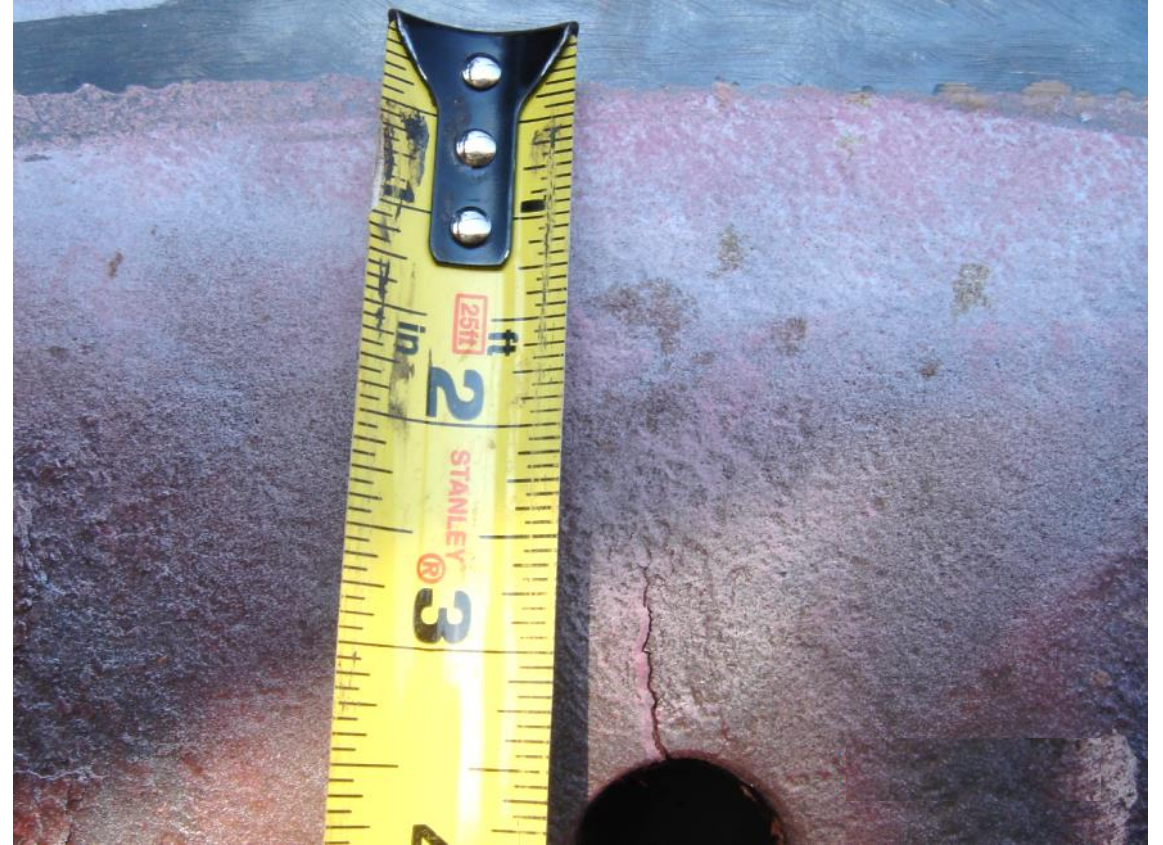
- 2003 Keyway and Inconel skirt weld cracks first found
- Monitored and repaired as necessary every 9-12 months
 - Weld repairs performed with Inconel and no PWHT
- 2010 Crack propagation rates began increasing
- 2014 a stair-step increase in severity observed during inspections

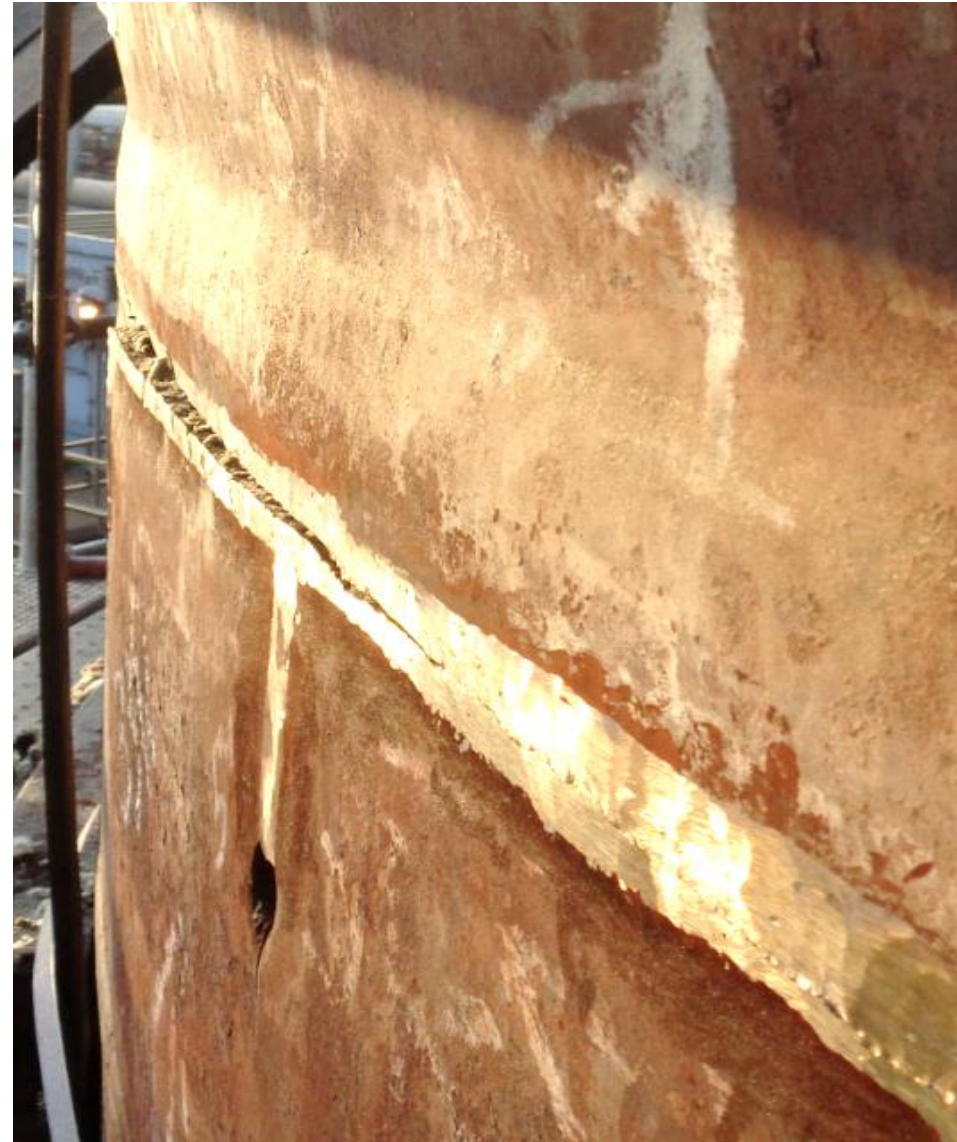
- 2010 Crack propagation rates began increasing, with a stair-step increase in severity observed during the 2014 inspections
- Cracks continued to worsen, making the skirt separate into panels
- Skirt panels were worked back in and welded with Inconel
- Inspection frequency further reduced to every 6 weeks

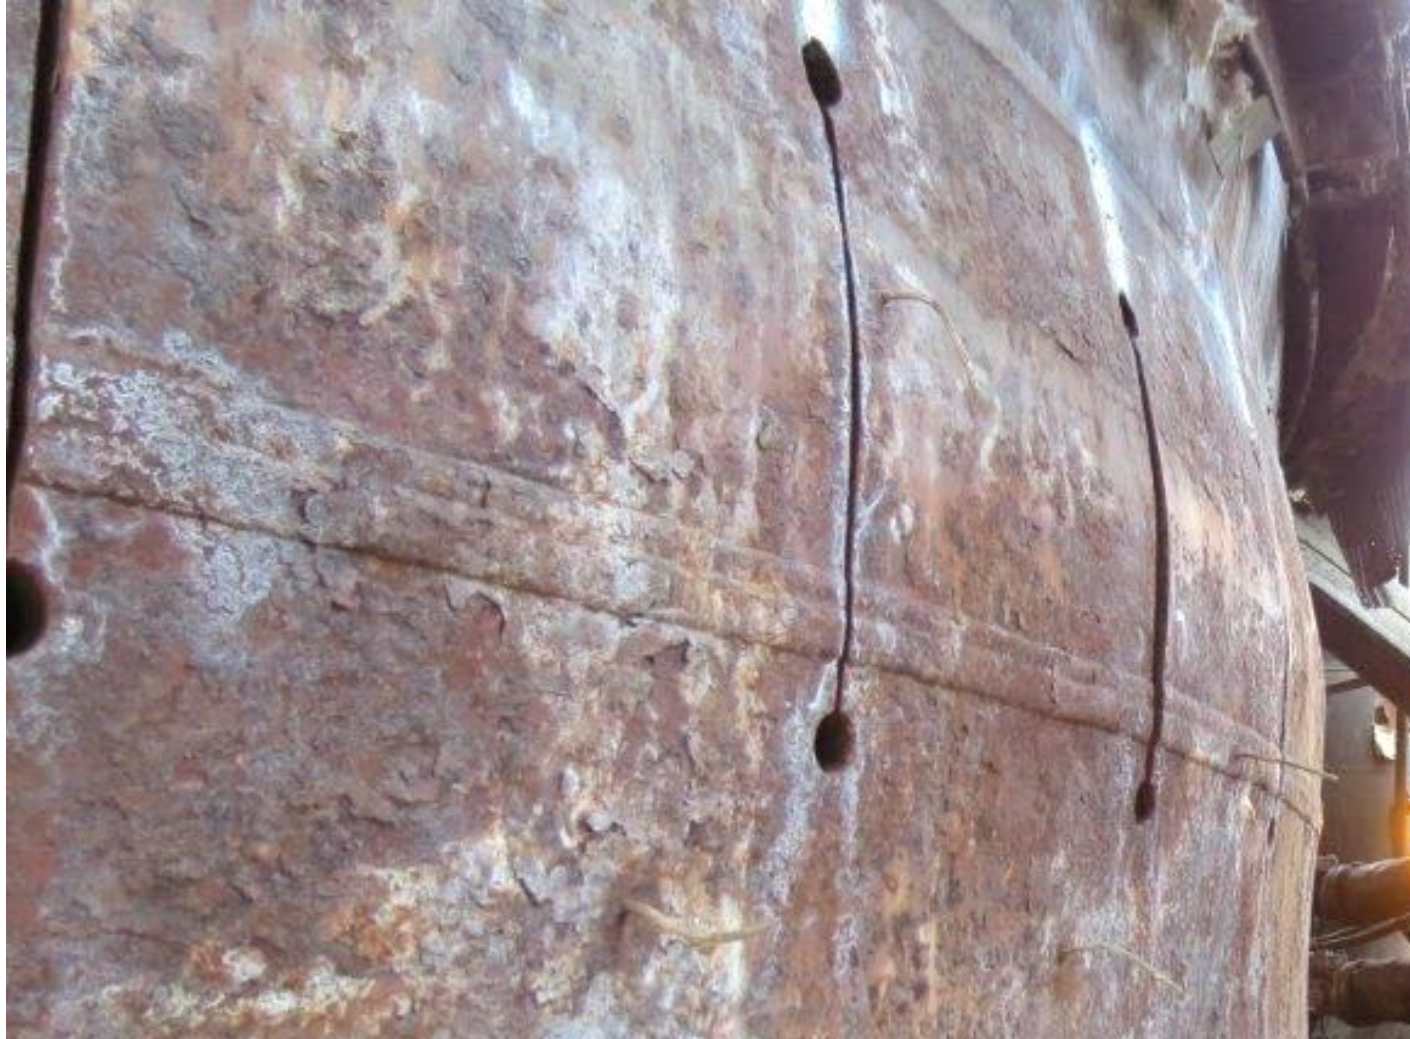
- In the areas adjacent to the cracking, the skirt began to bulge

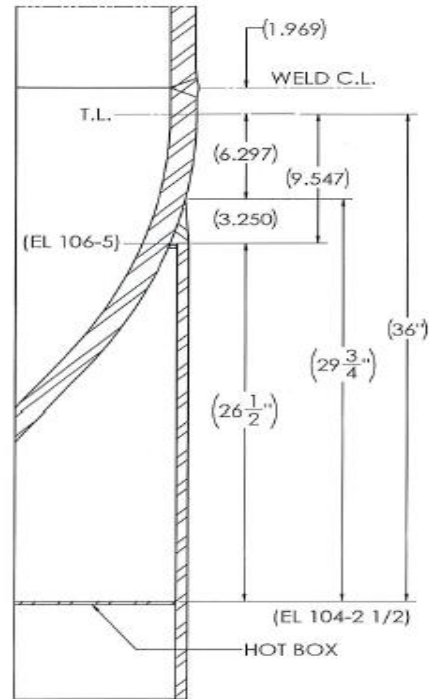
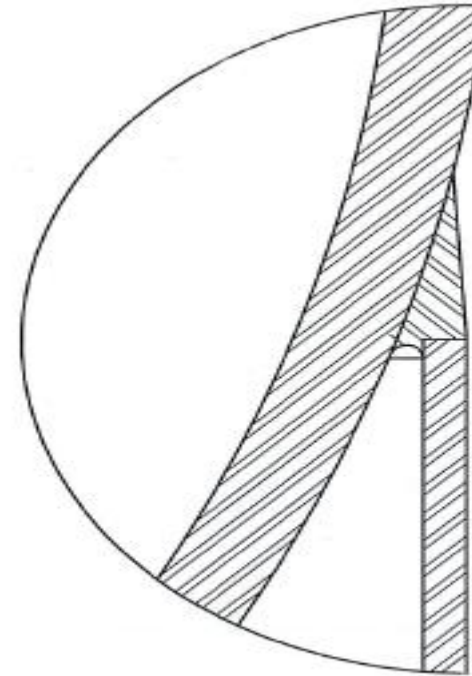
STEP 0. AS FOUND

- Original configuration (1996 vintage) with $\frac{1}{4}$ " crotch radius
- All 2-1/4Cr material

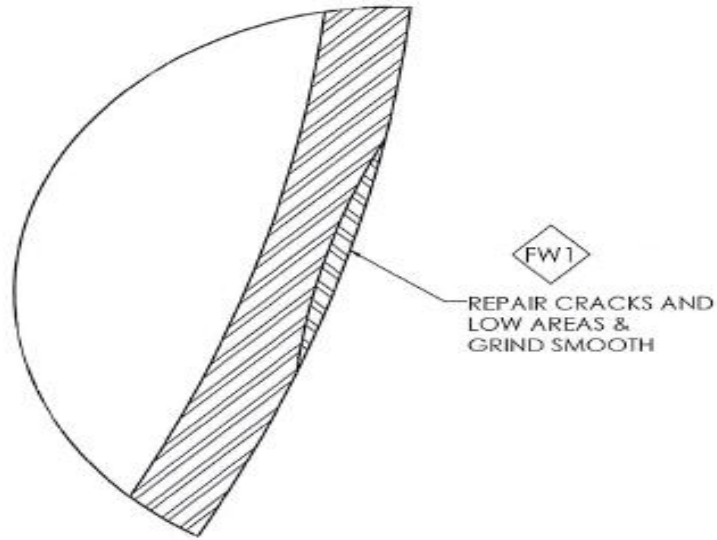
STEP 2. REPAIR AND REBUILD SHELL

- MT and PAUT inspection of base material performed after skirt and attachment weld has been removed
- Any rejectable indications are excavated and repair welding is performed and ground smooth using 2-1/4Cr (ER90S-B3) weld metal
