REFCOMM[®]
MUMBAI 2019

On Line Repair of DCU Vessel Skirt Cracks at Reliance SEZ Plant

Anand C Haridas –Head Corrosion & Inspection-Jamnagar Complex, RIL

Pedro E. Amador – VP Business Development & Technology, AZZ WSI

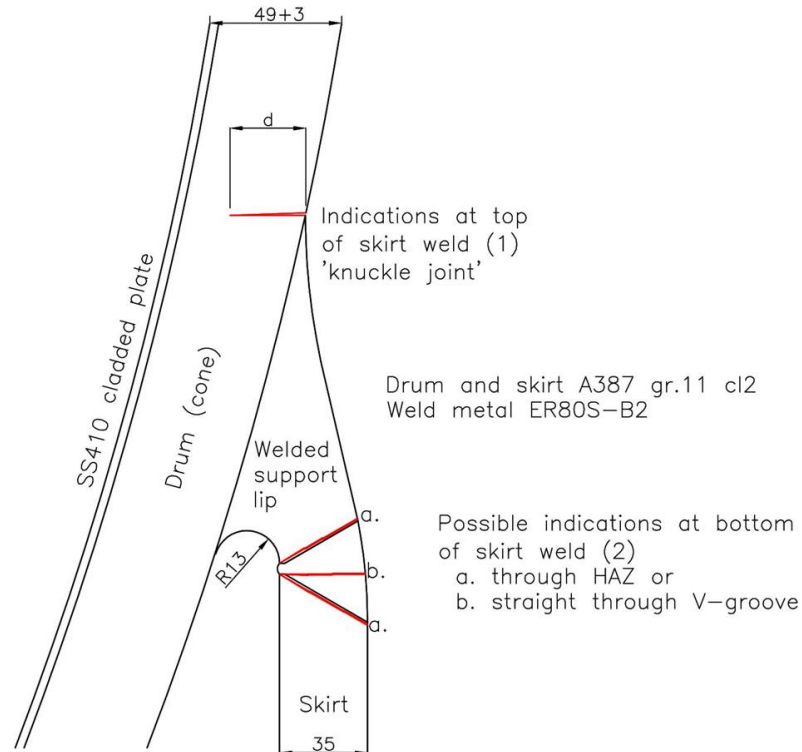
- Classic skirt attachment failure locations.
- Blend Geometry of upper knuckle to vessel not smooth.
- Multiple conventional repairs at the SC1 location.

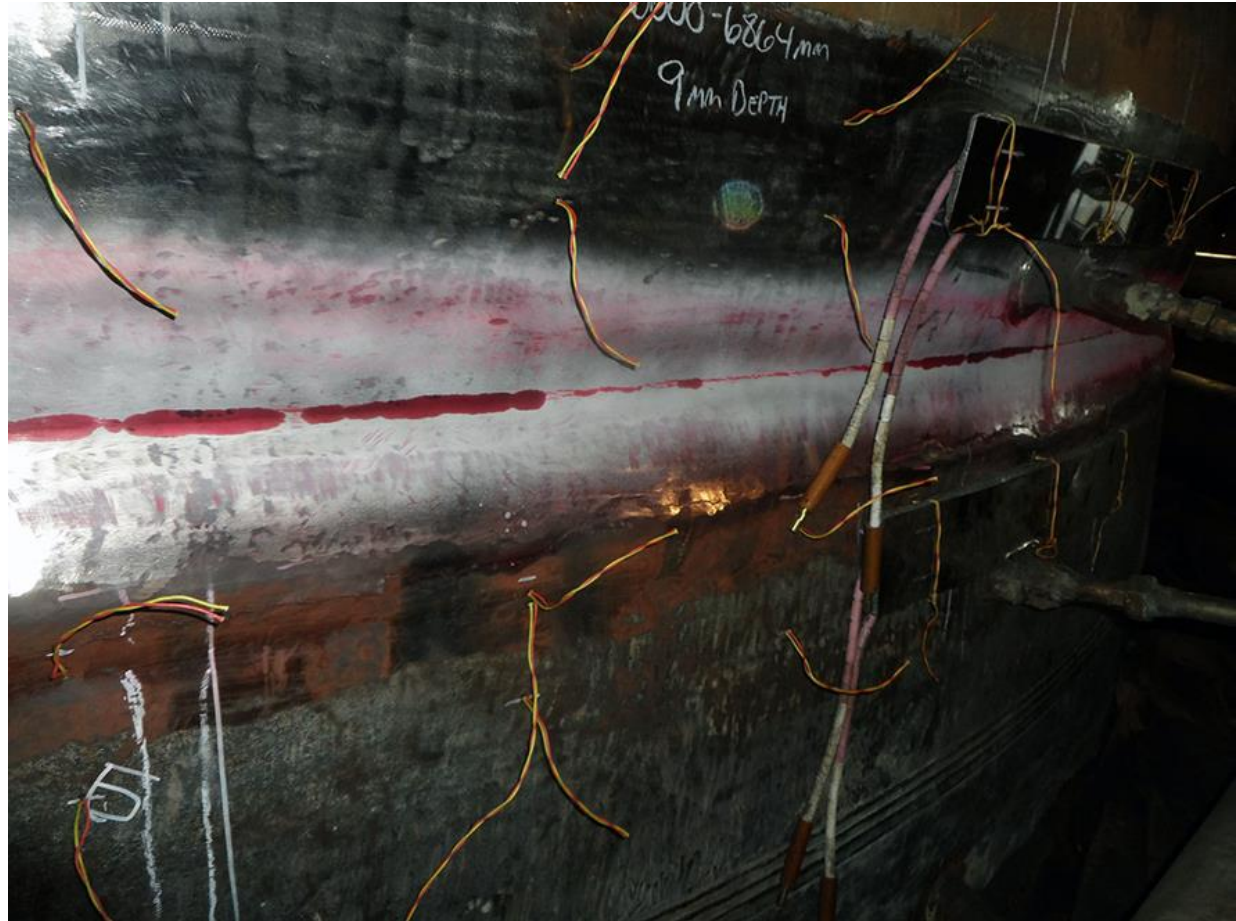
- Penetrant Inspection shows cracking at the top of the knuckle to vessel transition.
- Cracking ranged between 9mm to 25mm in depth.
- One location 35mm deep required ID/OD repair.
- Cracking was excavated until a clear PT was obtained.

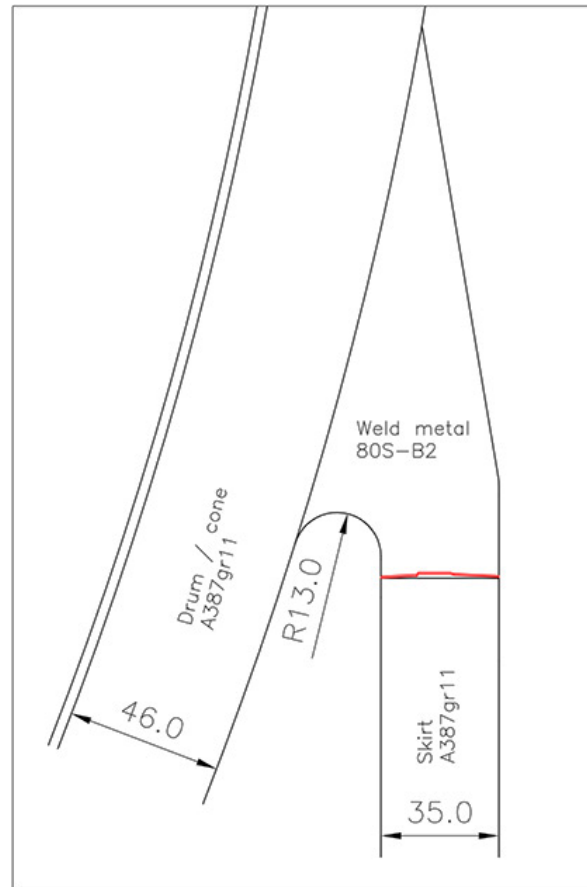
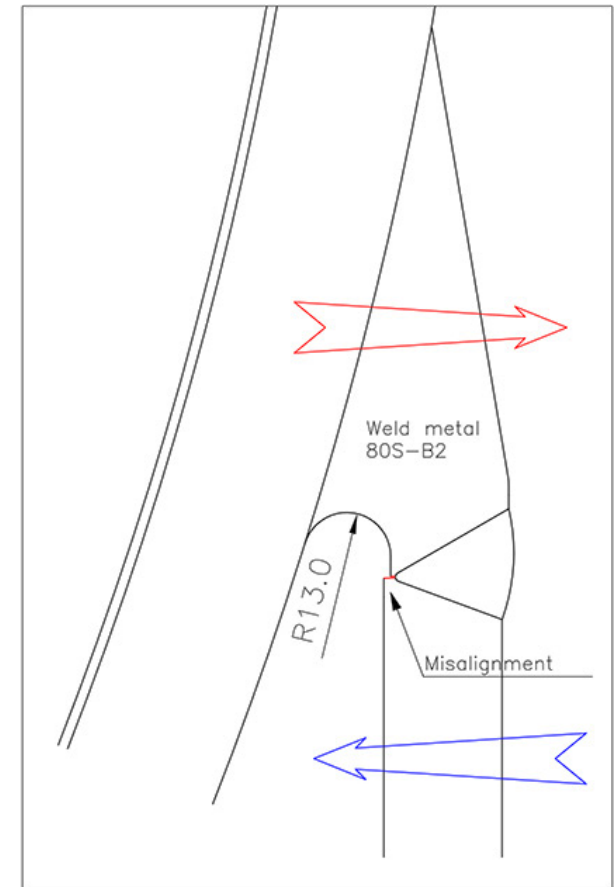
- Multiple repairs were made to this weld as needed to continue operation.
- Over time, the skirt and the knuckle became increasingly misaligned.
- This misalignment resulted in a decrease in size of the repair welds and created a location for future crack incubation.

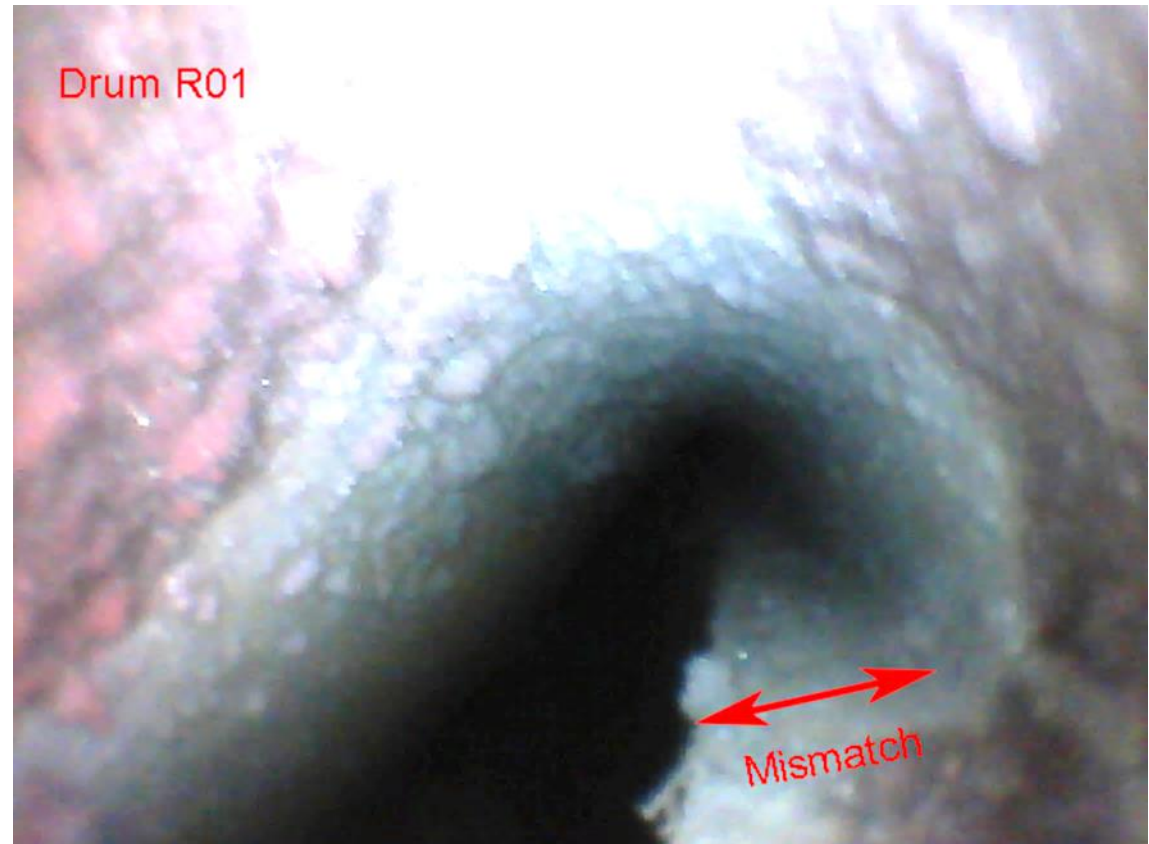
- In some cases the mismatch was large enough to allow the skirt to almost touch the cone.

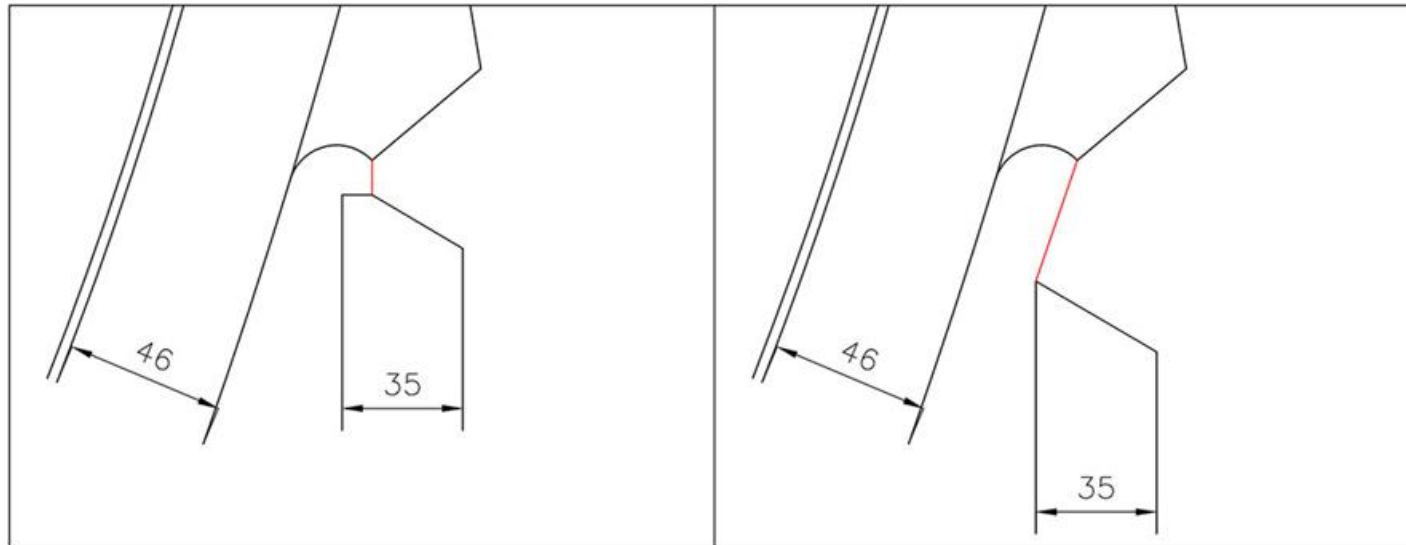
- The initial plan was to removed the damage metal and reinstall a weld that provided acceptable root geometry.
- The severe misalignment required that the width of the root opening be increased significantly to allow a proper geometry after welding.

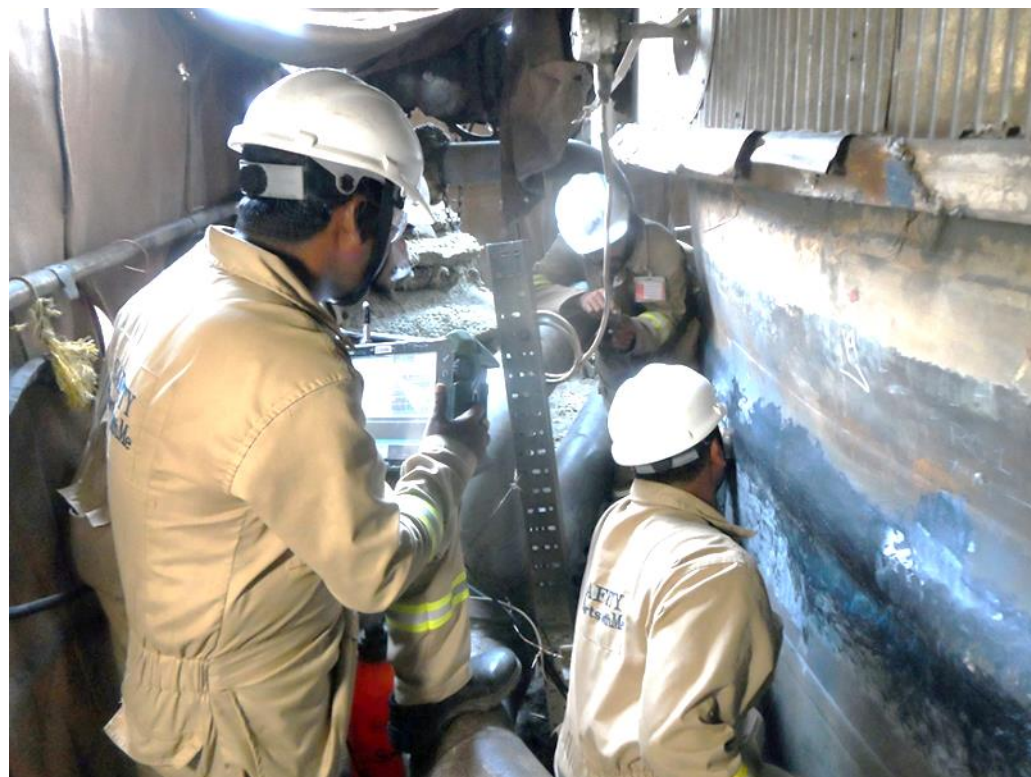
- PAUT was used to inspect all welding upon completion.
- An average of 6 repairs were identified in each circumference with a maximum of 12 repairs on one of the vessels.

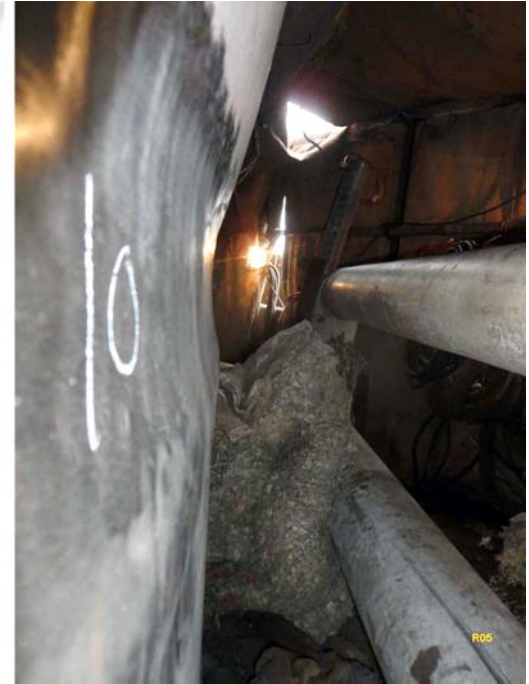
- Final Repair area with dye penetrant developer.
- Typical contour and surface finish for each drum.
