Online Monitoring and Life Extension of Coke Drums

Details of coke drums

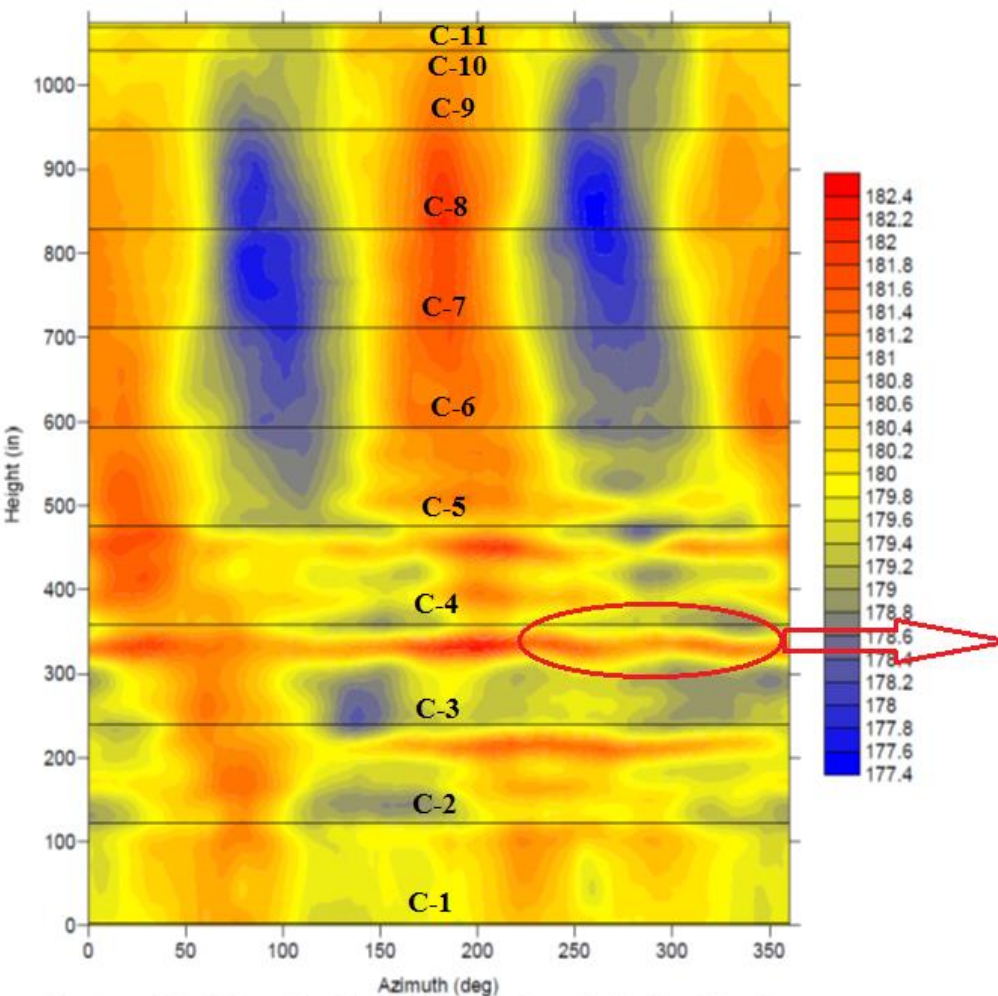
Laser Mapping data of Drum C

Contour plot of the radius (inches) looking from the inside of the drum

Drum nominal radius is about 180 inches
(4572 mm)

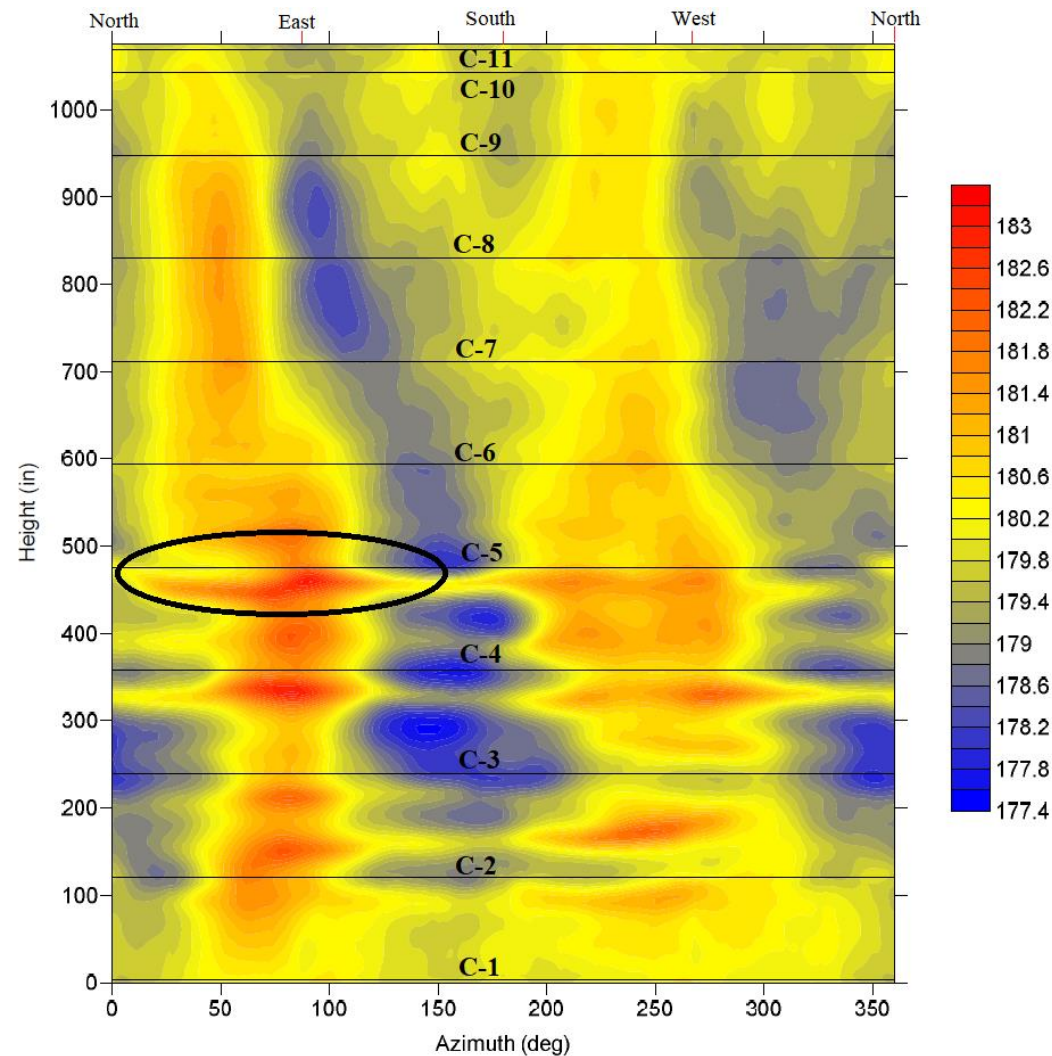
Laser Mapping data of Drum D

**Drum D-2018: Contour plot of radius (inches)
looking from inside of drum**

Drum nominal radius is about 180 inches
(4572 mm)

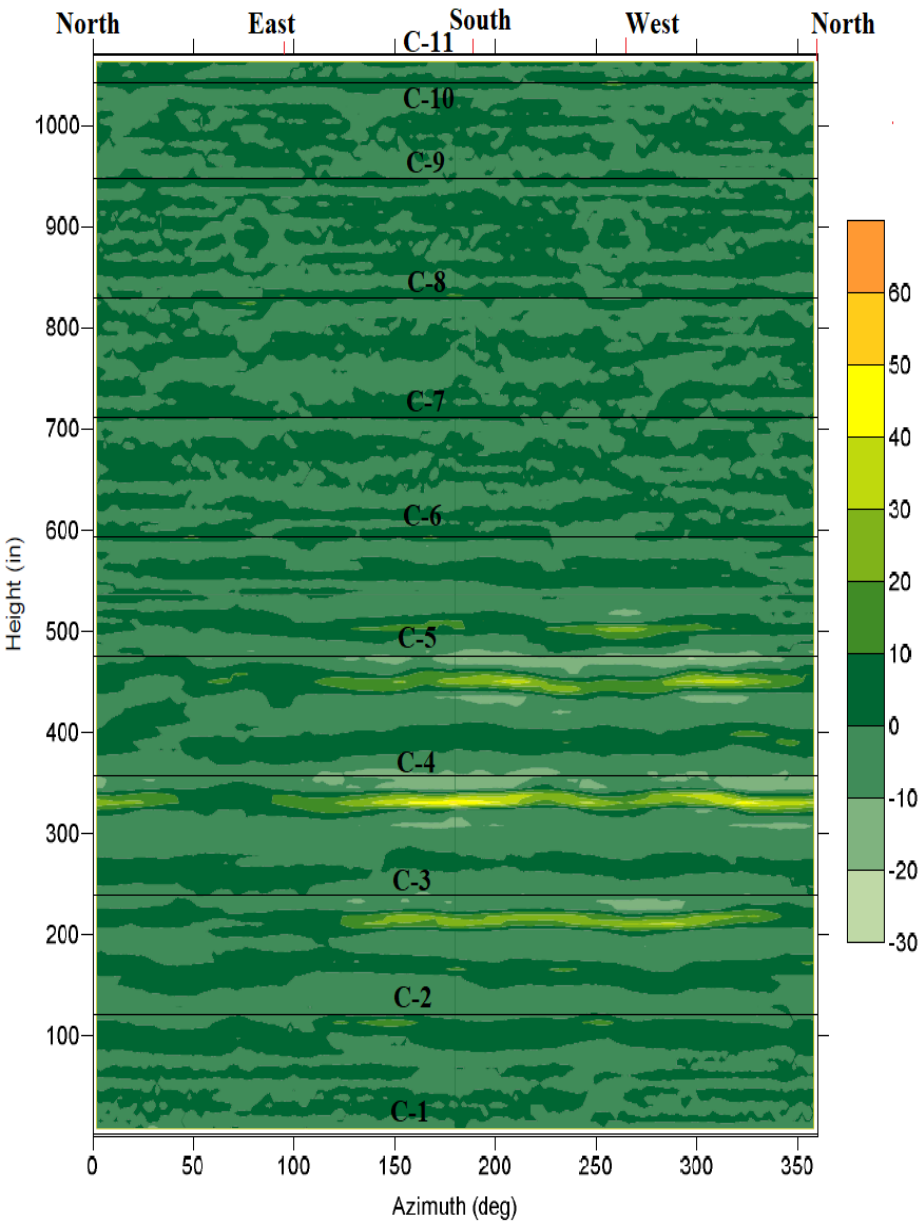
Drum C-2018 : Contour plot of the Plastic Strain Index (%)
looking from the inside of the drum

- Faster deterioration in SA-387 Gr 11 Class 1 drums is attributed to lower strength than Class 2 material typically used in industry.
- Inspection of identified bulging zones from inside and outside surface using Visual, DPT, UT.
- If cracks observed, design and implement high-quality weld overlay repairs at first shutdown.
- Annual laser scanning and strain analysis for bulge assessment

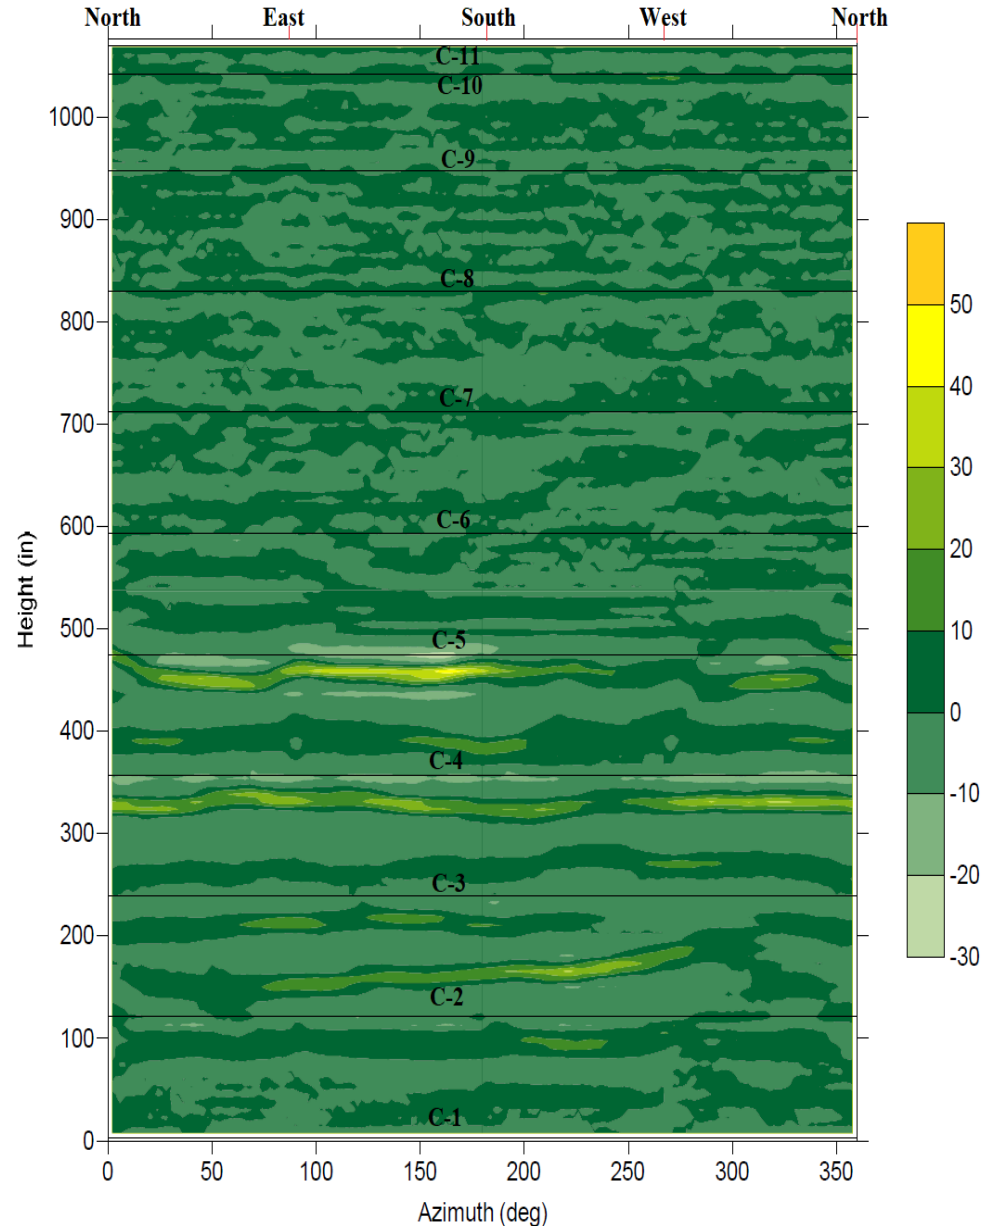
Drum D-2018 : Contour plot of the Plastic Strain Index (%)
looking from the inside of the drum

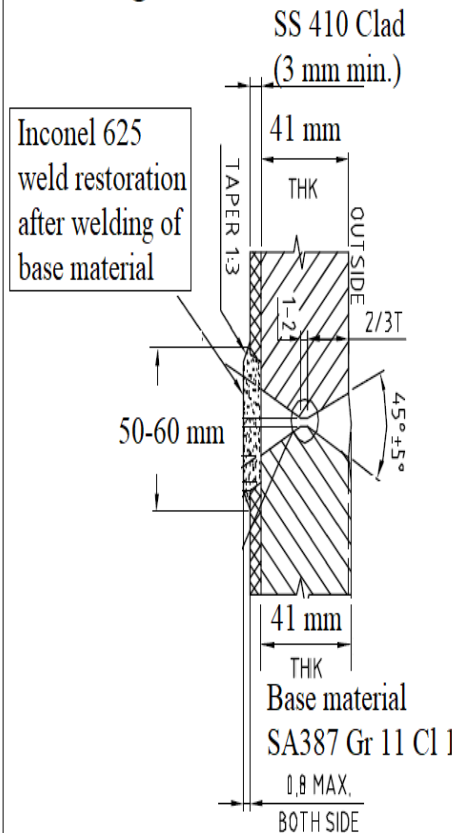
Welding Cross-section at C4

Total height/
axial extent
1118 mm,
44 inches
