Online Monitoring and Life Extension of Coke Drums

Details of coke drums

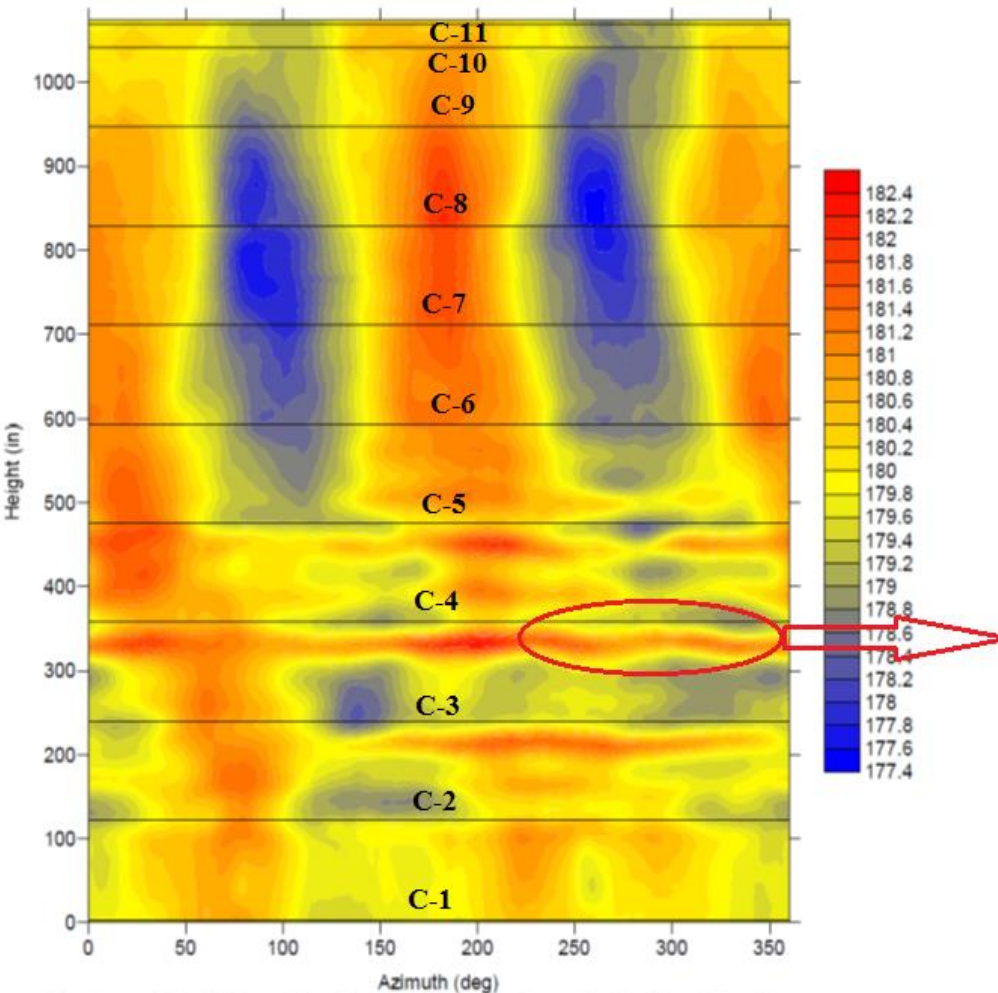
Laser Mapping data of Drum C

Contour plot of the radius (inches) looking from the inside of the drum

- Blue Inward
- Red Outward

Drum nominal radius is about 180 inches
(4572 mm)

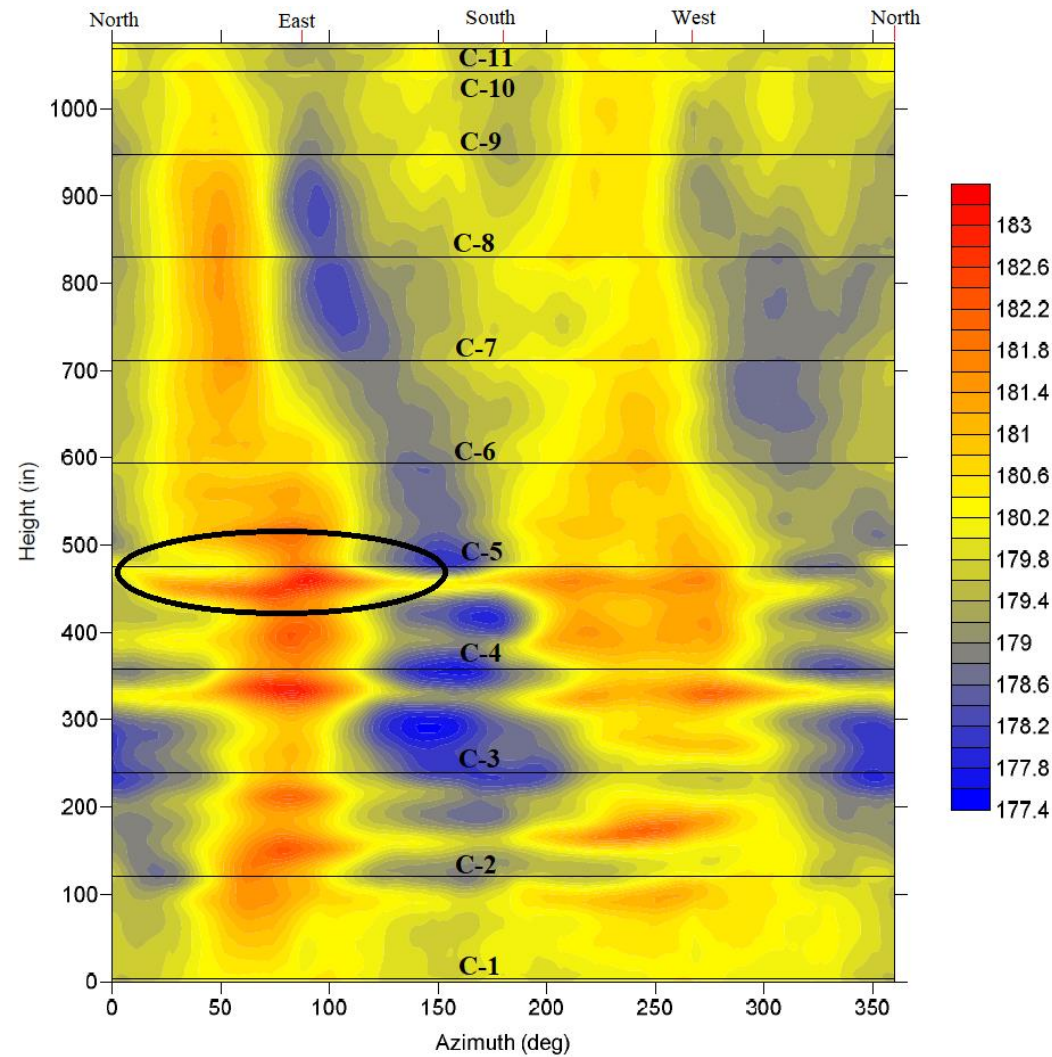
Laser Mapping data of Drum D

**Drum D-2018: Contour plot of radius (inches)
looking from inside of drum**

■ Inward
■ Outward

Drum nominal radius is about 180 inches
(4572 mm)

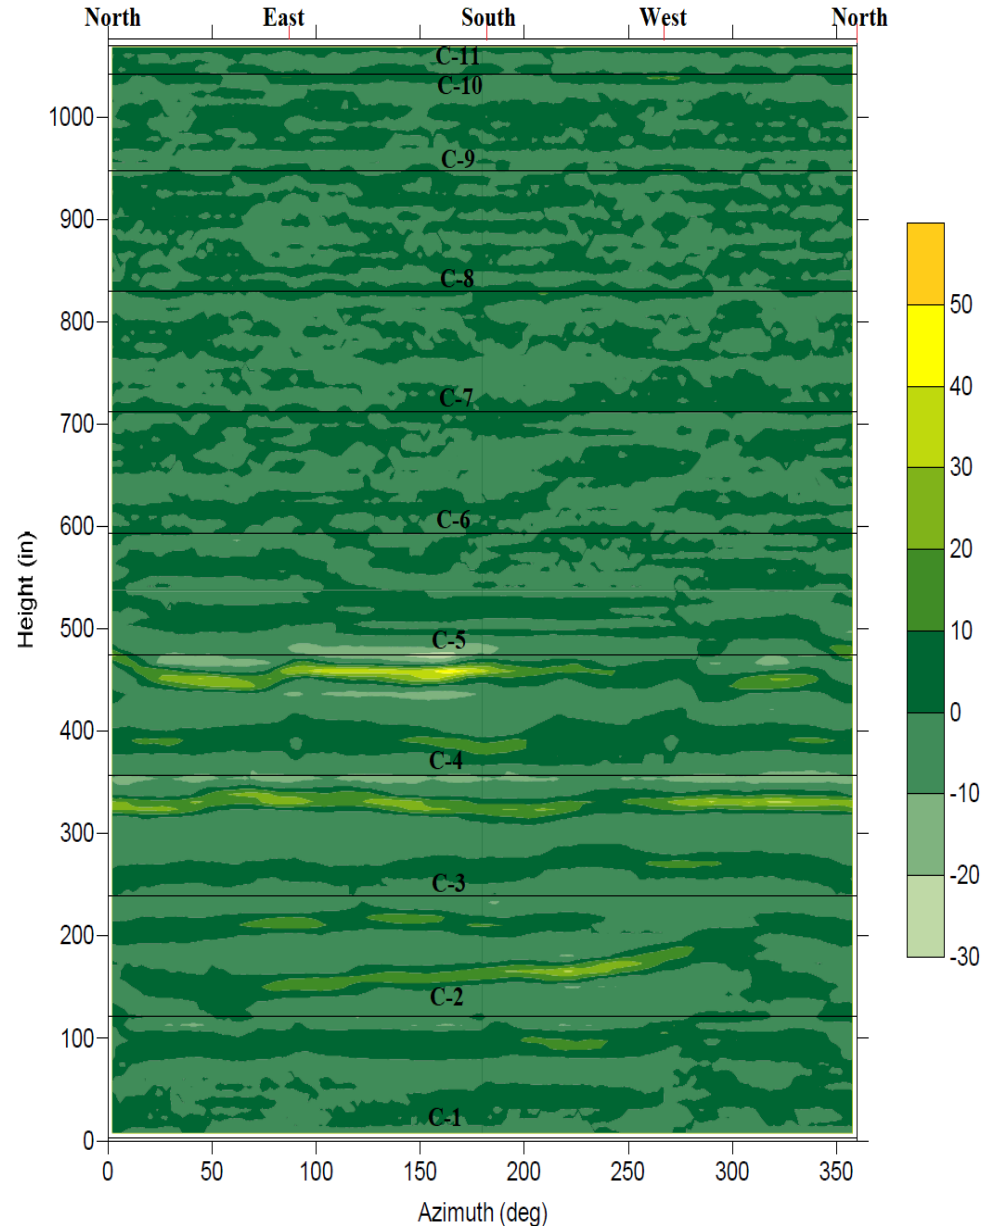
**Drum D-2018 : Contour plot of the Plastic Strain Index (%)
looking from the inside of the drum**

- Faster deterioration in SA-387 Gr 11 Class 1 drums is attributed to lower strength than Class 2 material typically used in industry.
- Inspection of identified bulging zones from inside and outside surface using Visual, DPT, UT.
- If cracks observed, design and implement high-quality weld overlay repairs at first shutdown.
- Annual laser scanning and strain analysis for bulge assessment
