# **INCINERATOR'S REFRACTORY AND SHELL DAMAGE DUE TO CONDENSATION IN TGTU ABSORBER OVERHEAD LINE**

**October 2022**

**ADNOC SOUR GAS**

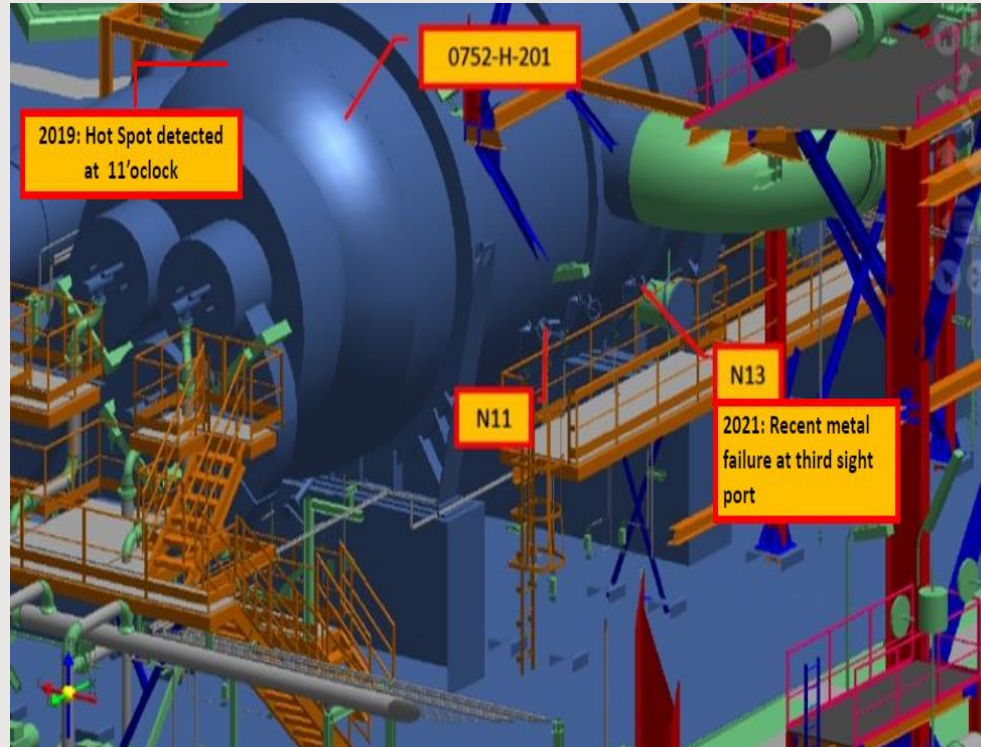
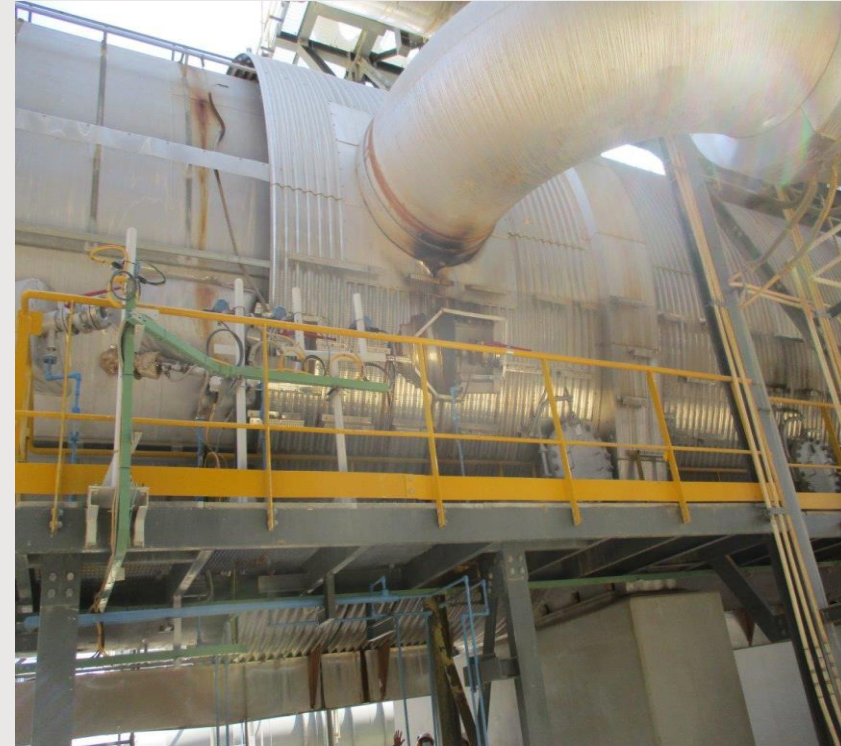
- Metal failure was reported on the third sight port at the 3 o'clock position (N13)

- Installed insulation layer on the TGTU Absorber Overhead lines. As an additional protection, heat tracing can be considered later.
- Upgraded the refractory in the Incinerator inlet nozzle lines, for better acidic corrosion resistance
- Re-located the 3rd sight glass port (N13) to another location

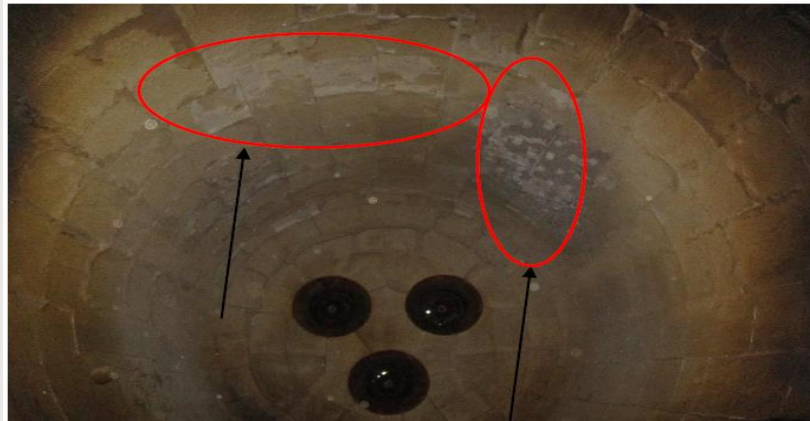
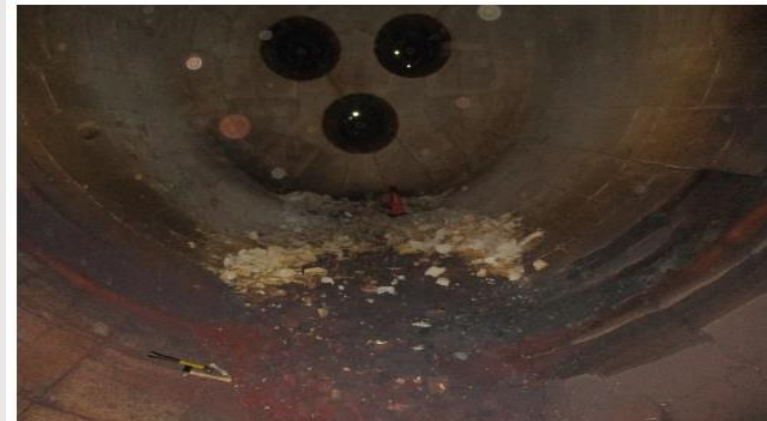
1. Flame Impingement	✓
2. Incompatible refractory material for operating temperature	✓
3. Operating life of the refractory	✗
4. Refractory dry-out	✗
5. Zone A (burner section of the incinerator) temperature too high	✓

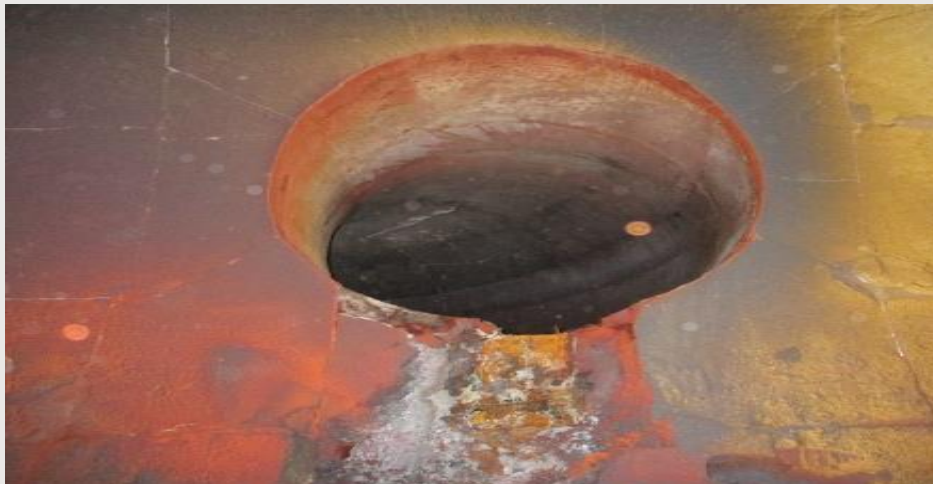
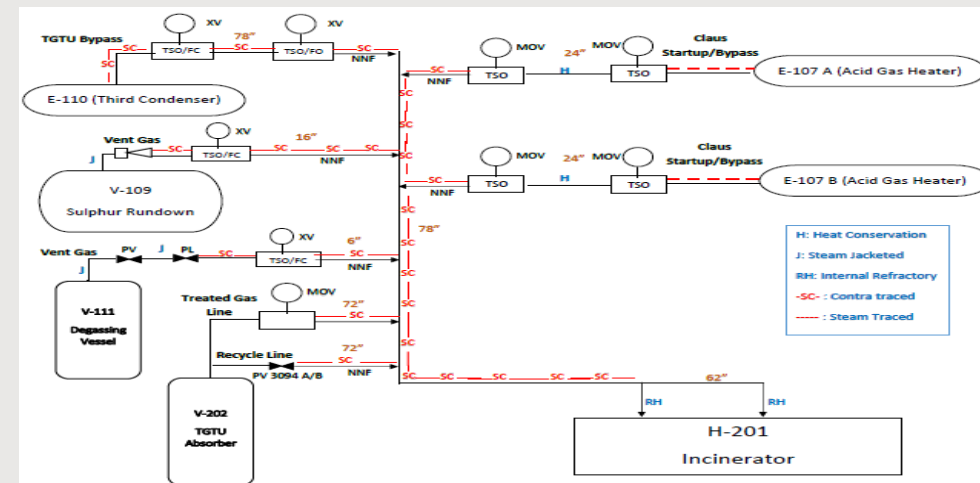
| 1. Liquid formation in the waste gas inlet line | ✓ |
| 2. Shell skin temperature low in some locations | ✓ |
| 3. Passing Valves on inlet lines to incinerator | ✗ |
| 4. Damage in the steam jackets of MOVs & XVs | ✗ |

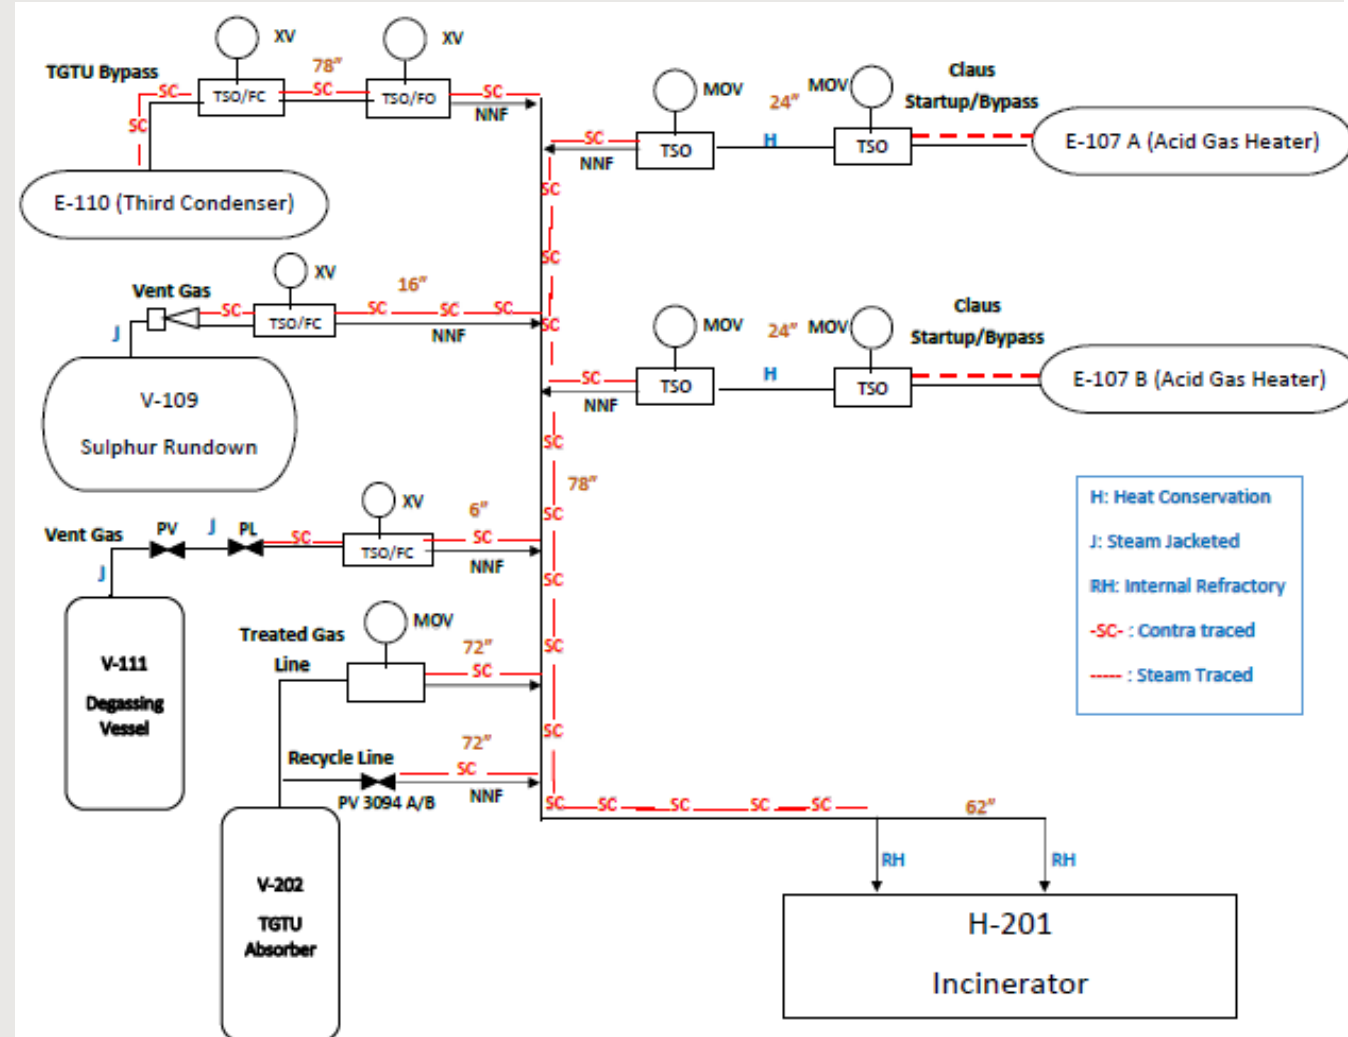
- Only 21m of the 125 m line was insulated
- Thermal survey of the line confirmed a temperature drop in the range 1 to 3 °C
- A benchmarking activity was done to compare ASG design with other licensors units (Worley, Shell etc.) and found that the line was specified with heat conservation insulation.

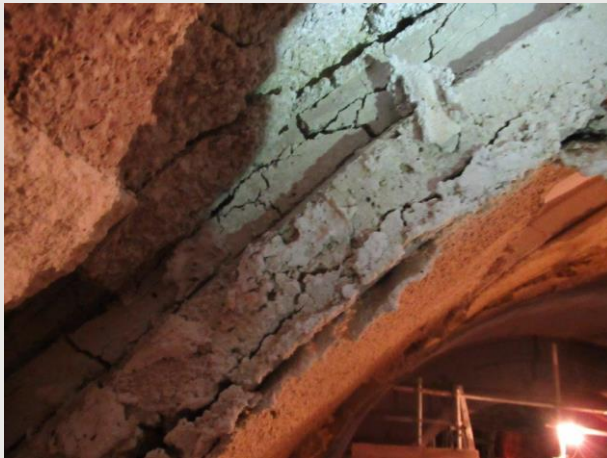
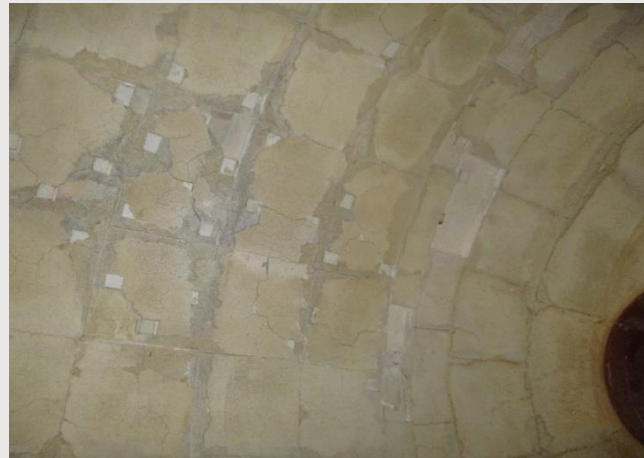
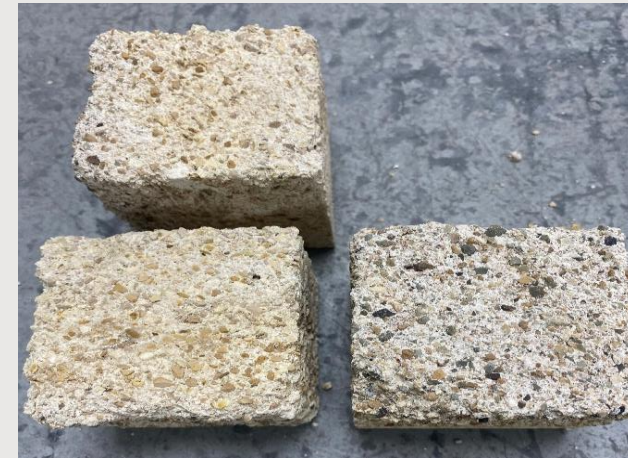
- 5 samples sent to laboratory testing, only 2 were eligible for conducting the mechanical testing. 3 samples were deteriorated during probe cutting, showing completely lack of mechanical properties of the refractory material.
- Mechanical properties of the Dense material sample (S1) presented only 15% of the values required by the datasheet on upper location exposed to high temperatures. Excessive branched cracking observed, limiting testing.
- Mechanical properties of the Backup material sample (S2) presented nominal properties showing good density and Cold crushing resistance.

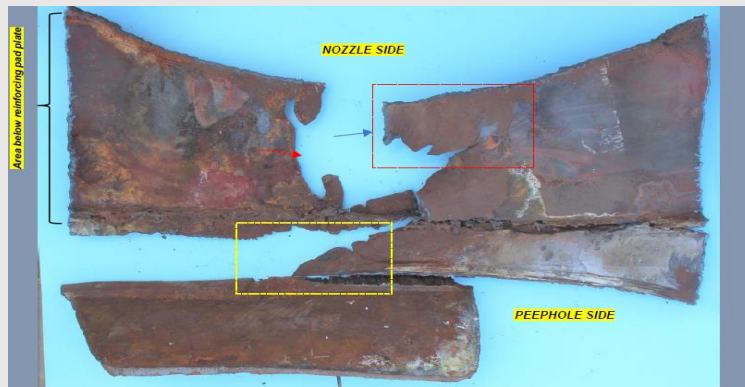
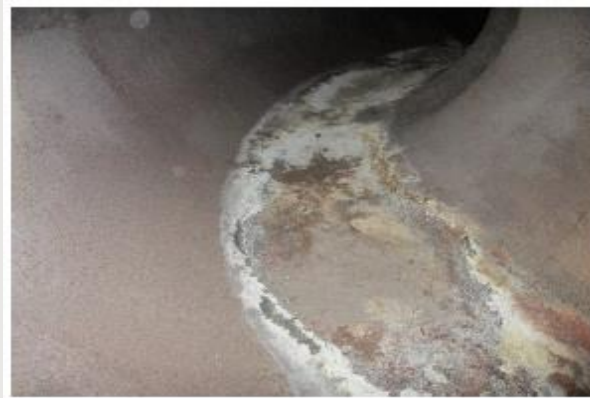
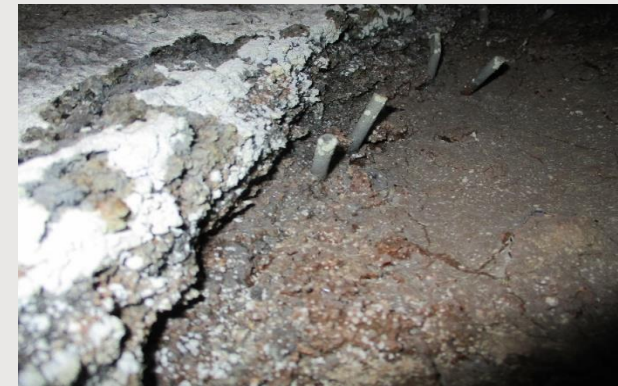
- Microstructural examination of metallic samples showed signs of oxidation products on the inner surface indicating exposure for high temperature conditions. Electrochemical reactions on the metallic surface (acidic low temperature corrosion) were found not predominant and evidenced by satisfactory UT readings on the feed gas line and laboratory results on the metallic samples.
- Refractory degradation (chemical attack) associated with carried liquid level. The sight of whitish deposit (Calcium Carbonates) is a visual sign that calcium is being leached from the structure and the refractory matrix degraded allowing spalling of the material and exposure of metallic surface to combustion chamber operating conditions.
