U.S. Chemical Safety and Hazard Investigation Board

Understanding And Addressing Operational Risk

**RefComm 2024
May 1, 2024
Galveston, TX**

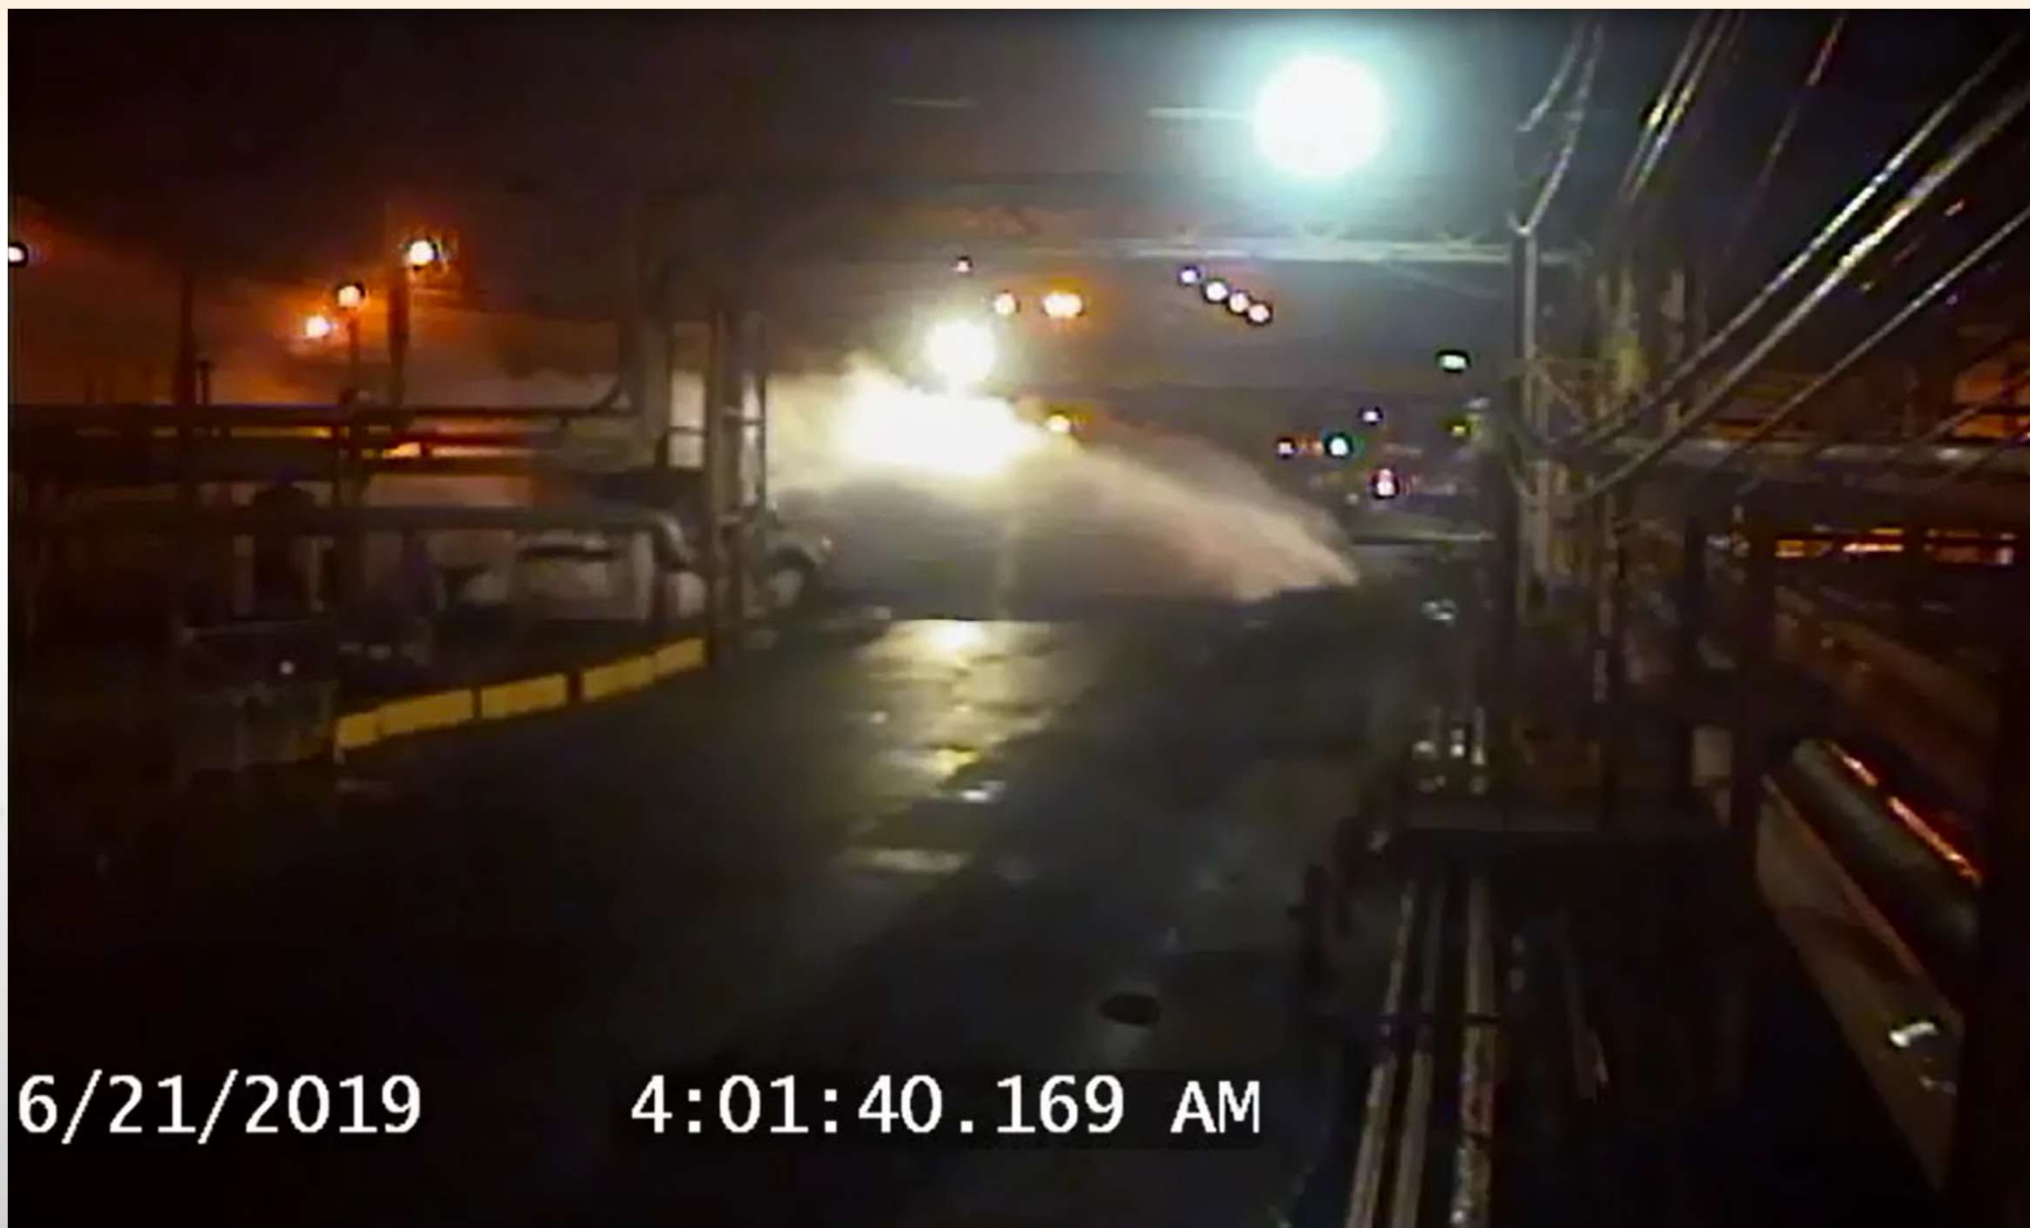
- A pipe elbow in the hydrofluoric acid (HF) alkylation unit ruptured.
- A large vapor cloud (95% propane, 2.5% HF, and other hydrocarbons) engulfed the unit.
- The vapor cloud ignited about two minutes after the start of the release, causing a large fire followed by multiple explosions.

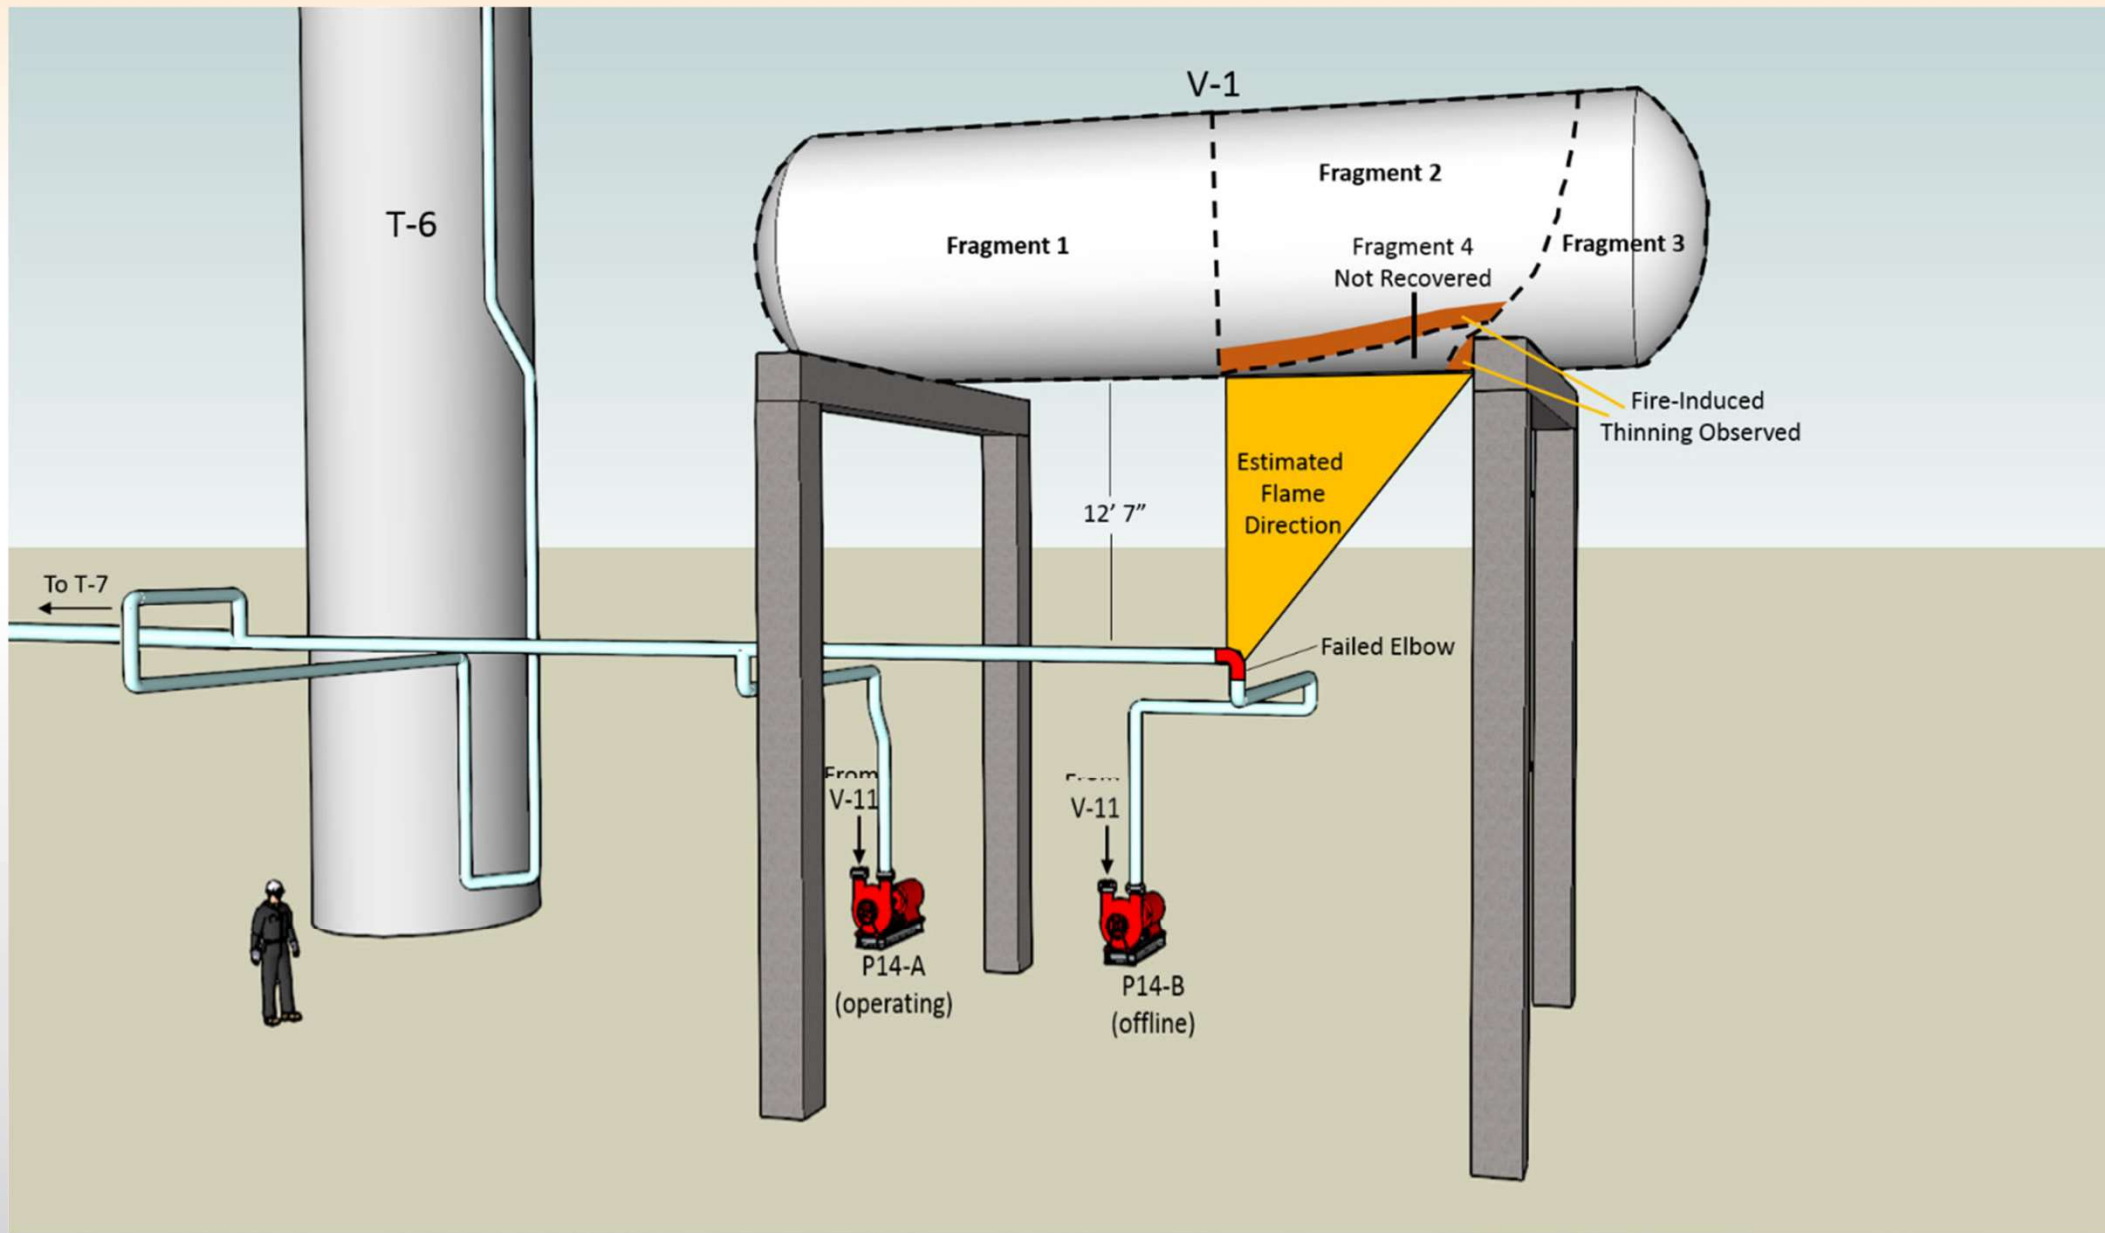
- The water mitigation system was activated manually approximately 40" after the incident occurred.
- PES estimated that 5,239 pounds of HF released from piping and equipment during the incident.
- It estimated that 3,271 pounds of HF released to the atmosphere and was not contained by water spray.
- PES also estimated that about 676,000 pounds of hydrocarbons released during the event, of which an estimated 608,000 pounds were combusted.

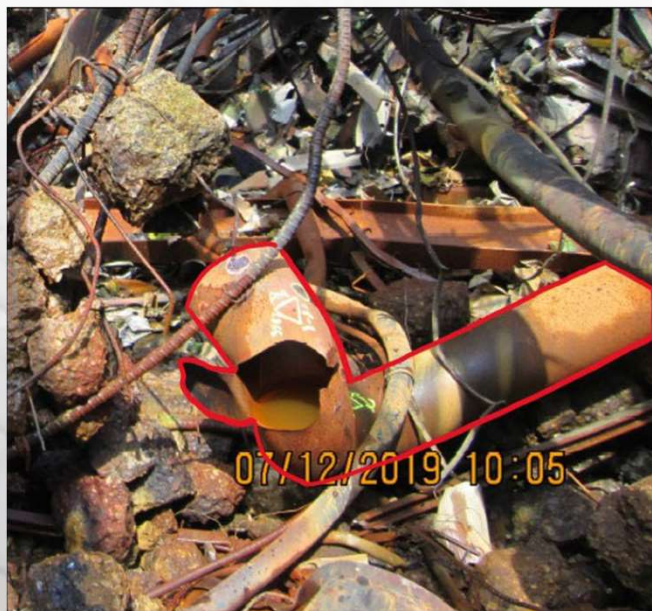
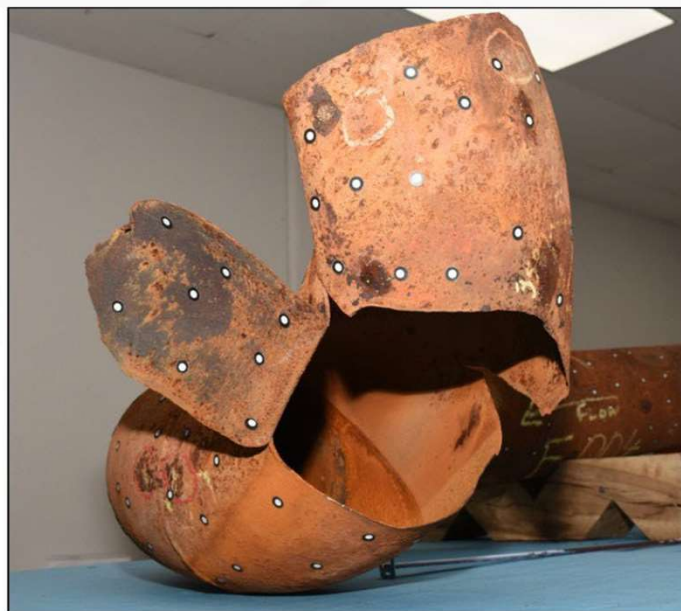
The rupture of a steel piping component with high nickel and copper content that had corroded from HF and thinned faster than adjacent piping components with lower nickel and copper content.

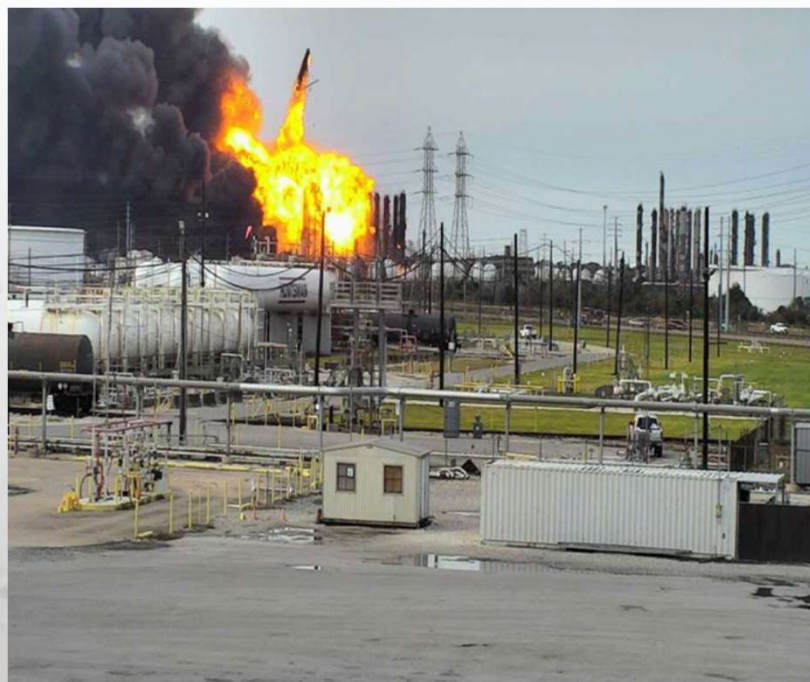
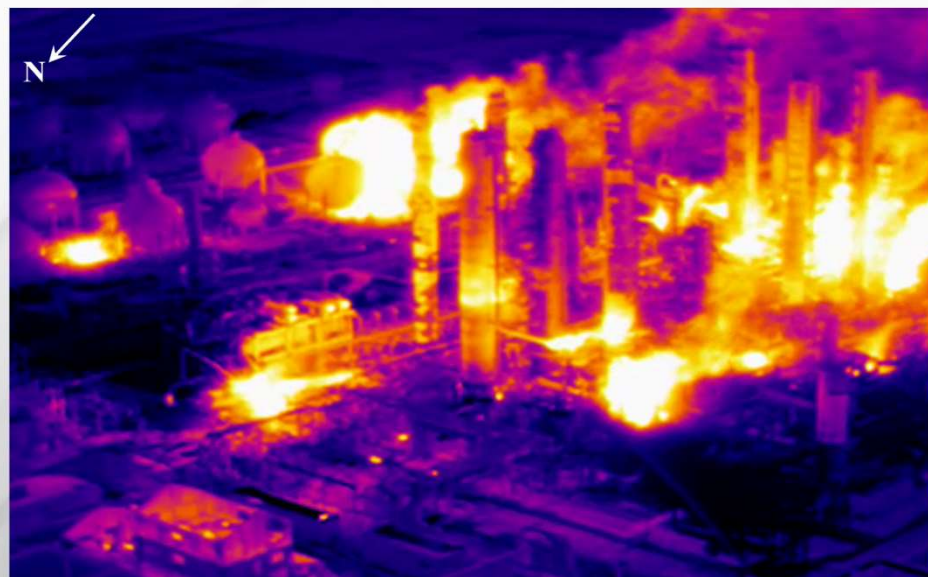
The popcorn polymer continued to accumulate and expand until the internal piping pressure increased to the point that the piping ruptured, releasing butadiene from the process unit.

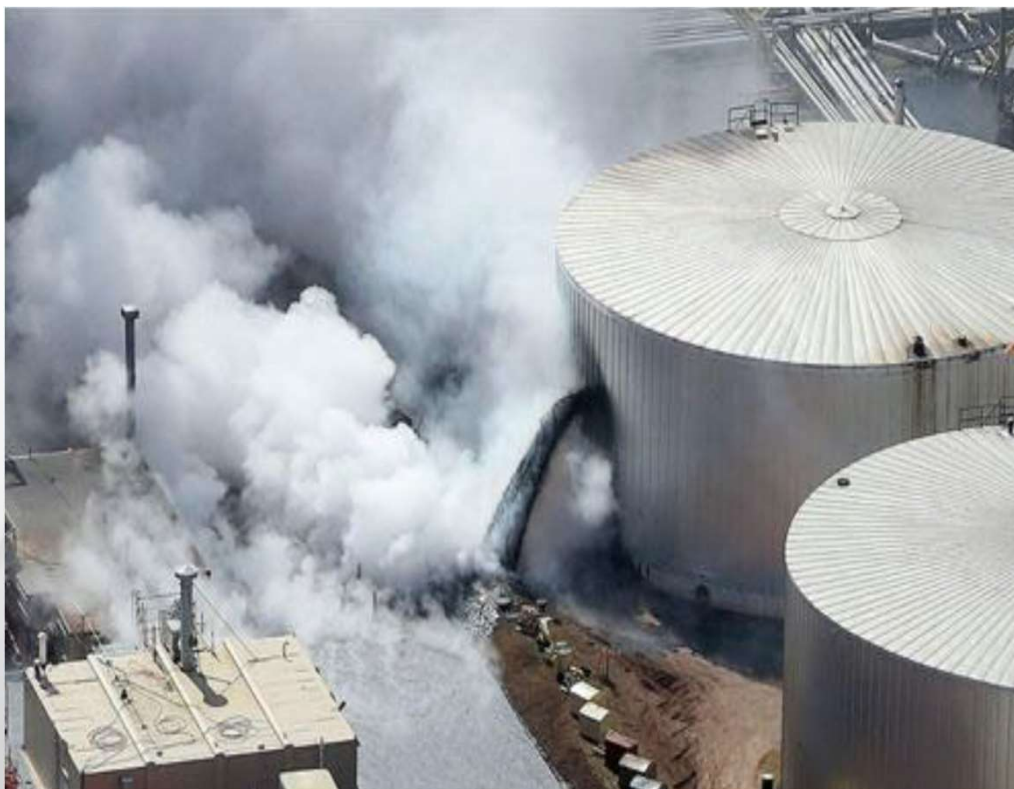
Explosion debris struck and punctured an asphalt storage tank.

Debris from the FCC unit did not impact the nearby HF storage tank (near-miss event).

Asphalt fire started at approximately 12:00 p.m.

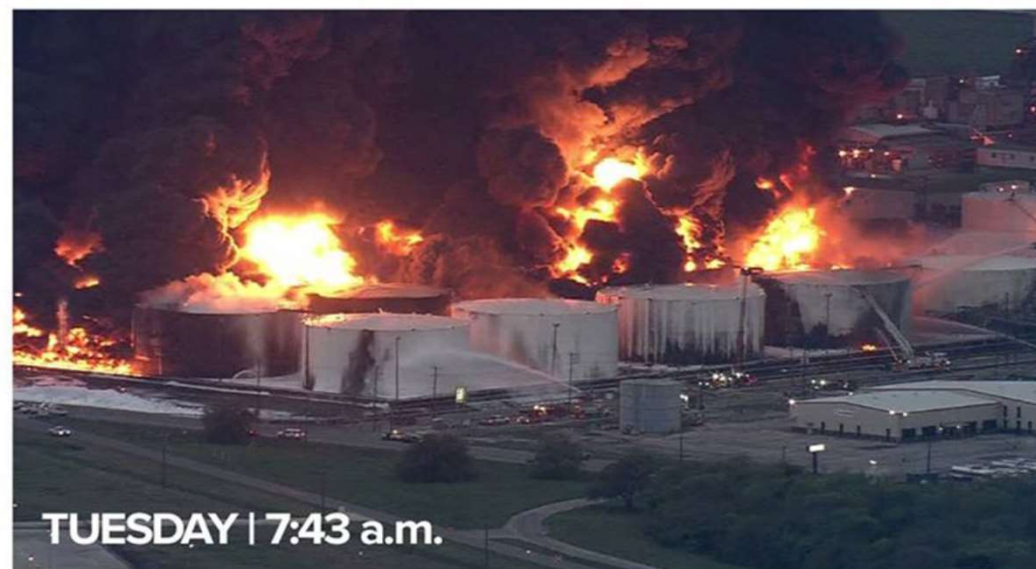
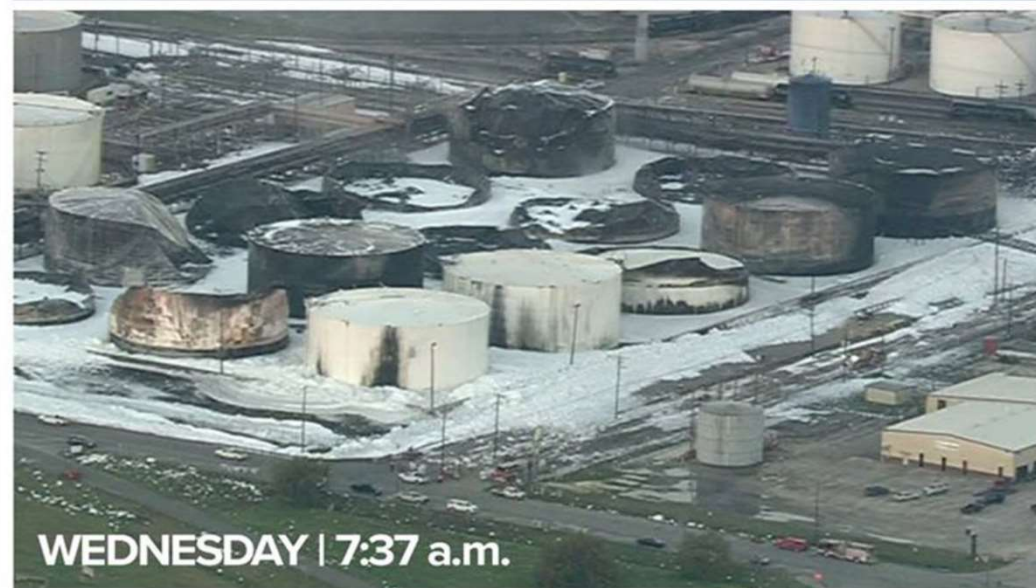
Once the fire erupted, ITC was unable to isolate or stop the release. The fire burned, intensified, and spread to the other 14 tanks in the same containment area.

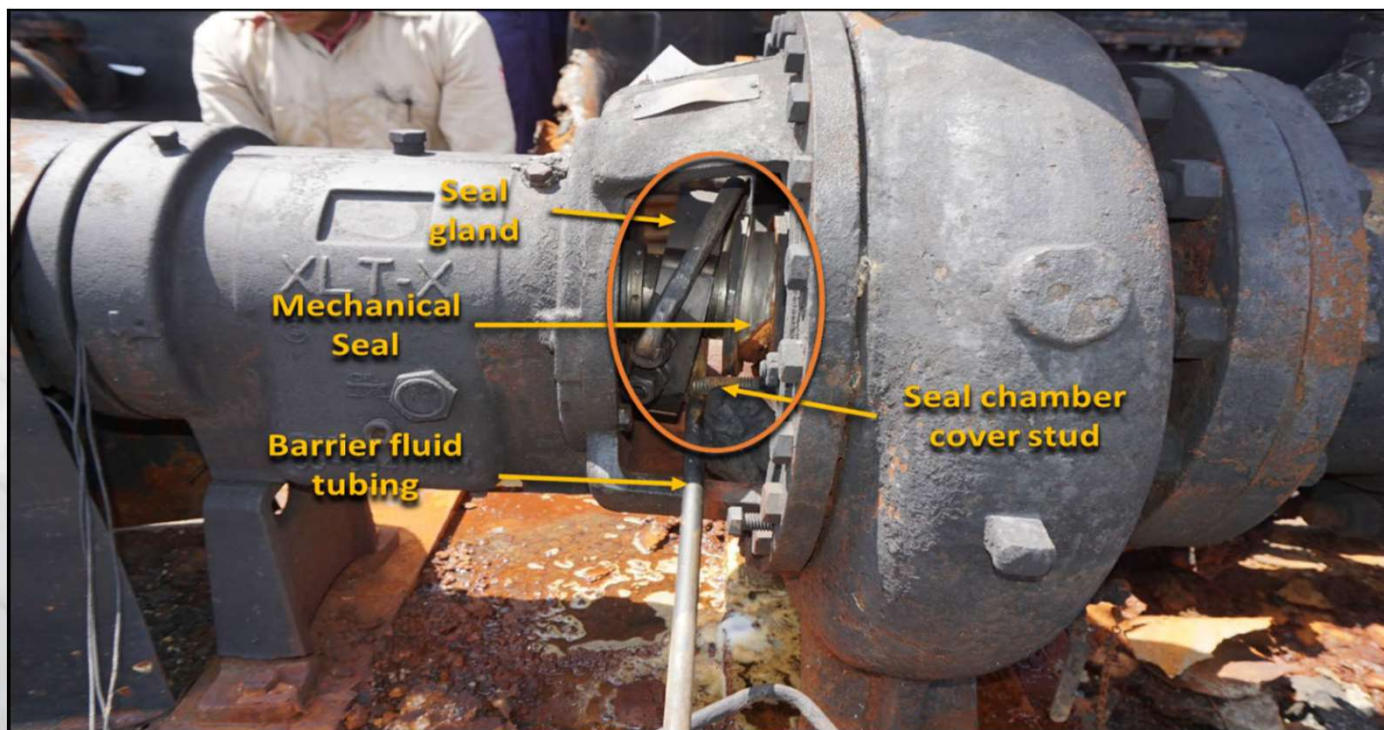
- The pump failed allowing butane-enriched naphtha product to be released from the pump's mechanical seal while the pump continued to operate.

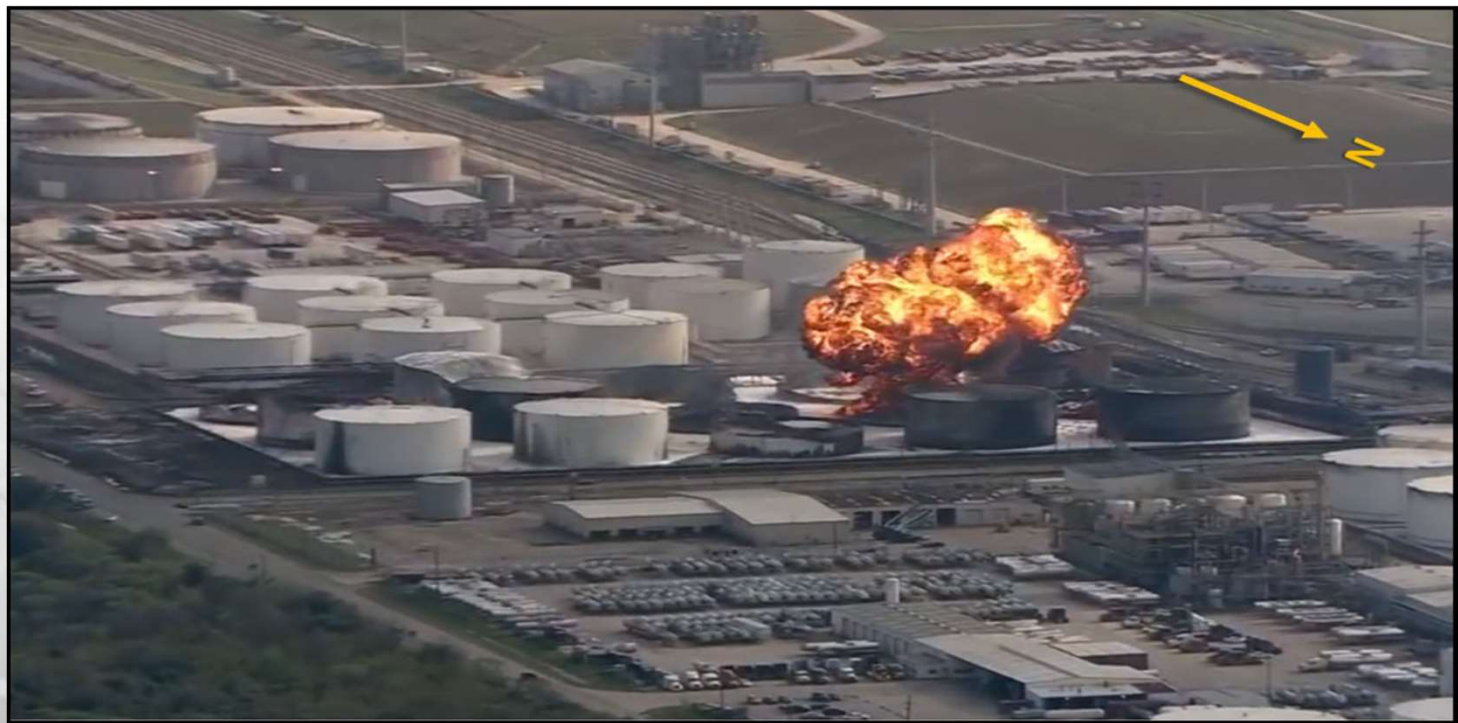
Tank 80-8 and the other aboveground storage tanks located in the First & Second 80's tank farm were not equipped with ROEIVs.
