## HANDLING POWER AND STEAM OUTAGE IN DCU RECENT EXPERIENCES

G D Vinothkanna – <u>vinothkanna gd@mrpl.co.in</u> Sudheer Pai – <u>SudheerPai@mrpl.co.in</u>

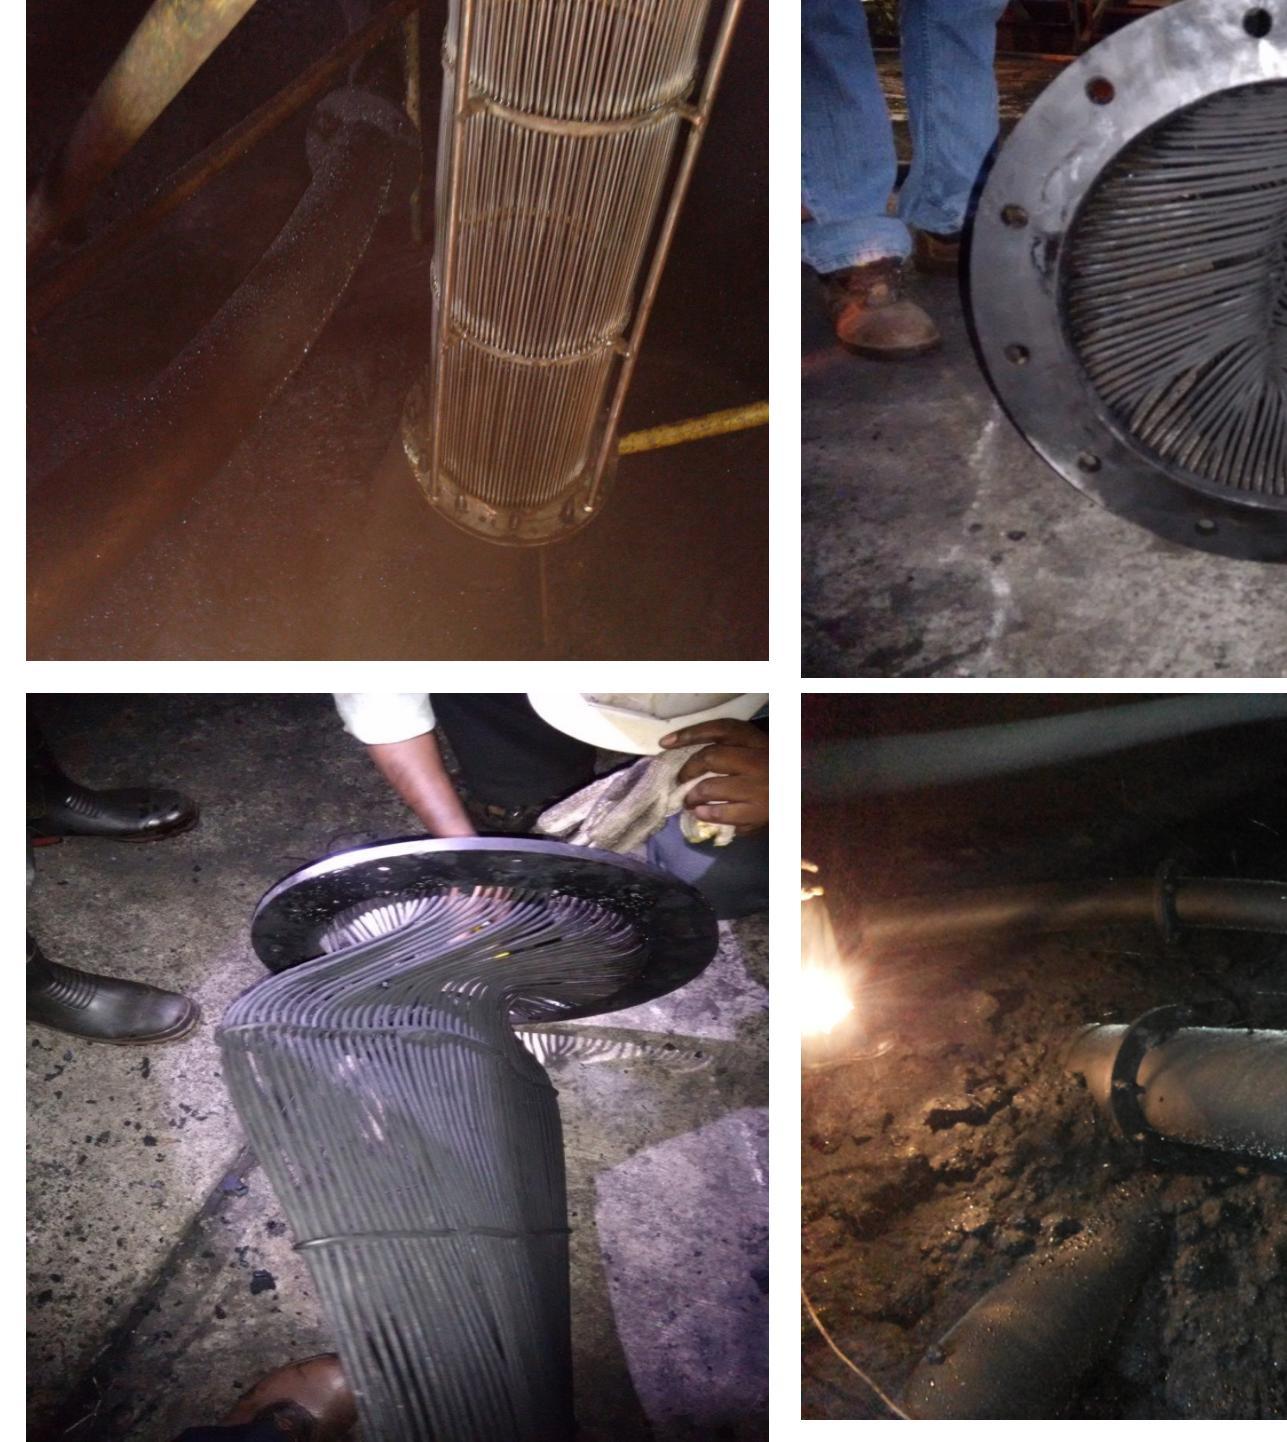
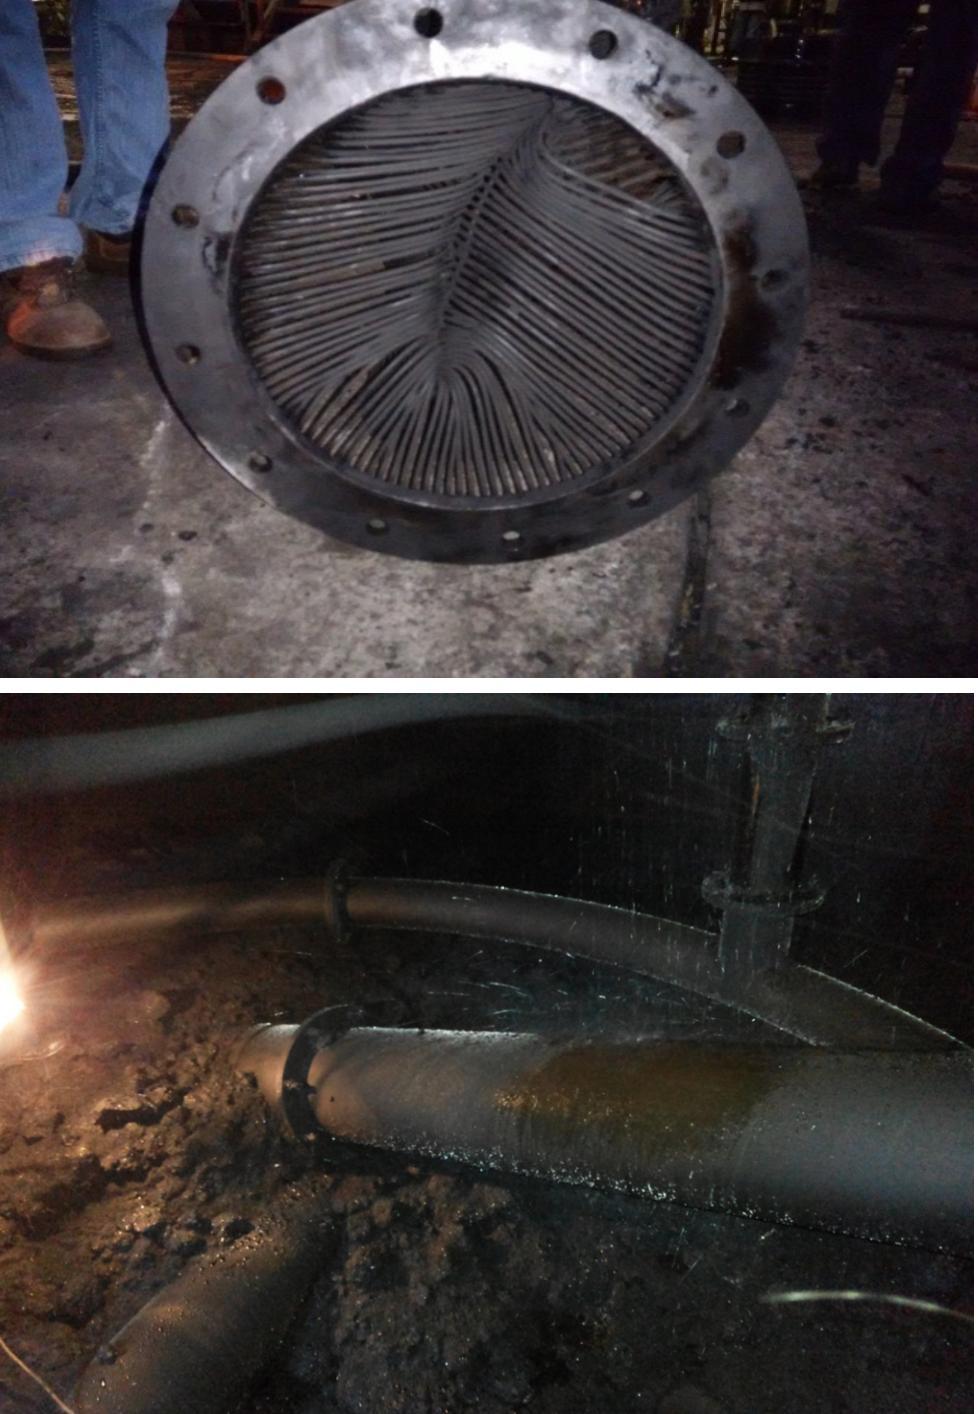
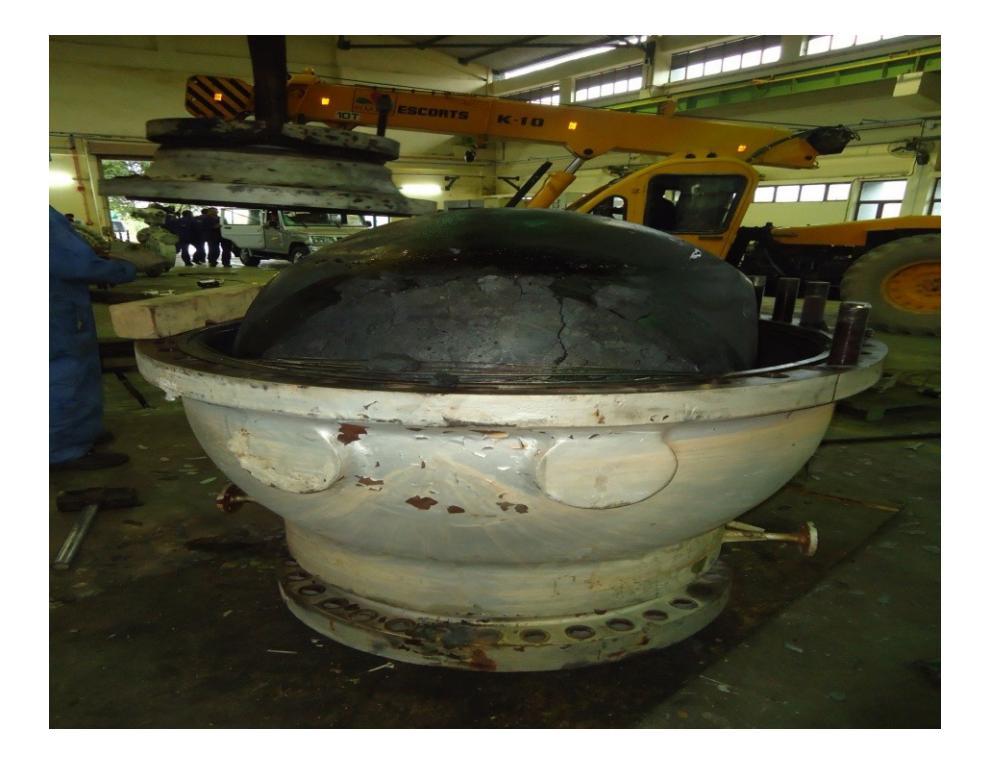
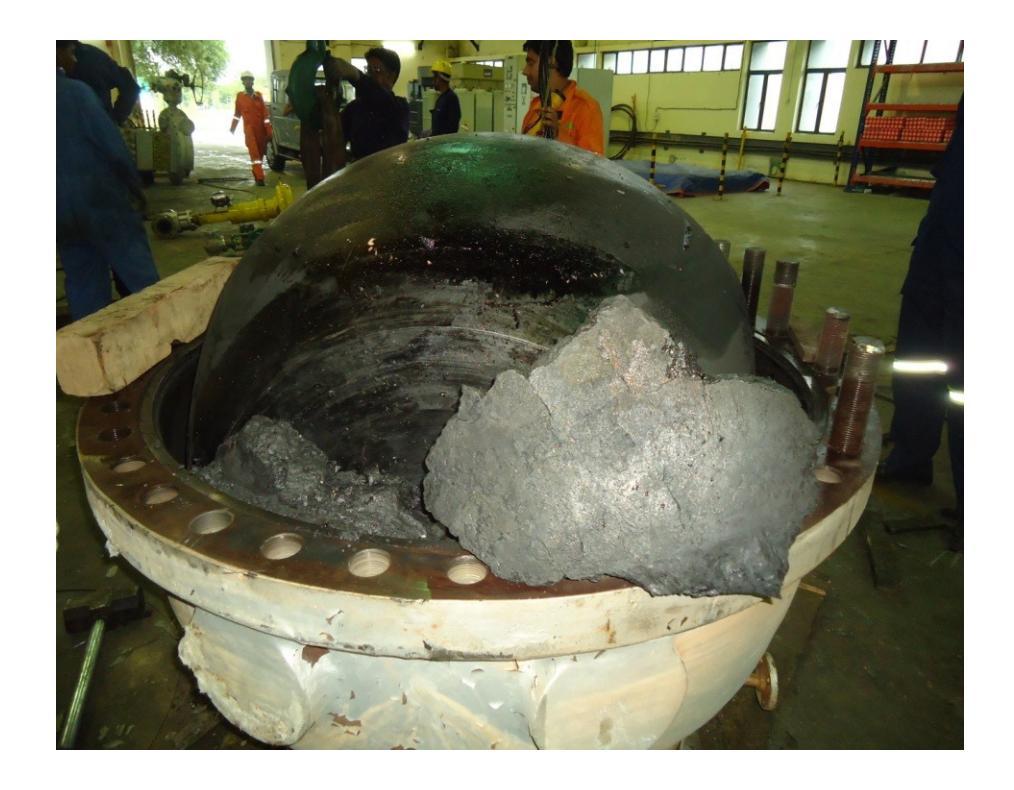
- 1. Bottom section of the coke catcher crippled and there was no gap for liquid to flow at the bottom of the catcher.
- 2. Down comer pipes were broken and fallen down.
- 3. The chimney tray below wash grid had refractory damage.
- 4. Recirculation pump suction and discharge observed to be clean and intact.
- 5. Both HCGO wash header flanges gasket damaged

- a. Higher viscosity and more coke bed height High coke carryover
- b. Antifoam dosing on time basis not on tendency of foaming
- c. VR from two wide range viscosity processed

- a. WGC surge while startup on 16<sup>th</sup> Jan leads to coke carry over to fractionator bottom.
- b. After plant startup frequent cleaning of charge pump suction strainer and tripping of heaters due to cavitation occurs.
- c. Coke catcher damage might initiated at this time.

- a. Feed interruption due to pump cavitation and localized heat flux leads to coke build up in heater coils
- b. Feed interruption leads to high skin temperature accelerate coke deposition in coils and shortening the run length of the heater

- 1. Suction strainer of both pumps cleaned.
- 2. Flushing oil at the pump suction line blinded.
- 3. Back flushing with flushing oil system done to dechoke strainer and coke catcher
- 4. Fractionator bottom feed quality checked and found normal
- 5. Heater charge pumps MCF control valves checked and found ok
- 6. Pump suction pressure checked and found abnormal (350 M3/hr-1.15Kg/cm2 and 522M3/hr 0.95Kg/cm2 versus design 522M3/hr 1.41Kg/cm2)
- 7. Shutdown initiated and fractionator opened for inspection
