aquilex welding services B.V.

Coke Drum Repair

October , 2011 Dusseldorf

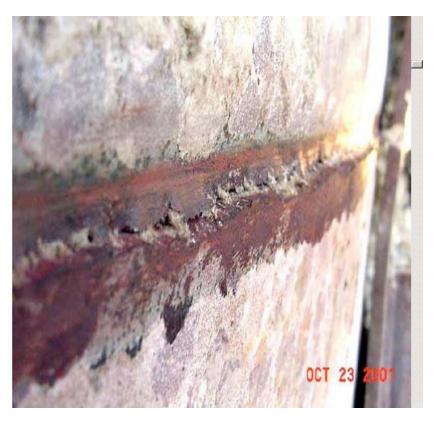
Typical Skirt Cracking

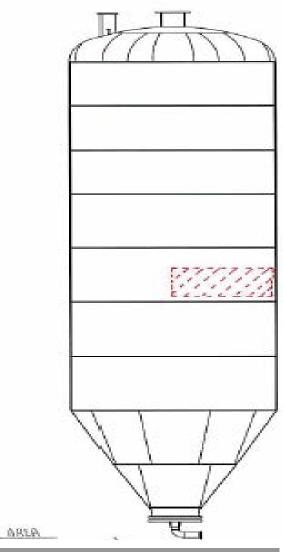
- 8 Coke Drums
- Material: SA 263 Grade C
- Wall Thickness: 22.3mm
- Diameter: Ranging from 7925mm to 9755mm.
- Height: Ranging from 20m to 29m
- One of the Cokers was experiencing excessive bulging due to fire in drum

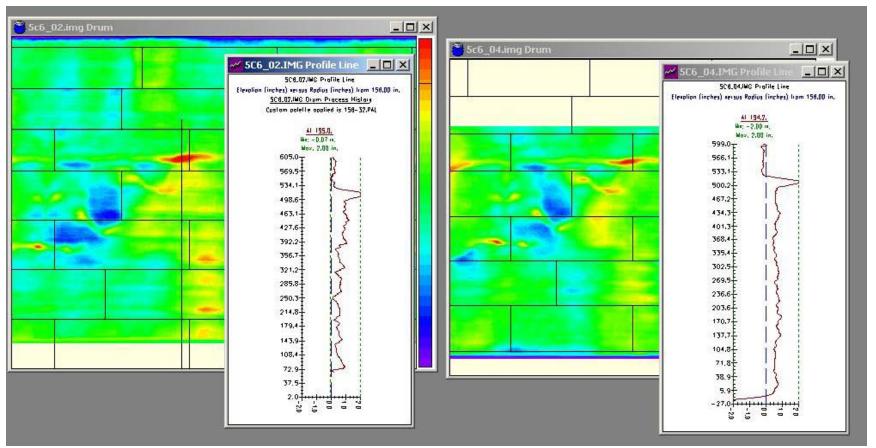
Of the eight drums reviewed, 1 Drum was identified with the most severe bulging at 2 Locations. We name them Bulge A & Bulge B.

Bulge Repair of Coke Drum Utilizing <u>Temperbead</u> Compare 2002 and 2004 Bulges

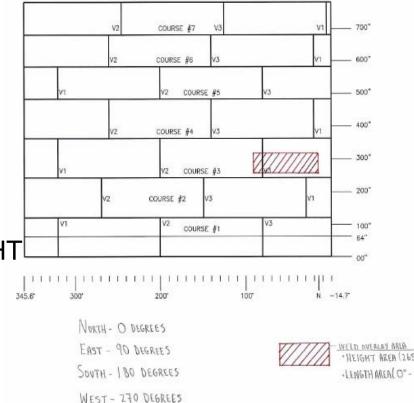
• Bulged area overlaid: 6.5m x 2m

- Applied Alloy 625, 9mm thick (2 layers), overlay utilizing temperbead utilizing (2) PLC controlled Unifuse Weld Systems
- •Temperbead eliminated the need for PWHT
- Post Soak of 450° F(233C) for 2 hours to eliminate any potential for hydrogen cracking

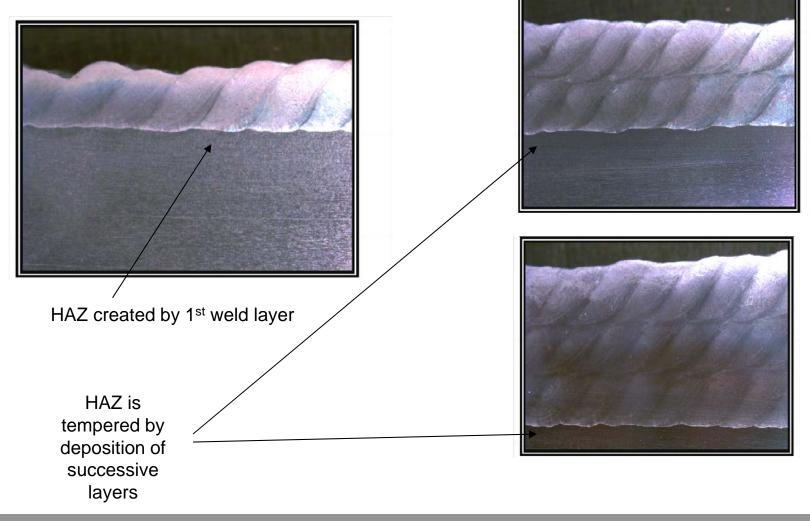
Temperbead Welding

- Assessment by Stress Engineering quantified remaining life of bulge, and validated overlay process
- Overlay extended life of drum (bulged area) by 3X
- Unifuse® Overlay controls enabled temperbead application and increased productivity

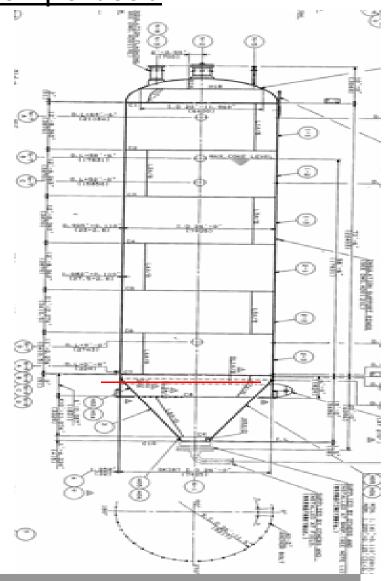
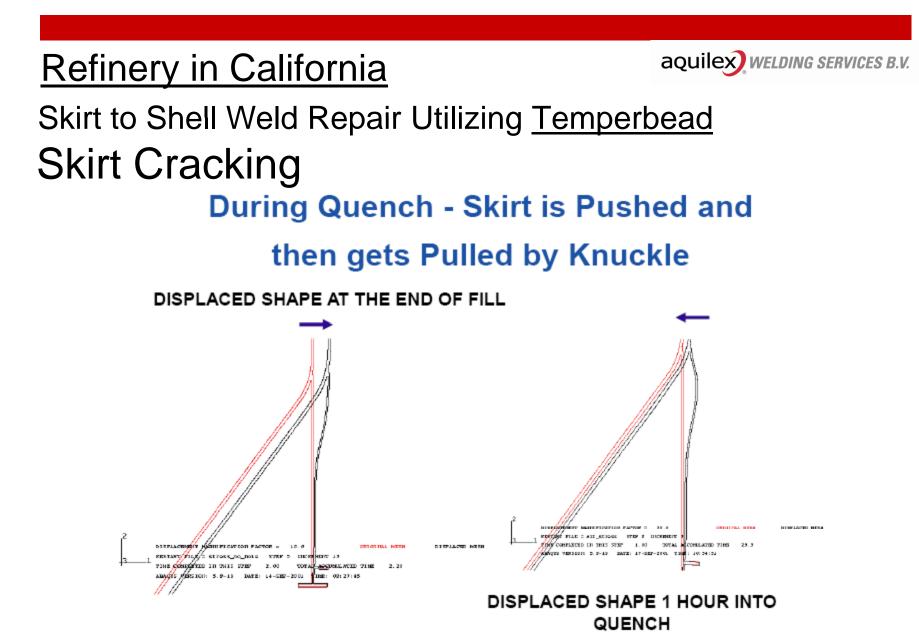
- 2 Coke Drums
- Tower details:
 - SA-387-Grade 11 material
 - 31.7m tall
 - 8m ID
 - Original wall thickness 31.75mm
- Turnaround inspection:
 - 2003 T/A repaired weld seams in Coker # 2
 - May 2006 found many indications approximately 5mm deep, 25mm long, throughout the entire circumference of the weld seam in both drums

(MAXIMUM STRESS DURING QUENCH OCCURS HERE)

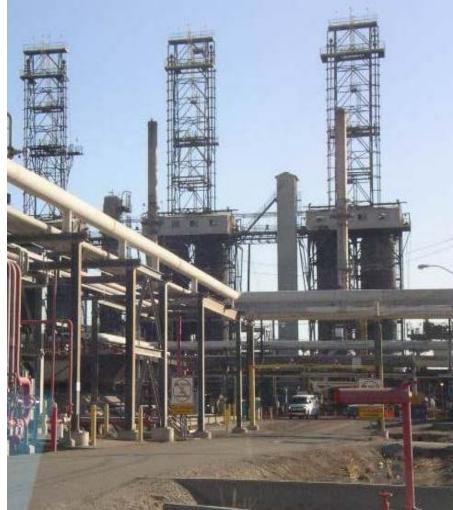
- 12 Drums
- Material: SA 387-12-CL2
- Drum Thickness: 1.377"
- Height: 90' Tan Tan
- Diameter:18'5" ID
- Customer was experiencing cracking below skirt to shell weld. Changed the skirt design (key hole slot) to reduce stress on skirt to shell weld.
