Coke Drum Repair

Coker Weld Overlay Project

Bulge Repair of Coke Drum Utilizing Temperbead

Skirt to Shell Weld Repair with Temperbead Process

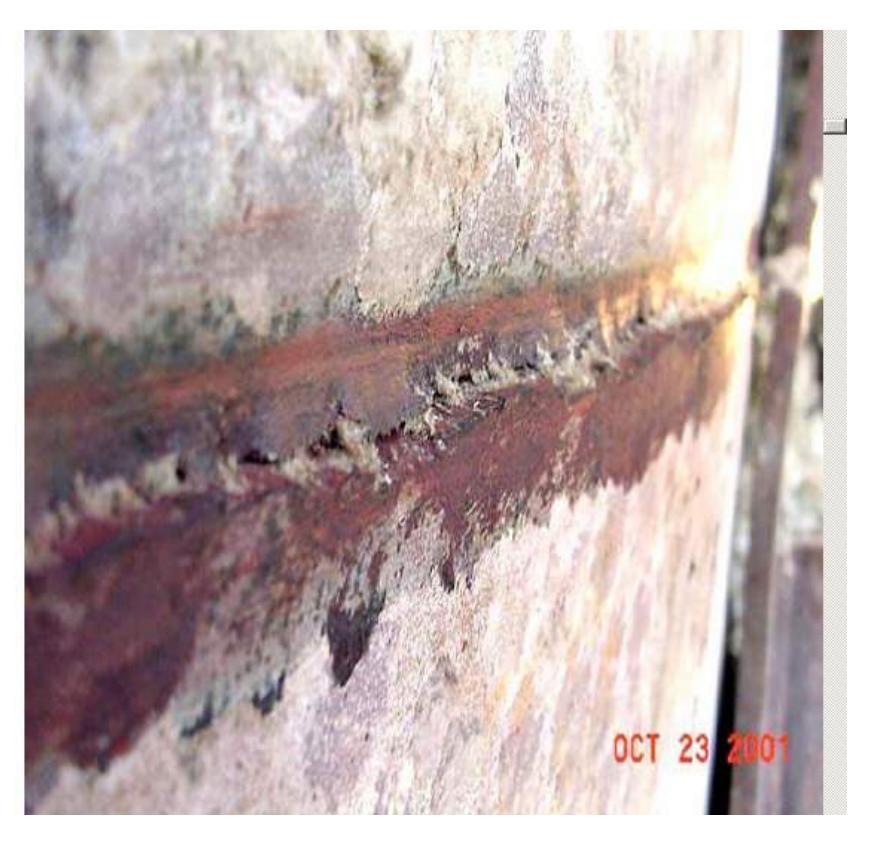
Many skirts are cracking within 5 years of operation

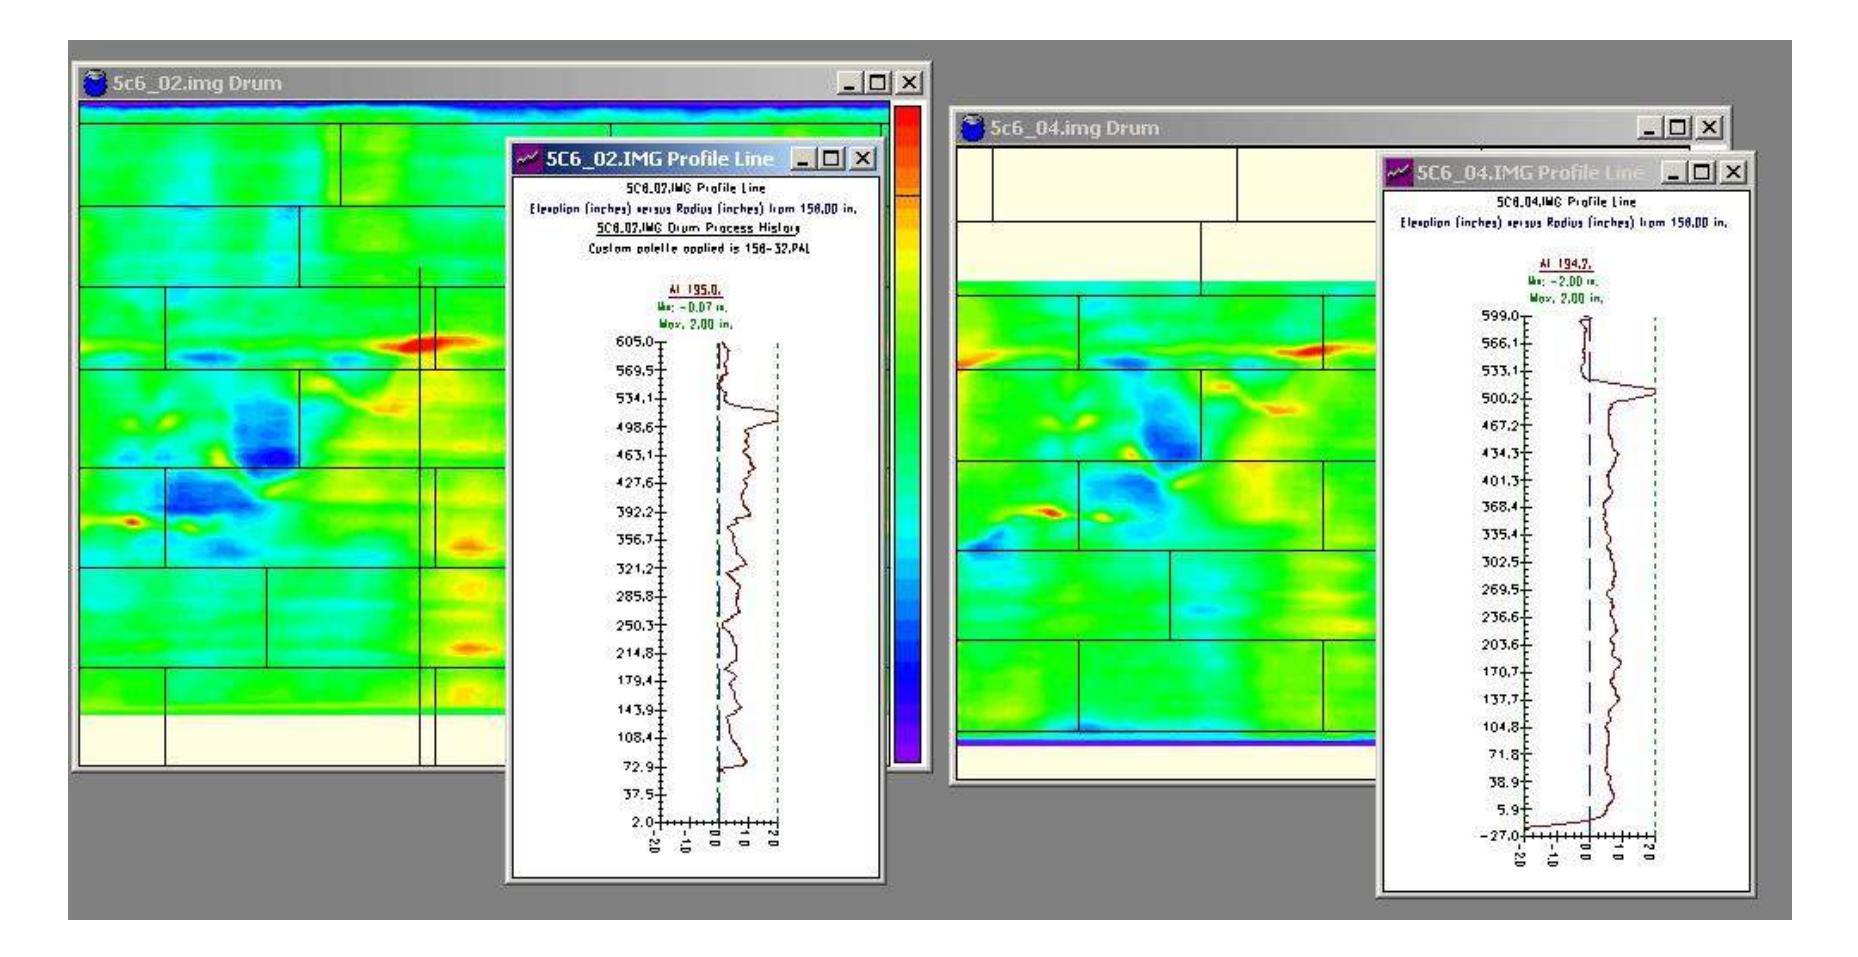
Compare 2002 and 2004 Bulges

Of the eight drums reviewed, 1 Drum was identified with the most severe bulging at 2 Locations. We name them Bulge A & Bulge B.

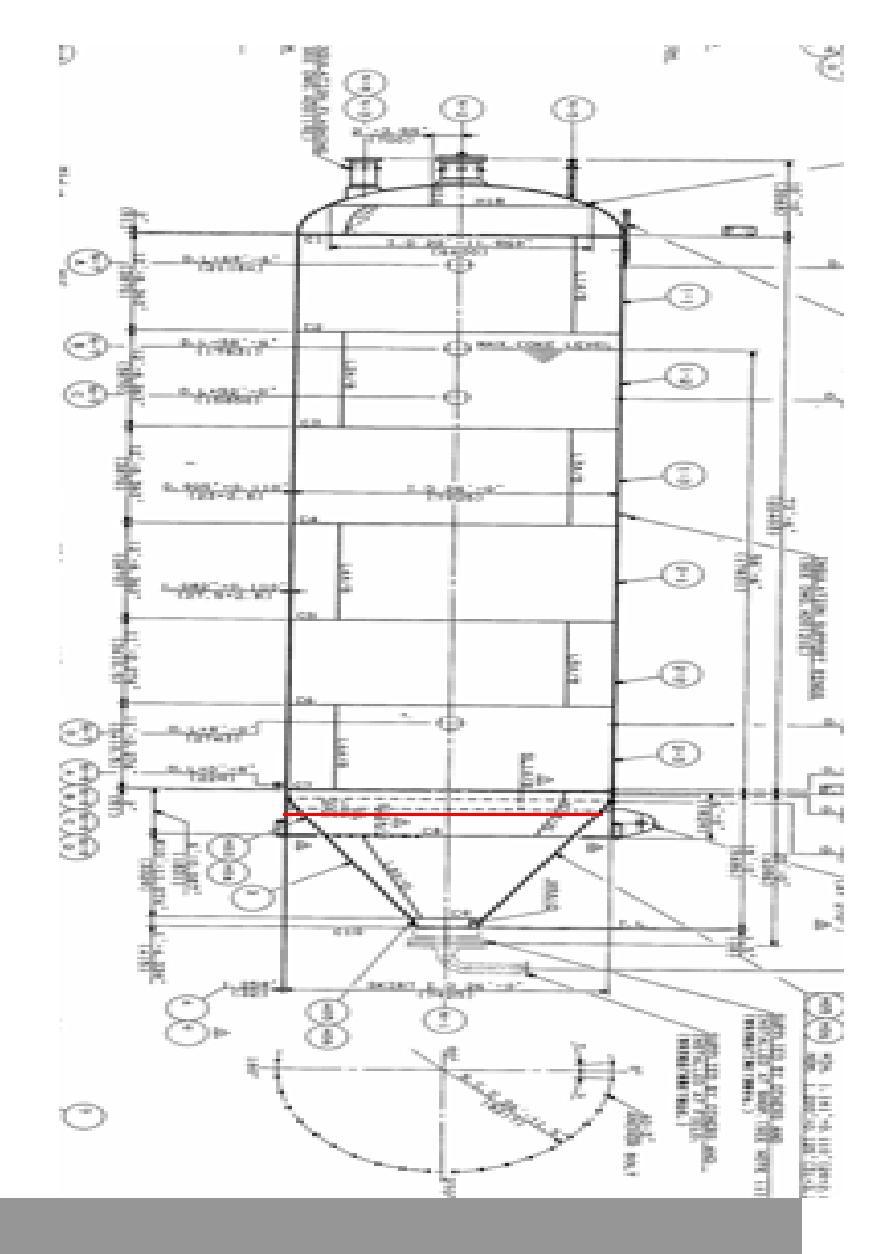
- 2 Coke Drums
- Tower details:
 - SA-387-Grade 11 material
 - 31.7m tall
 - 8m ID
 - Original wall thickness 31.75mm
- Turnaround inspection:
 - 2003 T/A repaired weld seams in Coker # 2
 - May 2006 found many indications approximately 5mm deep, 25mm long, throughout the entire circumference of the weld seam in both drums

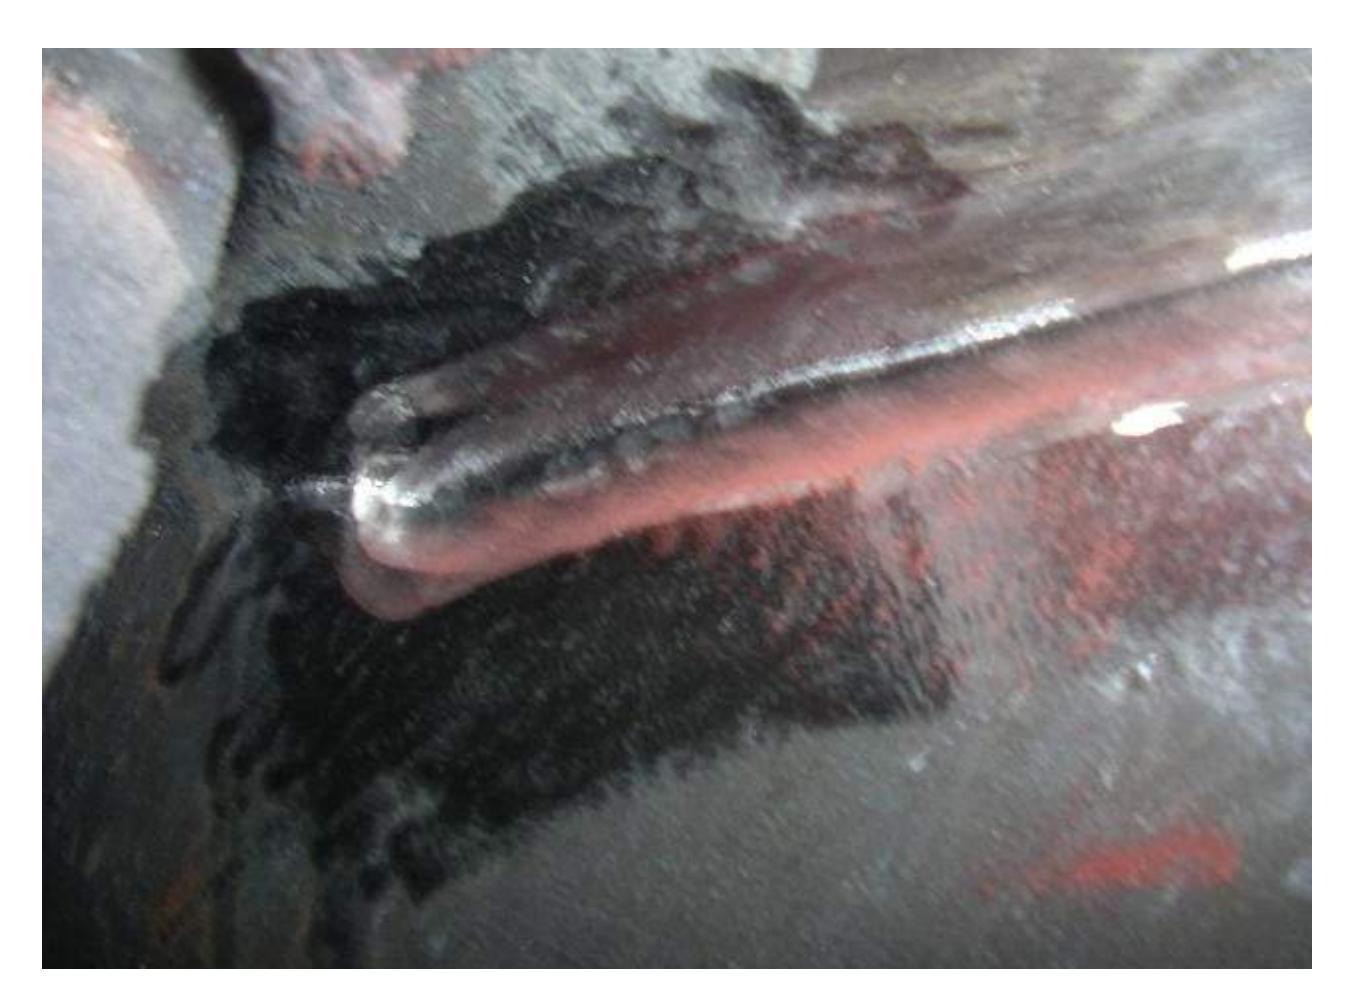
Shell Crack Removal

- The crack was excavated with the carbon arc gouge process.
- The cracks ranged in depth from approximately 0.188" to 0.75"
- The cracks were removed to a minimum of 0.380" to ensure an acceptable weld repair geometry.
- If the crack still existed at 0.380" then more excavation was done.
- MT was performed to ensure cracks removed
