Coker Vessel Life Extension Repair Implementation

Structural Overlay Life Extension & Skirt Cracking Repair of Delayed Coking Unit Vessels

Refinery Located in Minas Gerais, Brasil 24,000 bpd coking unit (4 coke drums designated as A,B,C & D)

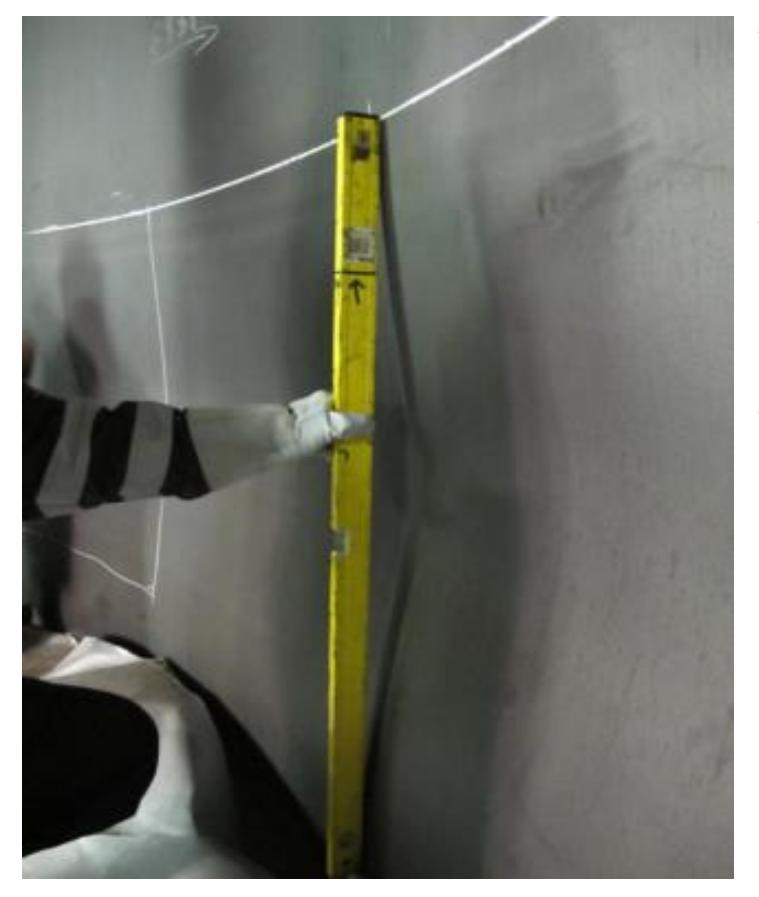
Typical Shell Bulging Example

Bulged Area in Coke Drum

- Common Condition in DCU Vessels
- Associated with low cycle fatigue
- Conventional repair methods have not performed well historically
 - Section Replacement
 - Window replacement

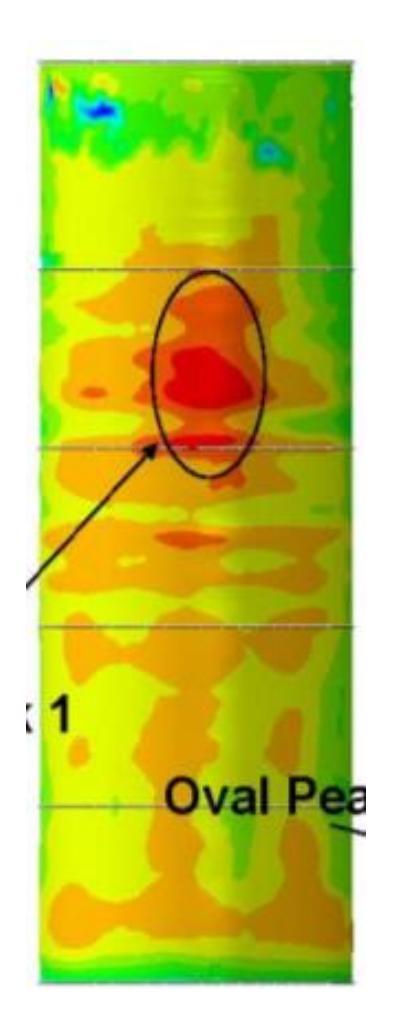
Typical Laser Mapping Data

120° (SE)

With the Laser Mapping Information and the detailed operating parameters of the vessel, a structural overlay can be designed to significantly modify the structure of the vessel in the affected area to significantly increase fatigue life.

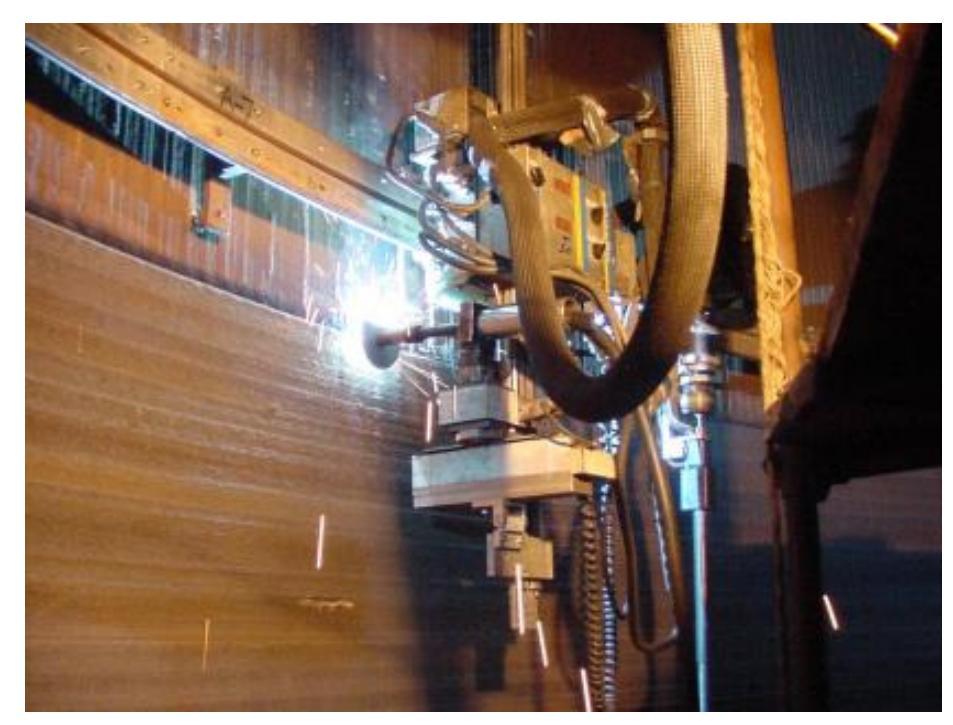
Automated Welding System Applying Inconel 625 in Pressure Vessel
