# Repair and Retrofit of a Coke Drum Skirt Attachment Weld

Coking.com Meeting Fort McMurray, Alberta, Canada October 2012

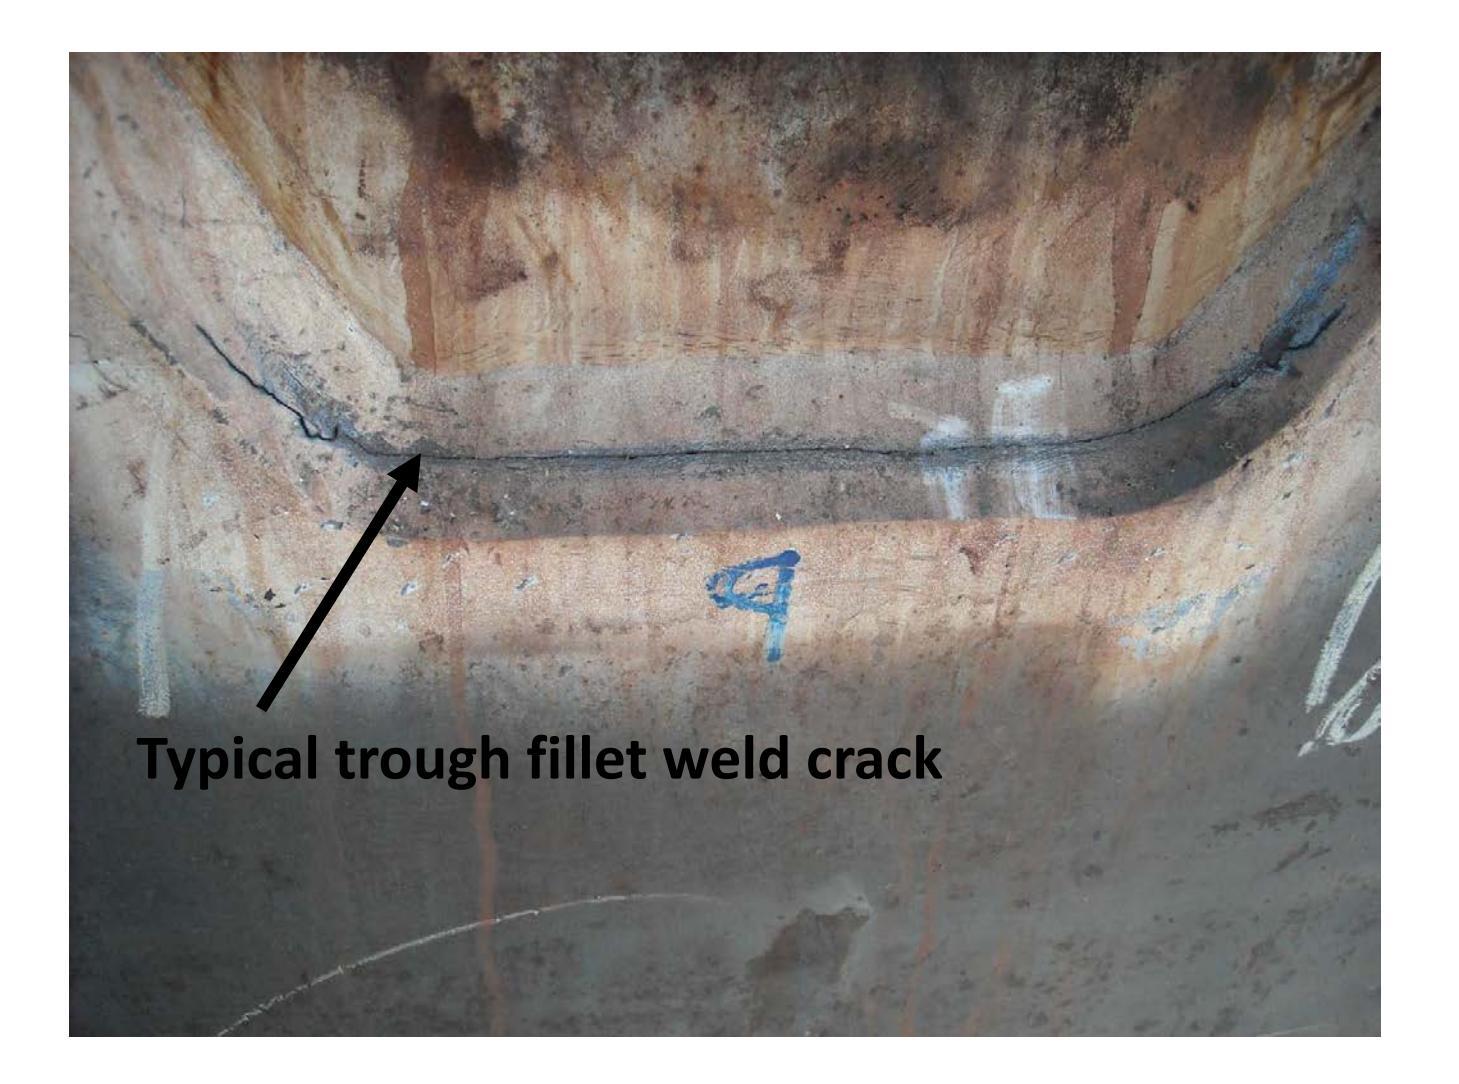
#### **Trough Cracks**

- Through the throat of the trough fillet welds.

Trough cracks were in the fillet weld throat. Cracks which did not extend through the full weld thickness appeared to originate at the weld root.

- Install sliding brackets for load transfer
- Allow through-throat cracks in scallop troughs to continue to propagate
- Manage crack propagation at scallop peaks by crack removal and addition of planned notches

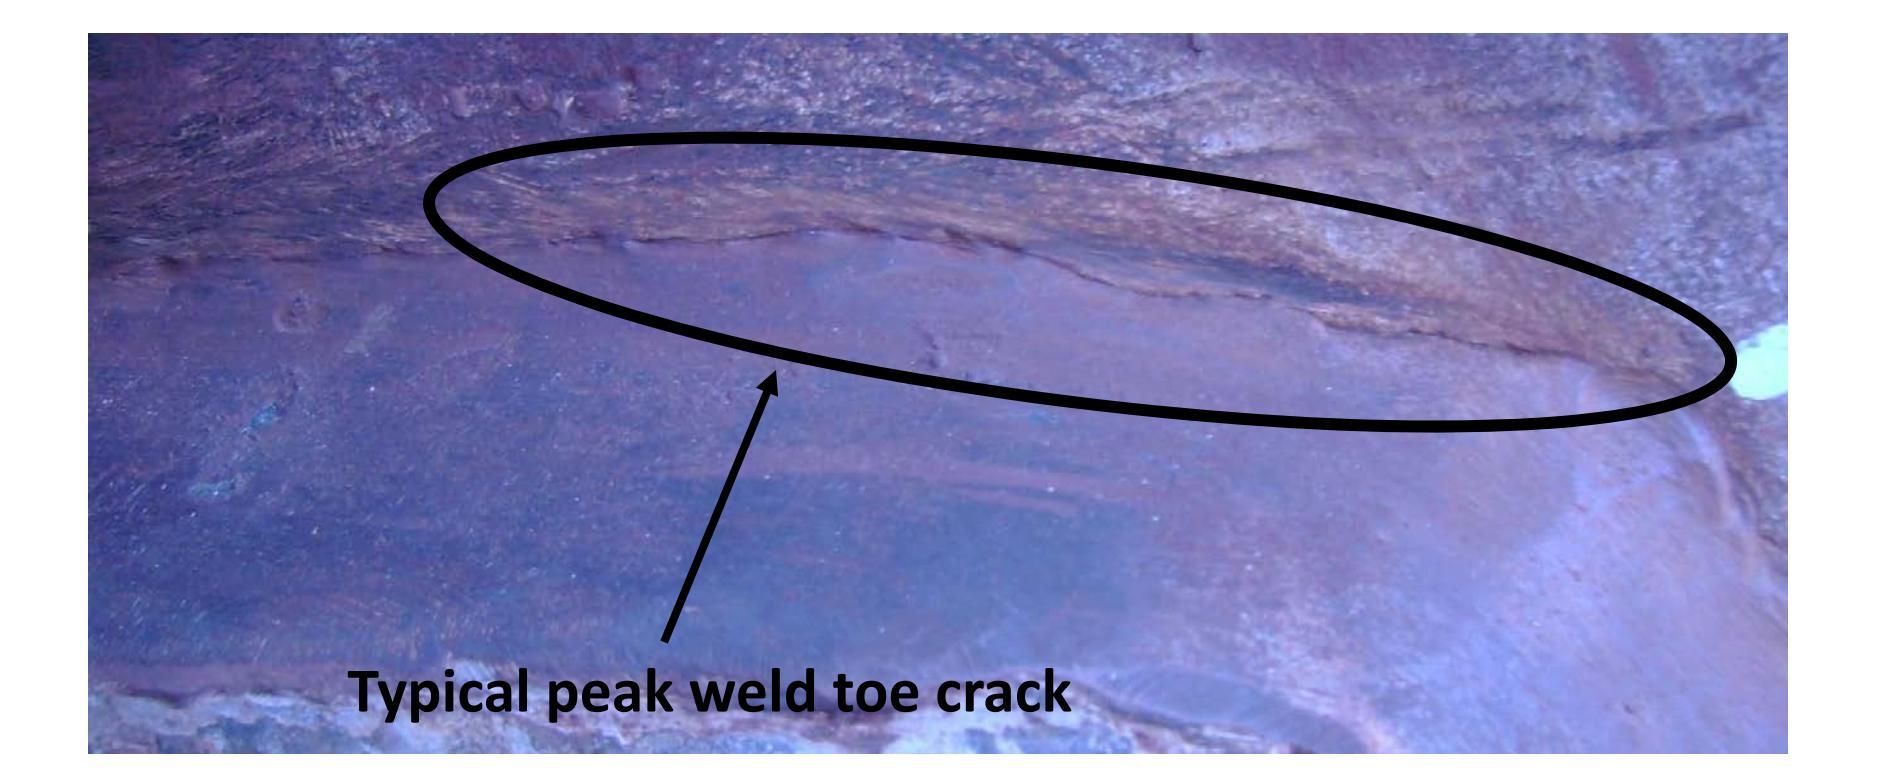
#### Peak Cracks

- Routine skirt attachment inspection scheduled prior to the Fall 2011 Turnaround
- Inspection was completed in June while the drums were in operation
- Extensive cracking noted during the inspection extending nearly full circumference of both drums
- Cracks were sized with dry, color contrast, MT and depths determined using UTPA
- The attachment weld was primarily cracked in two areas:
  - In the shell at the skirt attachment crown.

Peak cracks were at the toe of the fillet weld and in the base metal. Cracks were determined to be less than 0.10" deep.

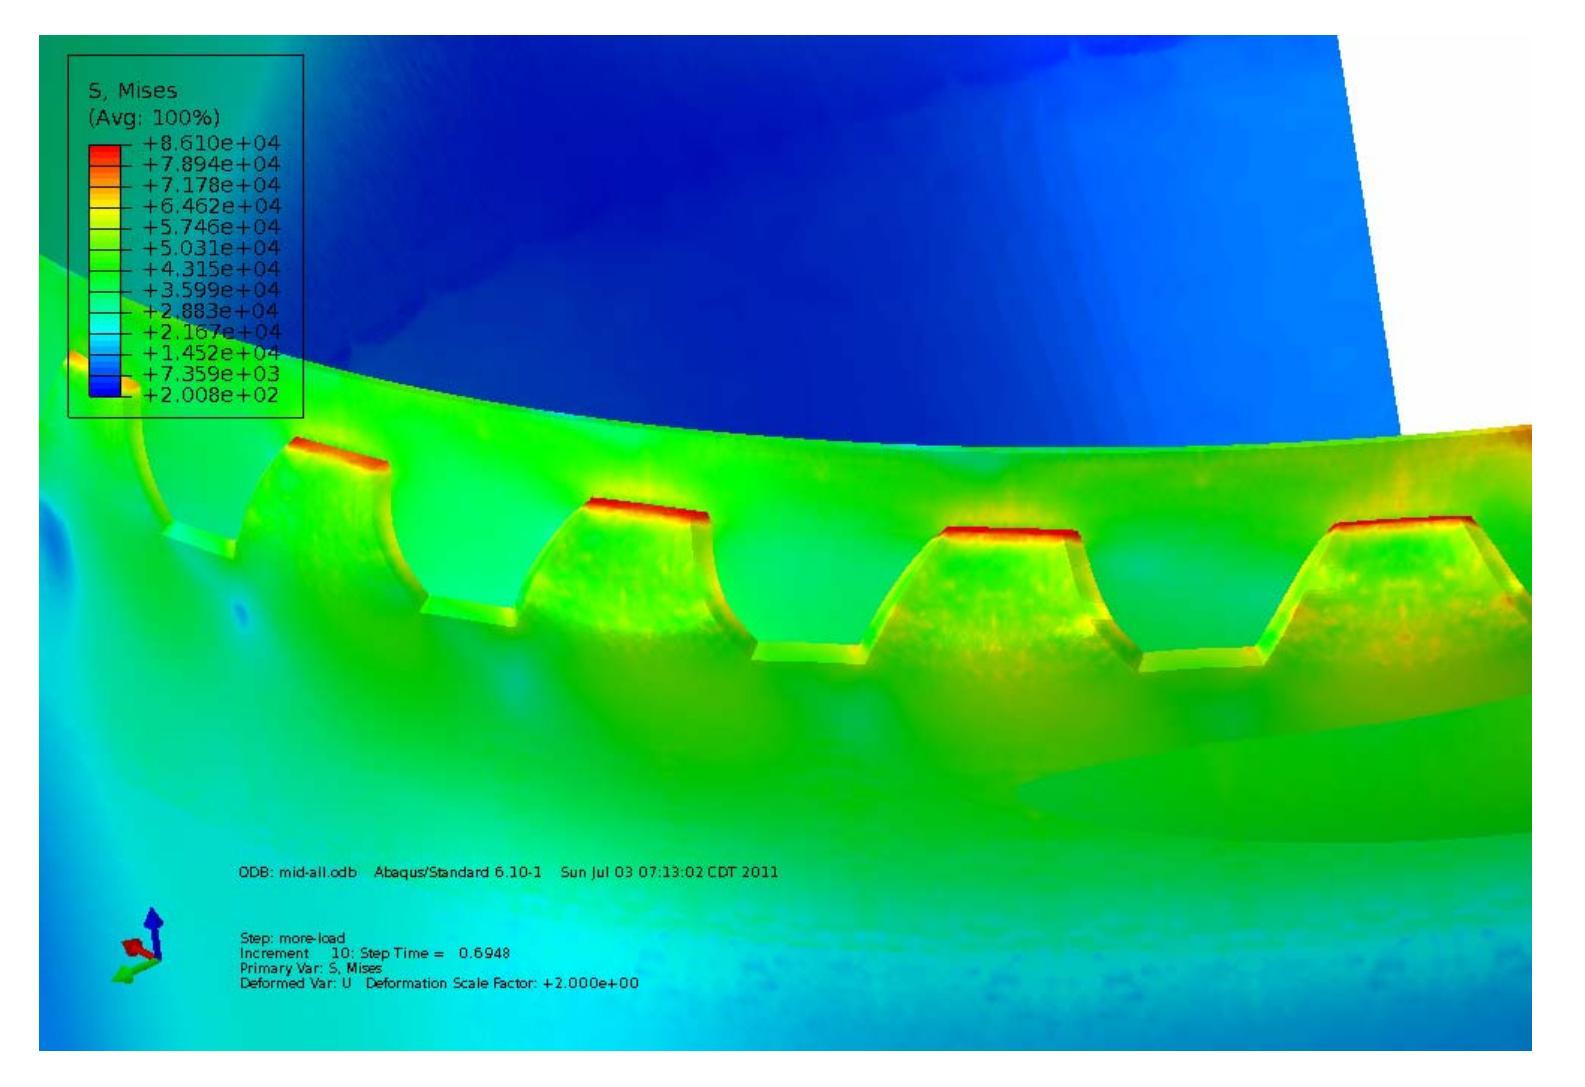
#### Von Mises Stress @ Collapse (Case 4)

- For the longest crack of 37.05", the minimum load multiplier was 1.23. This means that the remaining ligament of the weld (half of the top weld attachment) had 23% more strength than that required by API-579/ ASME-FFS.
- The combination of drum weight and filling temperature profile was the worst load case.
- Skirt should remain stable with sufficient margin as long as one half of the peak of the scallop remains intact.
- In lieu of complex fracture mechanics study, frequent inspections used to monitor crack propagation until TA.
