Addressing Increased Fouling Rates in Delayed Coker Heaters – A Case Study Identifying the Factors Behind the Increased Fouling Rates

Michael R. Kimbrell, P.E. 2019 Refcomm Galveston

Delayed Coker Heater fouling

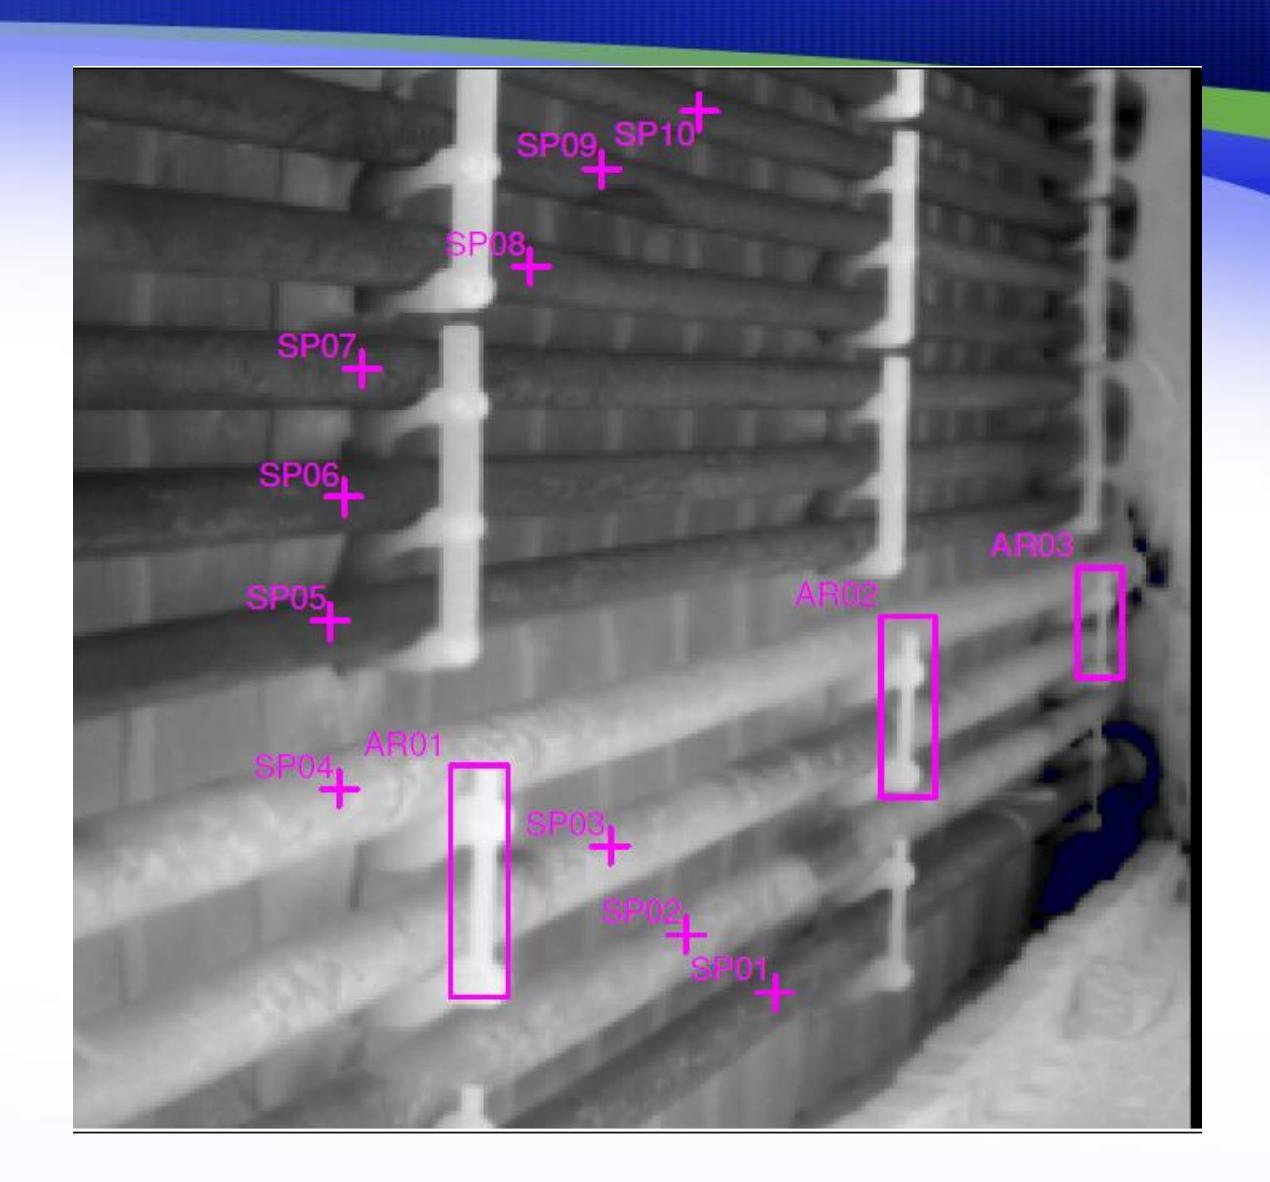
Typical thermal scan result

- Bottom four tubes are hotter than the other tubes in the heater
- Tube hangers are all about the same temperature.
- No obvious hot spots on the refractory which would indicate a non-uniform heat flux
- Concluded that problem was not fire side related

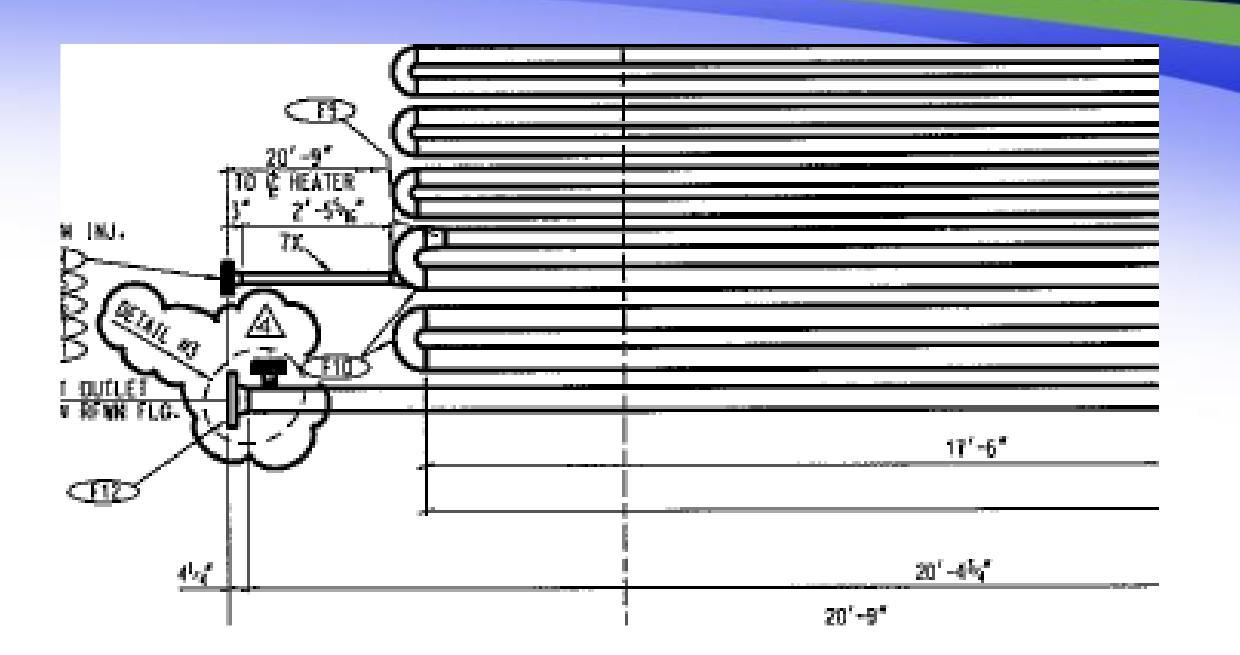
Coil configuration

- Each pass had the tube diameter increase for the last four tubes to reduce the pressure drop through the coil
- Existing heater coil had the ability to add velocity steam to the first of the larger diameter tubes.
- No velocity steam had been connected to this injection point since initial construction

- Site implemented crude oil testing to manage compatibility
- Velocity steam was added to first of the large diameter tubes on each pass
- These modifications have been in place since Jan 2019 with good results

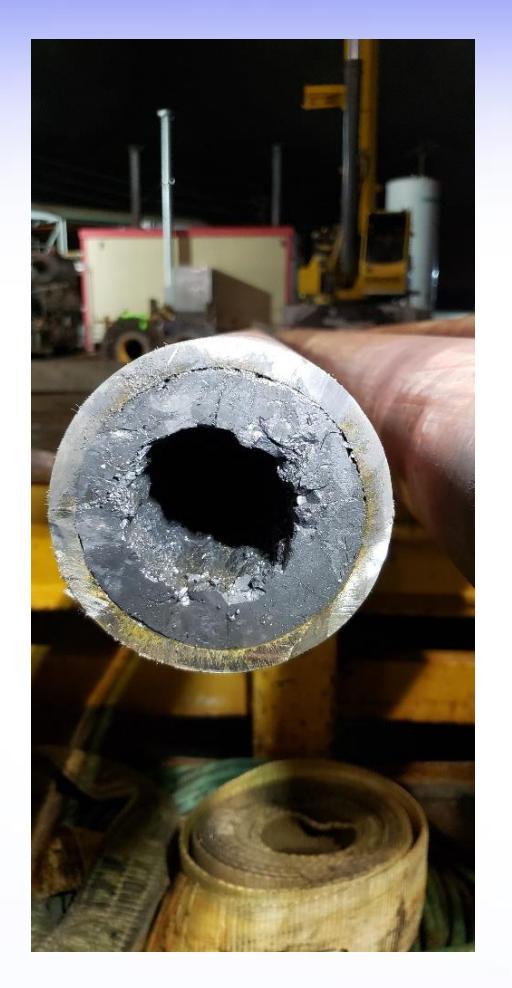
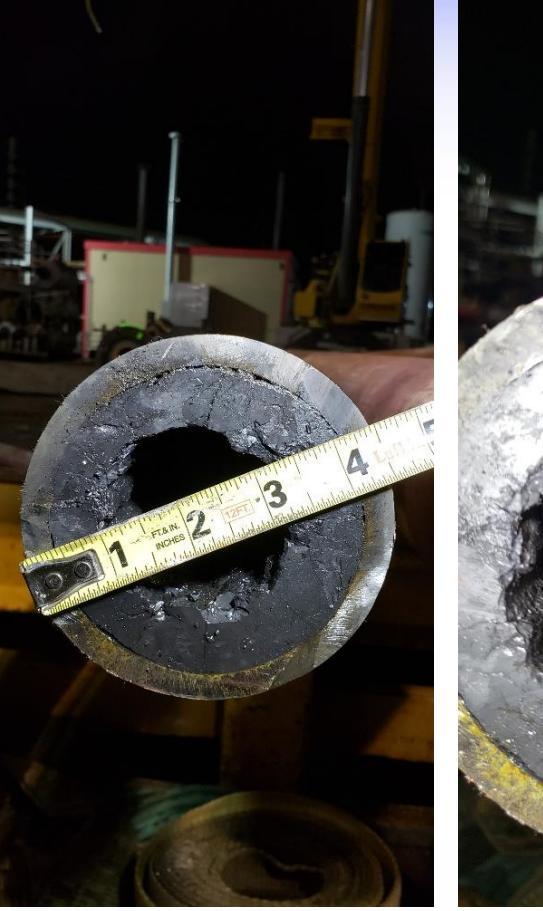
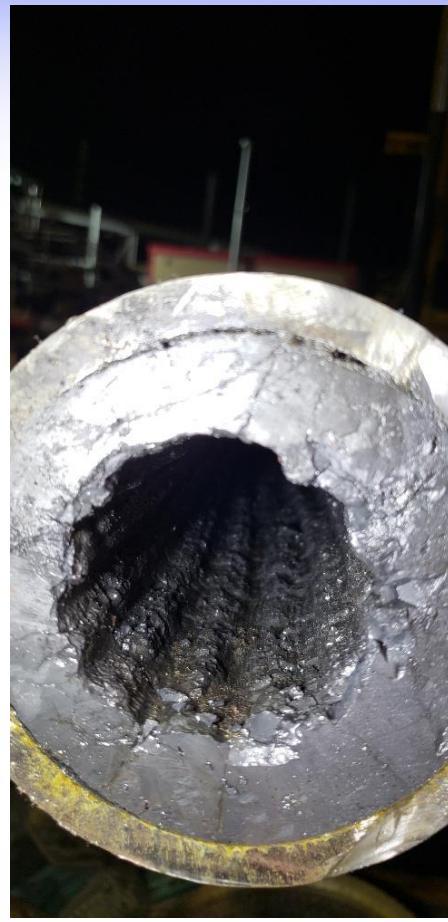
Coke properties

- Coke was extremely hard, dense, non-porous
- Larger tubes were cut out and replaced as replacing was faster than pigging due to the coke hardness
- Coke analysis showed extremely high concentrations of iron, calcium, sodium
- During low fouling rates the iron, calcium and sodium concentrations in coke are still high.
- Sodium in VTB is less than 15 ppm typically with occasional peaks to 30 ppm.
