#### **DCU Support Skirt Repair & Life Extension**

Pedro Amador – VP, Business Development & Technology – AZZ Yelena Rojas Yoris – Director, Business Development & Technology – AZZ B.V.

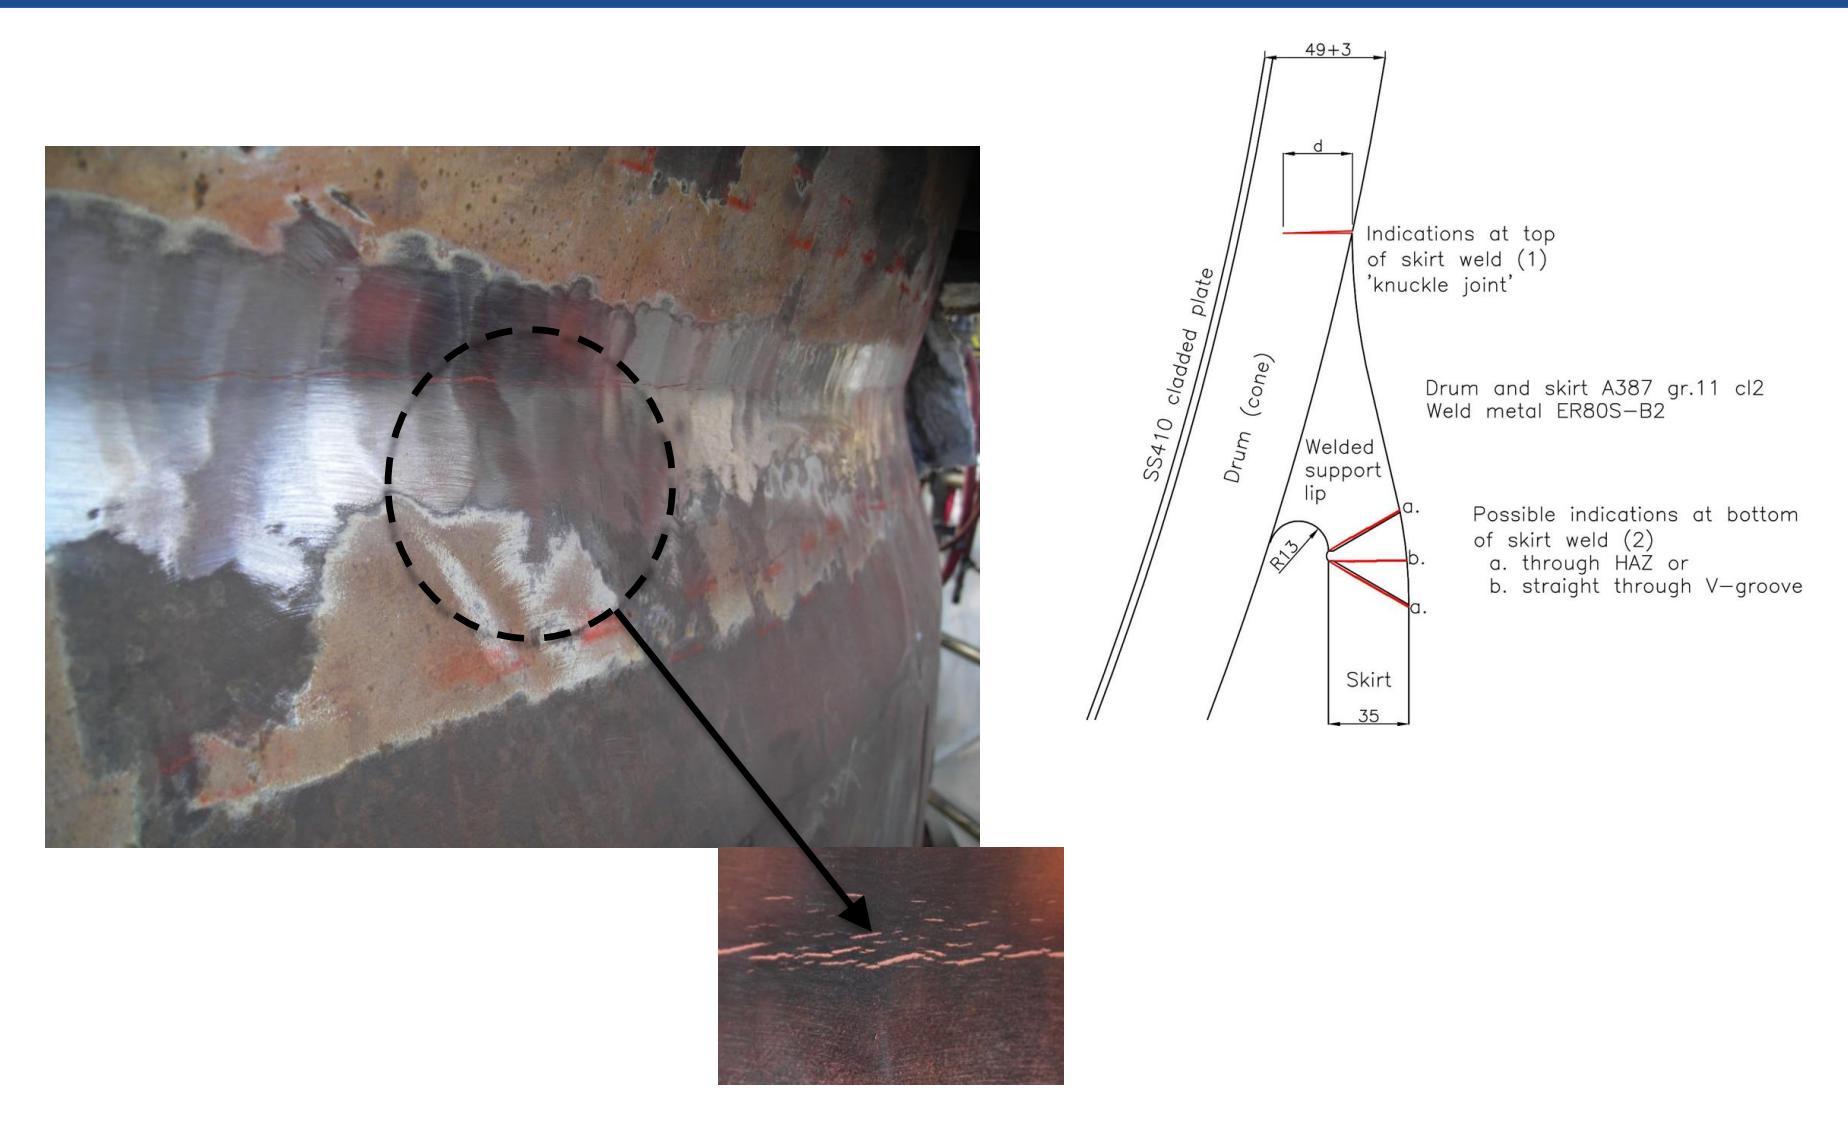
#### Indications at the Upper Knuckle Weld

**Common Upper Knuckle Cracking**

- 1. Excavate to remove cracks & previous repairs
- 2. Utilize temper bead technique to eliminate PWHT
- 3. Re-contour geometry to minimize stress concentrations

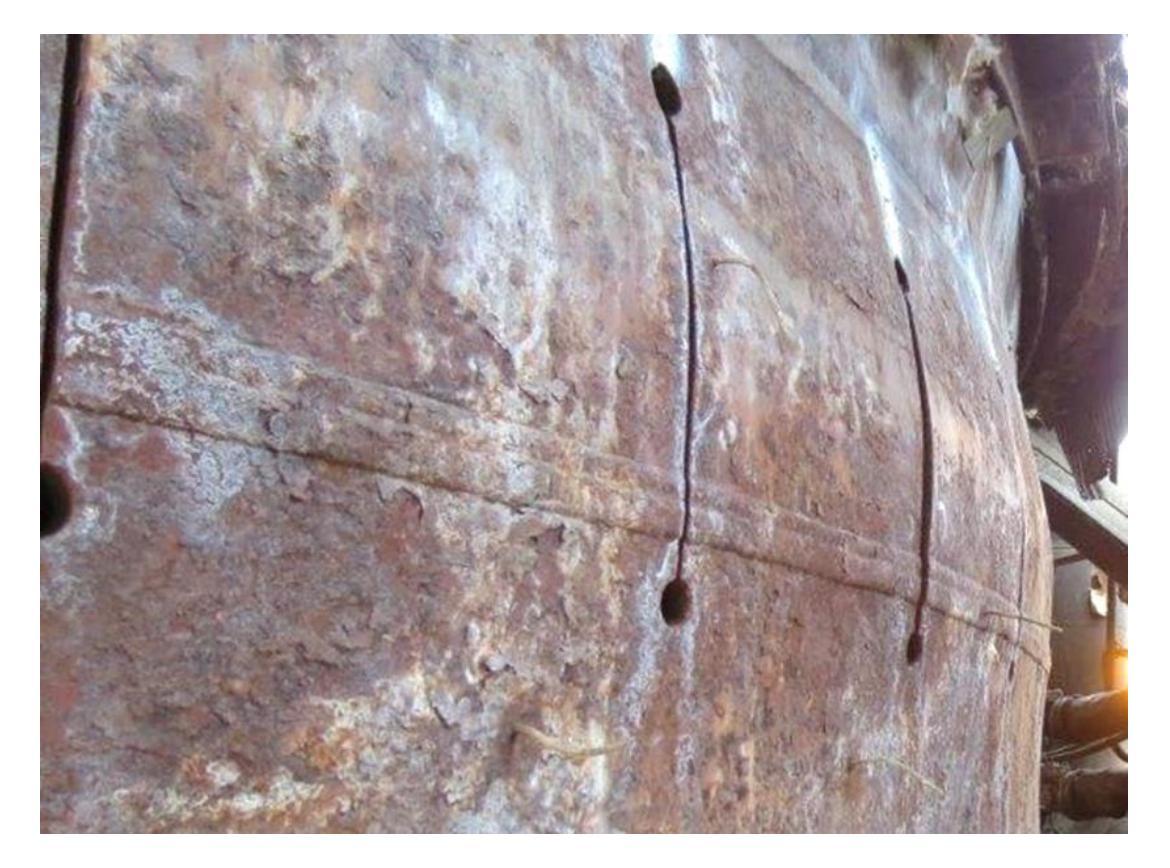
**Skirt Bulging**

Replacement in Progress

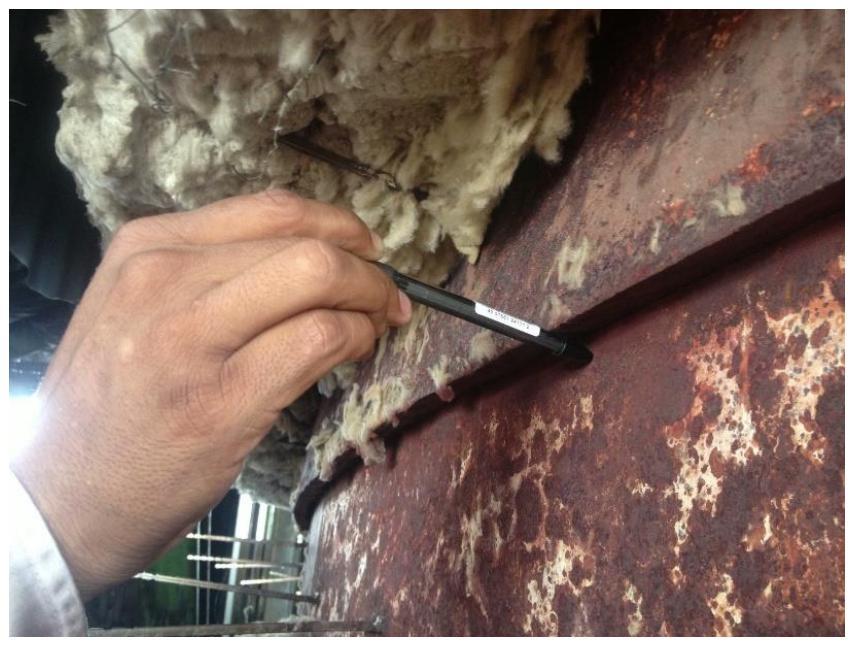
**Through Wall Groove Weld Cracking**

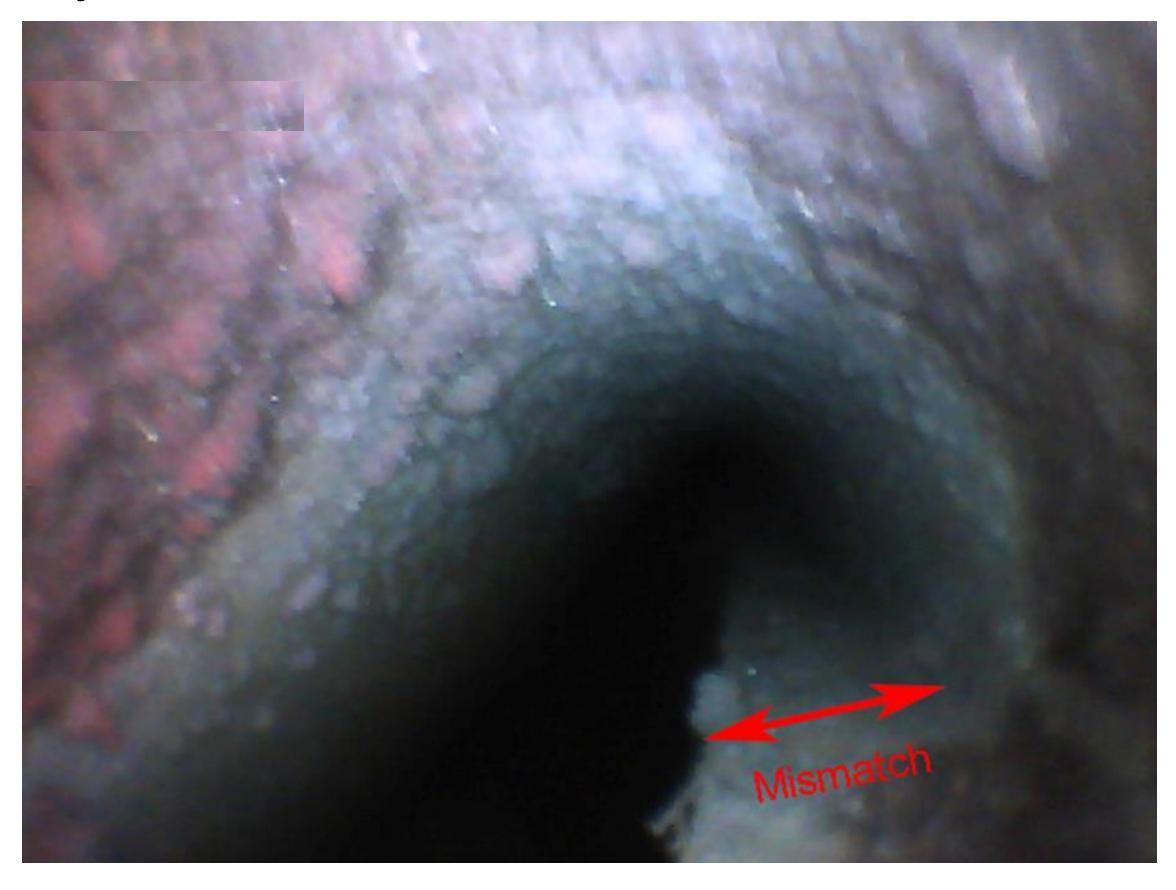
- It is common to encounter previous repairs in this location
- These repairs sometimes leave significant root misalignment
- The resulting root geometry can magnify stresses and shortens time to new crack incubation

**Groove Weld Root Misalignment**
