Case History: Sudden Drop and Tilt of an Operating Coke Drum

Dave Dewees PE Bobby Wright PE

THE WORLD'S PREMIERE DELAYED COKING CONFERENCE REFEONING GLOBAL Virtual Conference 2020

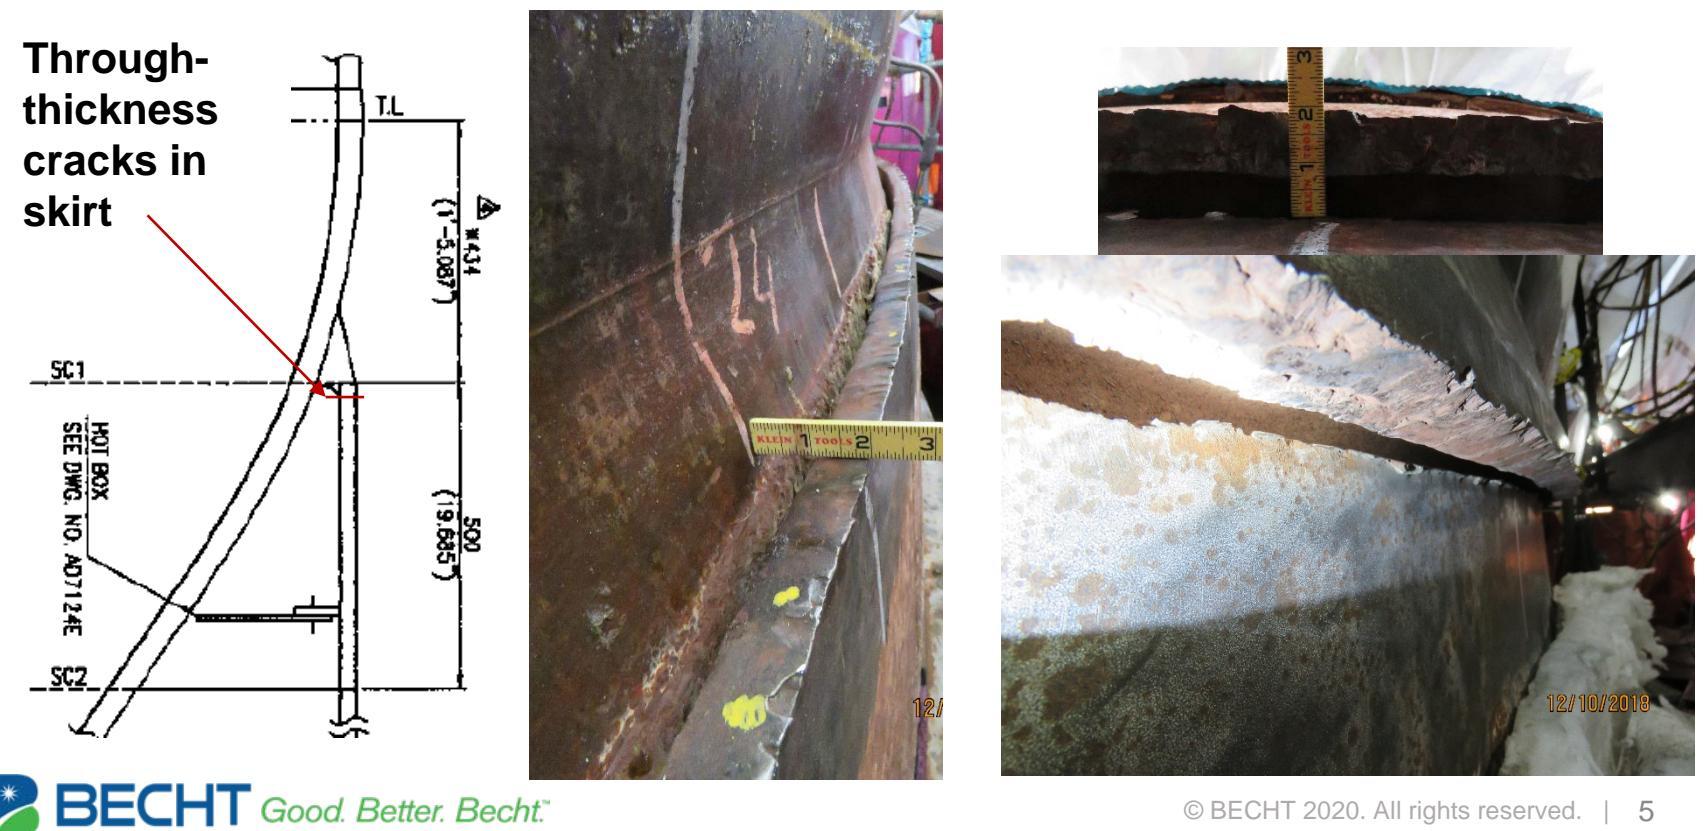
Condition Description

- When insulation removed found that skirt was fractured through thickness essentially all the way around
- Drum/upper skirt had dropped inside lower skirt on one side and lifted off on other
- Other 3 drums found to have same (non-displaced) cracking pattern, but not yet through-thickness all the way around

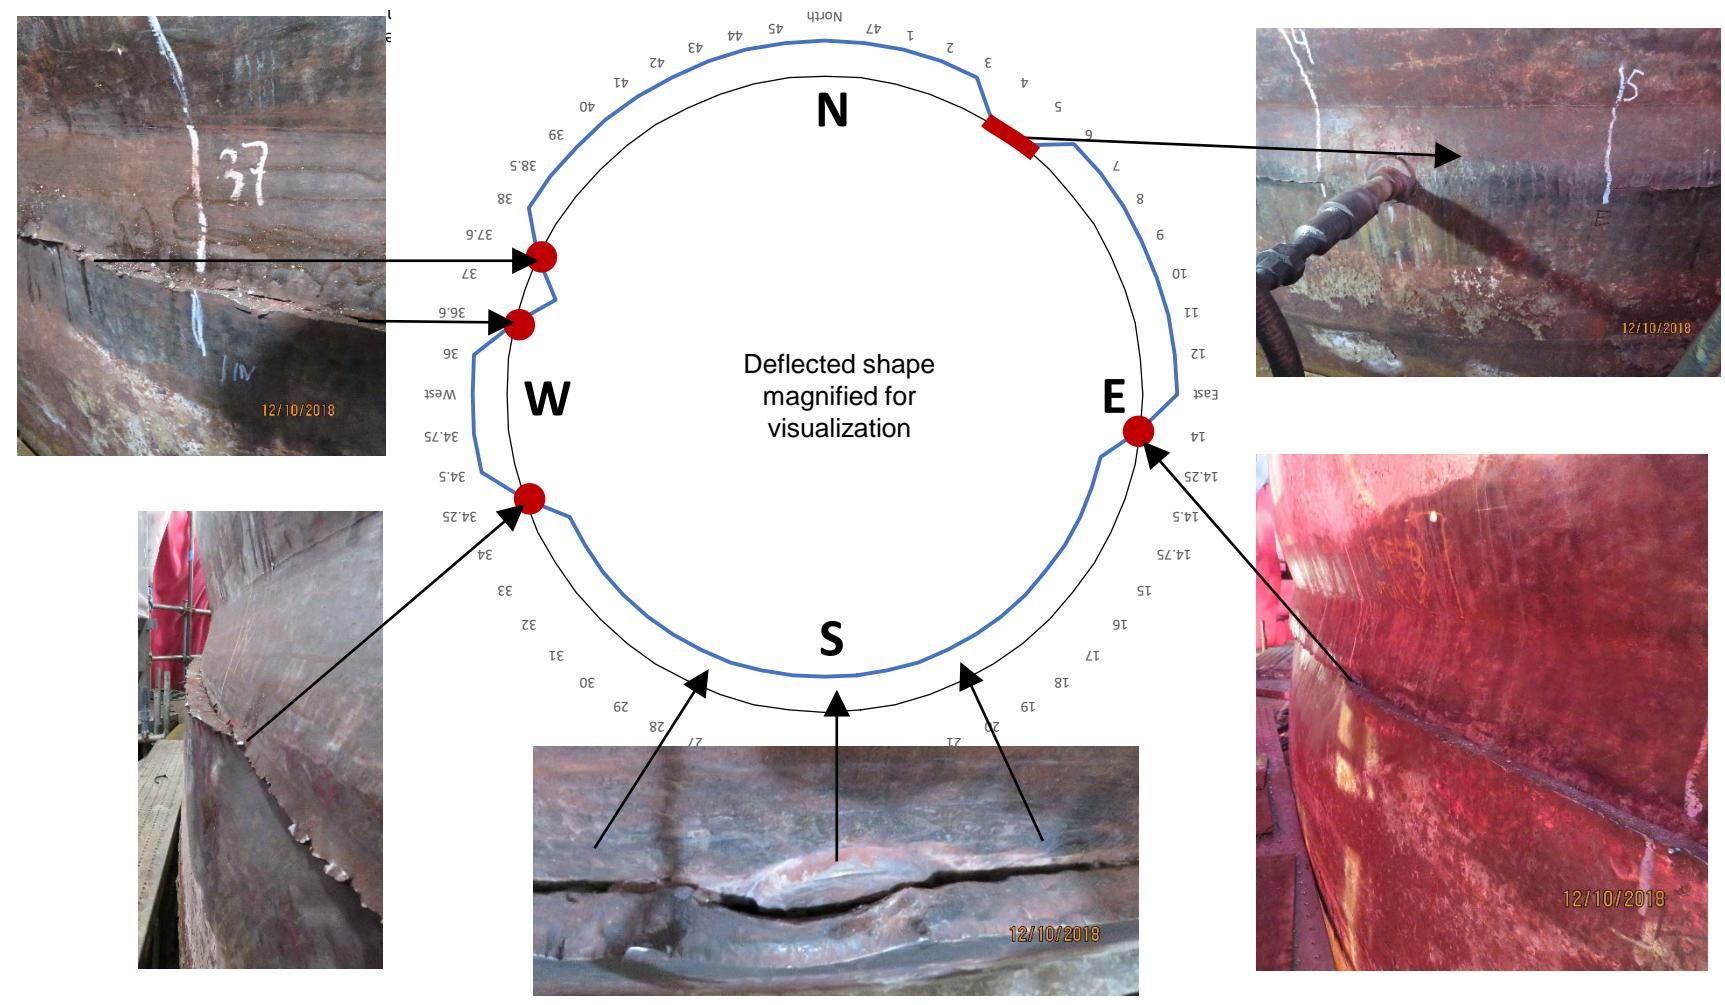
Skirt Condition

- No contact with (or support from) surrounding structure
- Minimal support from attached piping

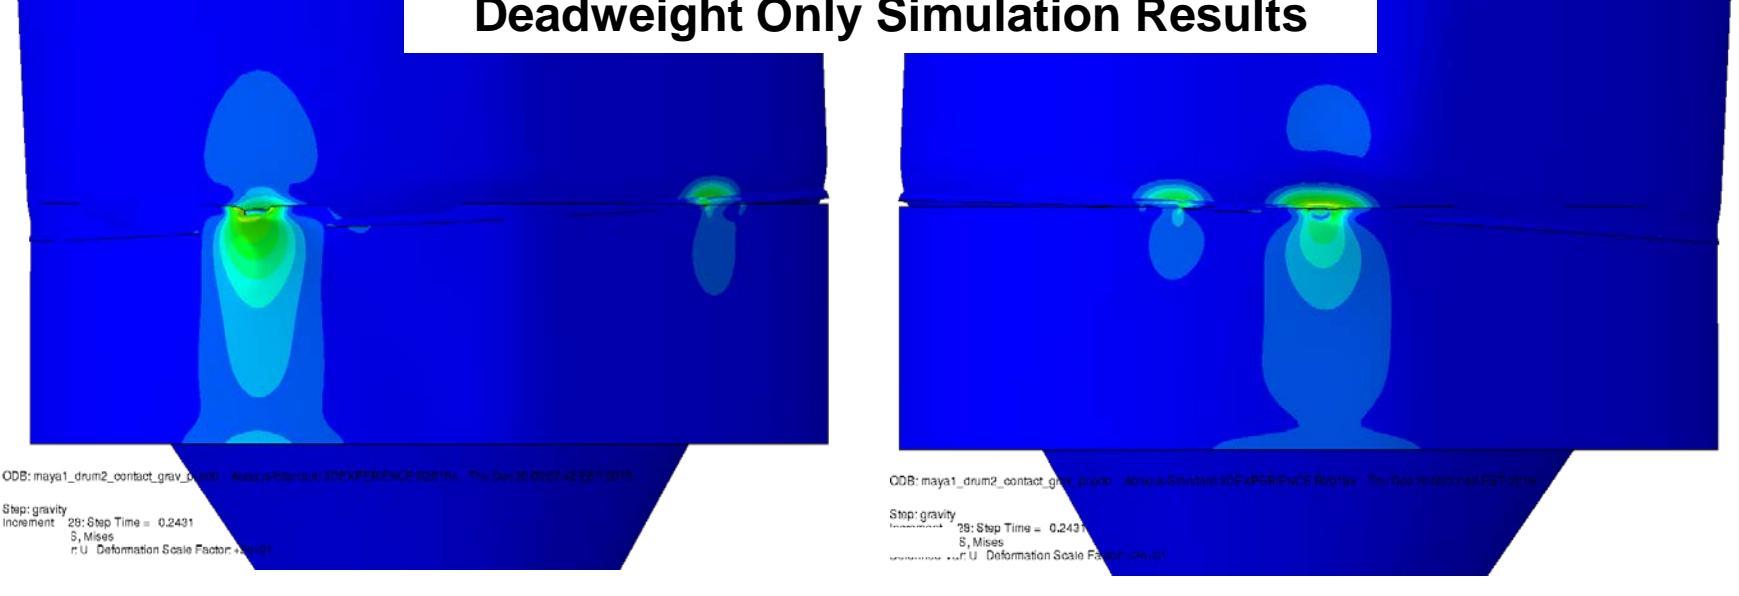
Deadweight Only Simulation Results

Stability

- Drum was displaced with over 4 million pounds and did not move while being emptied
 - Empty weight of 850,000 lbf
 - Gives a margin on deadweight of 4MM/0.85MM = 4.7
- Finite Element Analysis (FEA) used to look at wind load
 - Only 5 contact points, gives deadweight failure load of 2,100,000 lbf (so analysis is conservative by about 2x)
 - Wind velocity with actual deadweight solved for using same model: >140 mph

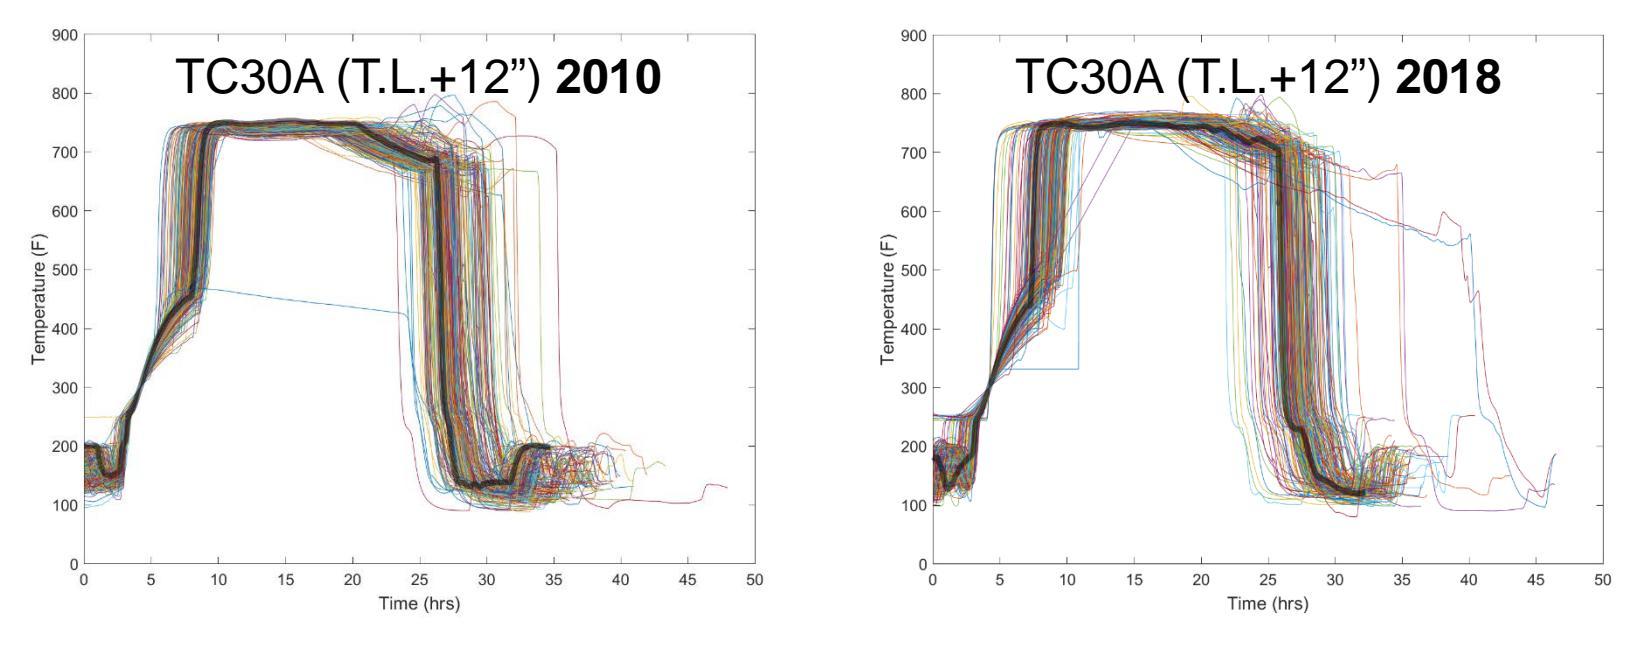
Root Cause

- Previous drums had actually suffered very similar cracking and skirt failure (1995 to 2007)
 - Operation was more severe at that time
 - Basic dimensions the same: diameter/skirt length = 4.6
 - Very stiff skirt . . .
- Health monitoring systems (HMS) exist on two drums
 - 3 complete years of data evaluated (2010, 2016, 2018) for both drums
 - ≈ 1300 cycles

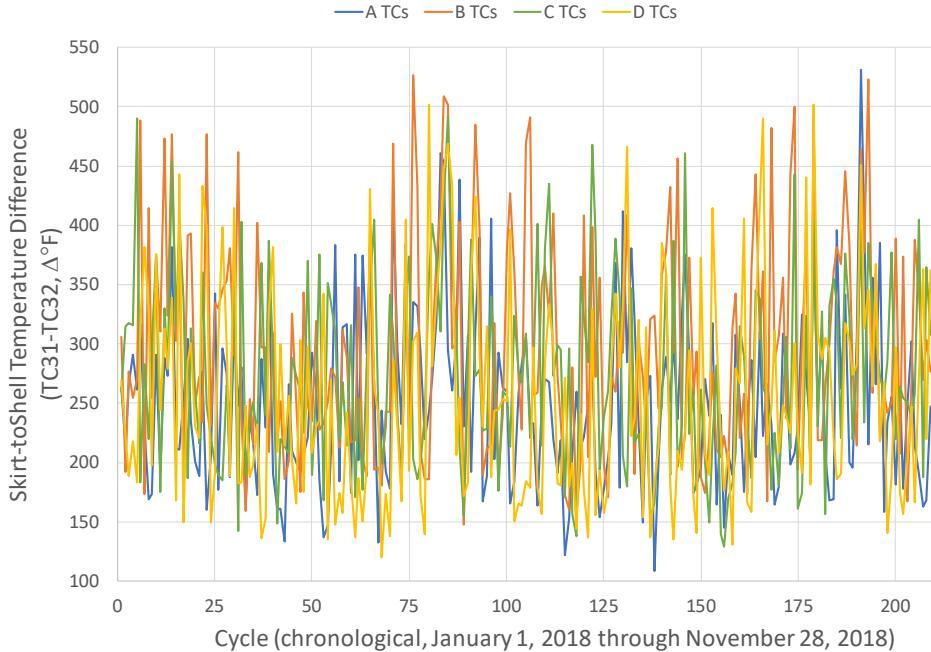
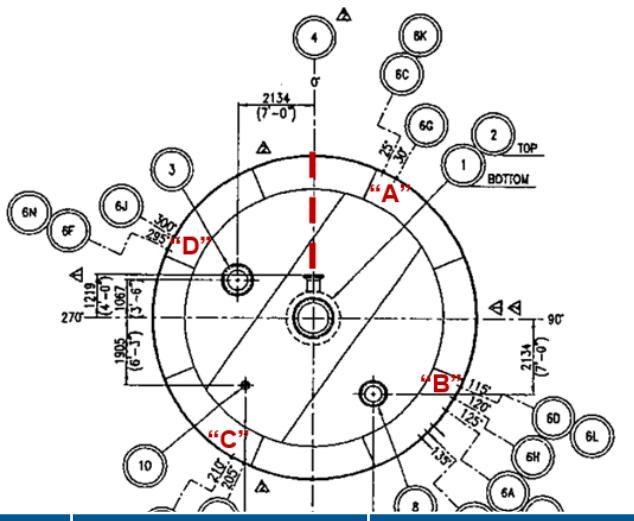
Drum-Skirt ∆T Data

- 2018 drum-skirt total ∆T (fill + quench) data shown below chronologically
- Worst location consistently moves around drum from cycle to cycle

Location of Max. ∆T Range	Number of Occurrences	Average Range of ΔT** (Δ°F)
Α	41	320
В	71	377
С	57	338
D	40	358

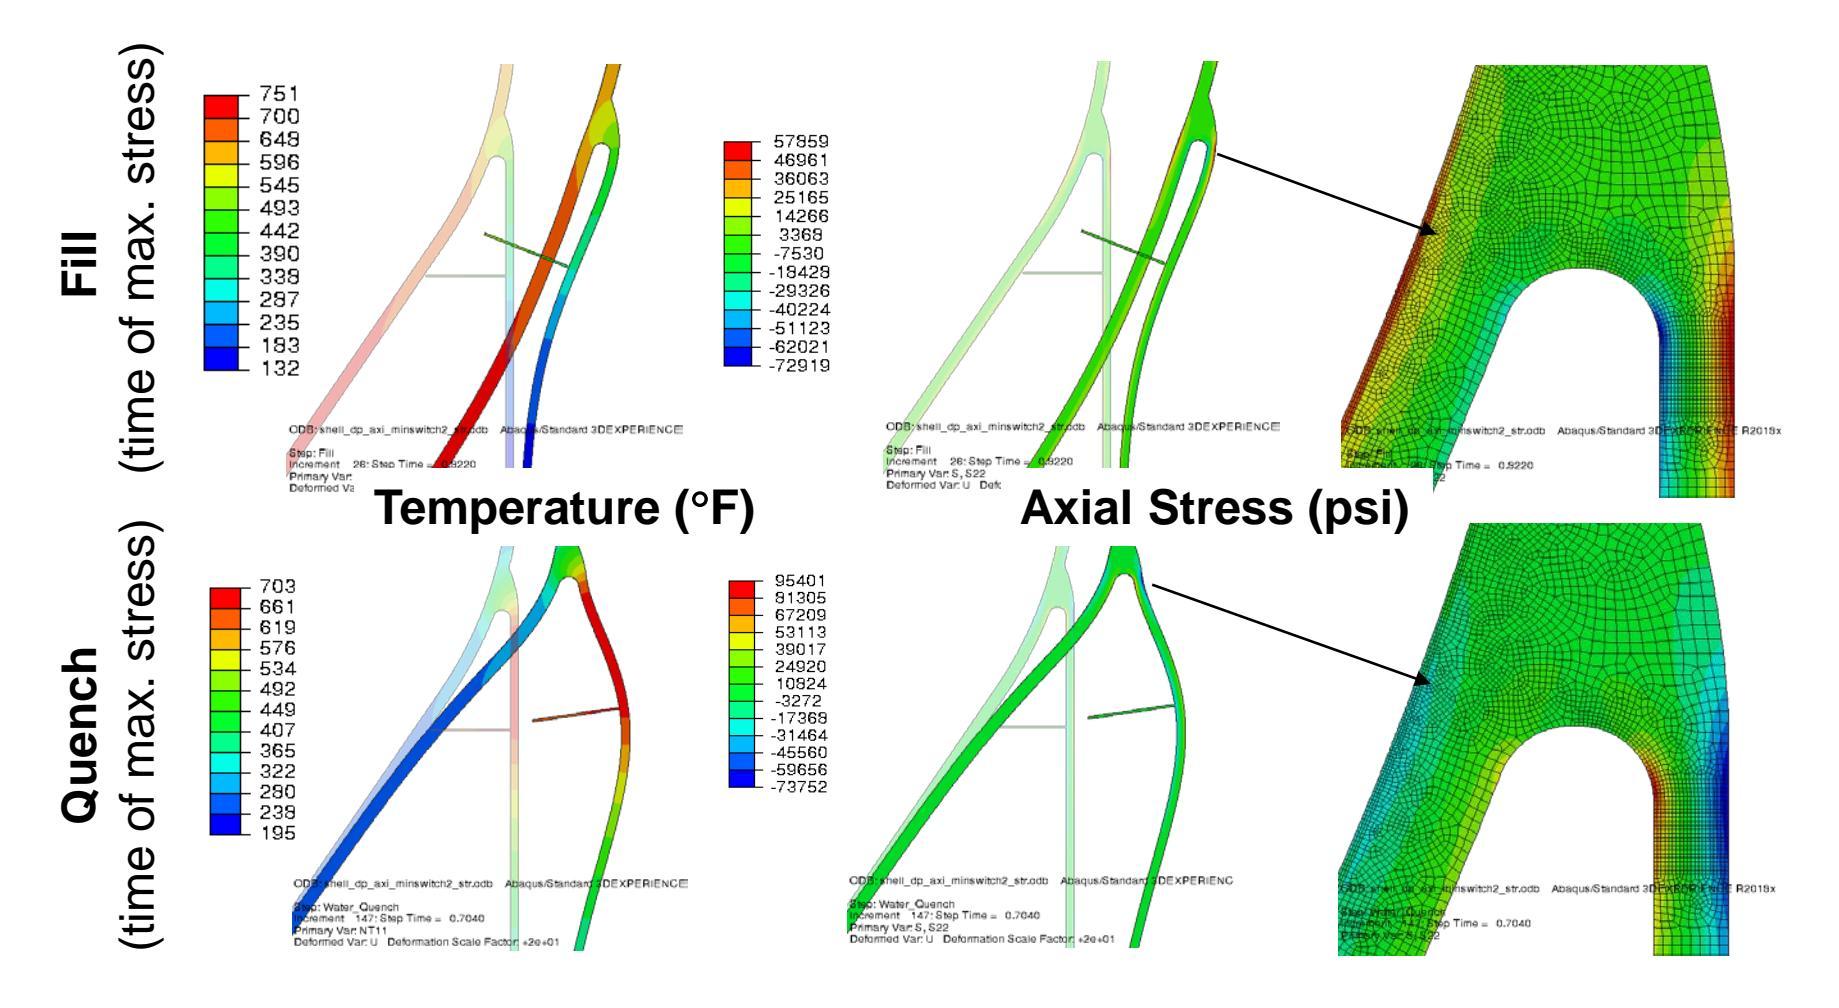
Stress Analysis Results (Min. Switch)

- Stresses are very large for worst case analyzed
- Stress range of ≈175 ksi

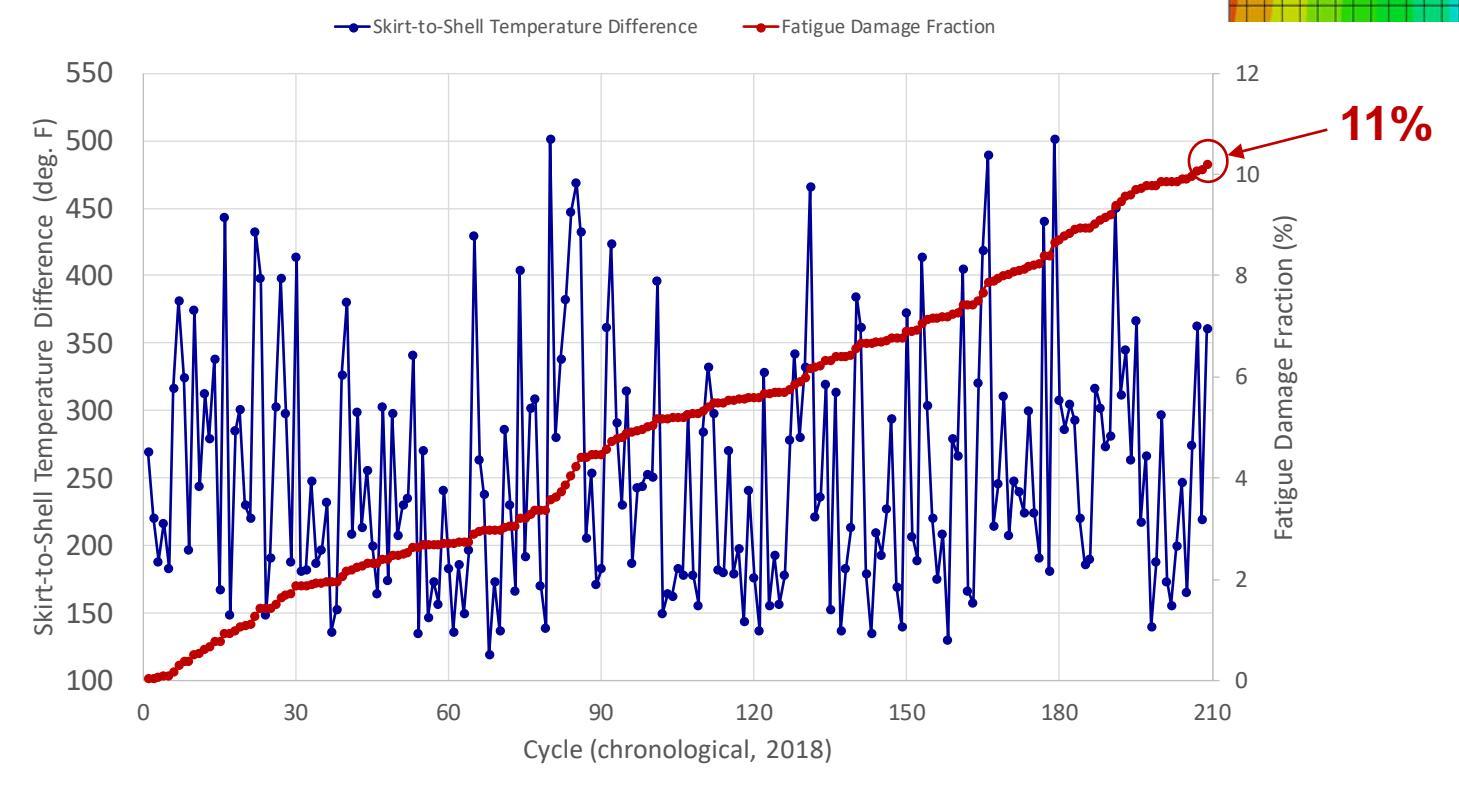
Fatigue Analysis Results

- 11% damage for 1 full year (228 cycles)
- 100% damage in 9 years (2049 cycles)
- 1.4 years to grow crack through skirt wall
- 10.4 years predicted for failure vs. 10-11 years actual

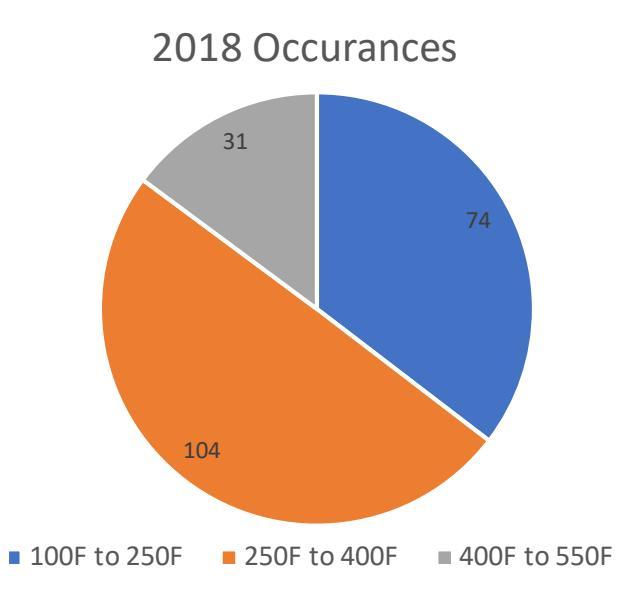
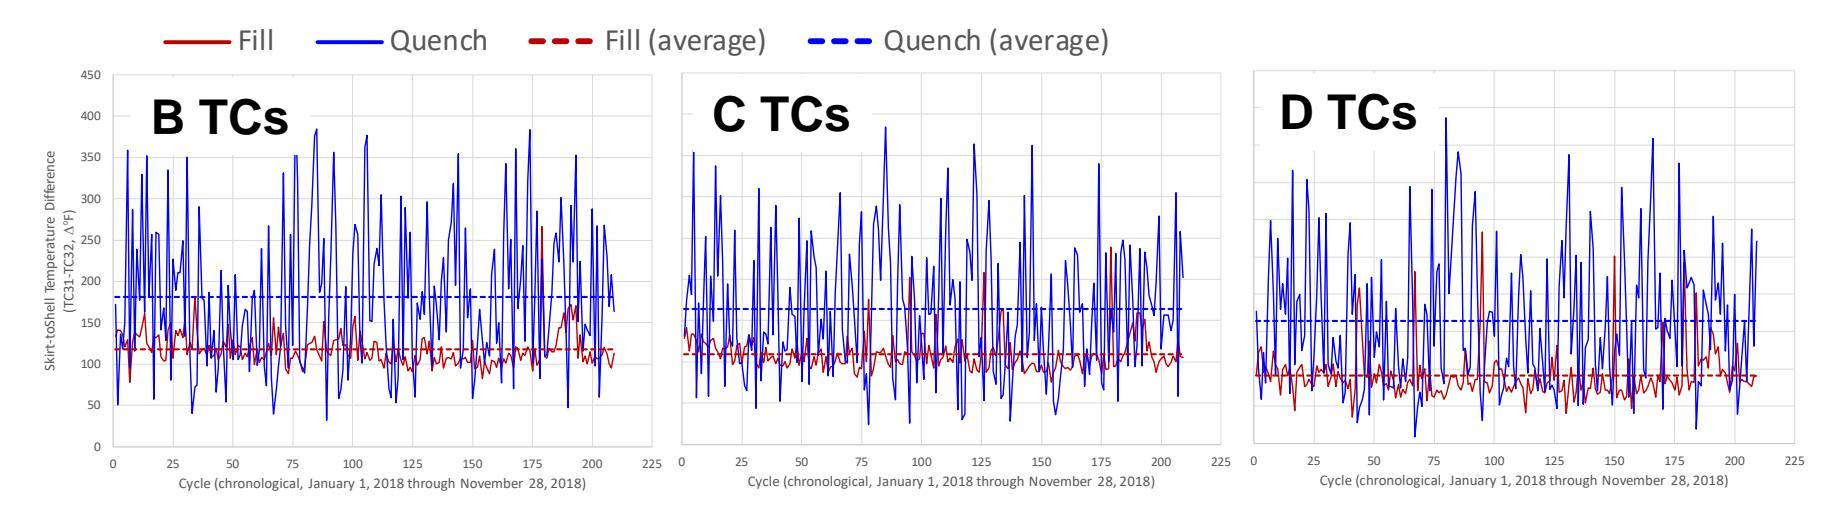
Drum-Skirt ∆T (Again . . .)

- Fill and Quench ∆T's separated below
- Most of variation and largest magnitudes comes during quench
- Quench is larger contributor to fatigue by about a factor of 3 to 1 here
