# COKER

## Safety and Reliability Lessons Learned

# COKER SAFETY & RELIABILITY

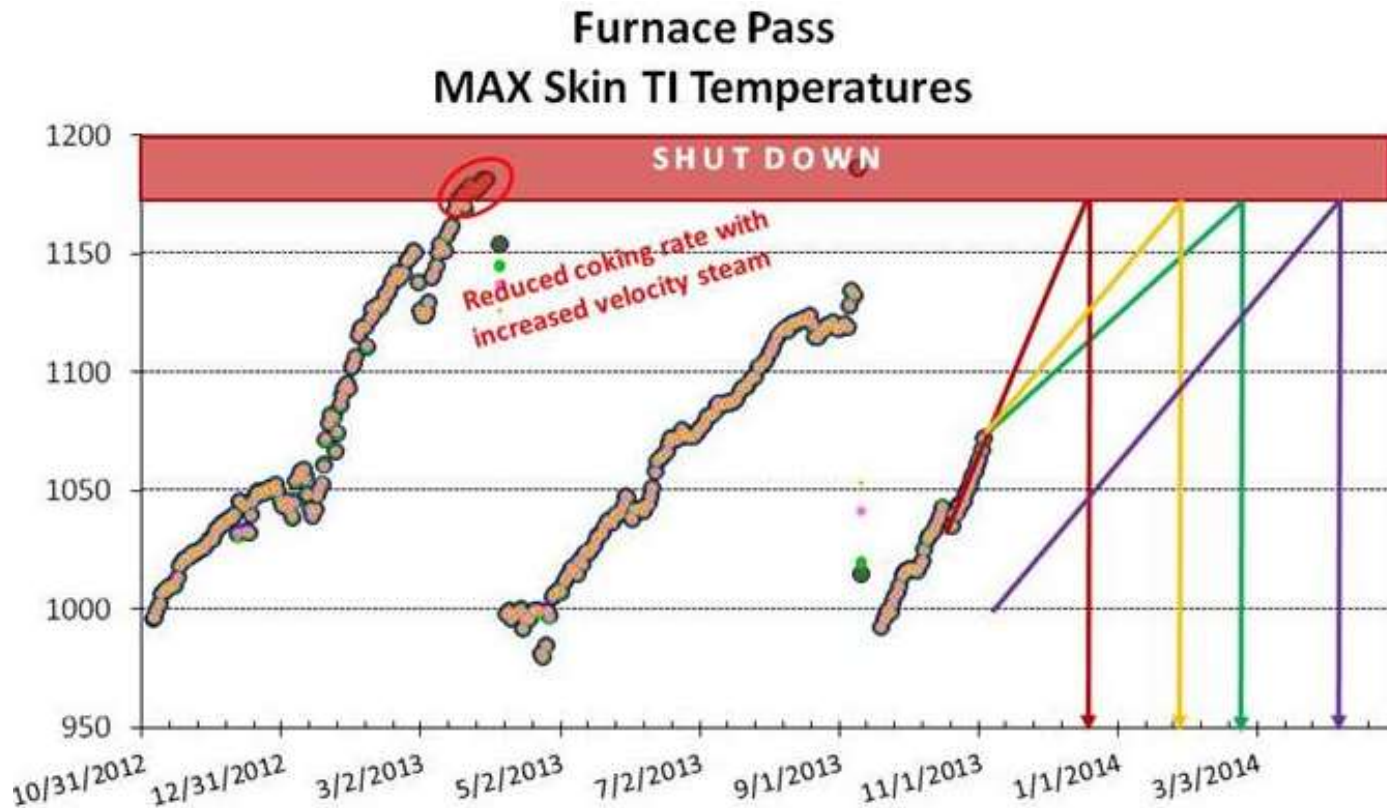
- Increased furnace fouling rate with paraffinic resid.
- Steam: air decoke typical for coke removal.
- Developed “on-line spall” procedure.

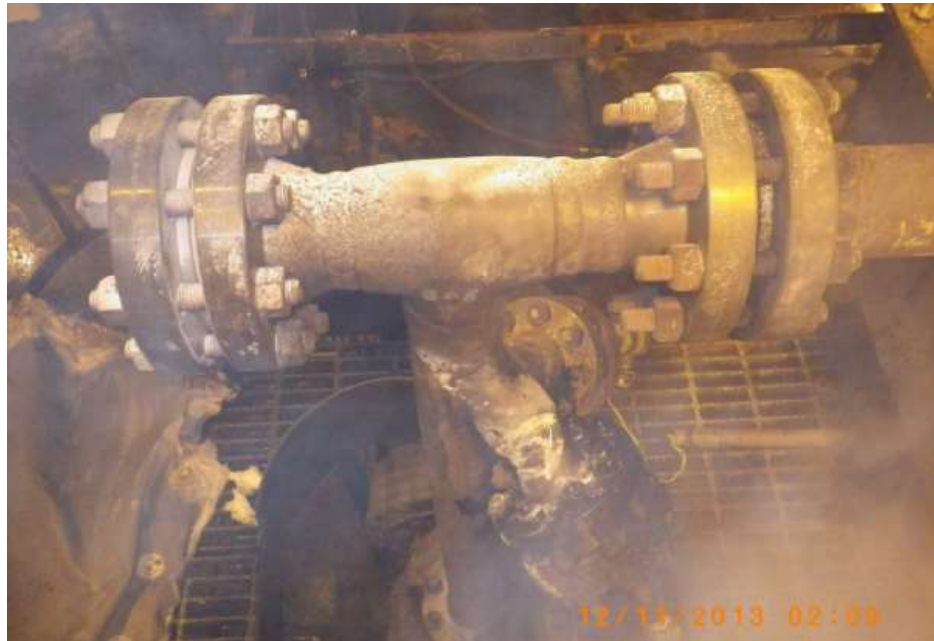
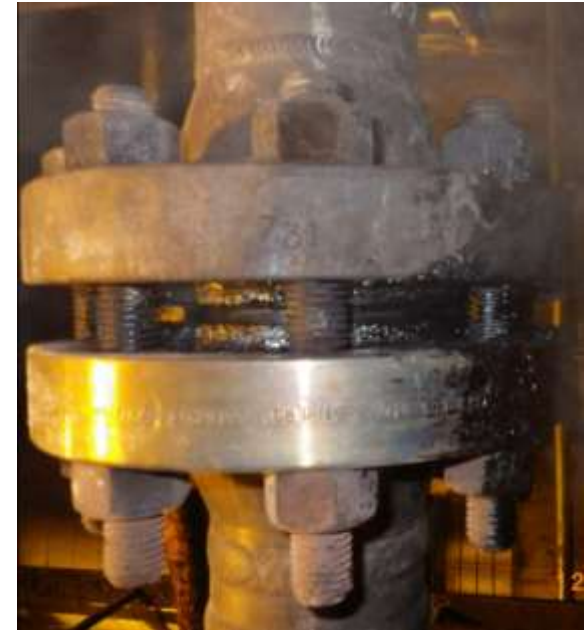
- Completed on-line spall.
  - Re-introduced resid to furnace pass
  - Outlet piping flange leak, small fire.
  - Removed resid, stopped fire.
  - Tightened nuts, able to achieve about ½ turn.
- Lesson Learned: Furnace outlet flange has severe thermal cycles. May need to tighten after spall / de-coke procedures.

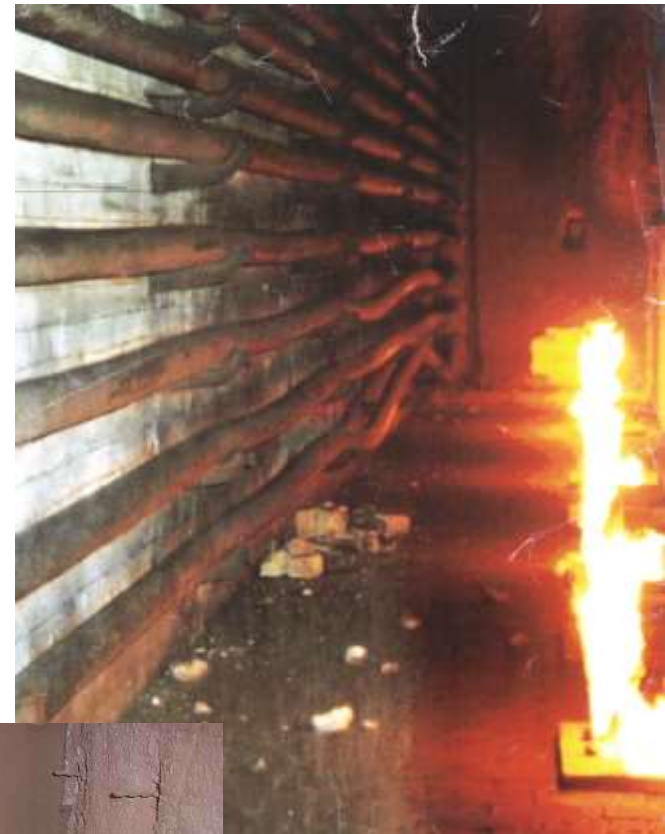
Flame Impingement, Overheating

1. Must monitor flame patterns and tube skin temperatures.
2. Recommend tube pressure test after steam air decoke prior to introducing oil.
3. If erosion occurs, a different u-bend geometry can improve safety.
4. Need to inspect u-bends periodically to determine erosion rates, insure adequate wall thickness.

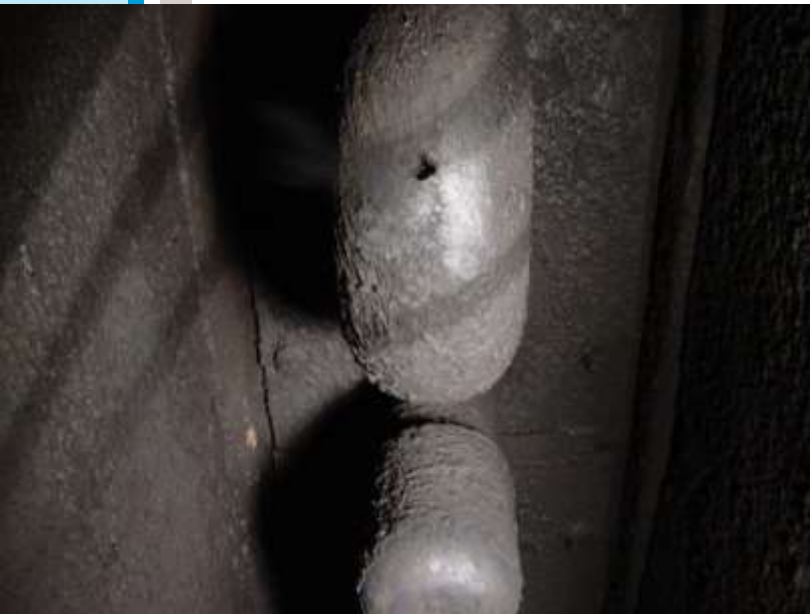
Erosion (during decoke)

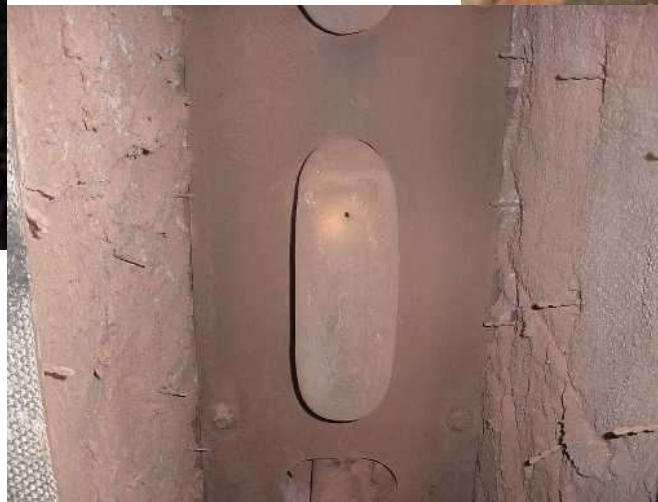
Rupture- Over pressure from blocked  
in incident(s)

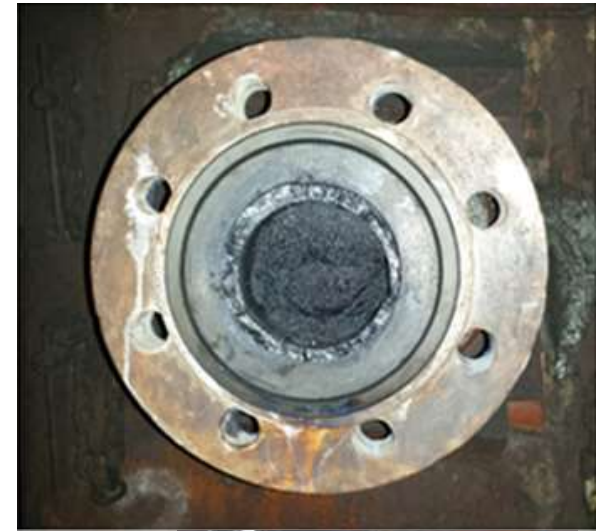
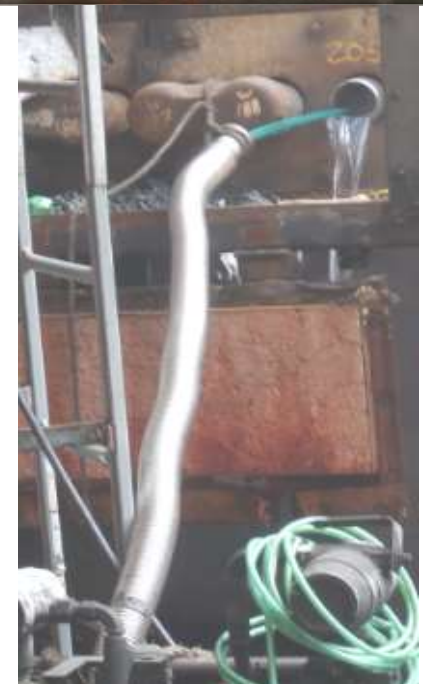
1. Resid isolation MOV returned from maintenance; bad signal into SIS.
2. Operations bypassing SIS to rotate switch valve ~ 10 days.
3. Connect laptop computer to SIS PLC, intend to bypass position signal for resid isolation valve **on feeding drum**.
4. The bypass command became a close command because of incorrect wiring
5. Blocks flow, unable to open for ~ 20 MINUTES due to Interlock permissive.

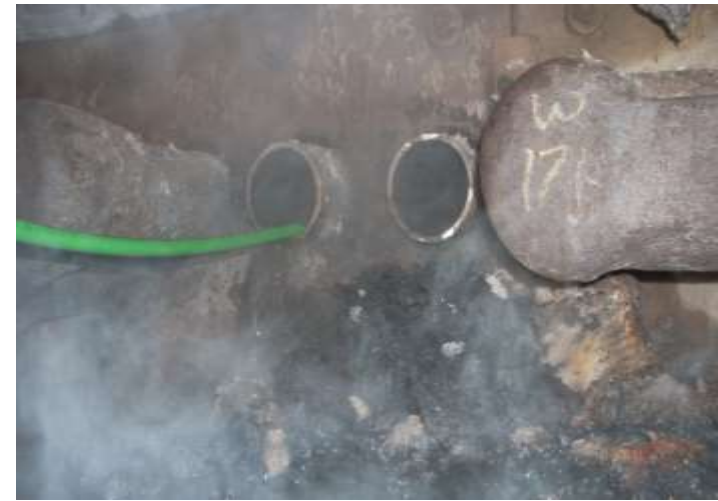
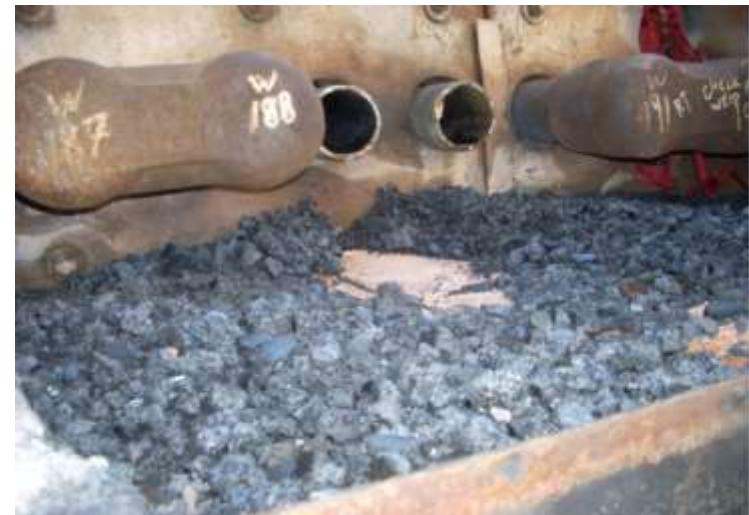
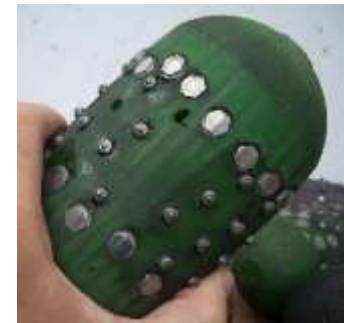
6. Operations chops fuel gas. Pressure reaches  $\sim 920\#$  but tubes do not rupture ( $600\#$  design).

CONSEQUENCE Severe coking.  
Radiant section required cutting u-bends, Aqua-Drill to bore out coke, then pig.

- \* Do not do any type of work on a feeding coke drum.
- \* Need to improve SIS system training, make information more visible on DCS, validate all repairs.

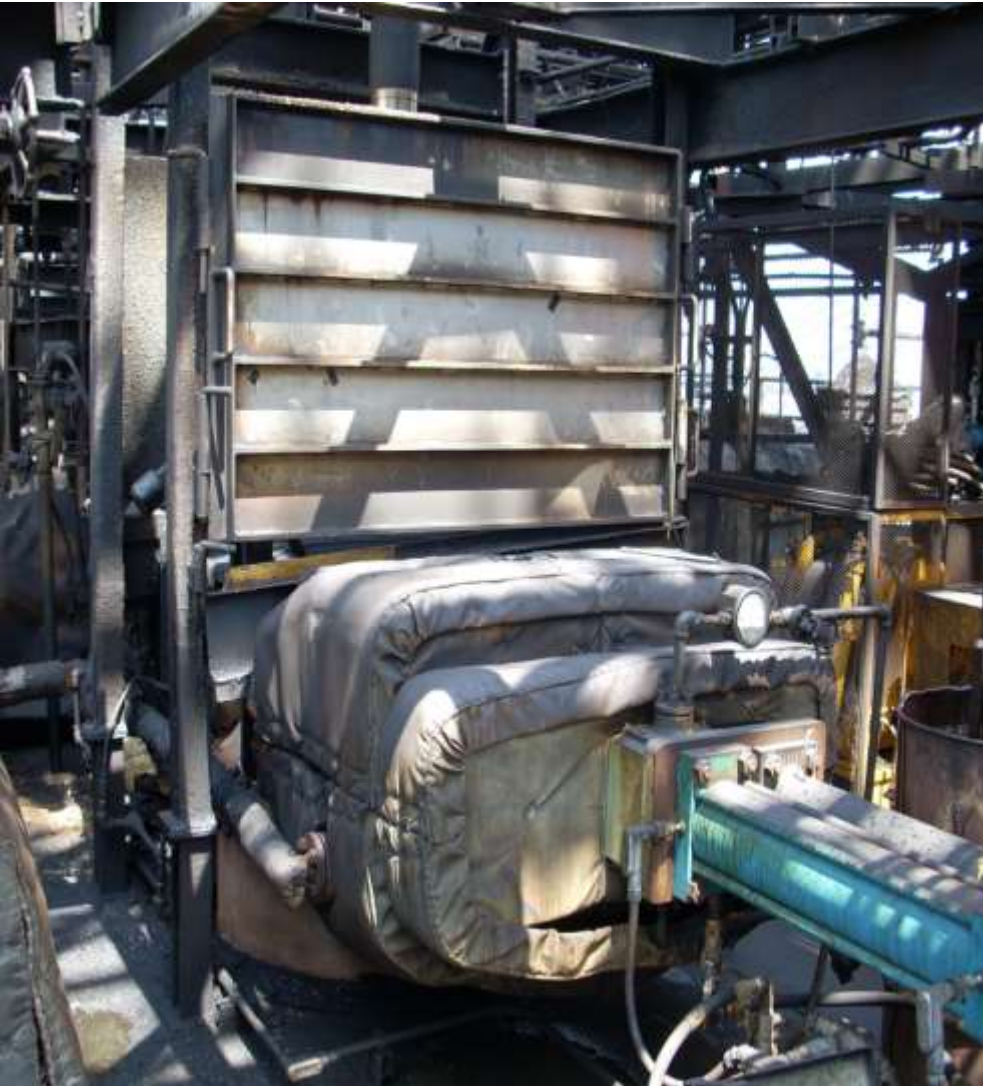
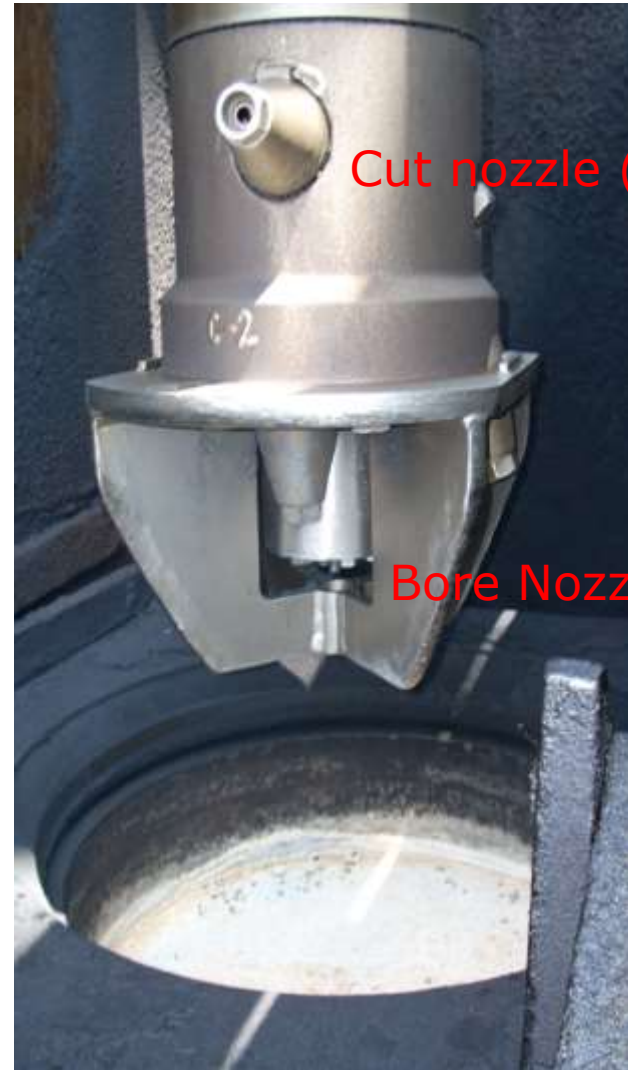
Cut nozzle (2)

Bore Nozzle (4)

Delta Valve, fully automated,  
remote operation, no manual  
labor.

Auto-switch cutting tool

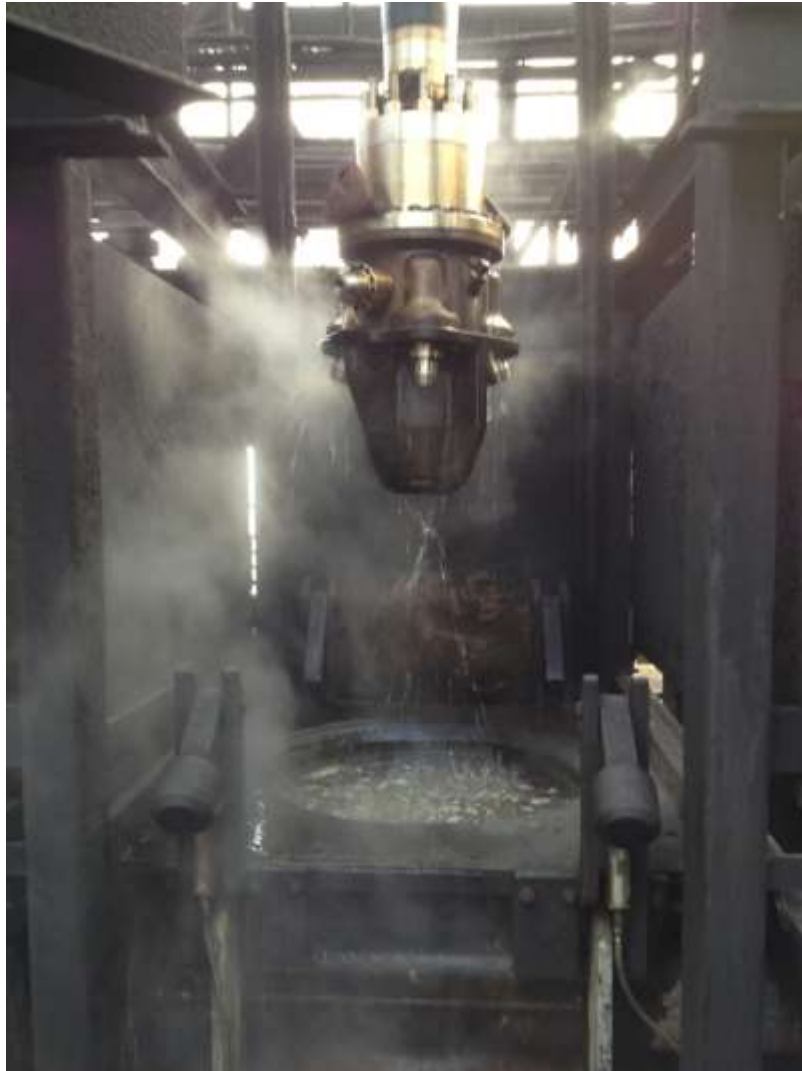
Cutting water isolation valve leaking, allowing water to drain from drill stem to top of slide gate valve.

Auto-switch cutting tool not functioning, required manual rotation.

Driller decided to climb up and rotate drill position while the drum was hot, still feeding.

12/2012 – slip into condensate, burn to foot.

**LESSON LEARNED** Be sure procedures are clear to only perform manual function after drum has been cooled.

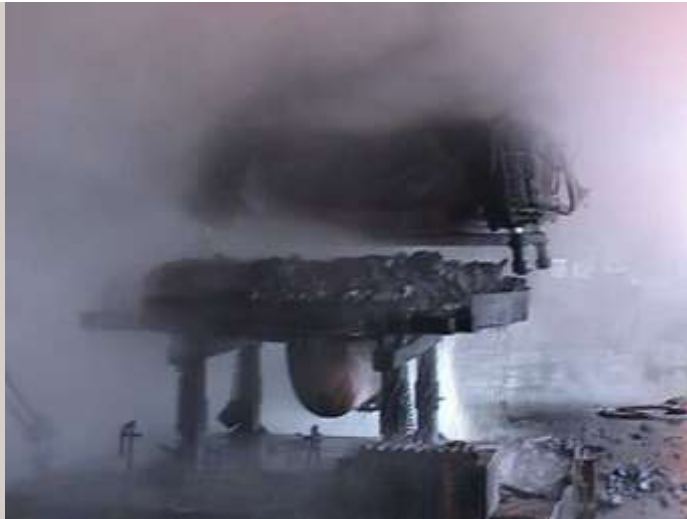
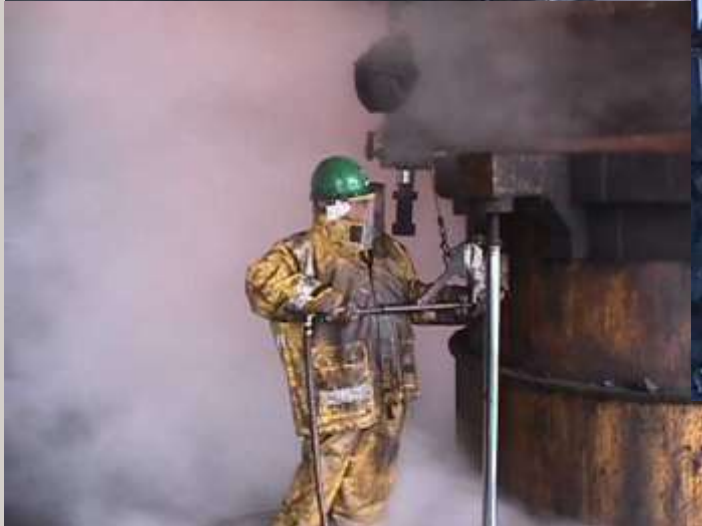
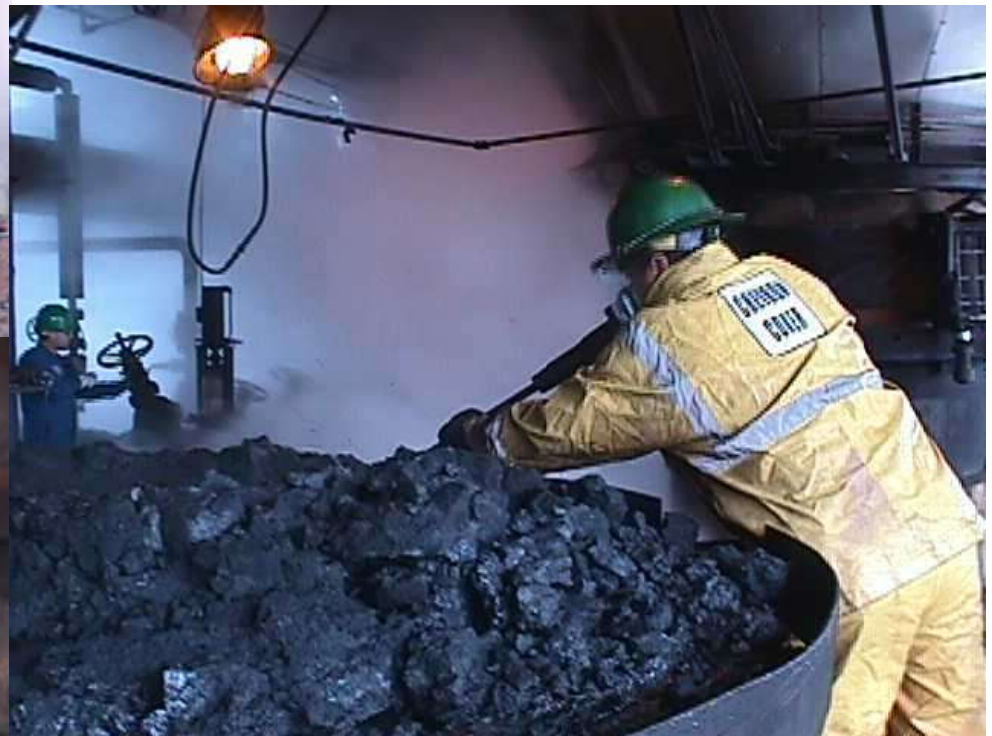
Coke drum unheading involved manual unbolting of a coke drum bottom head and physical separation, exposing ~850 tons of coke to the atmosphere.

Chute attachment and bottom head cleaning required manual steps with high exposure, partially mitigated with extra PPE.

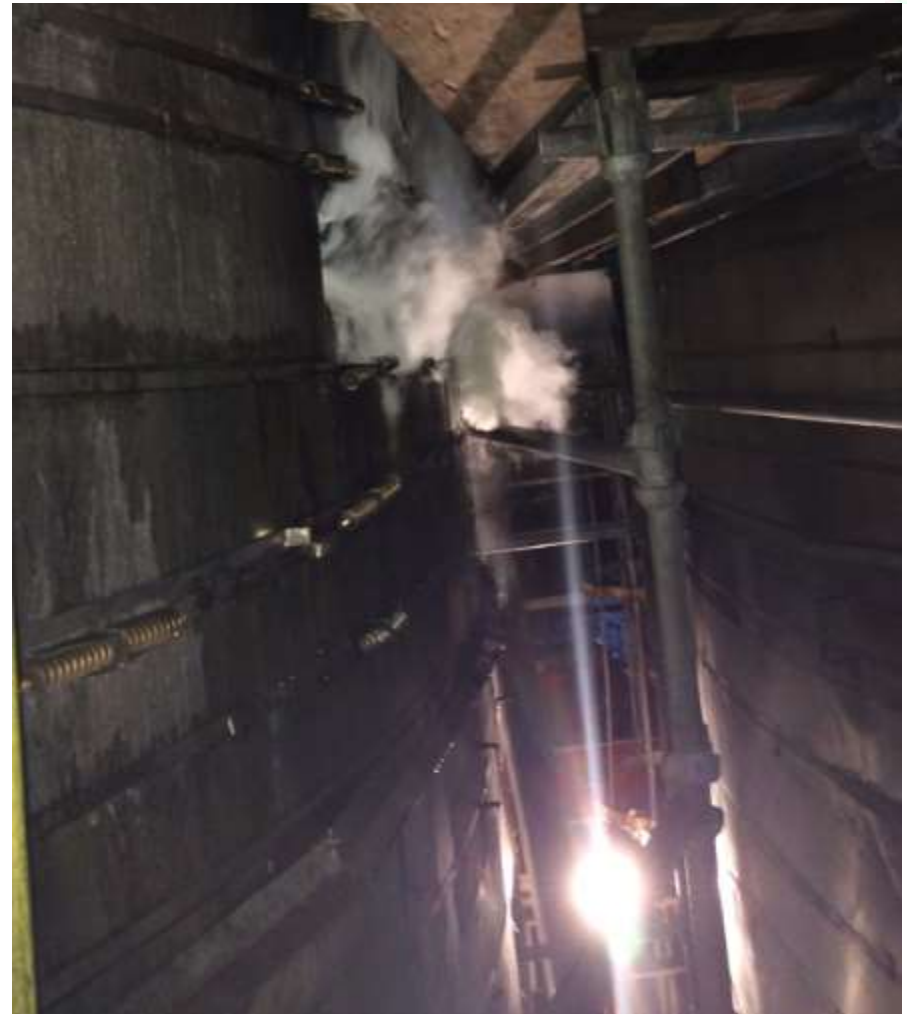
Original 1968 drums –  
replacement in 2014

Jan 2014 night shift - Drum crack at 4<sup>th</sup>  
circumferential weld on feeding drum

- Aim fire monitors at the leaking vapors.
- Reduce furnace feed rate and outlet temperature.
- Drain and pressure test module bypass line.
- Bypass module; begin steam strip of coke drum.

- POTENTIAL TARRY DRUM – feeding time only 75 minutes.
- Tarry drum guideline developed primarily for loss of furnace fires.
- OPS and Engineering developed furnace procedure to remove resid, superheat velocity steam and re-introduce to coke drum. Executed procedure, heating to 1050 F for 4+ hours, not letting skin TI's exceed 1175 F.
- Quench, depressure, vent, drain through Delta Valve to pit.
- Clean Delta Valve condensate lines and traps.
- No issues cutting or loading coke to belts.

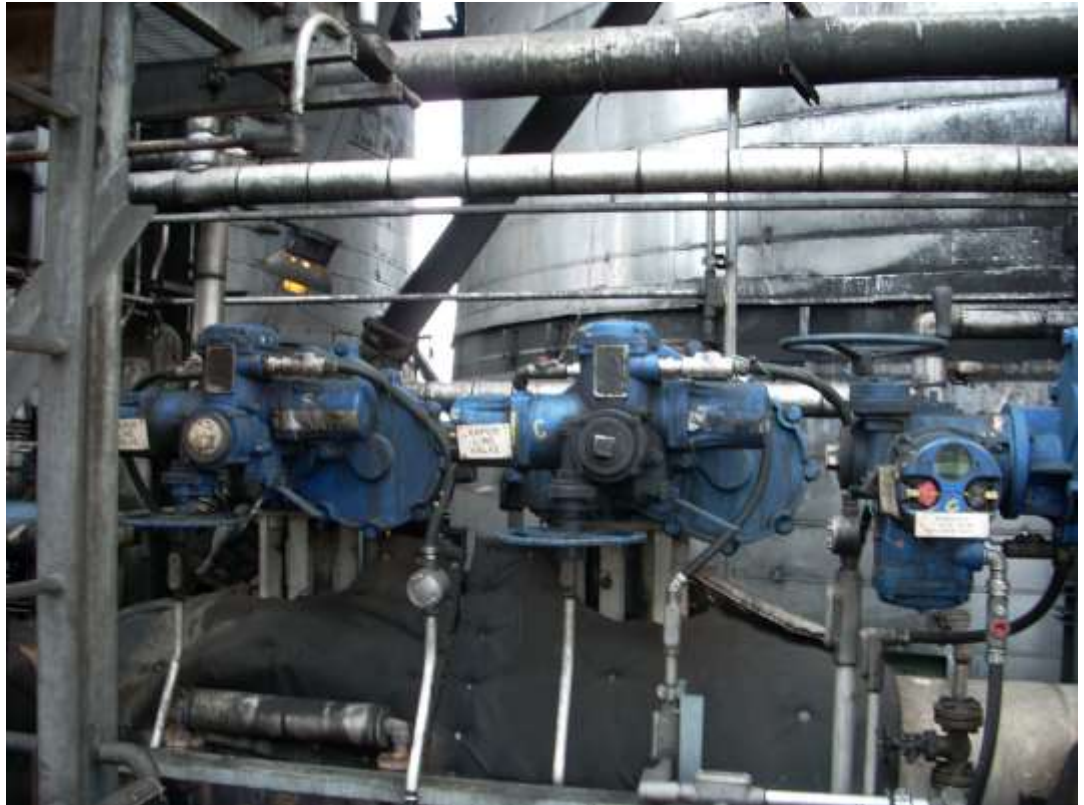
**Preventative Maintenance:** Must maintain steam purges to prevent coke in valves which leads to over torque incidents.

**Opportunity:** Improve MOV RELIABILITY ; reduce bad signal, valve jammed, and data highway communication errors to the Interlocks Programmable Logic Computer (PLC).

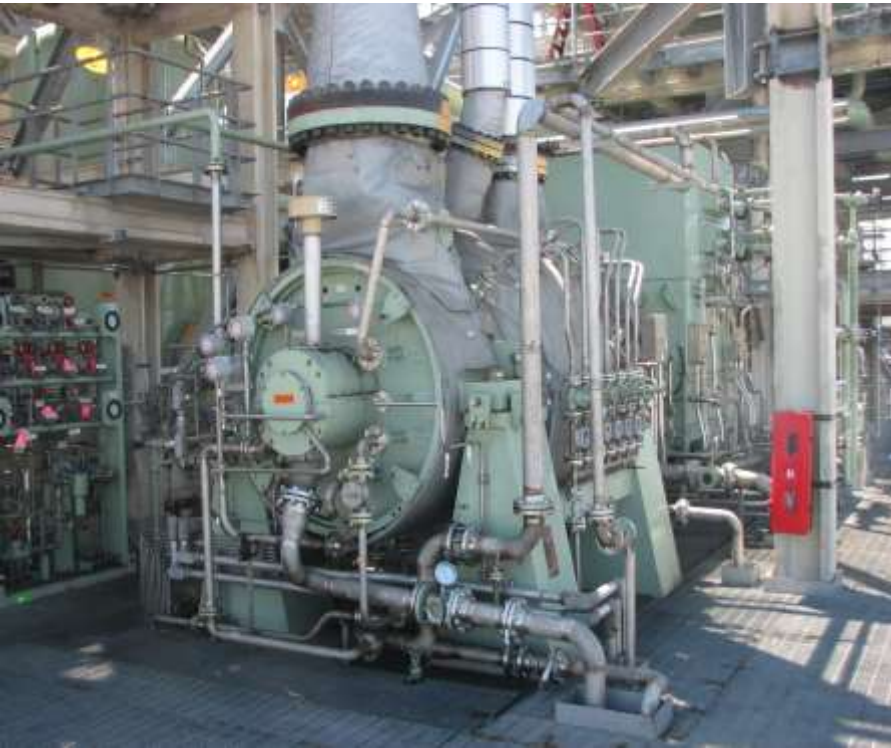
- Non-PLC shutdown

- Oil ingress into electrical wiring for speed measurement.
- Speed probe failure, shutdown compressor.

Eliminate oil ingress.

Evaluate if one of one speed voting logic for shutdown is the appropriate design for motor protection.

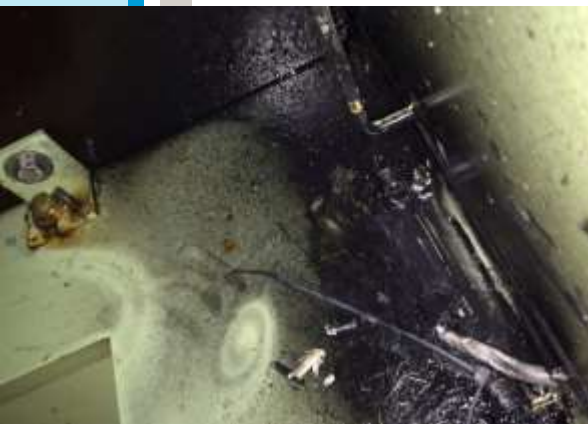
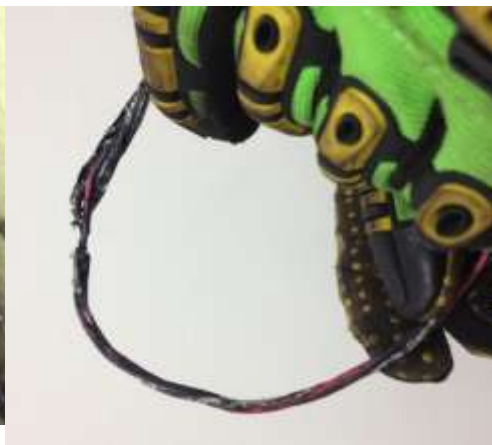
# Wet Gas Compressor K-8320 - Pascagoula

About 60 seconds after the motor was started, catastrophic gear box coupling failure.

Motor speed synchronization did not occur. Sheared coupling, shattered coupling guard. Found loose exciter wire that prevented proper speed control.
