Reliability improvement of Coker Charge Pump

GUJARAT REFINERY INDIAN OIL CORPORATION LIMITED (IOCL)

REFCOMM
BAHRAIN
8-12 NOVEMBER 2015

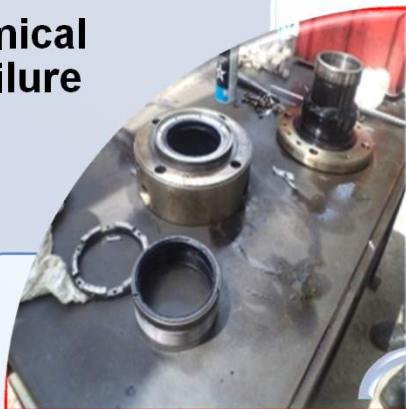
- NDE Mechanical seal failure

Observations: High wear and wear marks on Bellow

Root Cause-1: Insufficient API Plan-32 Seal oil flow

Root Cause-2: Improper selection of seal face combinations

- ★ To avoid Mechanical seal failure:
 - Primary Seal faces combination changed from C vs SiC to SiC vs SiC

- Replaced the primary Caron bellow with SiC (Harder face)
 - Set alarm limits on DCS for Plan-32 Flow
- ★ High erosion on pump wetted parts, caused by Catalyst carryover through CLO from FCCU (mixed in feed tank), high velocity at wetted areas and low surface hardness.

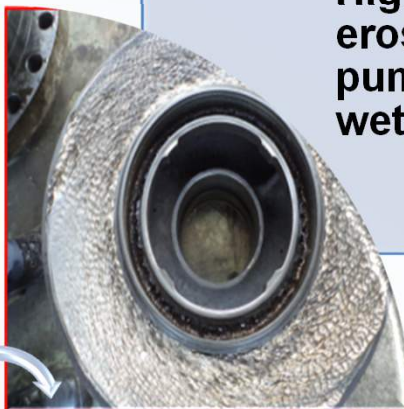
- High erosion on pump wetted parts

Observations: Decrease in discharge Pressure

Root Cause-1: Catalyst carryover through CLO

Root Cause-2: High velocity at wetted areas

Root Cause-3: Cavitation issues

- ★ To eliminate High erosion on pump wetted parts:
 - ❑ Analyze the failure modes and directed the OEM to reduce the velocity at landed areas. Replaced the Crusher ring with Chock Rings to avoid lower NPSH problem.
 - ❑ Tungsten carbide (WC) coating on casing internal surface using HVOF thermal spray system.
 - ❑ Impeller metallurgy upgraded to A532 CL III A (upgraded to better response to HVOF process)
 - ❑ Second stage wear ring design has changed to minimize the clearances.

- Change pump wetted parts material from A487 CA 6NM/A to A532 CL III A (Impellers), applied hard coating tungsten carbide (HVOF- HIGH VELOCITY OXYGEN FUEL) on casing internals and reduced the velocities at landed area by changes in geometry.

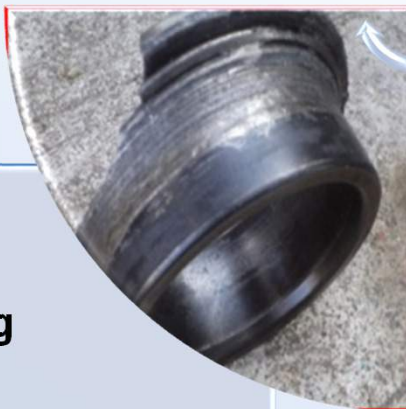
- Thrust bearing failure

Observations: Dent marks on inner race & Slippage of lock nut

Root Cause-1: Insufficient minimum flow during start up.

- ★ Failure of thrust bearing due to high thrust load during the startup and slippage of lock nut.
 - **Installed the double lock nut to avoid the slippage.**
 - **Maintained minimum flow during the start up.**

- ★ Failure of thrust bearing due to high thrust load during the startup and slippage of lock nut.
 - Installed the double lock nut to avoid the slippage.

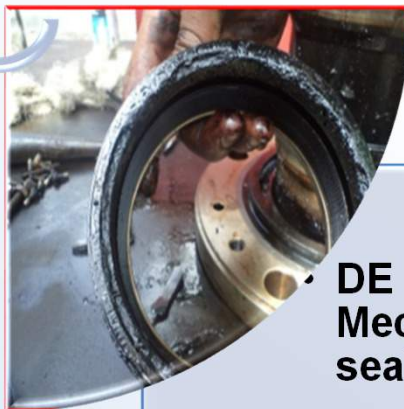
- DE Mechanical seal failure
