REFCOMM[®]
GALVESTON
MAY 2-6 2016

CASE STUDY COKER JET PUMP MOTOR

CURRENT SIGNATURE ANALYSIS
PAYS OFF

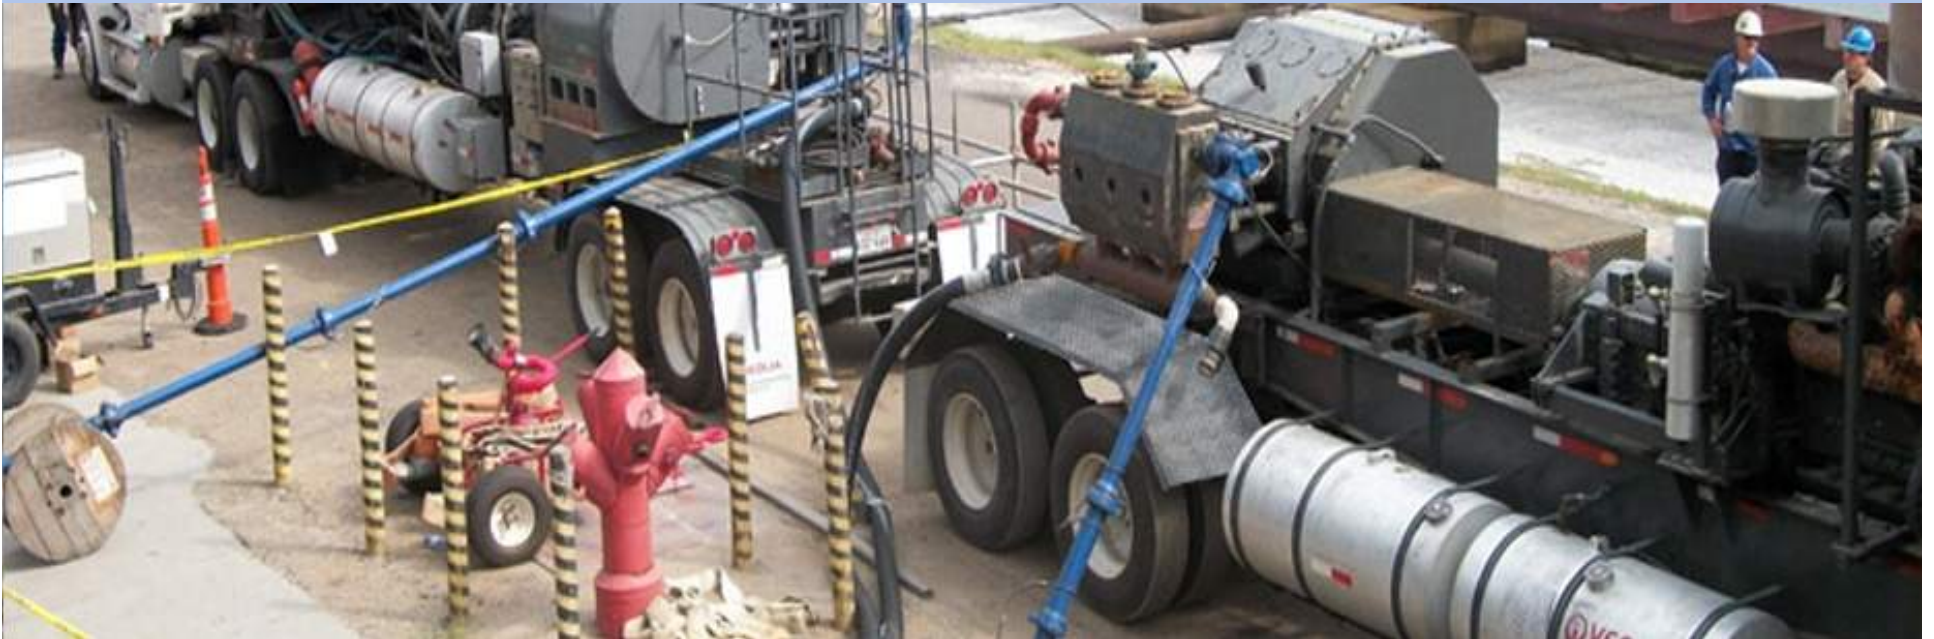
When things don't go well,
this could be the result

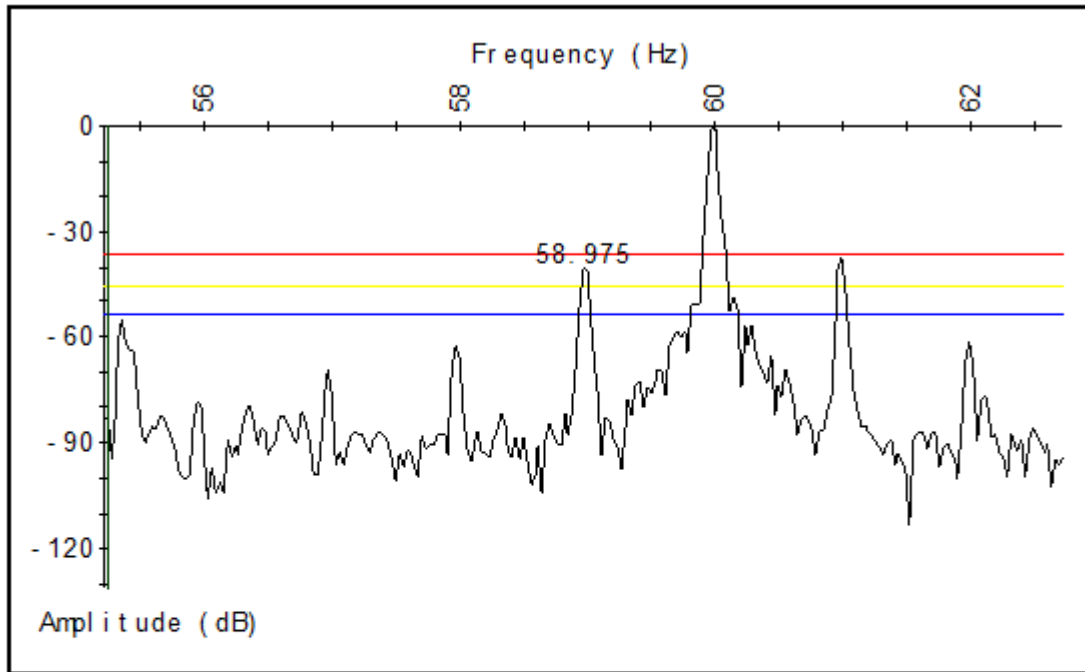
This reading was taken 1 month prior to replacement.

Frequency	I 1	Speed (NP)	3575.00
RMS Amps		614.14	Speed (RPM)	3569.25
% FLA		96.41	Slip (%)	0.85
Cursor	55.254	-82.77		
Peak dB Level	60.000	45.69		
	58.975	-39.91

Motor supplier was able to improve lead time enough to make turnaround window

New motor was received at refinery and replaced

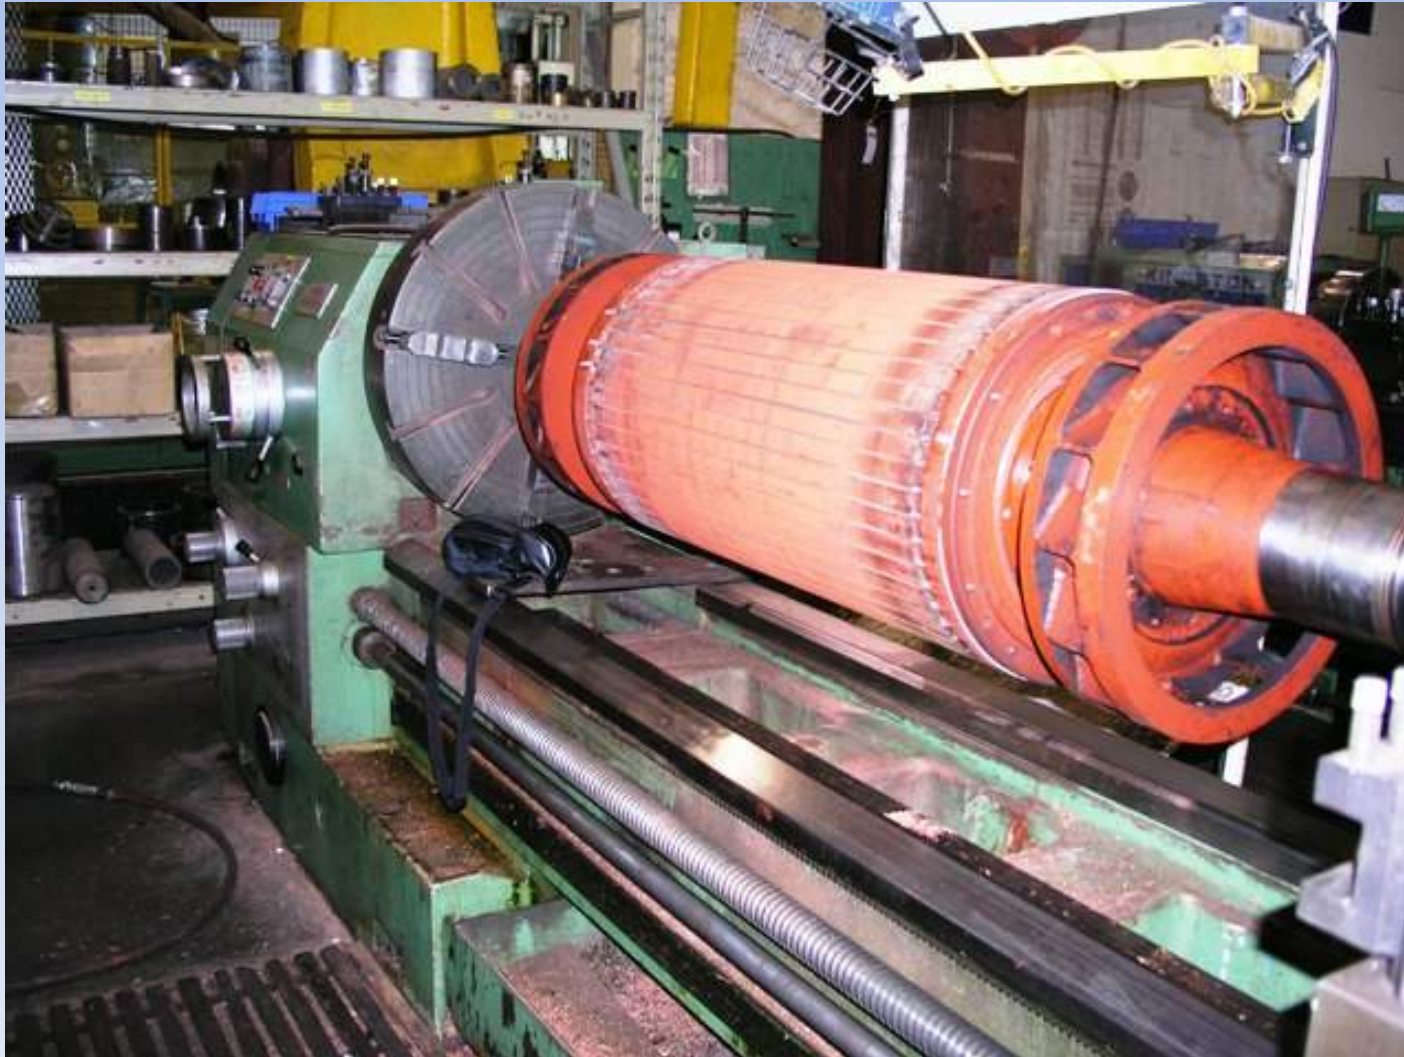
Autopsy of suspected bad rotor confirmed conclusions made from the current signature analysis

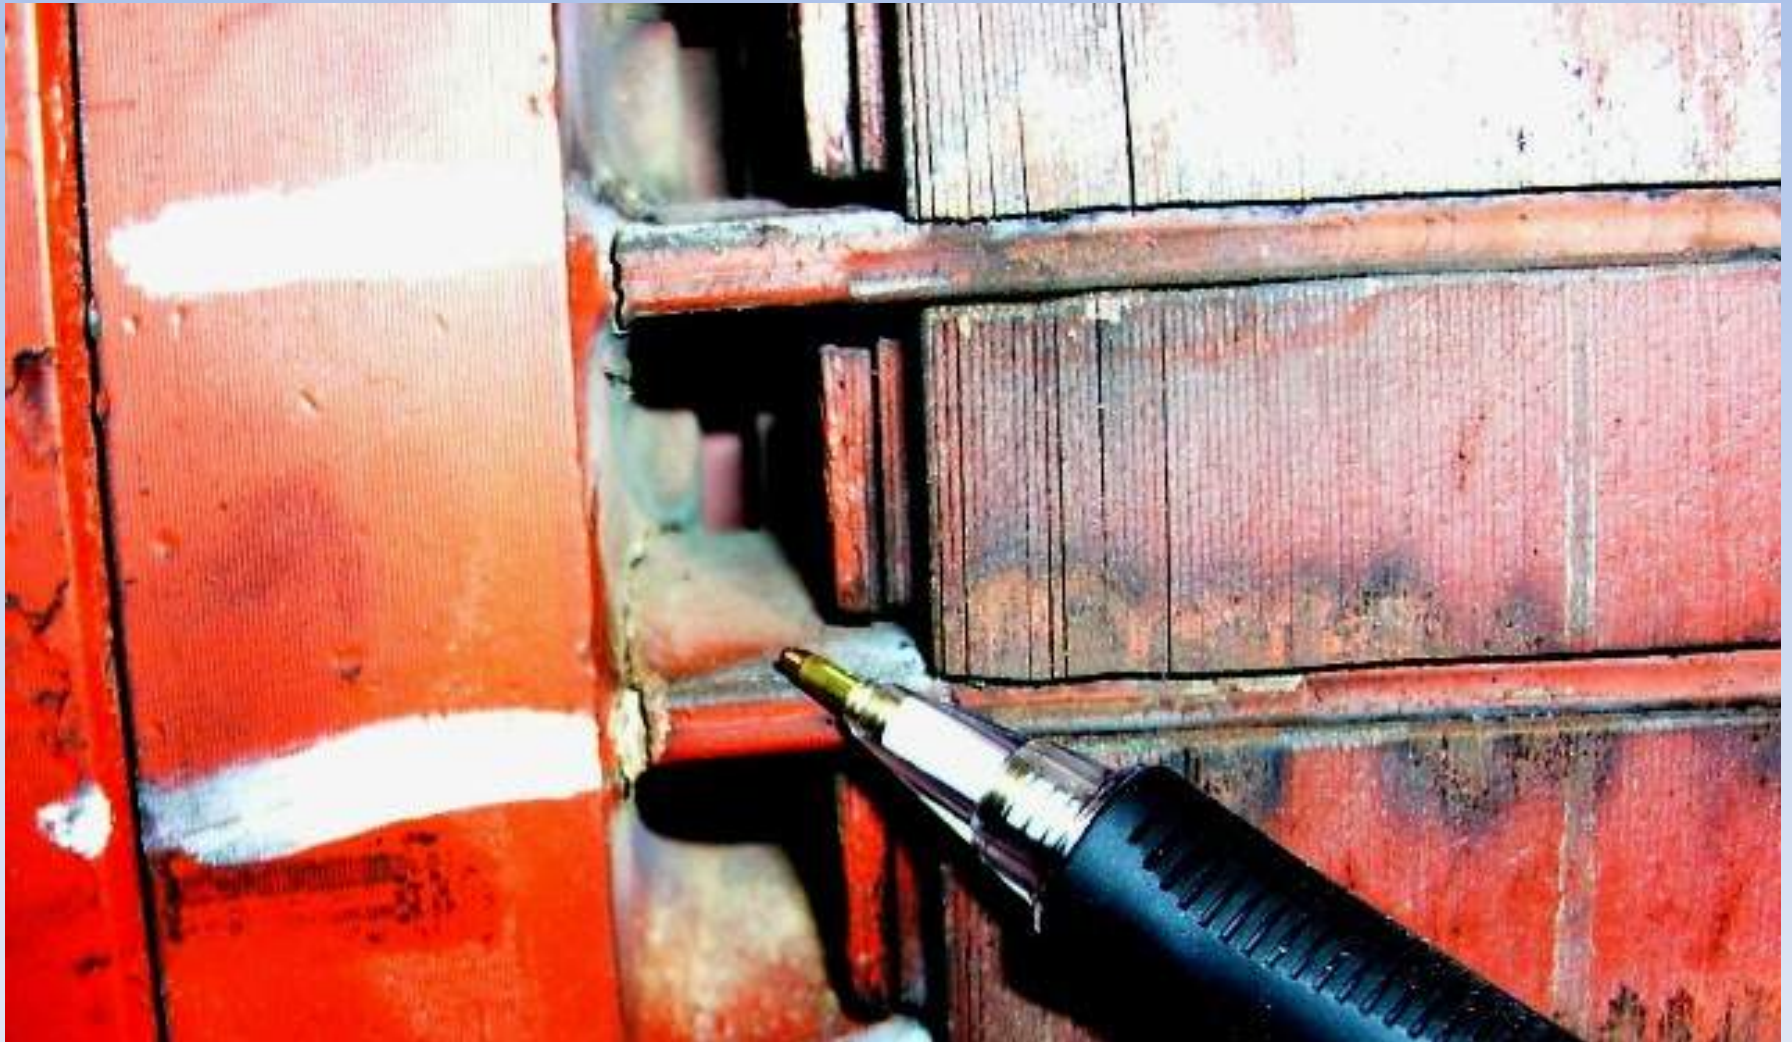
Motor Shop Inspection results:

5 locations where rotor bar connections had cracked

Several bars bent next to the end ring connection point

Serious overheating at multiple locations
