Start-up Experiences with Operation & Maintenance of Motor Operated Valves in a Delayed Coker

Coking.com Safety Seminar

Houston, Texas USA April 18 - 21, 2005

Michael Fynan
Staff Mechanical Engineer
Shell Oil Products US
Martinez Refinery
Martinez, California 94553 USA
925-313-5418

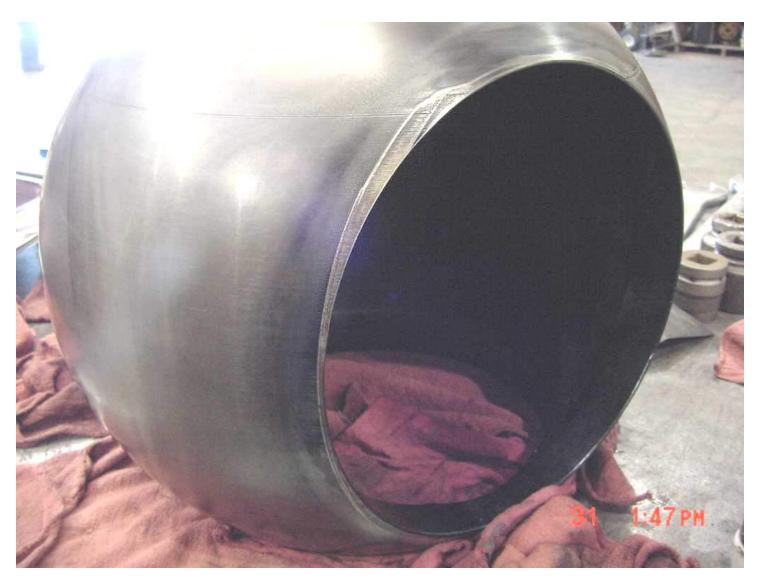
Figure #13: Switch Valve Ball Damage

- After upgrading the actuator and valve stem couplings to deliver more torque, the sticking switch valve was removed and the spare valve installed in early March of 2001.
- This spare valve was brand-new from the factory and had never been in service.
- During the coker start-up in late March, the switch valve seized when attempting the initial switch from Drum#1 to Drum #2.
 Despite all our attempts, the valve would lock-up when going from Drum #1 to Drum #2 but would turn easily when going in the reverse direction.
- After the new switch valve was disassembled in the shop, the immediate cause for lock-up was readily apparent.
