Fatigue Testing of Coke Drum Plates Reinforced With Weld Overlay: Summary of Results

Fábio de Castro Marangone, Petrobras,Ediberto Bastos Tinoco, Petrobras,Julian J. Bedoya, P.E., Stress Engineering Services, Inc.,Luiz Carlos Largura Jr., Stress Engineering Services, Inc.

29 Sept - 3 Oct 2014

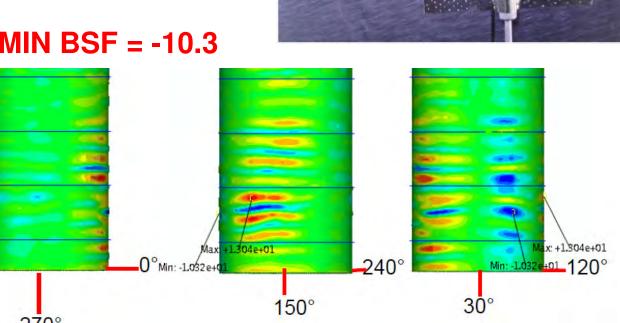
How is Bulging Assessed?

- A bulge severity analysis is performed
- Ranks bulges based on stress amplification factor
- Method to identify and track specific characteristics of each bulge during life of drum
- Useful in choosing strain gauge and thermocouple locations and interpreting their results
- The stress amplification factor obtained from this analysis can also be used in fracture mechanics assessments

MAX BSF = 13.0

MIN BSF = -10.3

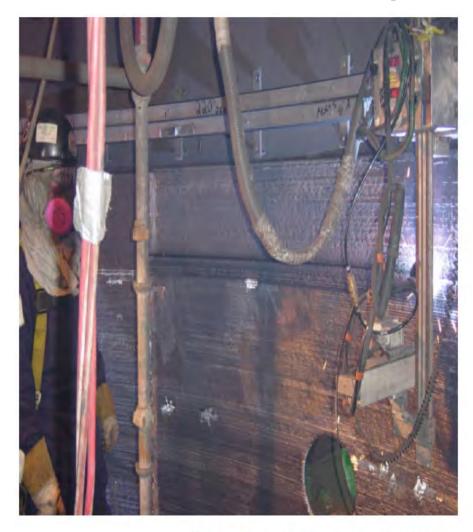
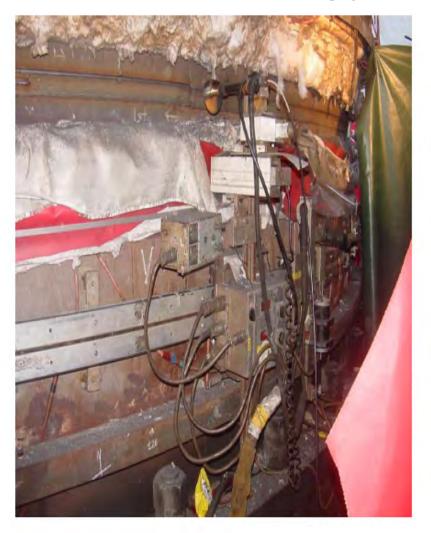
Pictures Courtesy of WSI

Shell, Cone, and Skirt Repair with Automated Temper Bead Technology

- Weld overlay (WOL) for bulge reinforcement
 - Automated temper bead technology
 - Reduce outage time for repair
 - Full PWHT not required
 - Repair from inside and/or outside
- Window replacement
 - Material is too degraded and must be removed
 - Bulge is too severe for weld overlay
- Can replacement

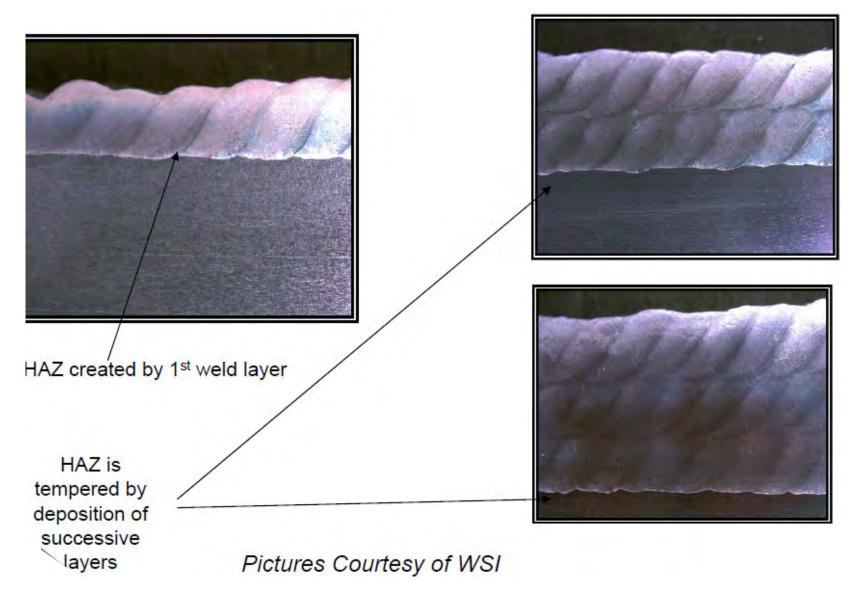
Temper Bead Welding

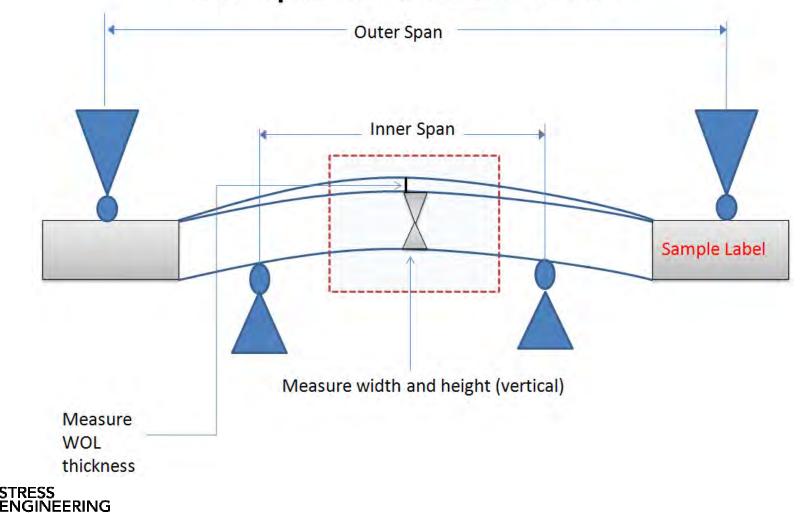
Loading of Samples

Sample with Circ Weld

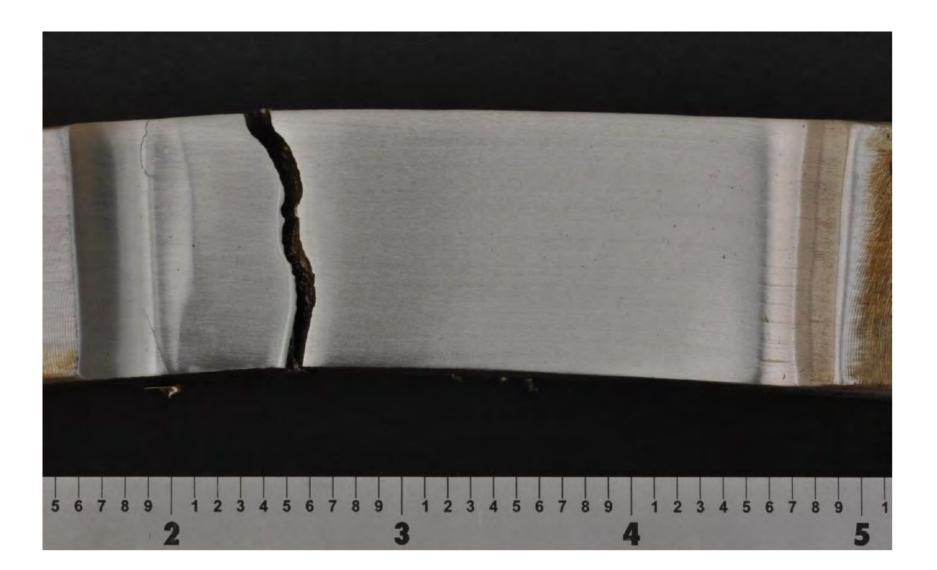
Results: Bending Fatigue Testing – Base Metal

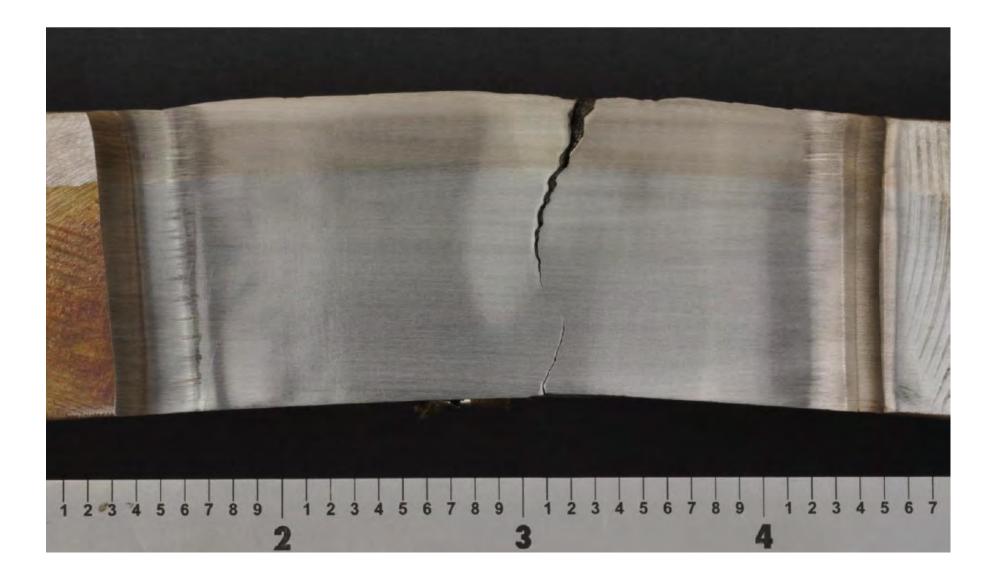
Results: Bending Fatigue Testing – WOL Mid

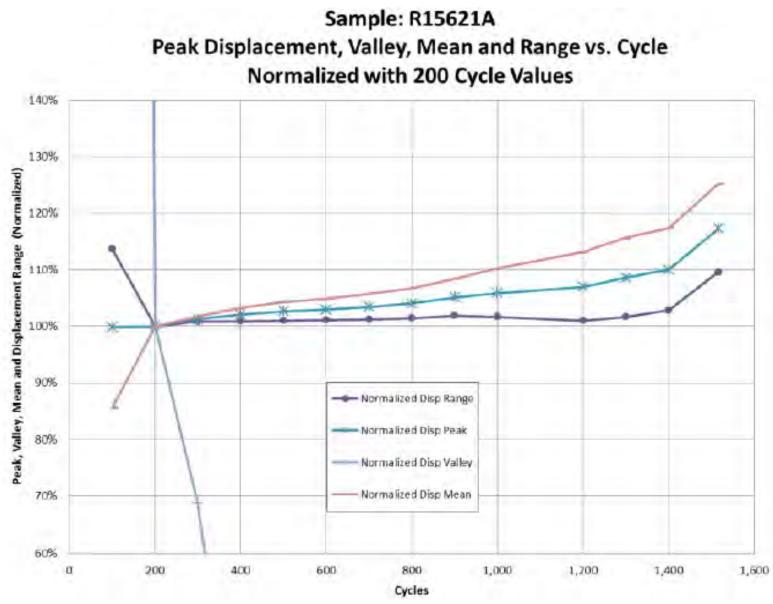
Results: Bending Fatigue Testing – WOL CW

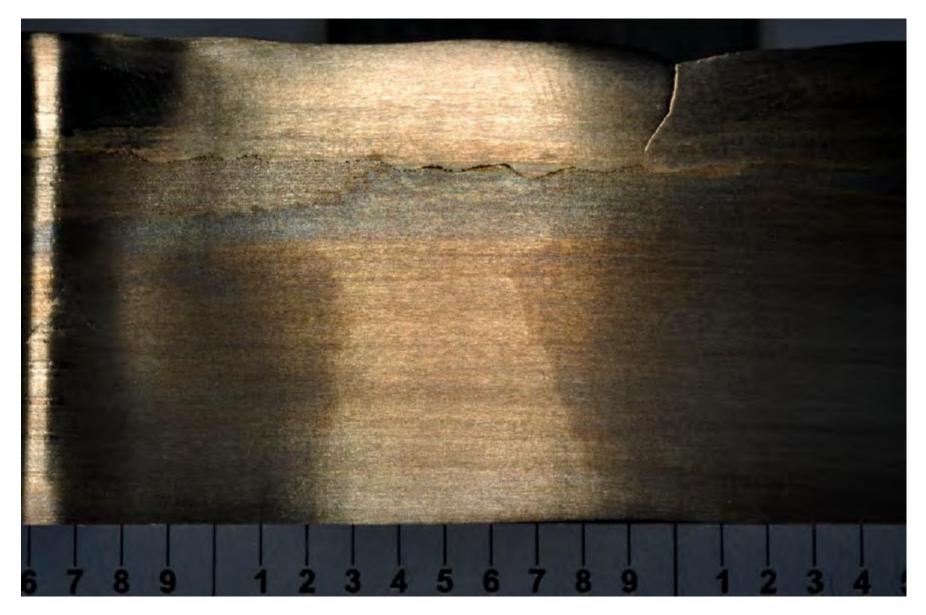
Results: Bending Fatigue Testing – WOL CW

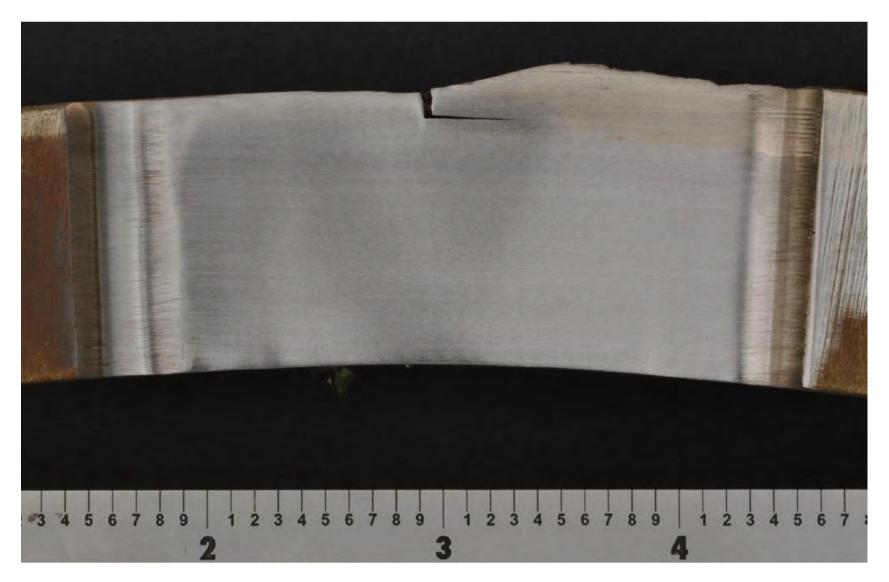
Results: Bending Fatigue Testing – WOL Transition

- All transitions are susceptible to cracking due to having a stress concentration factor. To maximize chance of success, transitions should be located in regions away from high stresses, or bending stresses.

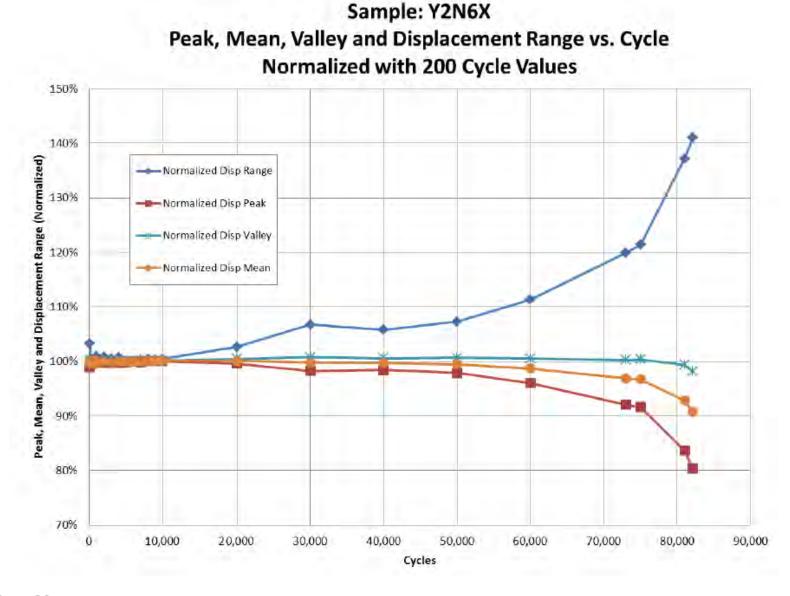
Results: Bending Fatigue Testing – WOL on Clad

- Less pronounced effect in mid-plate samples
 - Perhaps a significant contributing factor in circumferential weld samples
- Reinforcements in samples without the cladding removed, appear to be effective, so long as the bond strengths are sound, and any stress concentration factors caused by ridges are not significant enough to create problems.

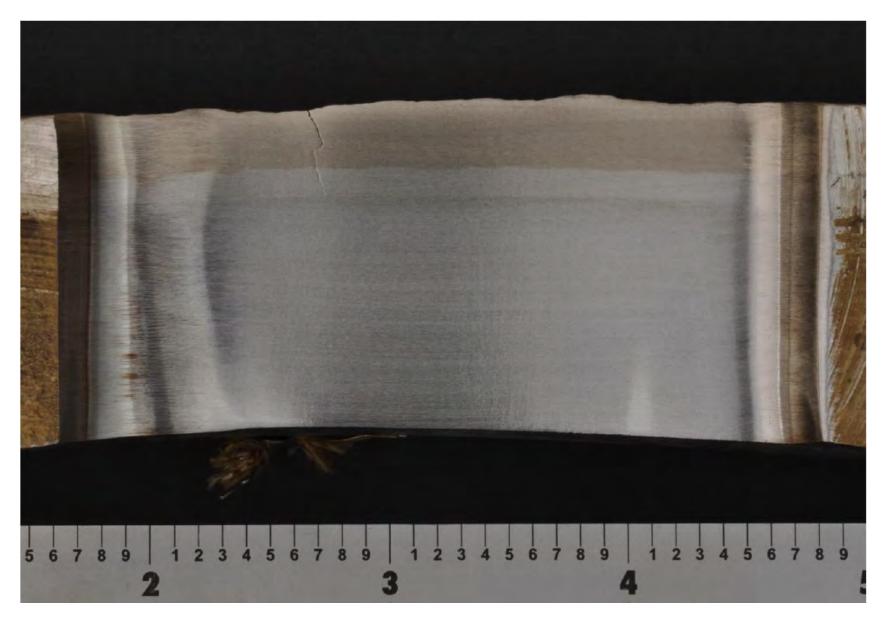
Results: Bending Fatigue Testing – WOL on Clad

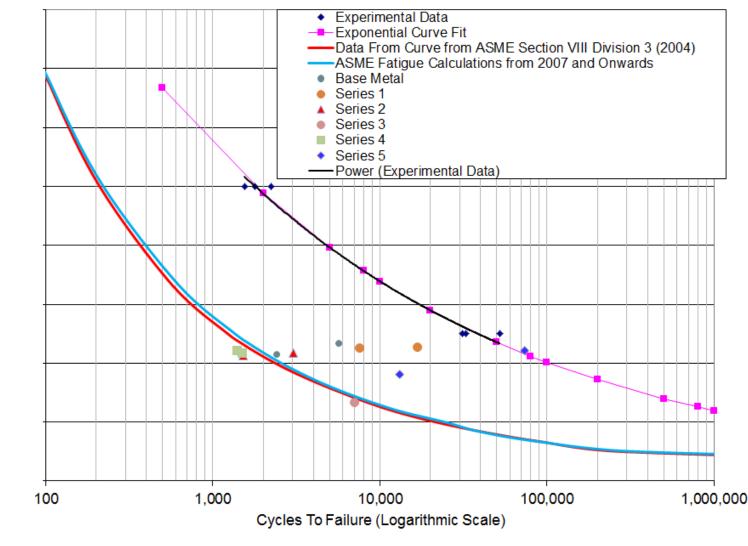
Results: Summary of All Tests (Failure)

Strain Amplitude vs. Cycles to Failure for Low Cycle Fatigue Tests At Elevated Temperature on Dog-Bone Specimens Overlaid with Inconel 625 with the Base Material Removed by Machining

- LCF testing of WOL material shows that Inconel 625 has a much higher degree of fatigue resistance than the base metal
- The material being tested is not virgin (10 year use). As such the previously accumulated damage is not readily quantified, and this may result in scatter in the results. However, results so far are very encouraging.
