Reliability of Drills and Drill Stems

Al Kaye, Reliability - Integrity Engineer

Ft.McMurray , Oct. 2012

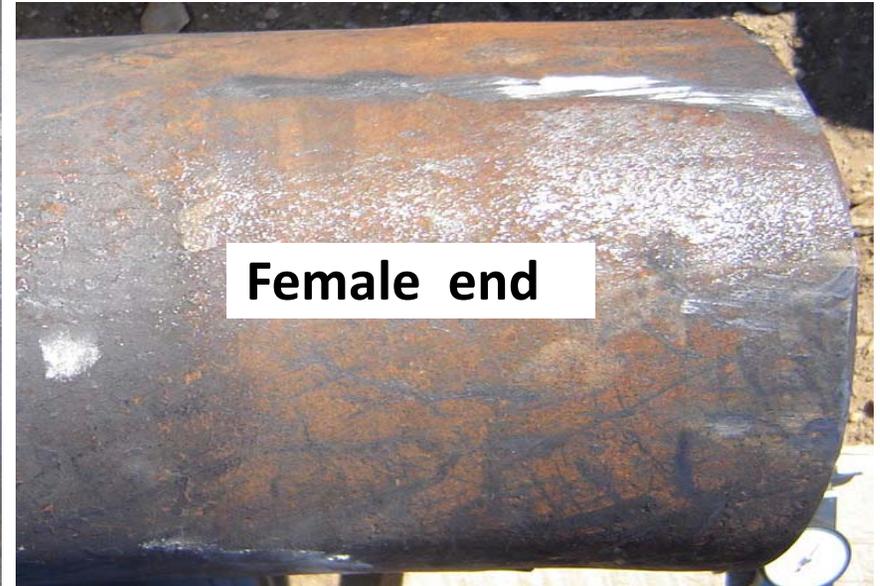
Female end

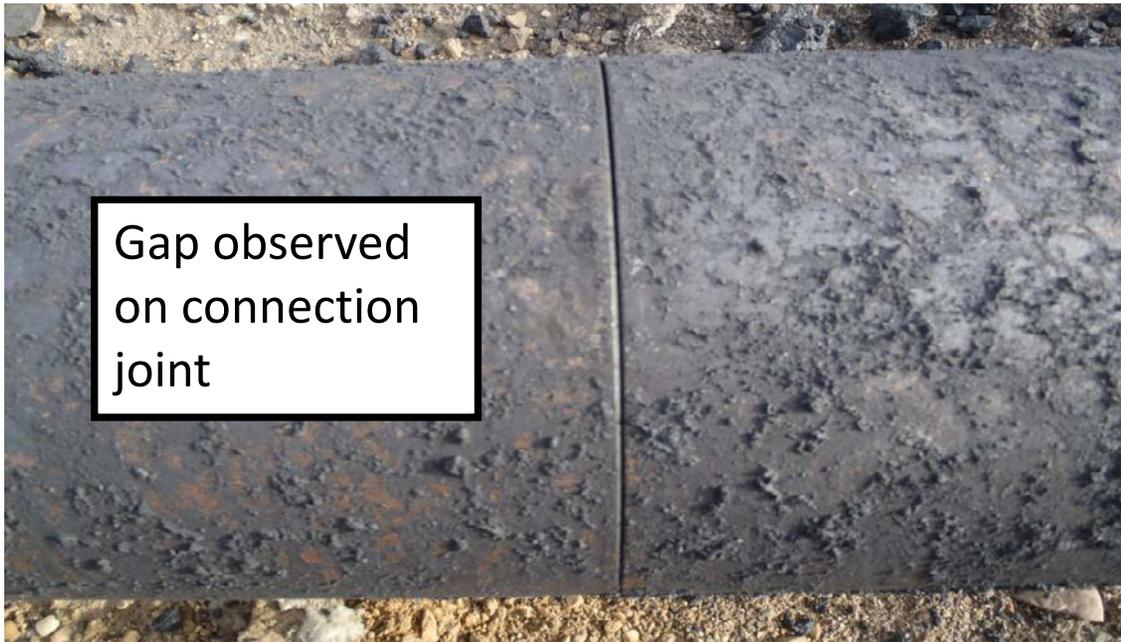
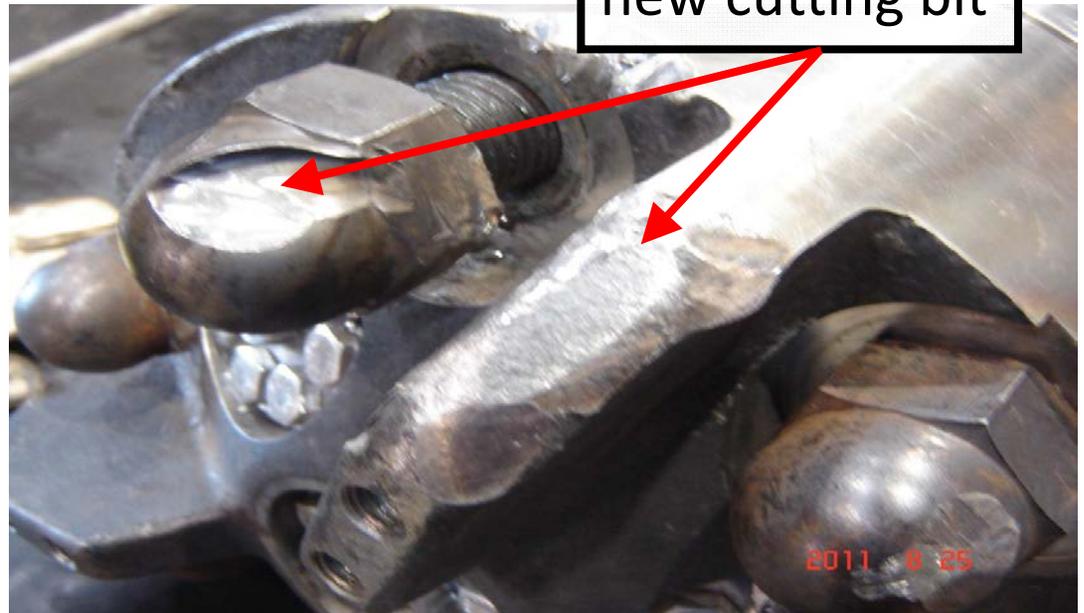
Drill Stems to **Cutting Bit**

Scarred nut exhibits from unknown source and found loose.

Fatigue Cracking.

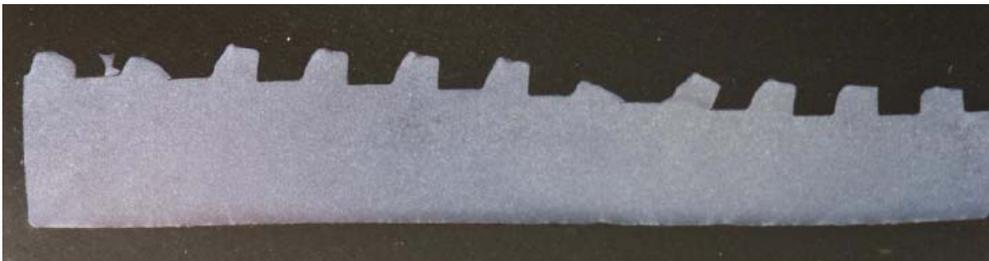
Thread Damage
