# THE LARGEST COKE DRUM BULGE REPAIRS IN INDUSTRY HISTORY

## **Amish Jani**

## **Mahmod Samman, Ph.D., P.E.**

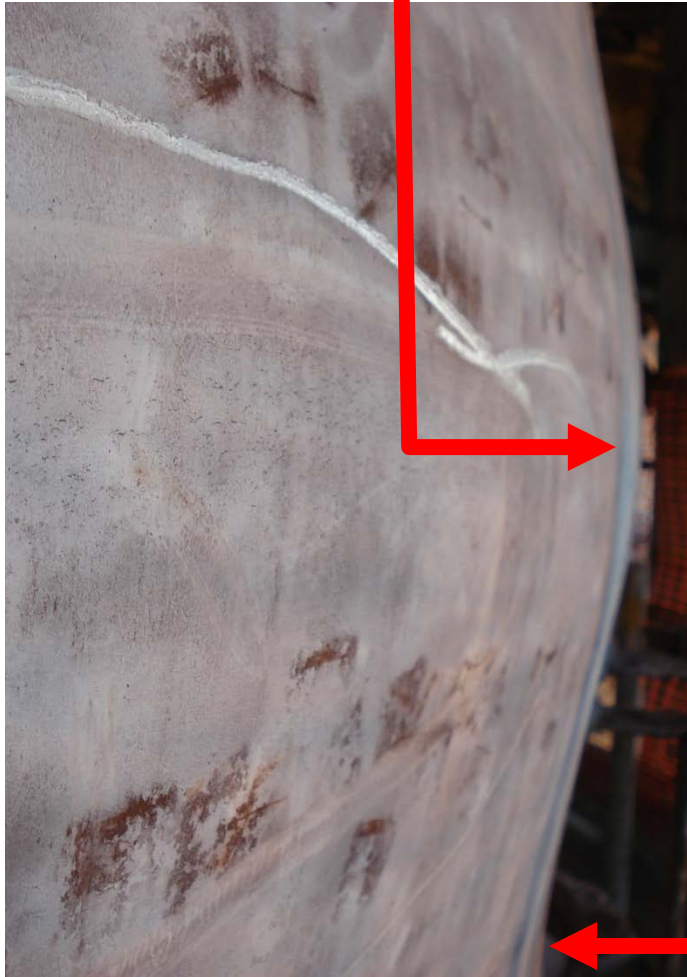
INTERIOR

# Bulging-Induced Cracks

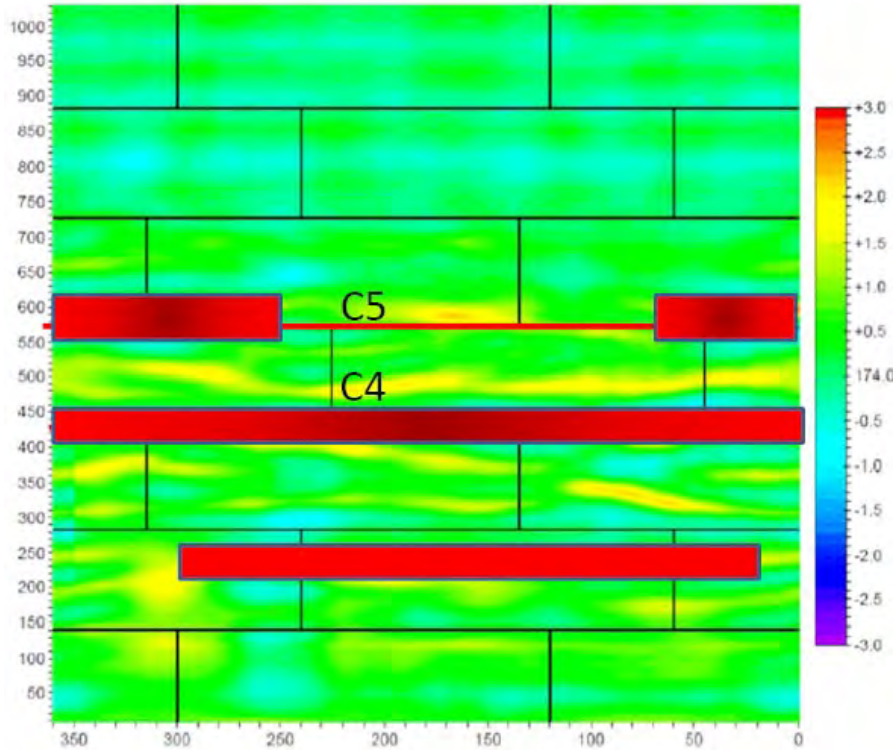
Typical Shell Map with repair areas on shell courses

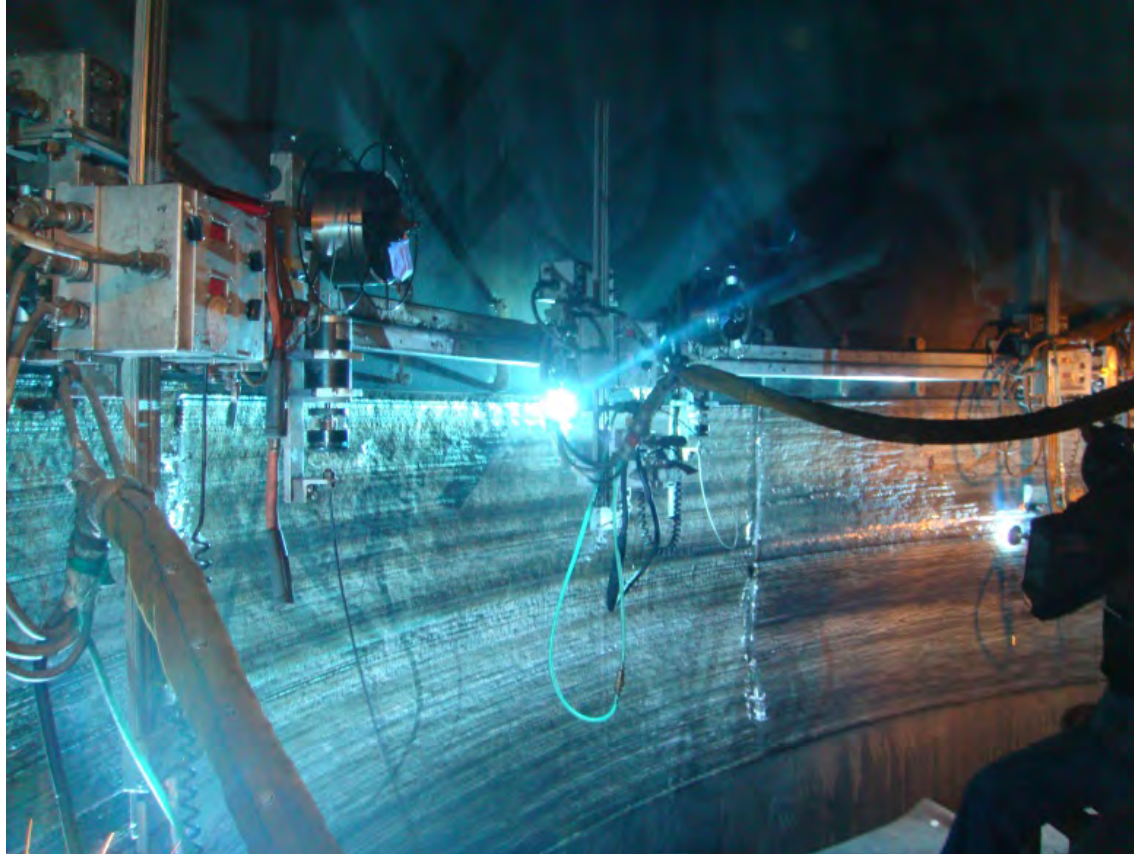
Typical bulge overlay repairs inside of the coke drum
