Vibration Testing and Troubleshooting of Coke Drums

Mahmod Samman, Ph.D., P.E.

Stress Engineering Services, Inc.

Coking.com Coke Drum Workshop

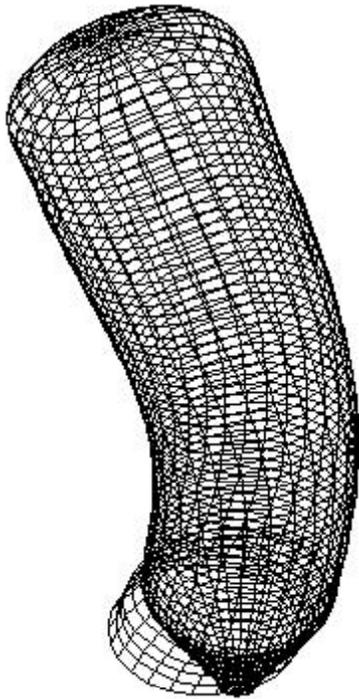
all 3d model of 28.5' drum
5-tiedcoke.cdb ABAQUS/STANDARD

rvalue solution
10342. Freq = 16.185

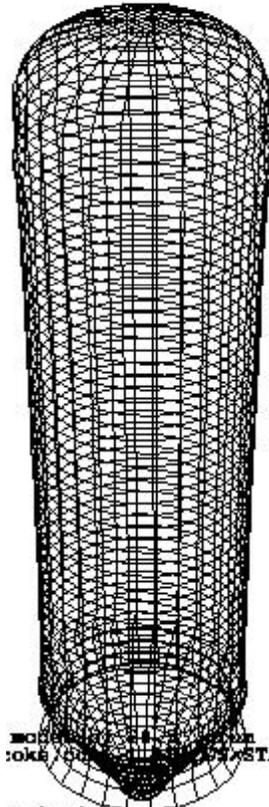
all 3d model of 28.5' drum
5-tiedcoke.cdb ABAQUS/STANDARD

rvalue solution
10342. Freq = 18.377

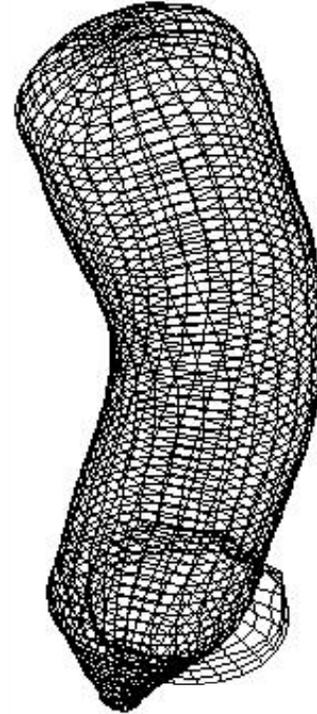
all 3d model of 28.5' drum
5-tiedcoke.cdb ABAQUS/STANDARD

rvalue solution
34466. Freq = 29.547

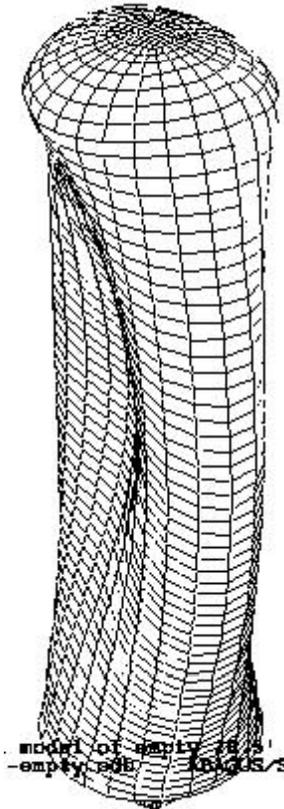
all 3d model of 28.5' drum
5-tiedcoke.cdb ABAQUS/STANDARD

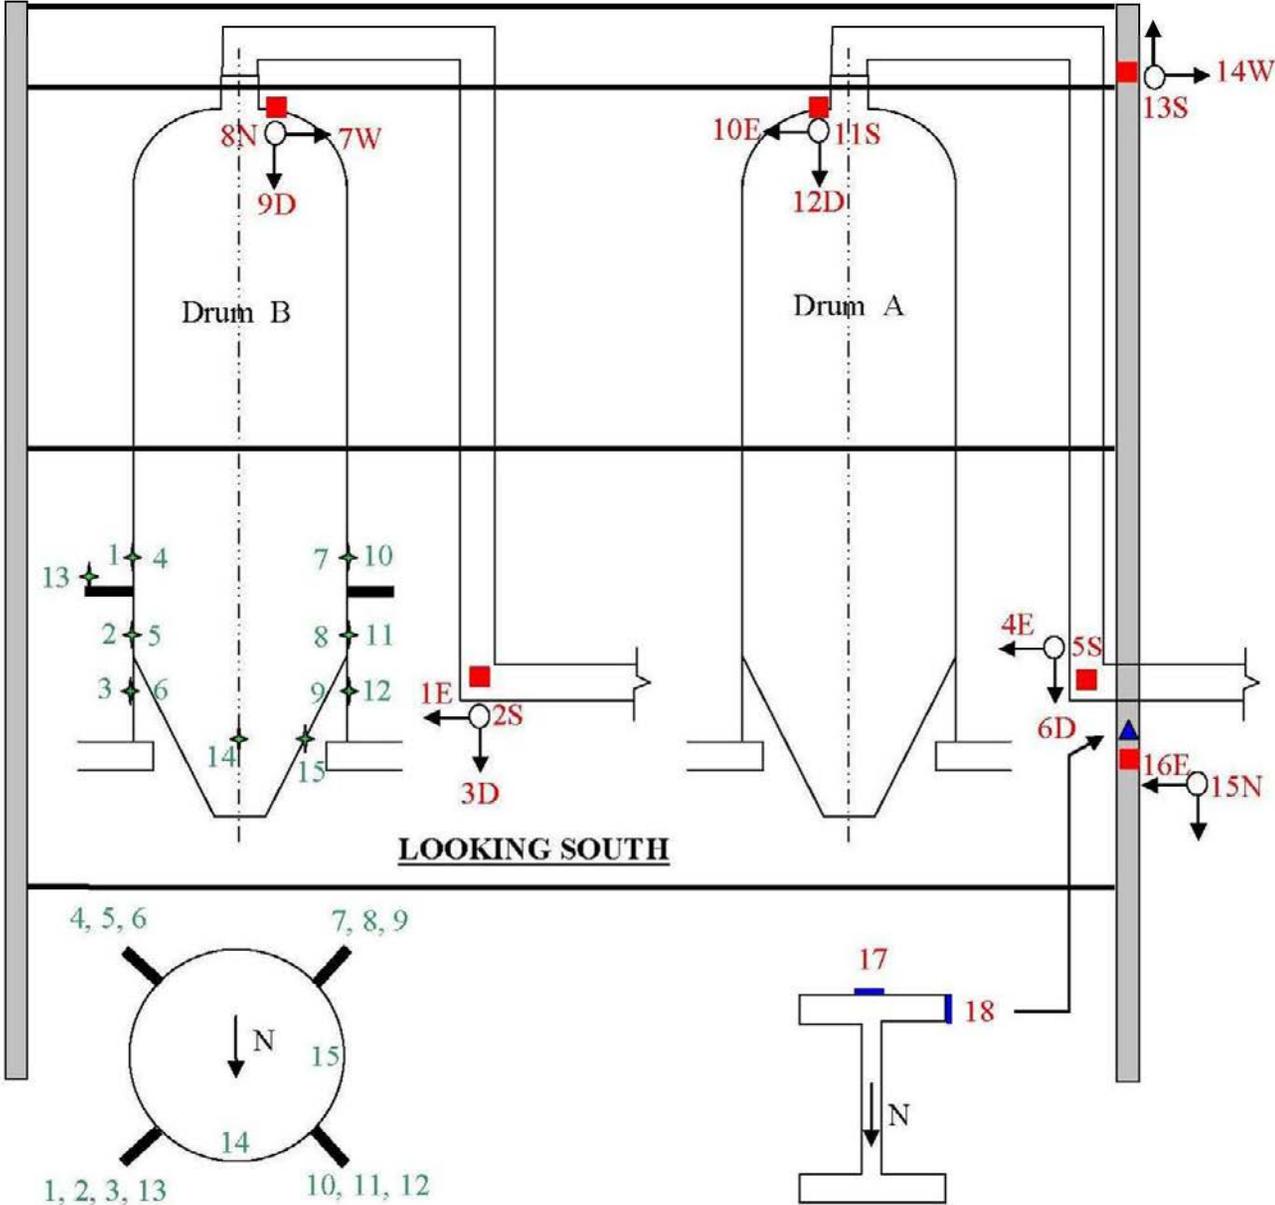
Sensor Layout

- ✦ Thermocouple
- Accelerometer block
- ▲ strain gage

- Installed 33 sensors and two data acquisition systems on the drums, piping, and structure.
- Monitored the unit for a period of 20 days (14 cycles)
- Processed and analyzed the data in time and frequency domain.
- Analyzed the correlation between key process variables with vibration, strain, and temperature measurements.

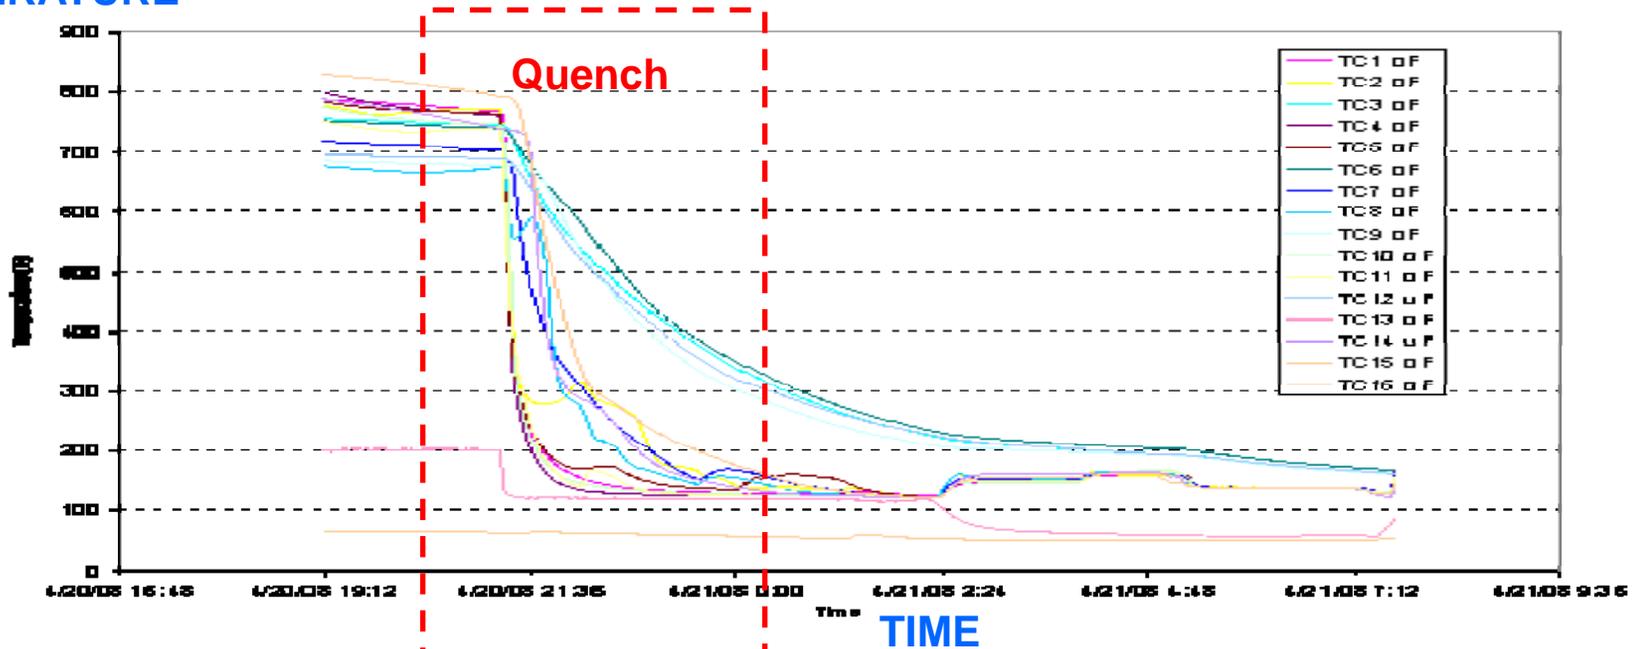
Example Quench Transient

TEMPERATURE

TIME

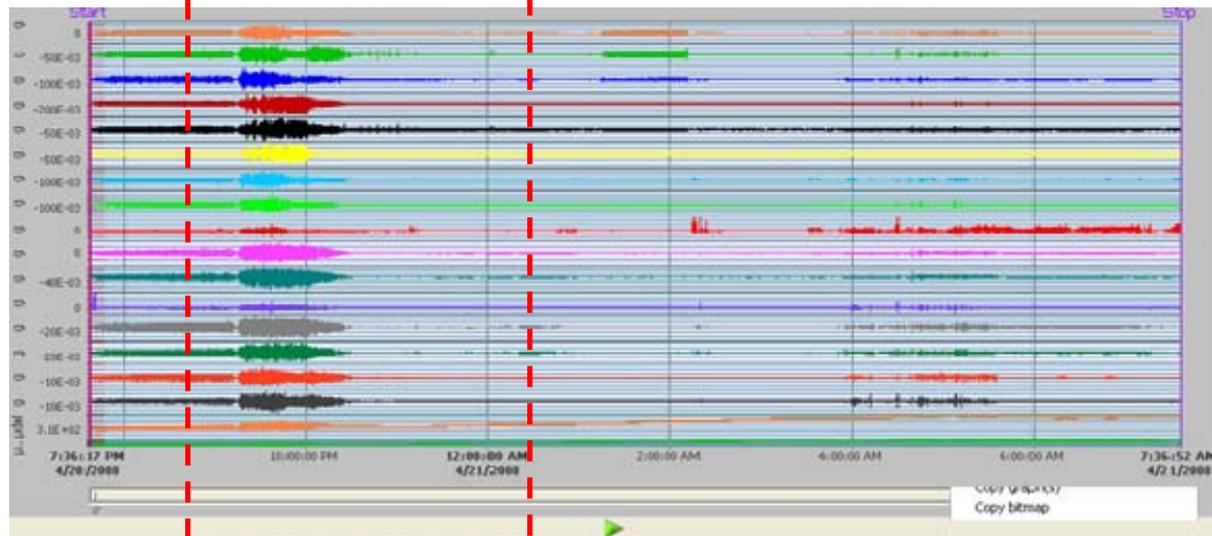
ACCELERATION

- Drum vibration magnitude was maximum during the quench part of the cycle in the East-West direction.
- The two drums vibrated in a comparable manner both from magnitude and frequency standpoints.
- The maximum recorded peak displacements were 0.58, 0.35, and 0.23 inches for the drums, the piping, and the structure, respectively.
- Measured dynamic strains in the structure were below the fatigue-inducing levels
- The correlation between vibration levels and recorded process parameters was established

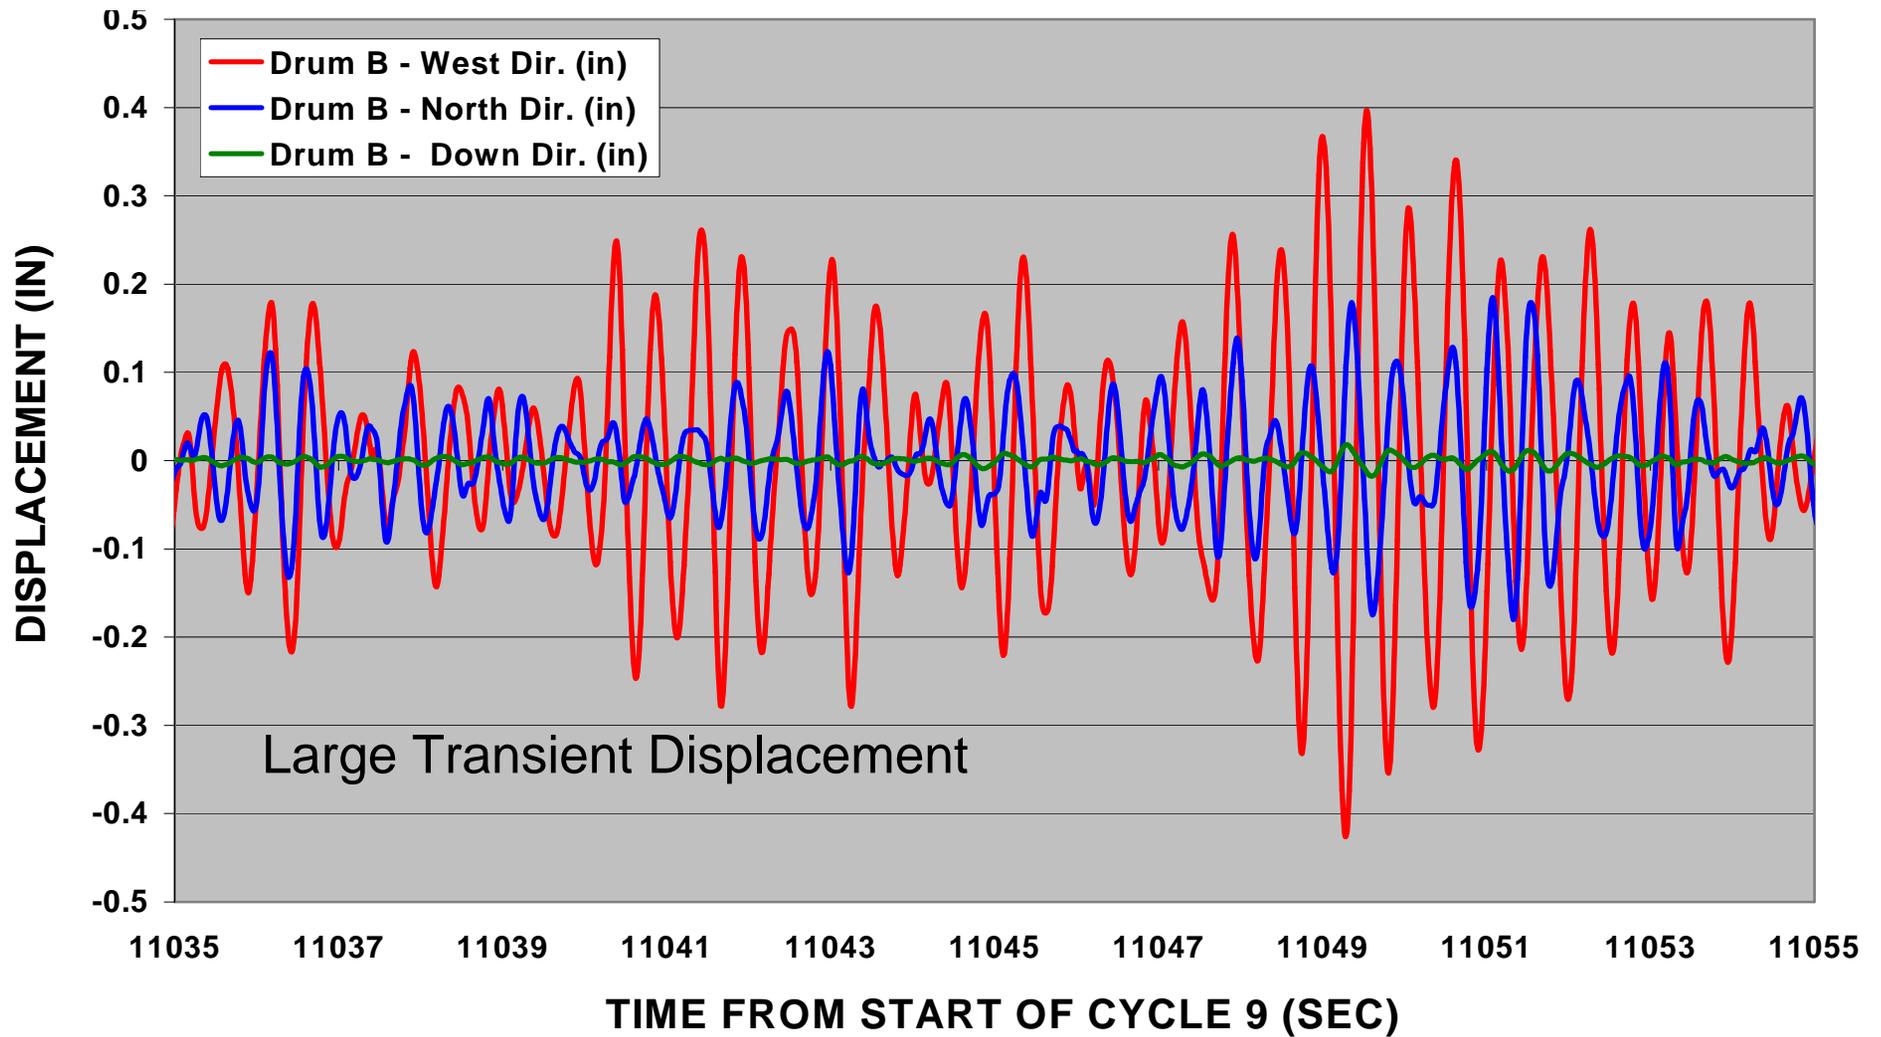
Integrated Displacement Data

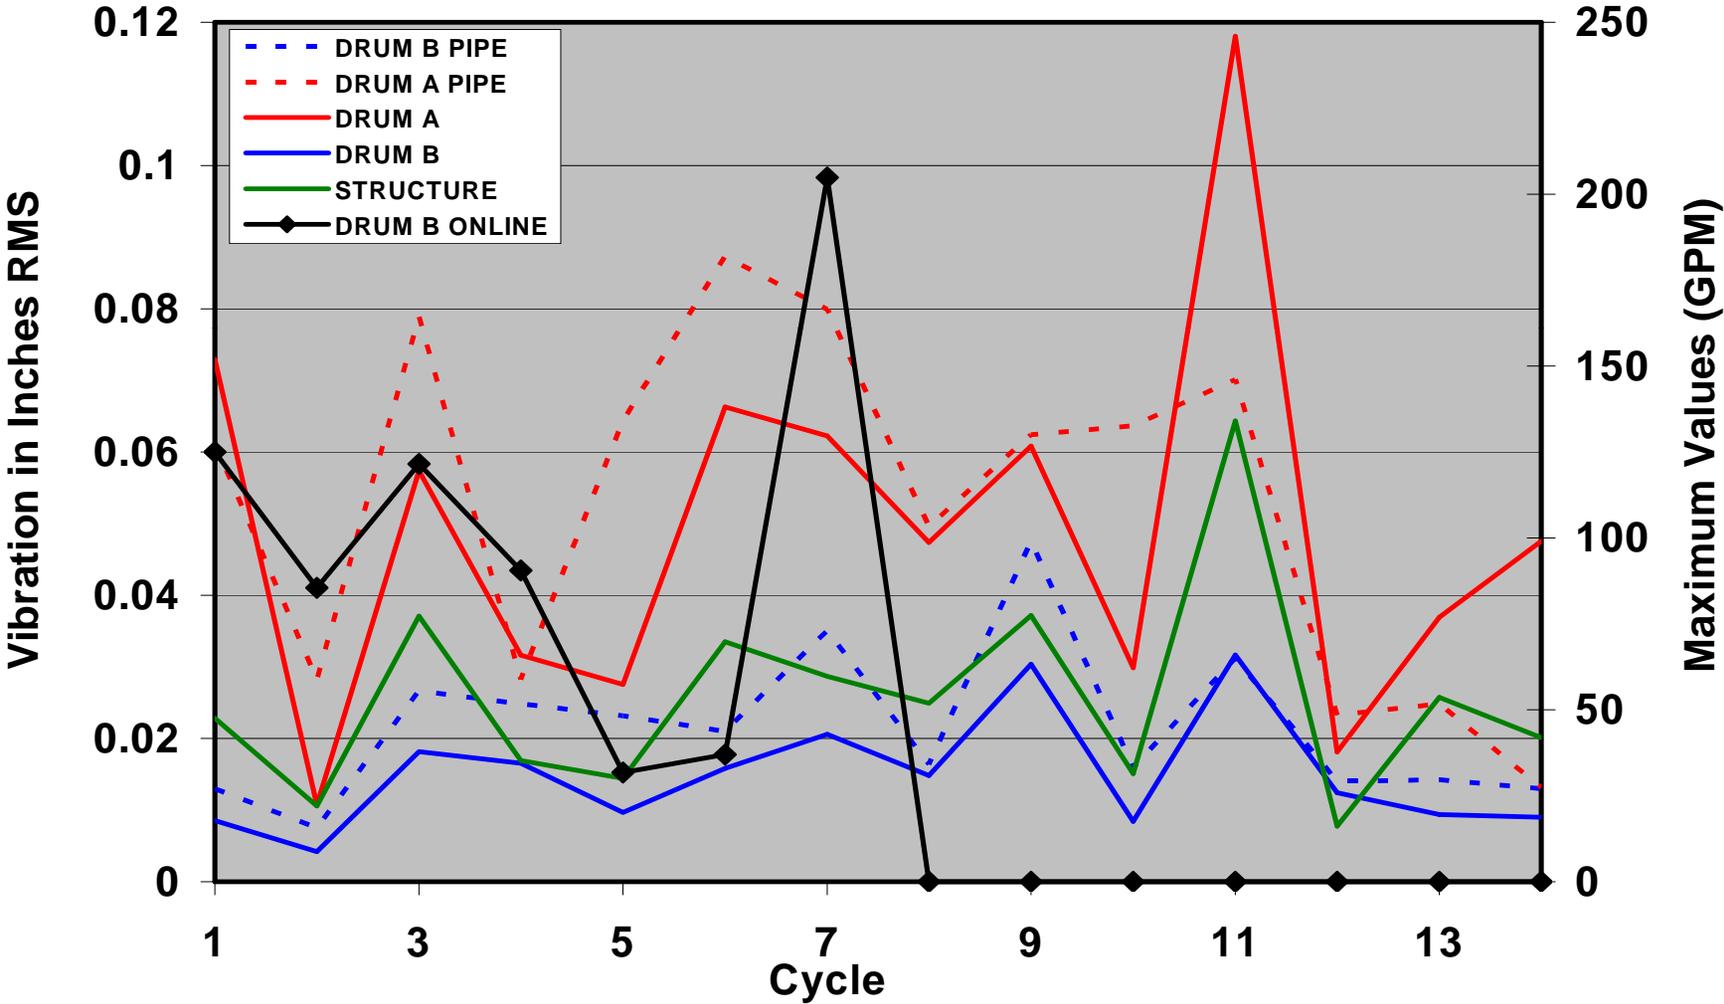
Vibration Versus Flow Rate

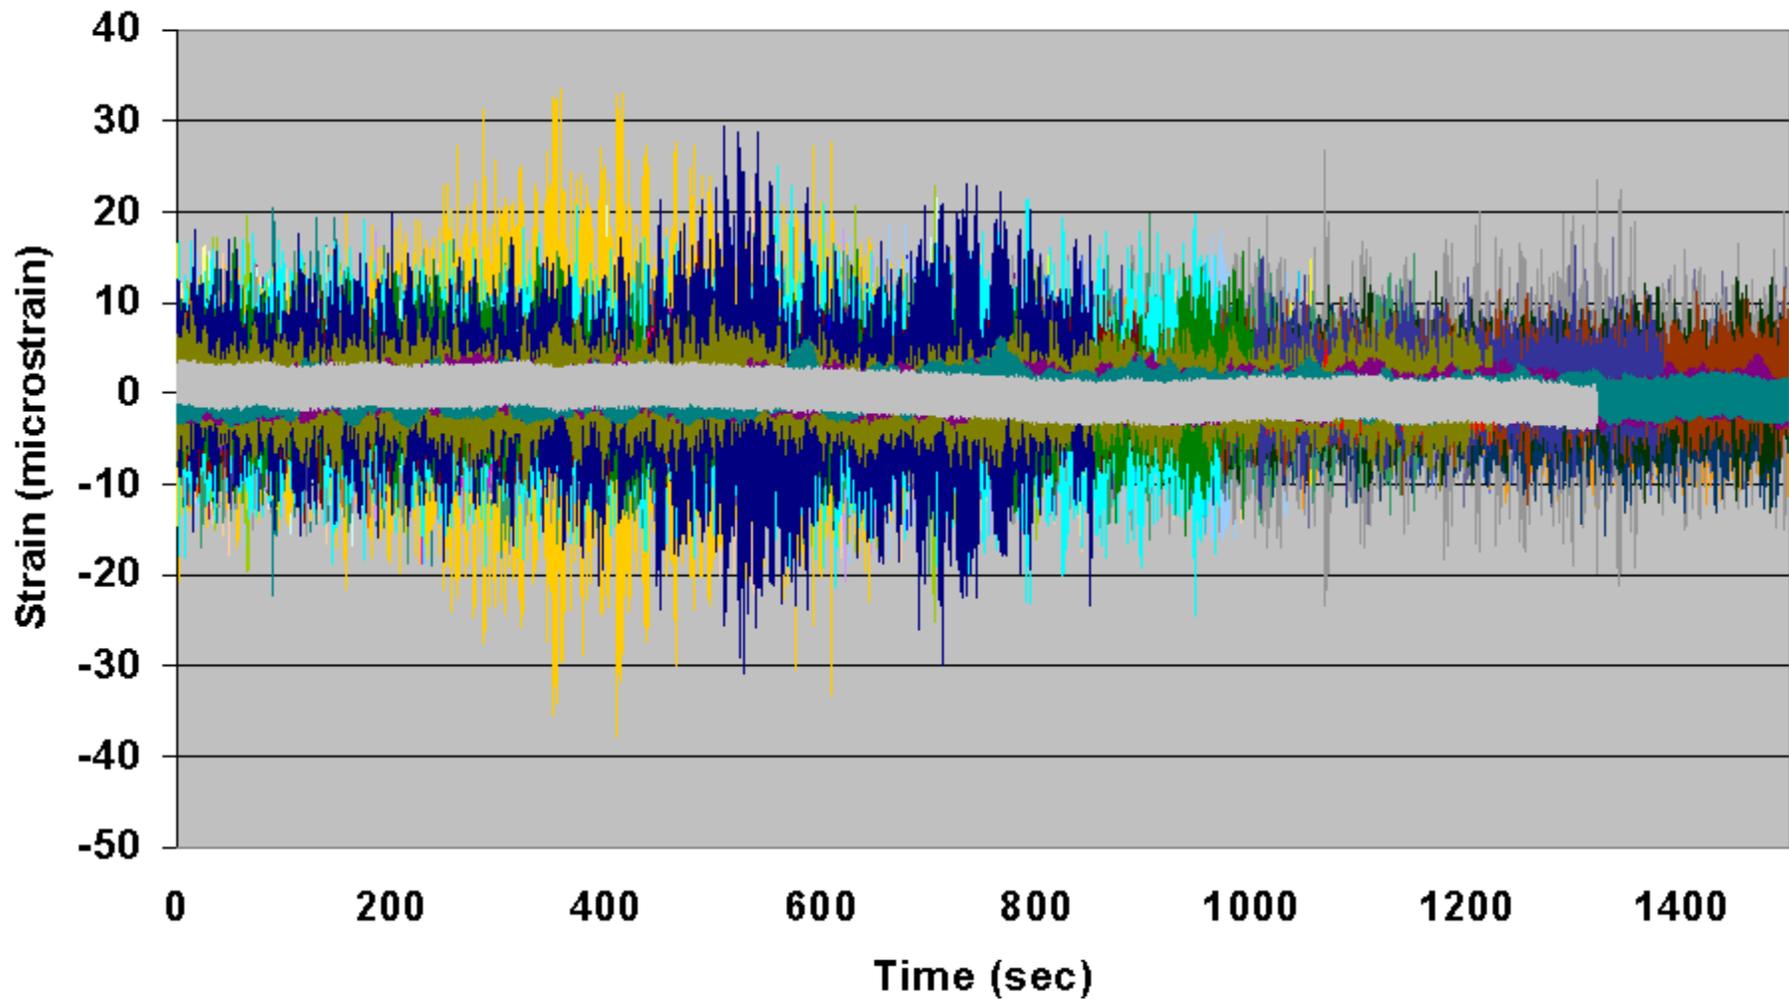
Strain Gauge Data

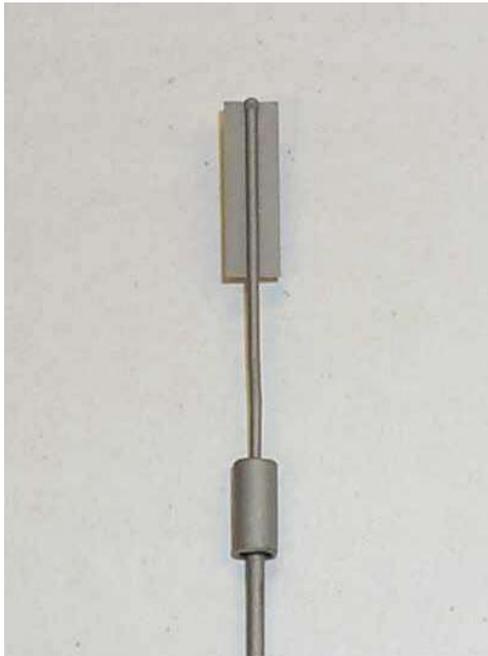
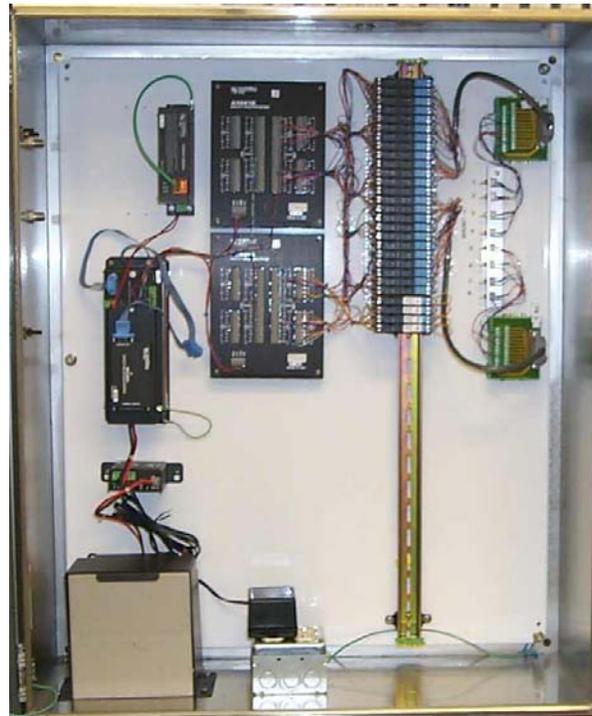
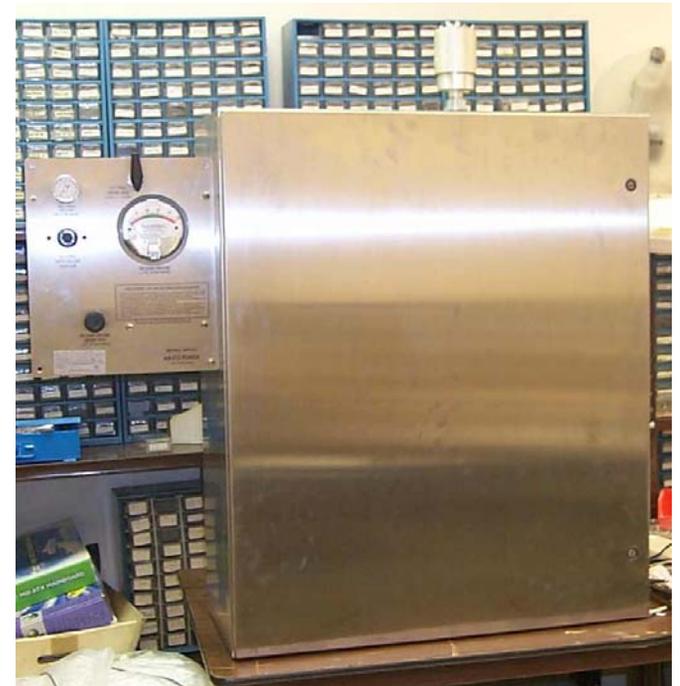
Intrinsically Safe Instrumentation System

1. Instrumentation
 - Strain gages
 - Thermocouples
2. Extraction of loading conditions
3. Finite element analysis
4. Fatigue Assessment

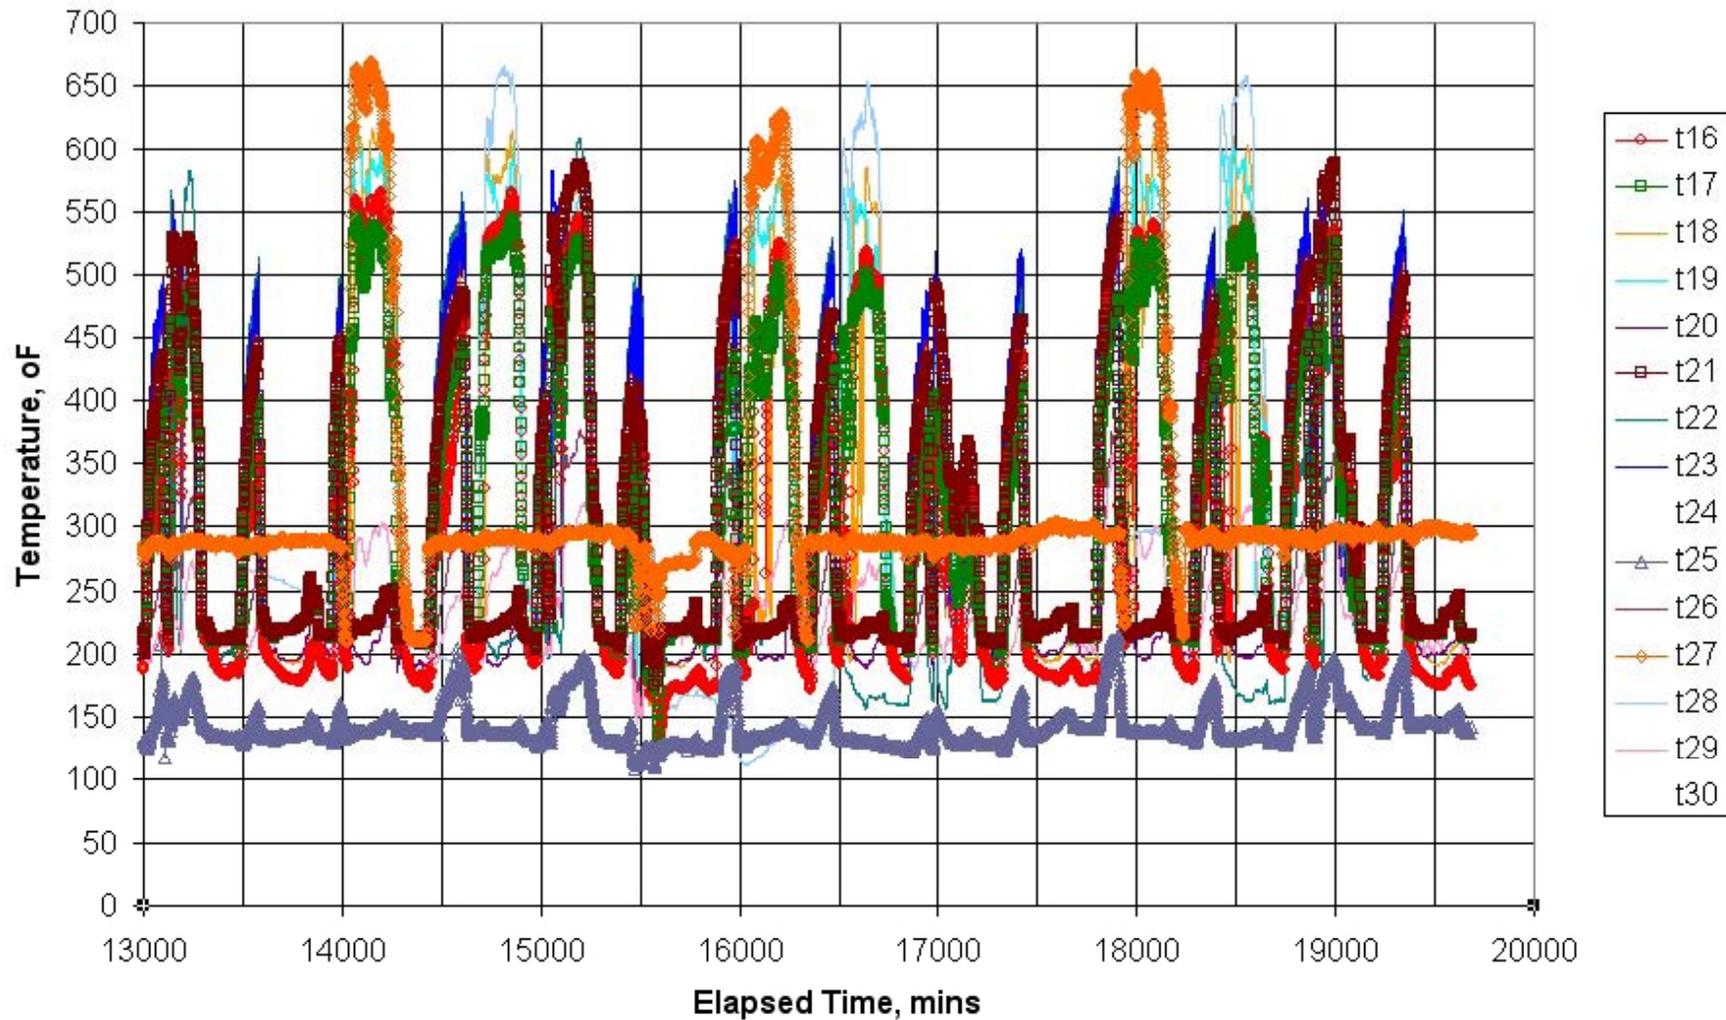
TEMPERATURE MEASUREMENTS

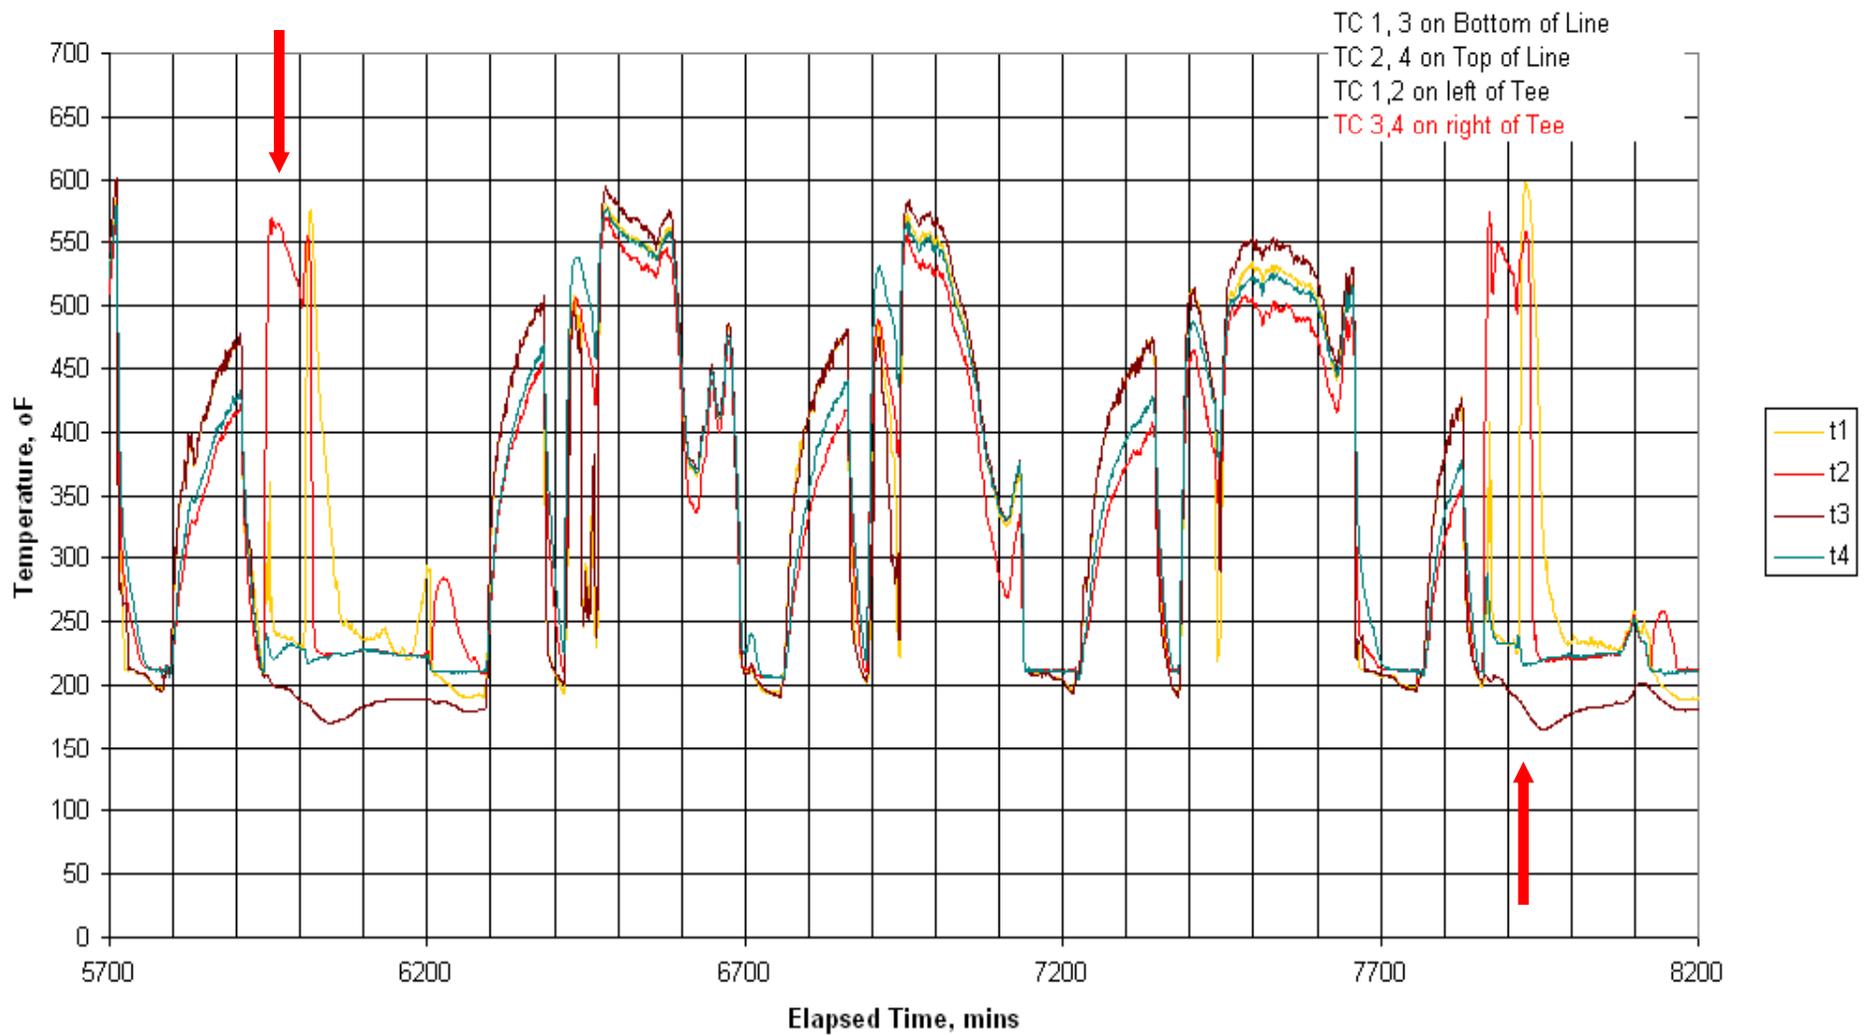
THERMAL GRADIENTS

Every fourth cycle

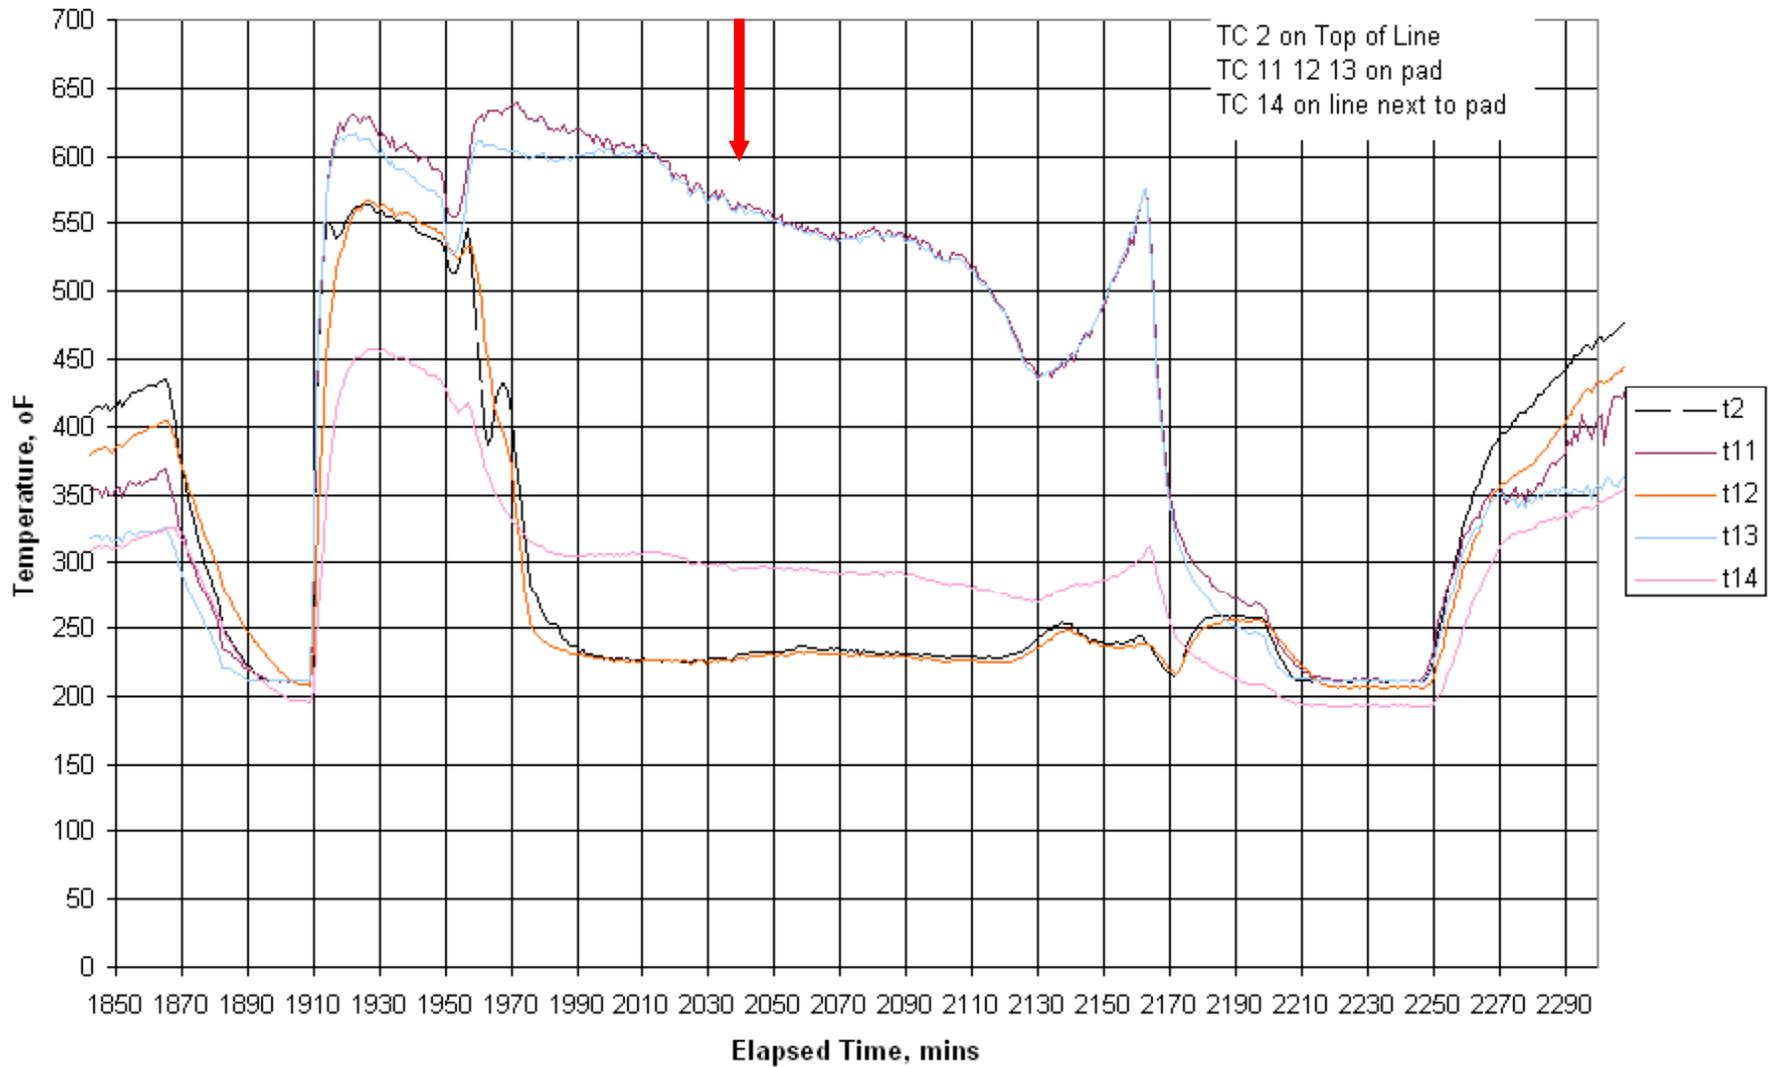
PAD THERMAL GRADIENTS

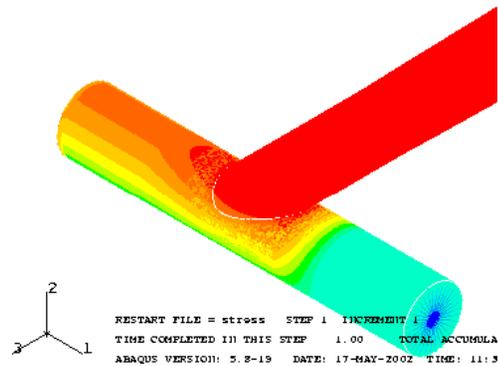
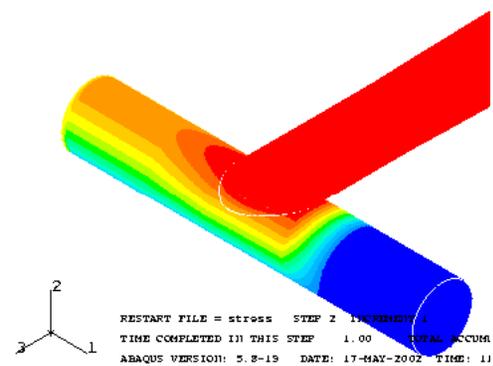
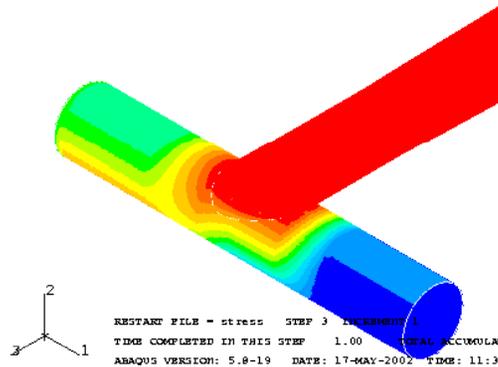
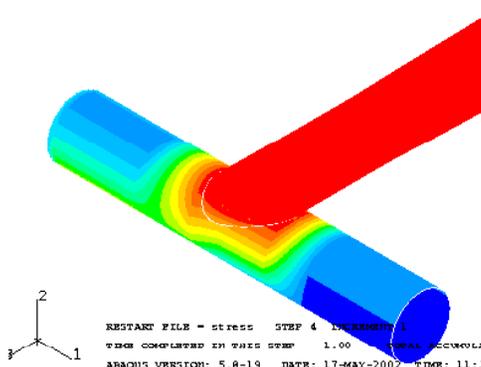
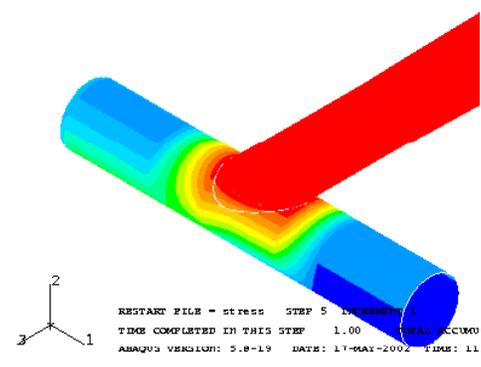
Extracted load cases

Five thermal profiles during the coking cycle

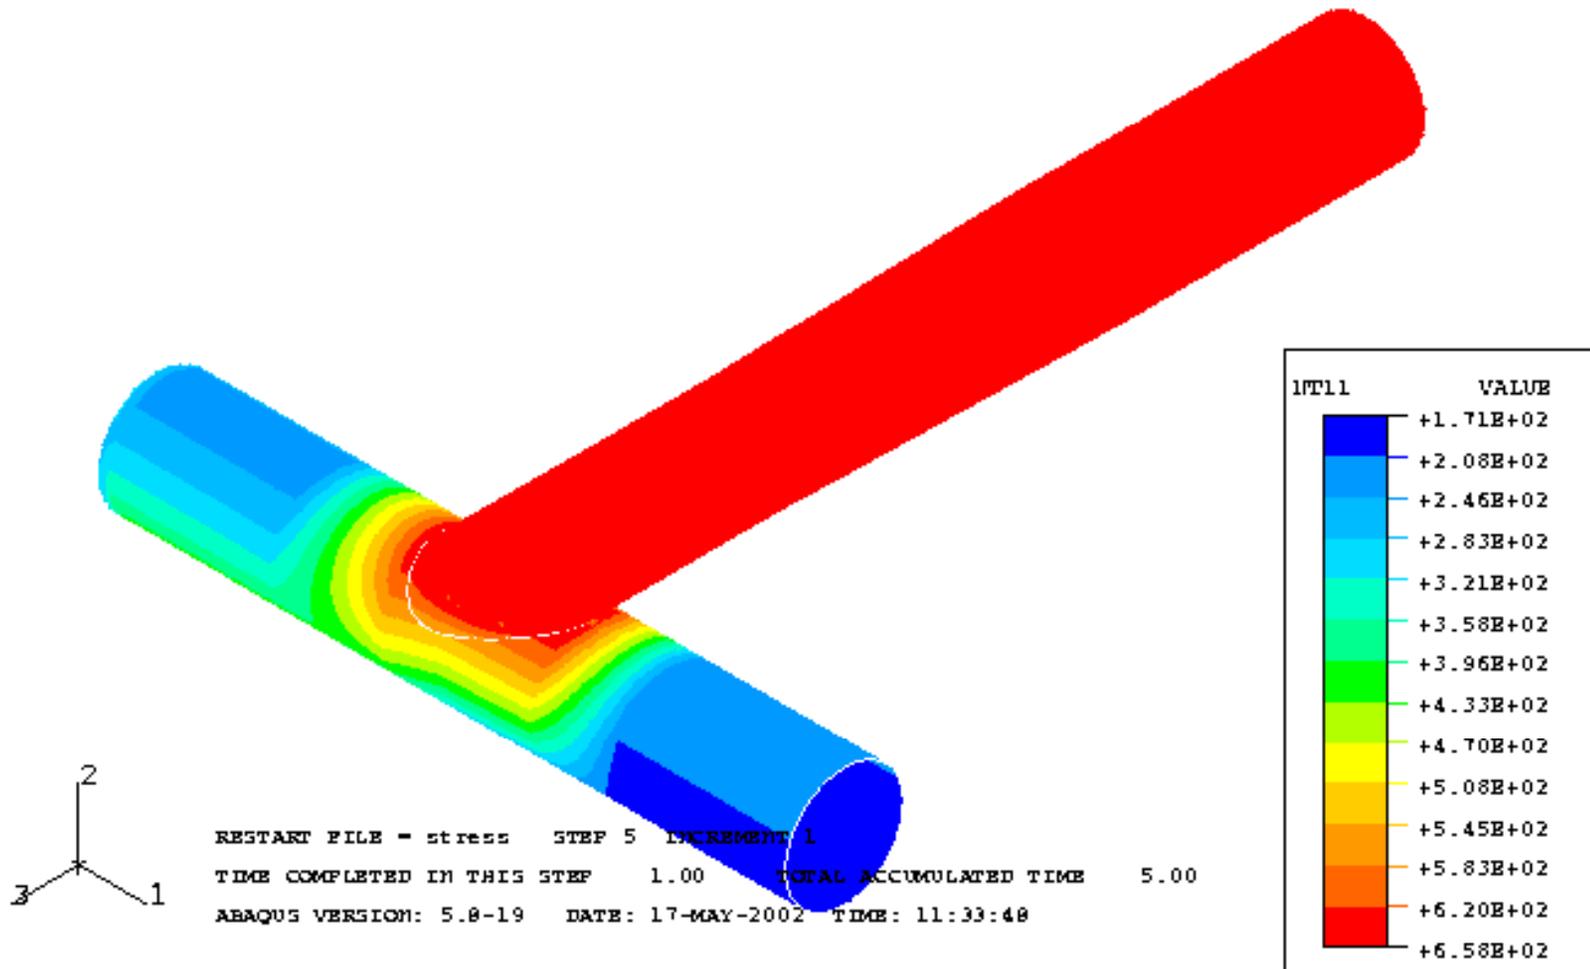
Thermal Load Case

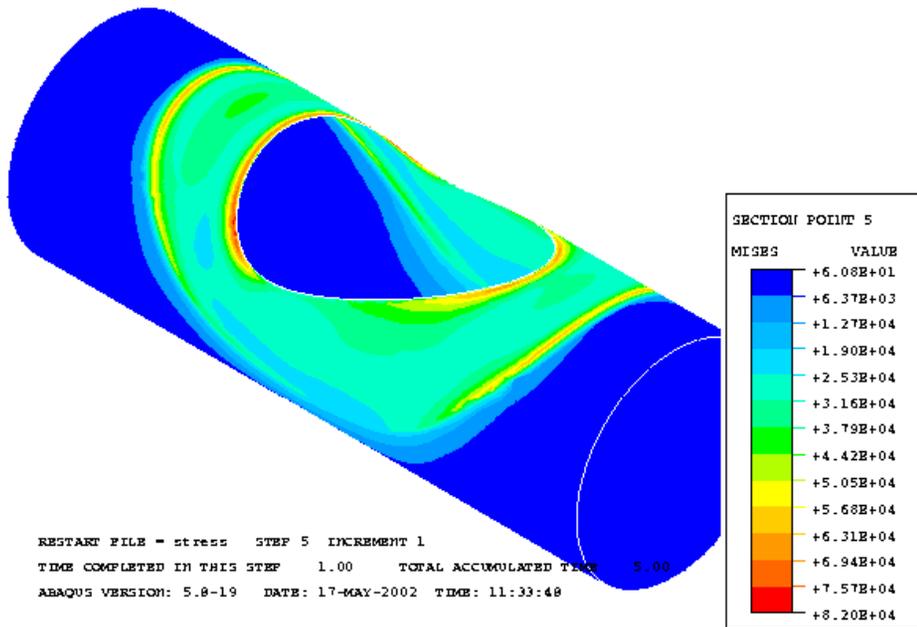
Von Mises Stress in the pipe

outside

- Maximum thermal stress range is 92 ksi.
- Alternate stress is 49.8 ksi.
- Correction for E at 400⁰F
- Fatigue life is 4,441 cycles.

- Vibrations and pressure are not the main problem.
- The failure is caused by severe thermal transients that generate 92 ksi stress range in the pipe at the location of cracks.
- Recommendations to minimize stresses and increase fatigue life:
 - Redesigned integral fitting.
 - Fatigue-resistant welds.

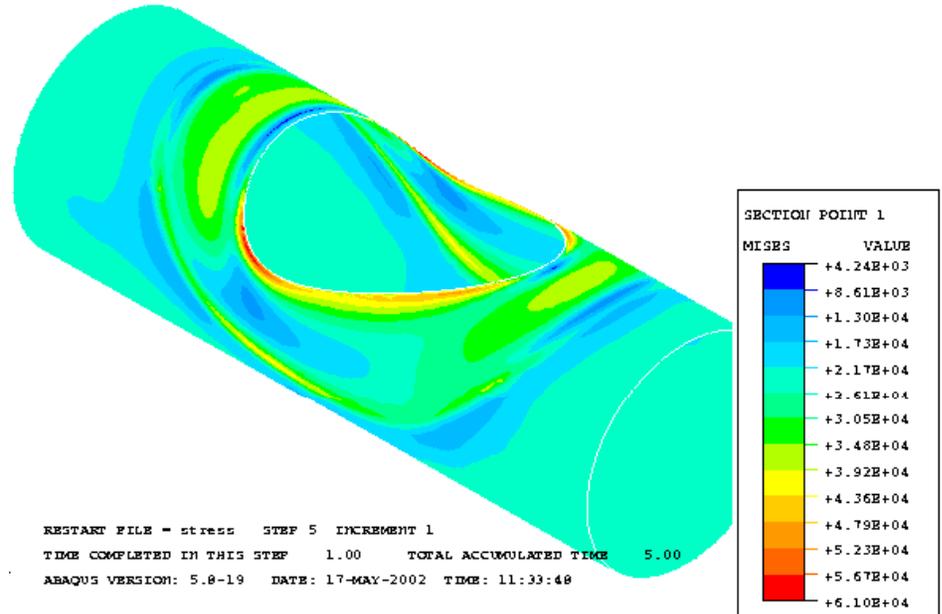
inside

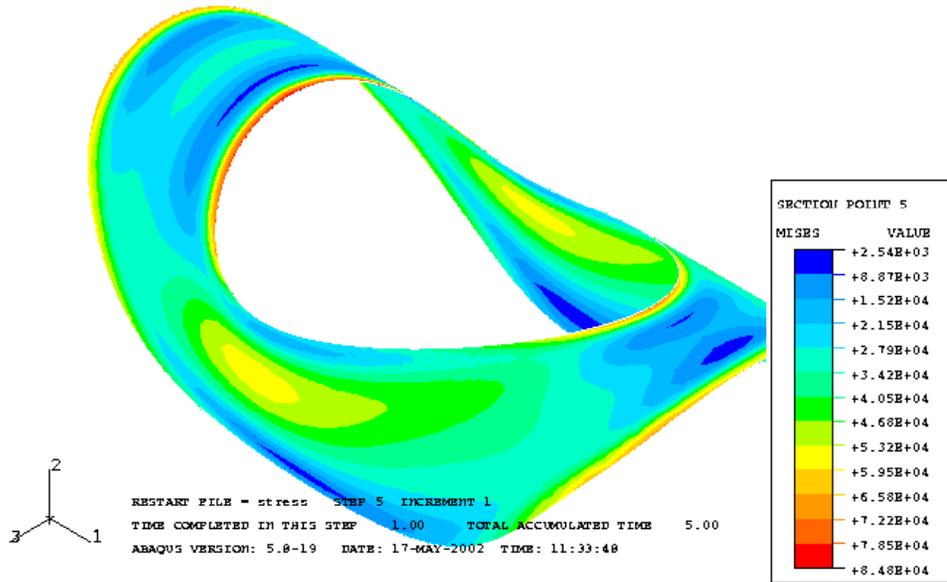
Von Mises Stress inside the pad

outside

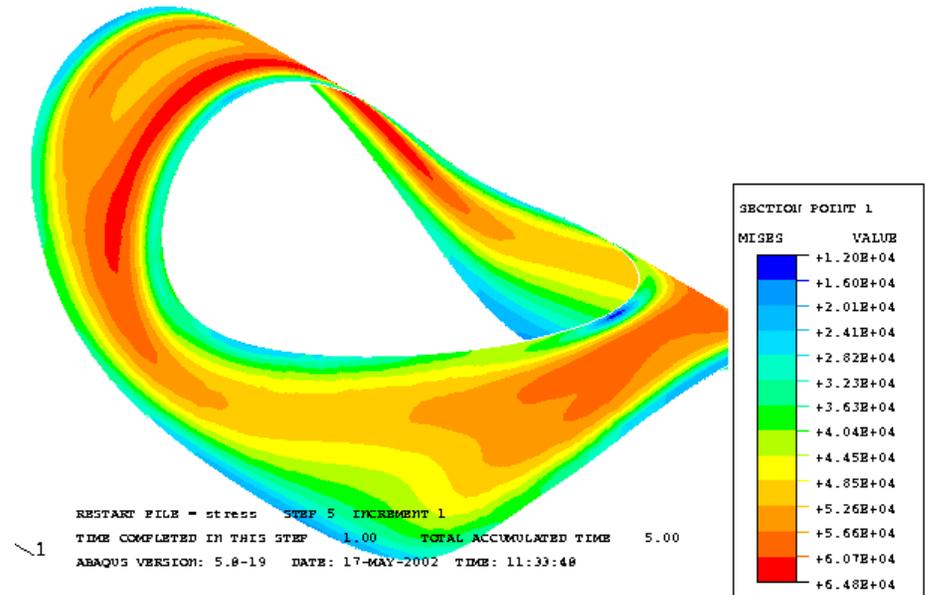
inside
