# Failures of High Alloy Expansion Bellows in Refinery Catalytic Cracking Units

*Gerald W. Wilks  
Senior Corrosion and Materials Engineer  
CITGO Petroleum Corporation  
Lemont Refinery*

# Presentation Summary

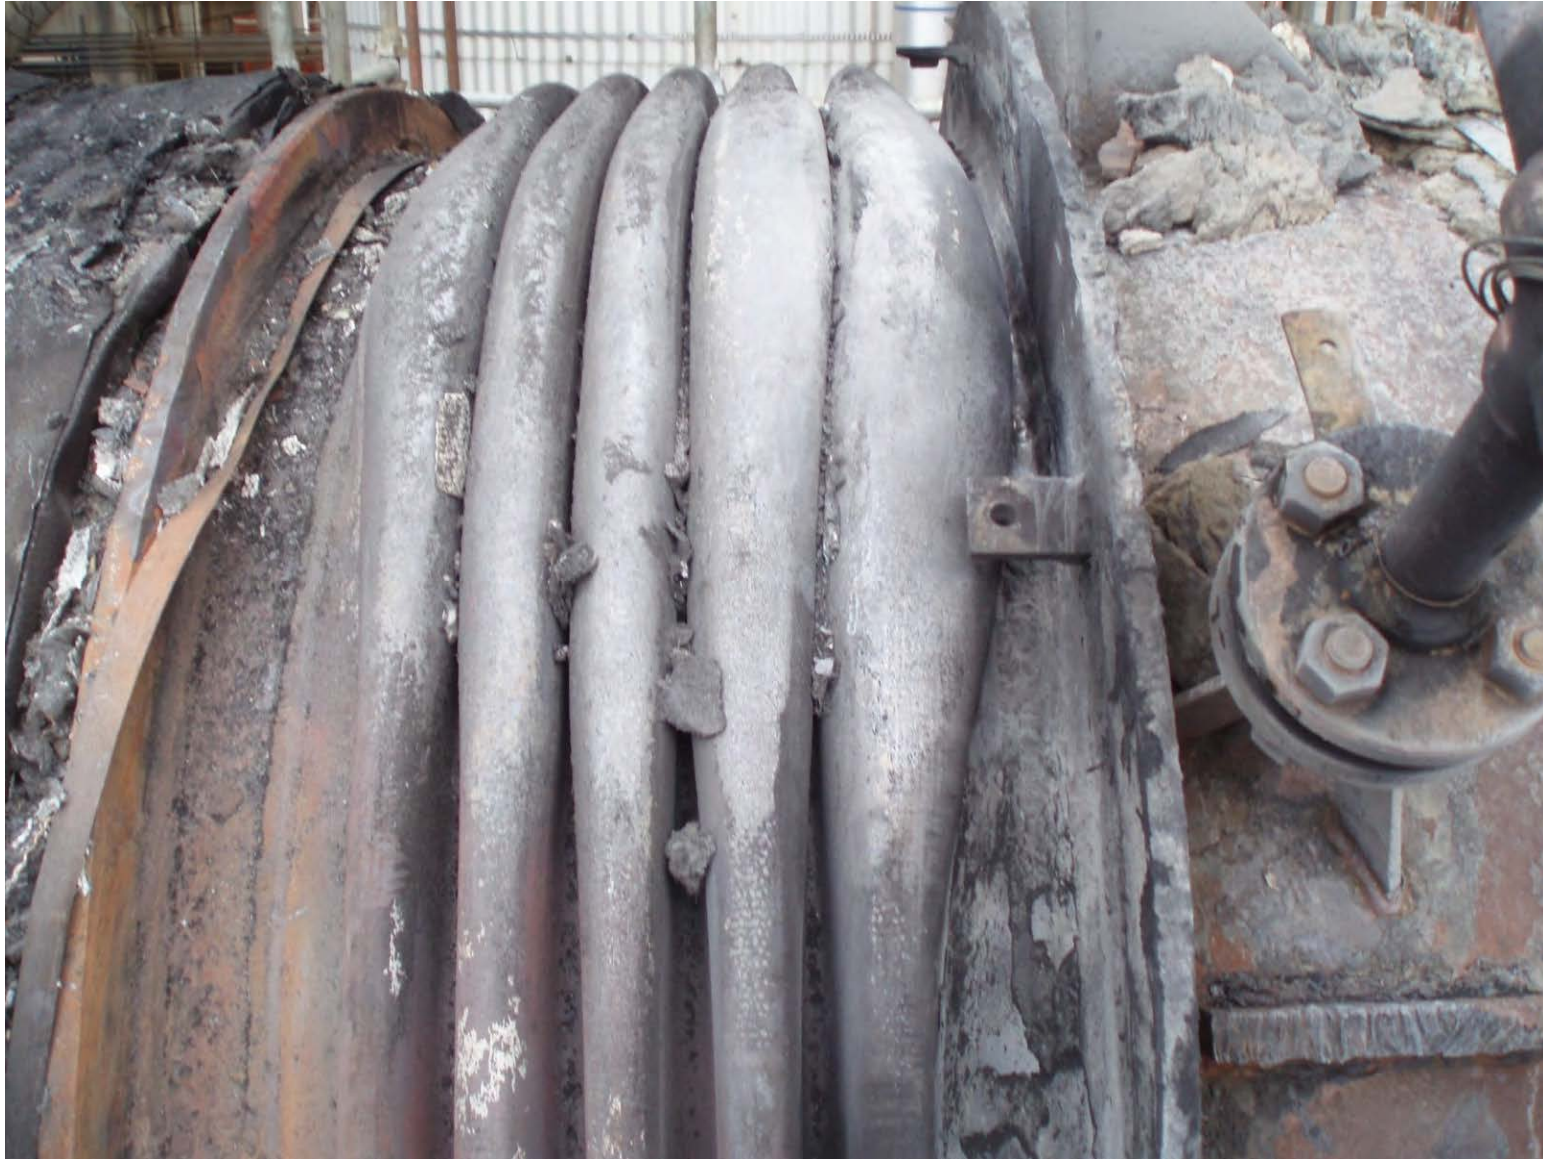
## Fire Damaged Area of the Bellows

# The Reactor Overhead Line Bellows Failure

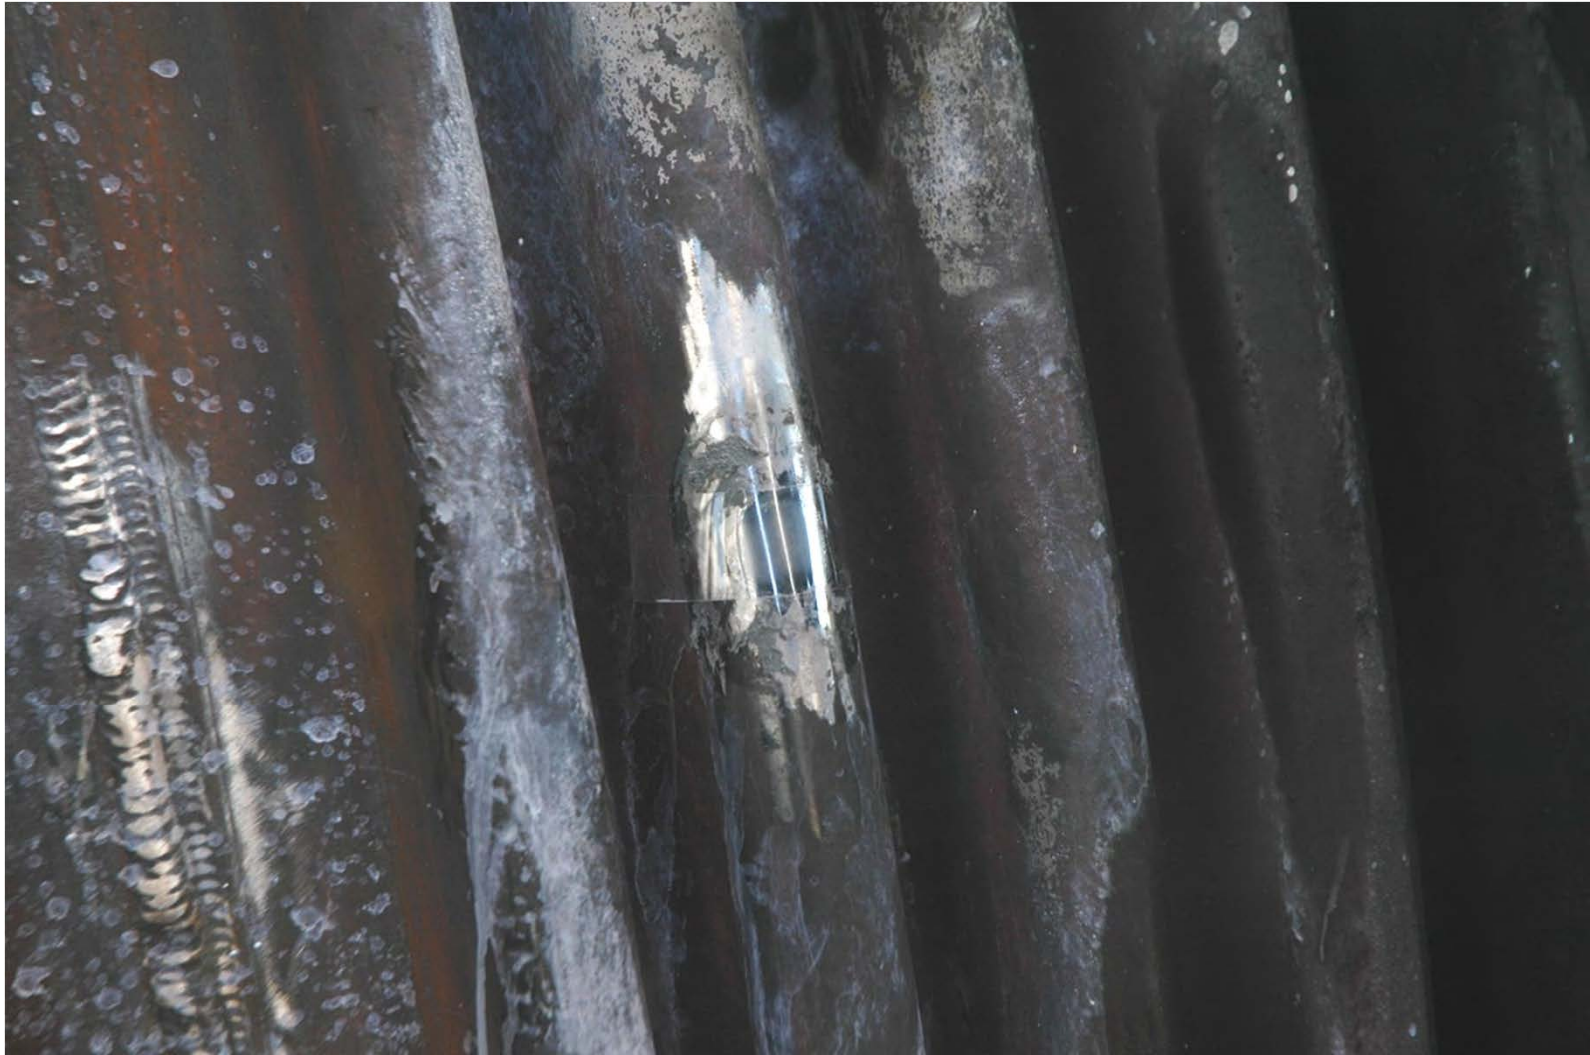
# Insitu Metallography of the Reactor Bellows

This indicated the steel was sensitized.

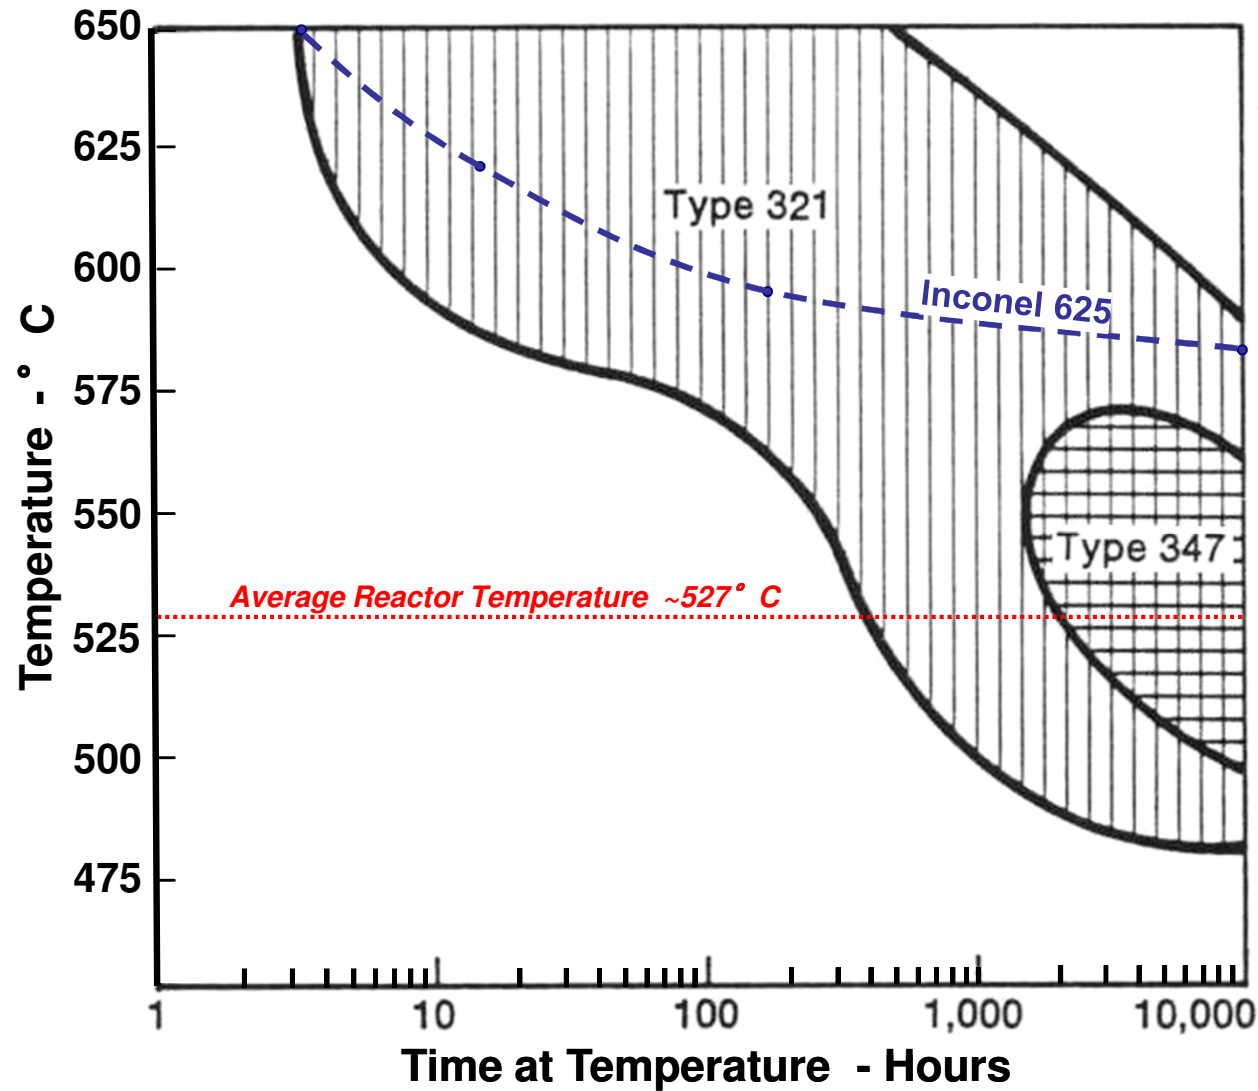
# Sensitization of Stainless Steels and Inconel 625

Could the bellows be sensitized?

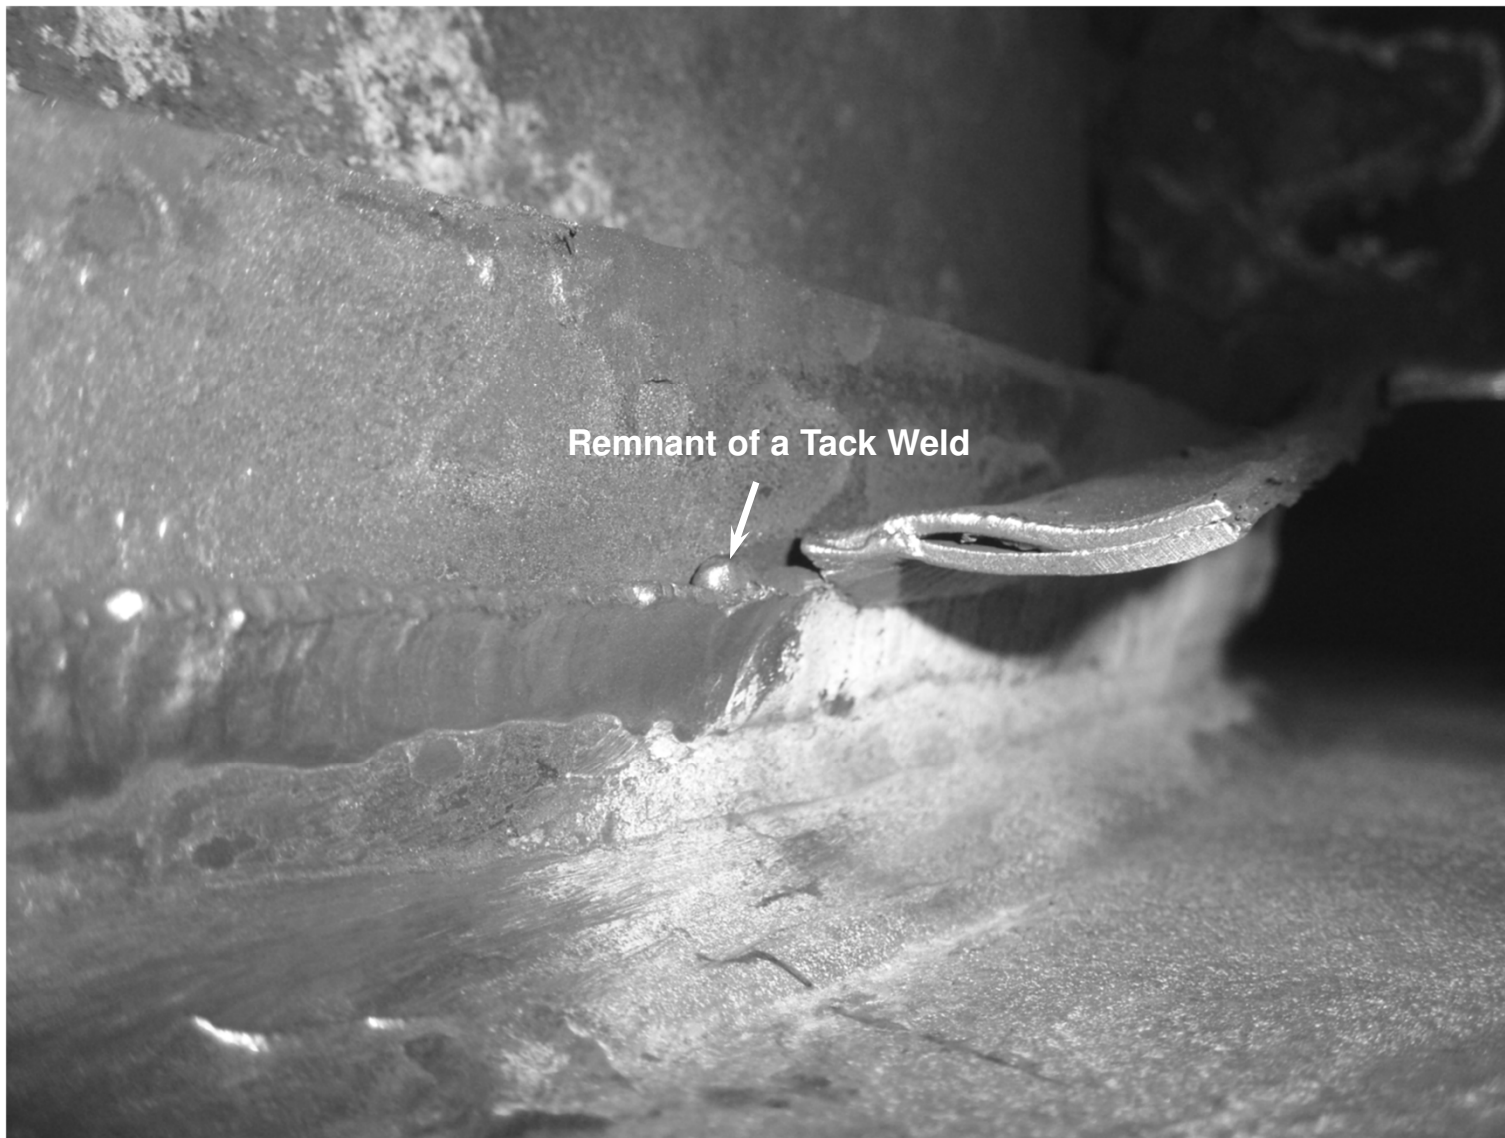
# Unusual Weld Features

Tack Welds that Weren't Melted by the Attachment Weld

- Primary cause was attachment weld defects.
  - Unmelted tack welds
  - Lack of fusion at tack welds and along weld joint.
  - Attachment welds couldn't be thoroughly inspected with ultrasonic testing due to fillet weld geometry
  - The attachment welds were dirty – field installation.
- Secondary cause was the defects in the resistance welds – relatively large defects at the attachment welds.
- Sensitization of the 321 stainless had not occurred.
- Bellows replaced with Inconel 625 bellows.
- Weld geometry improved.

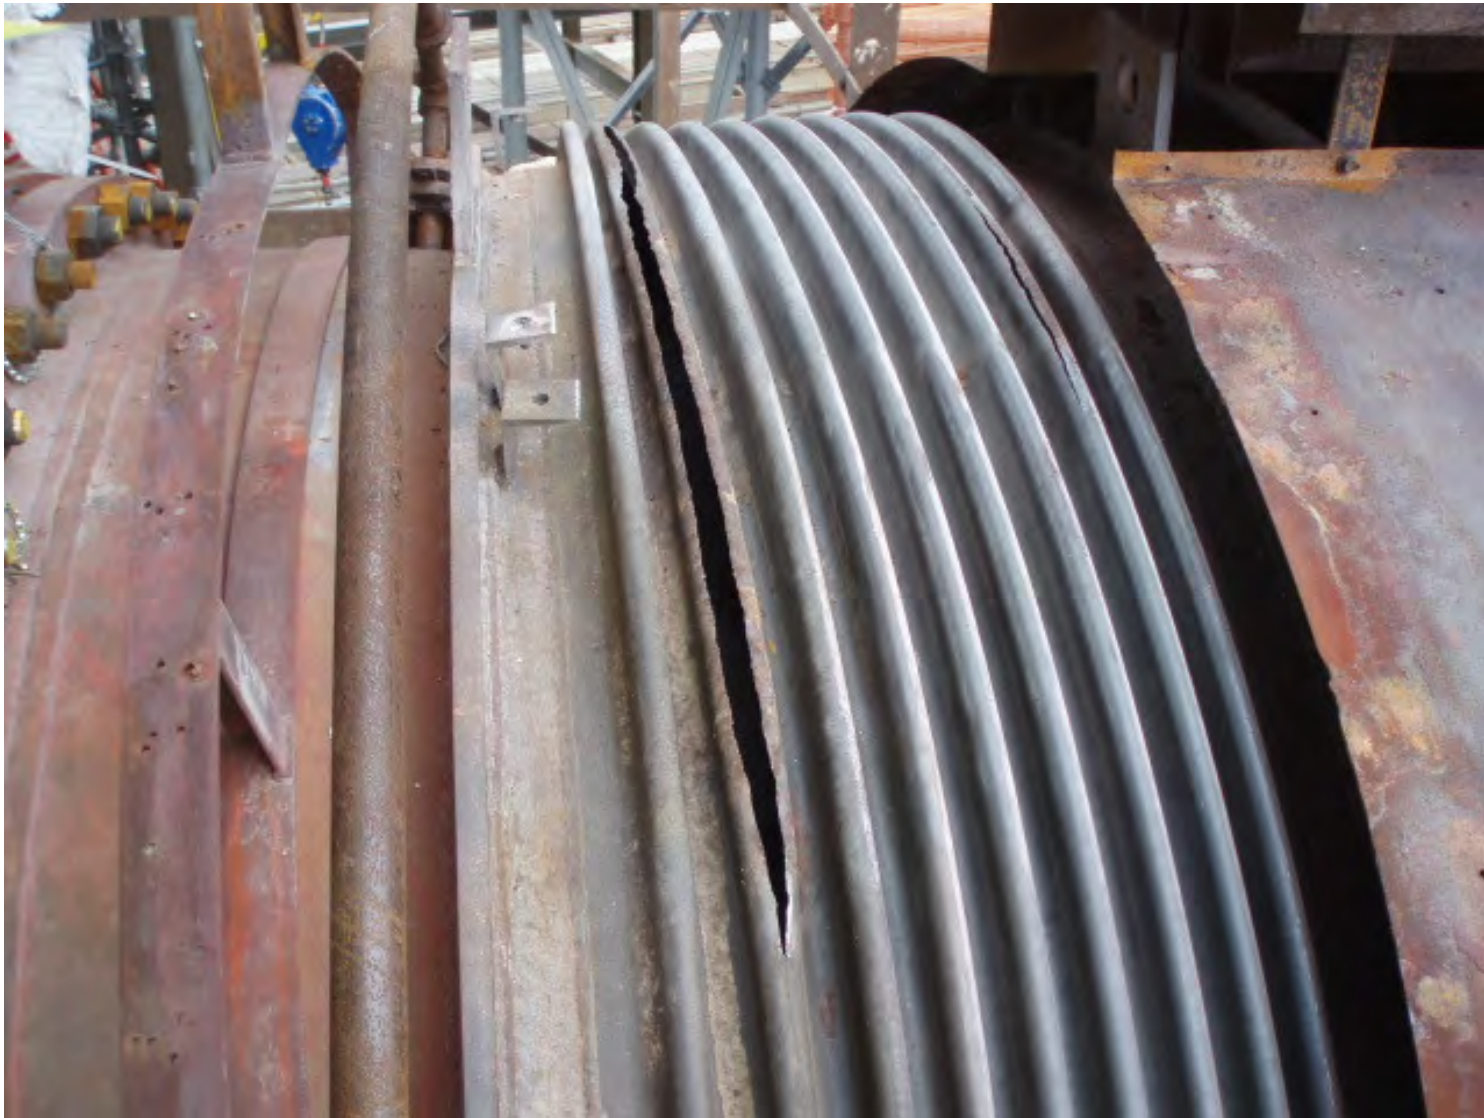
# The Regenerator Off Gas Bellows Failure

Multiple Jagged Cracks Throughout the Incoloy 800 Bellows

- Sensitization was identified as the cause of the failure.
- Systems upgraded to keep the bellows cooler – more purge steam and more internal insulation.
- Bellows replaced with Inconel 625 LCF bellows:
  - Reduced chance of sensitization.
  - Increased resistance to H<sub>2</sub>SO<sub>4</sub> corrosion.

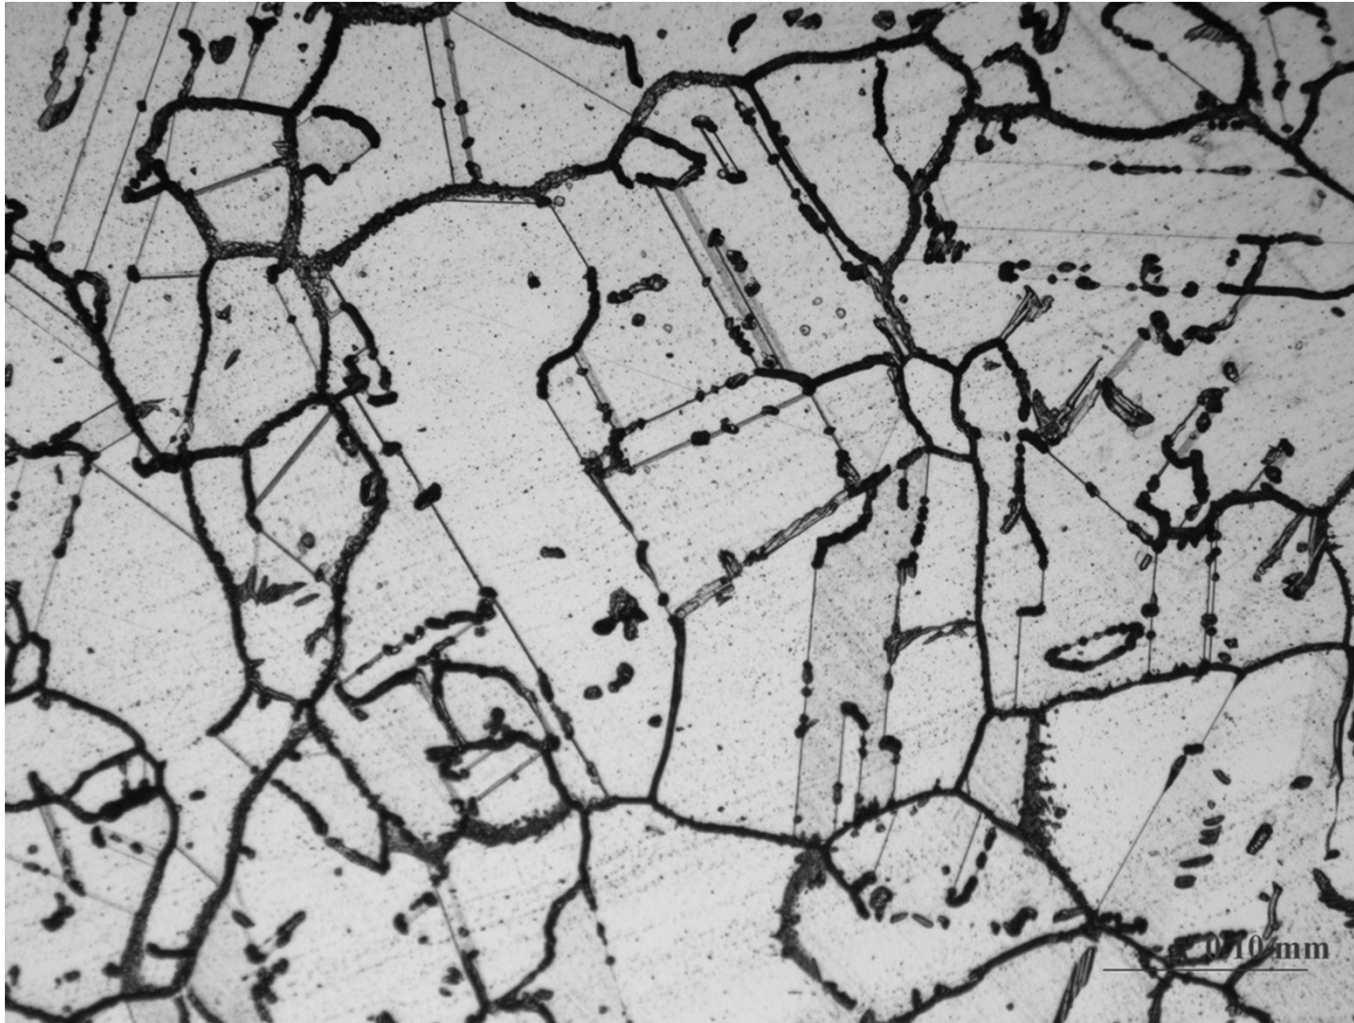
# Metallographic Test for Sensitization

The corroded boundaries indicate it was sensitized.

Electrolytically Etched with Oxalic Acid      Original Magnification – 200X
