# Successful Approach to the Repair of Reinforced Concrete Support Structures in Delayed Coking Units

STRUCTURAL TECHNOLOGIES, LLC – Houston, Texas – USA

**REFCOMM**  
BAHRAIN 2015

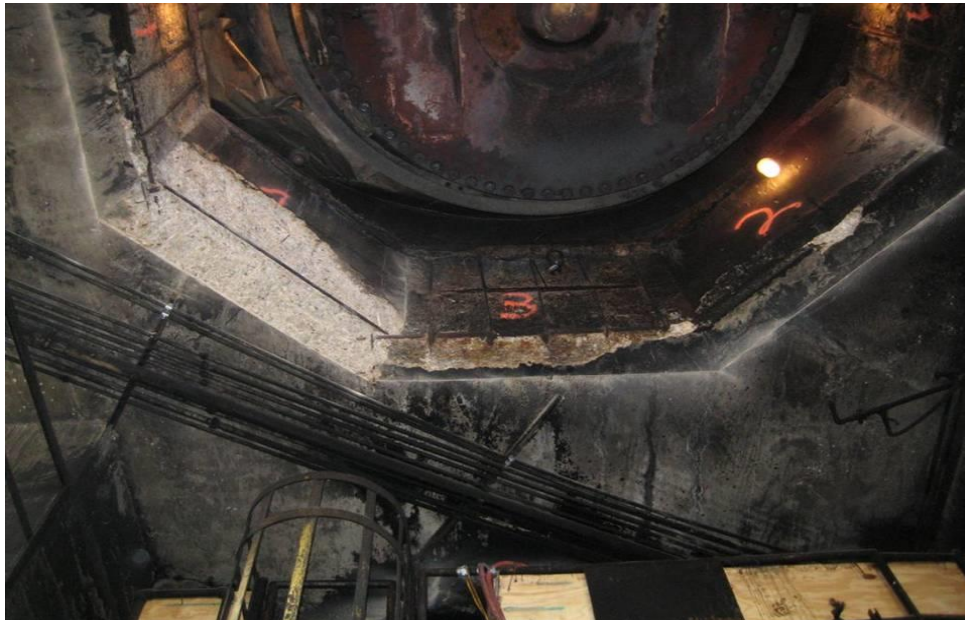
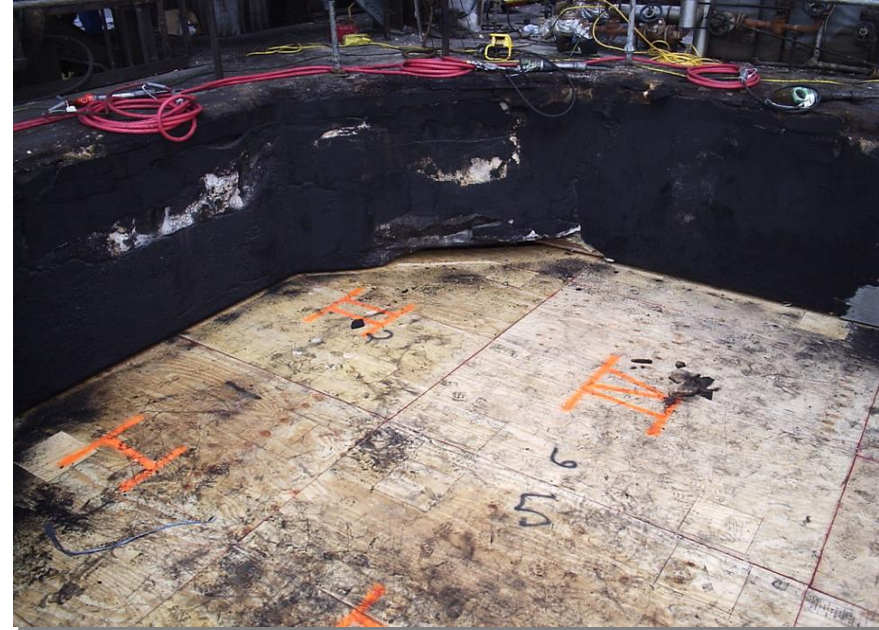
- Coker Octagonal or Circular Slab Penetration

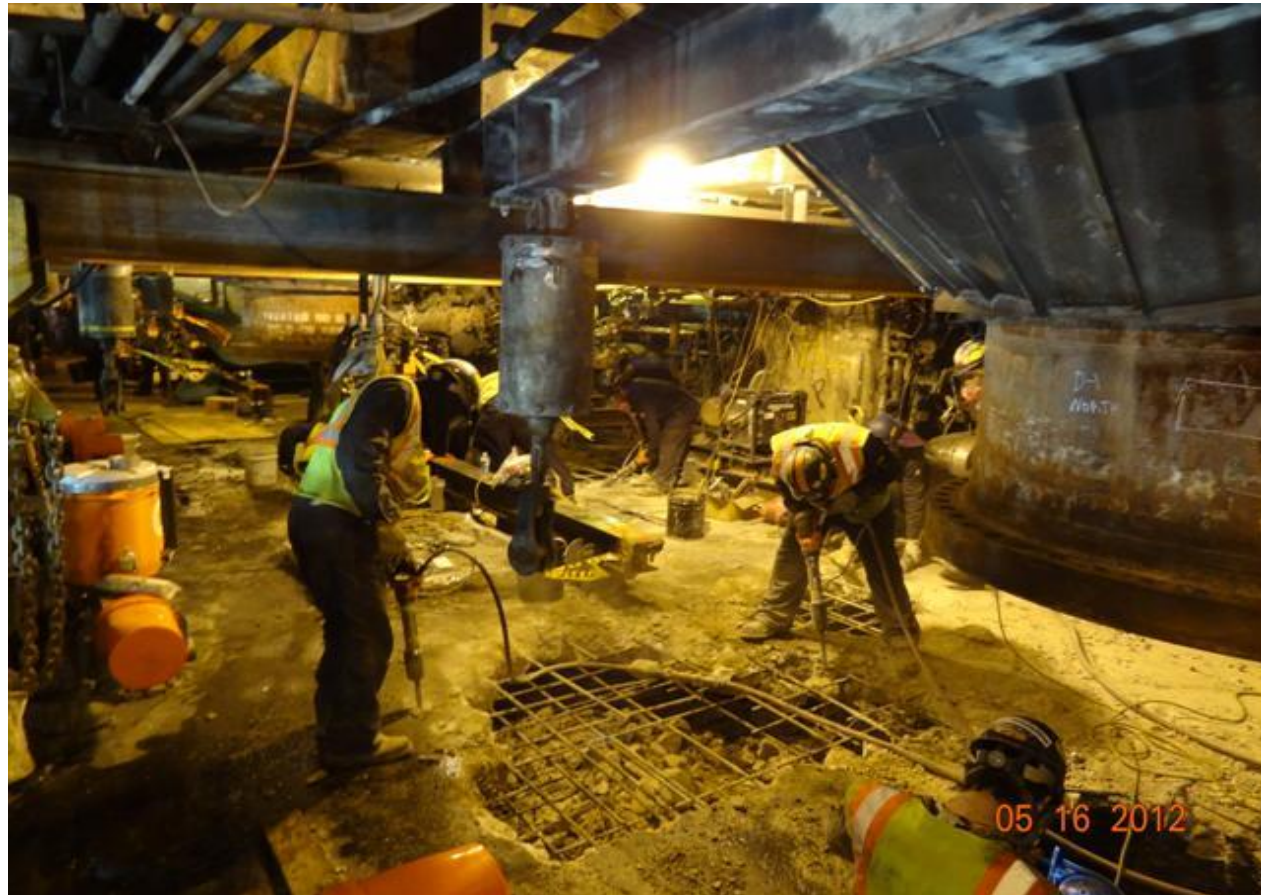
- Coker Head Deck

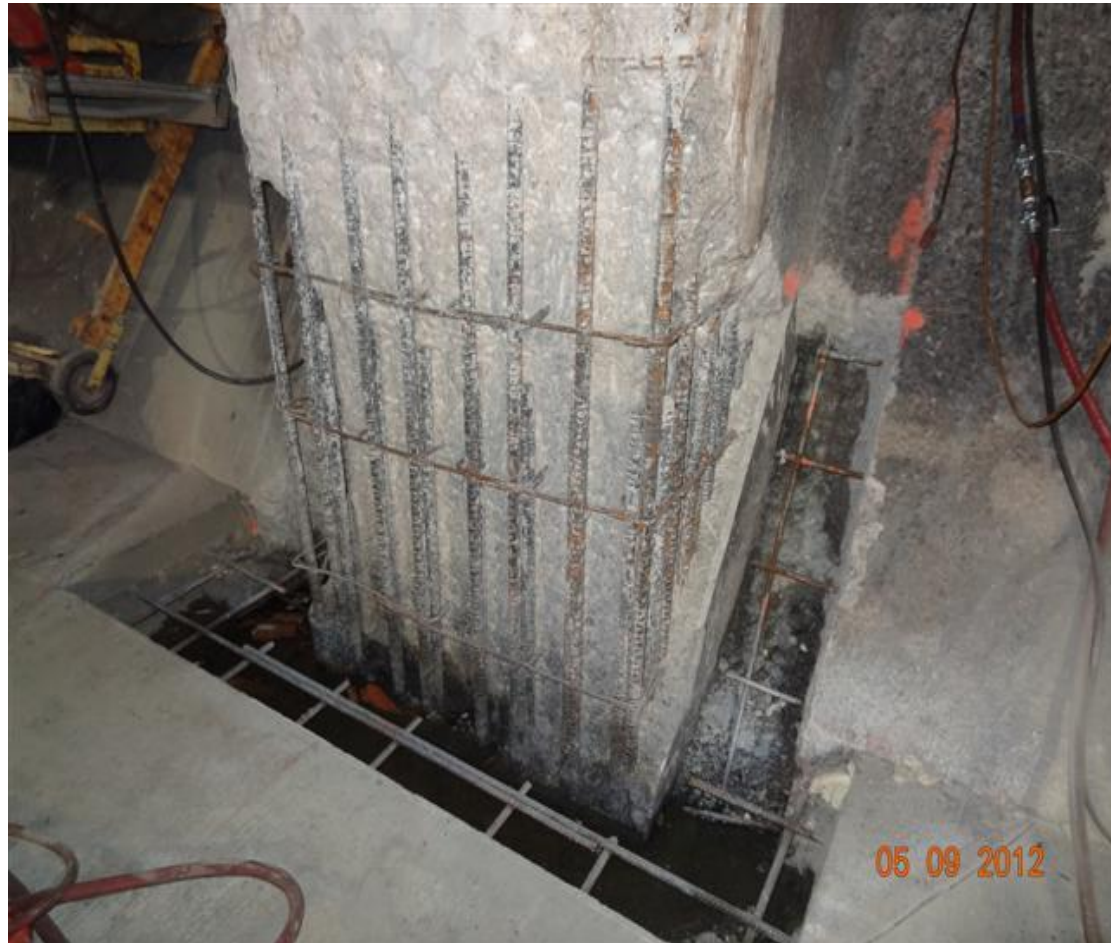
- Coker Columns

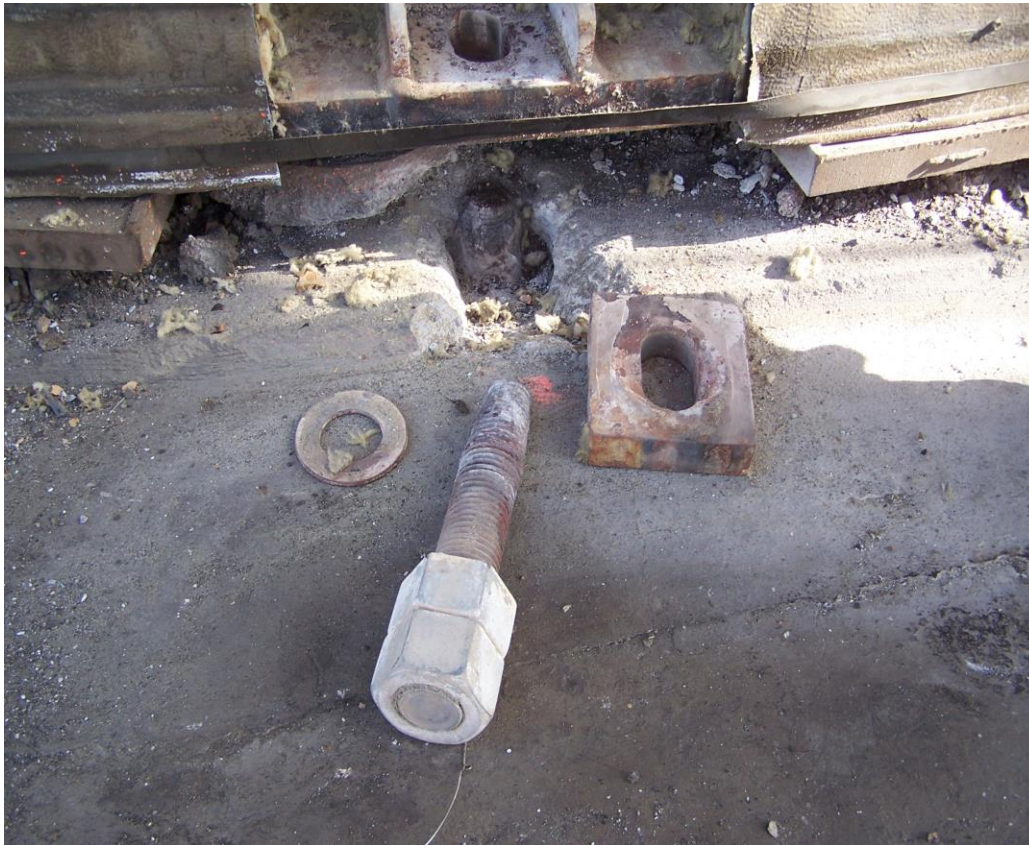
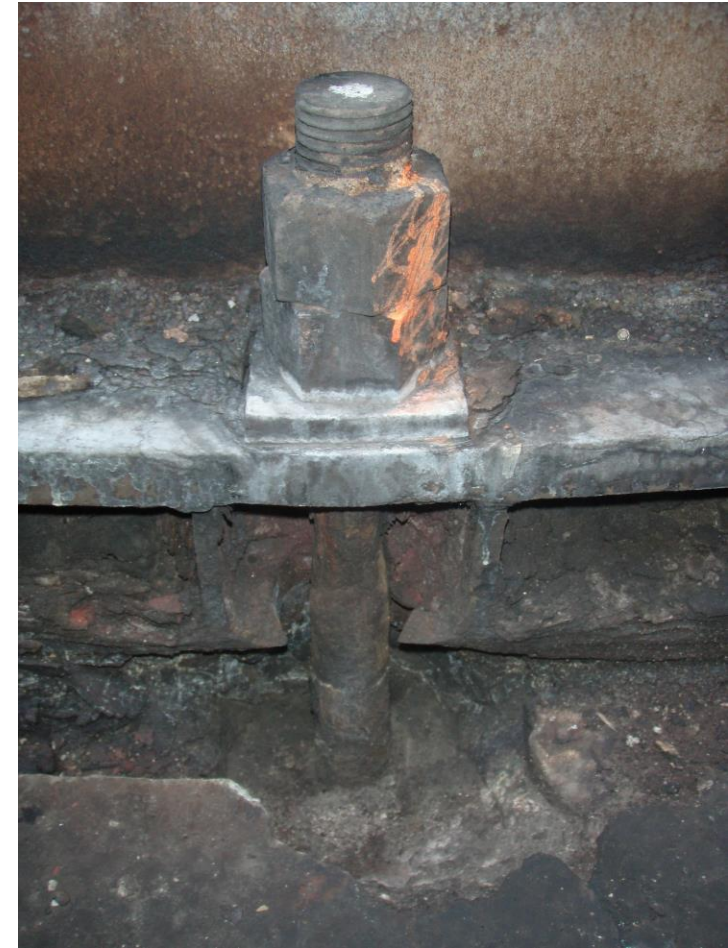
- Anchor Bolts

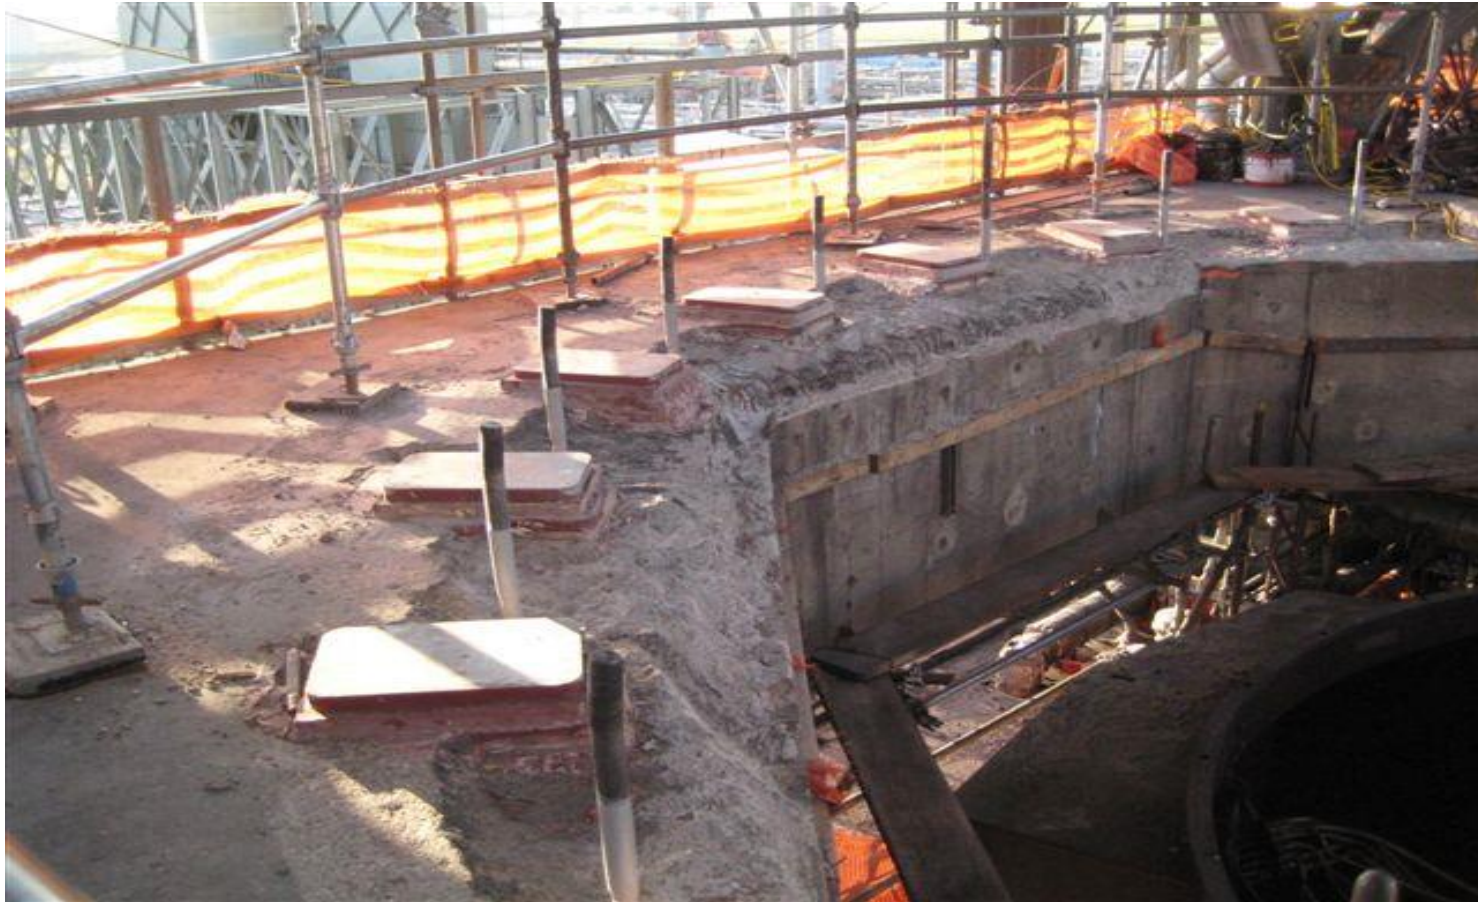
- Grouting

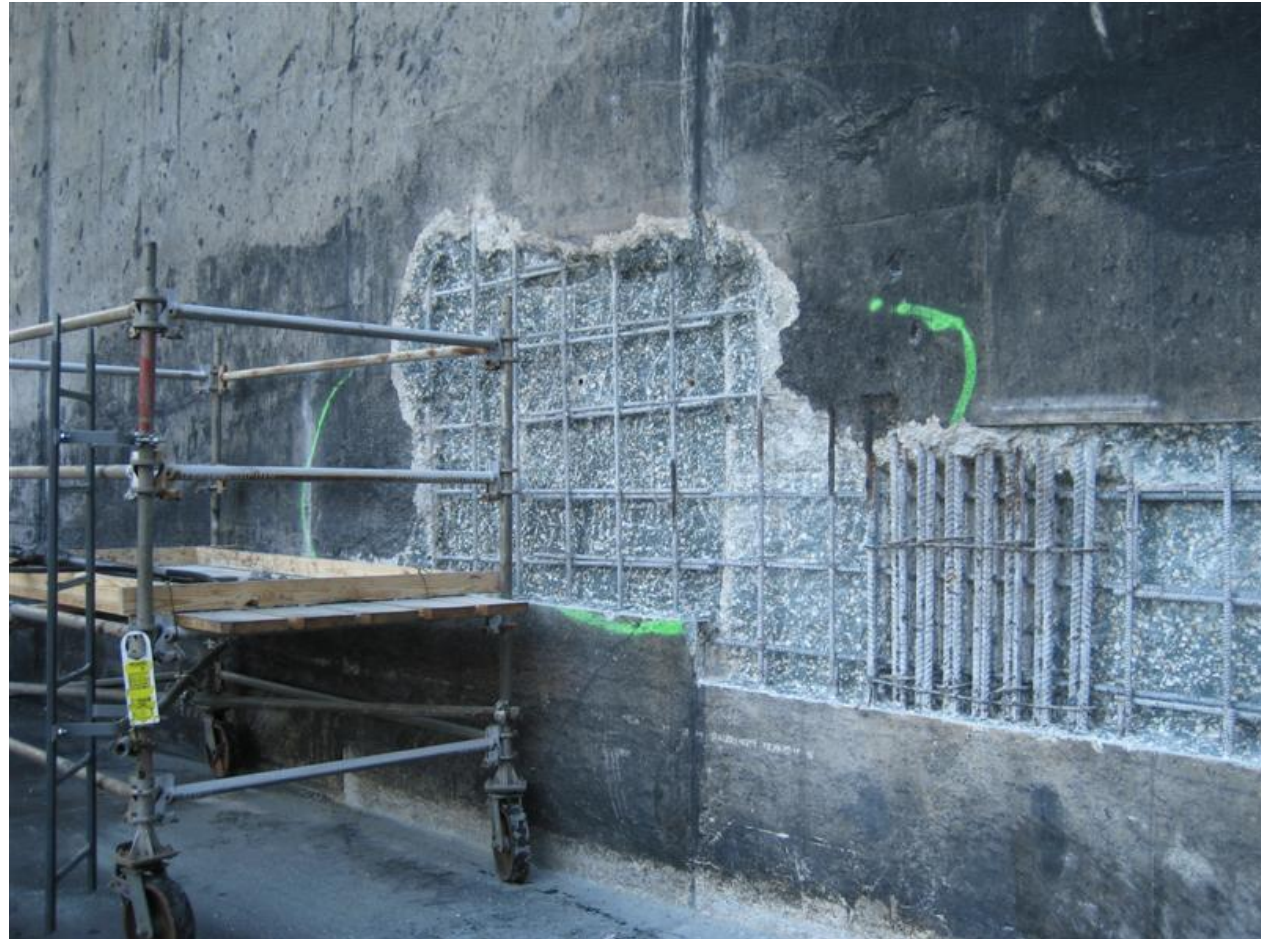
- Coke Pits

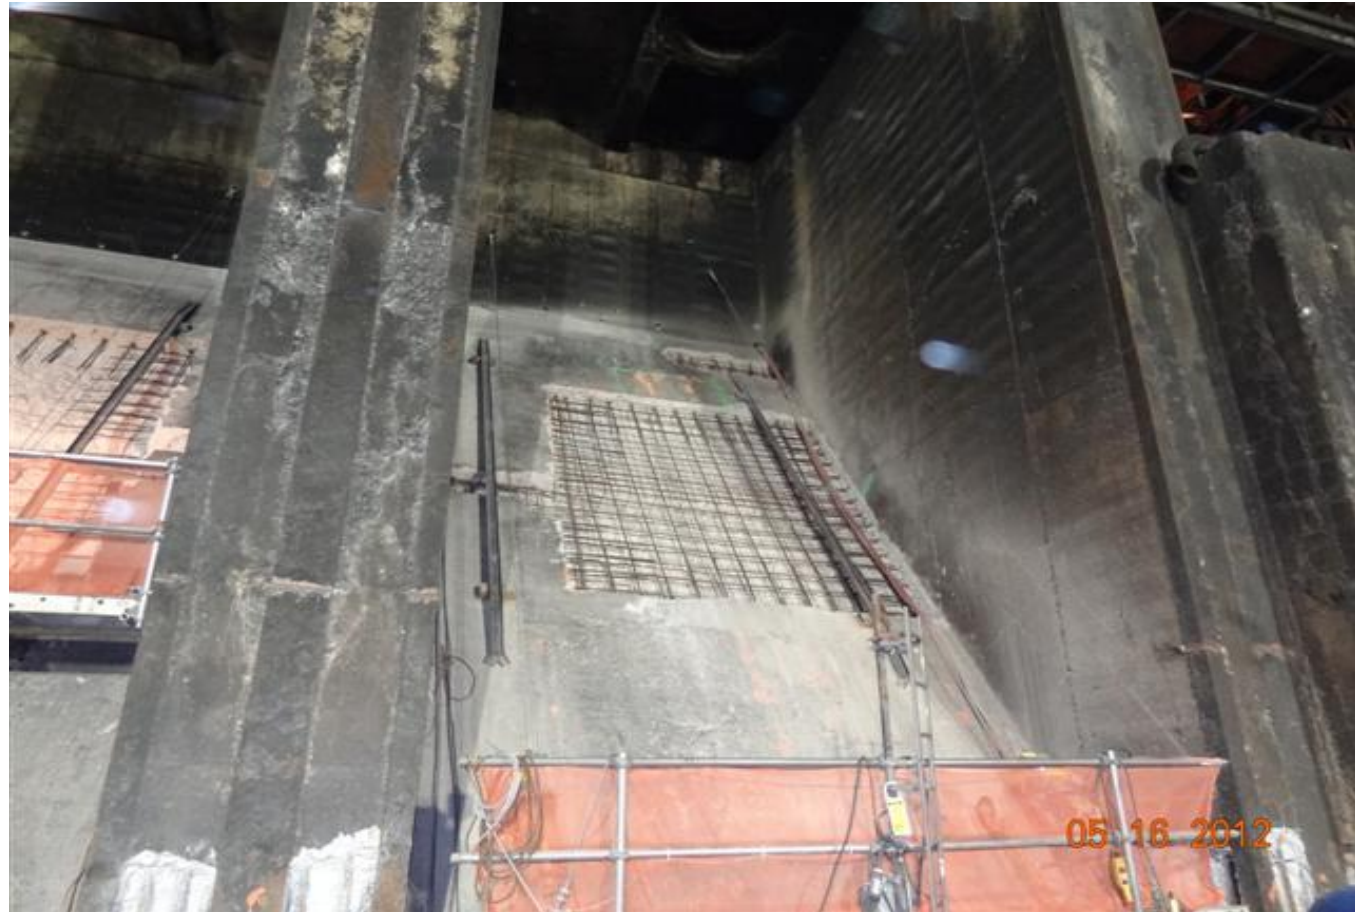
- Coke Chute

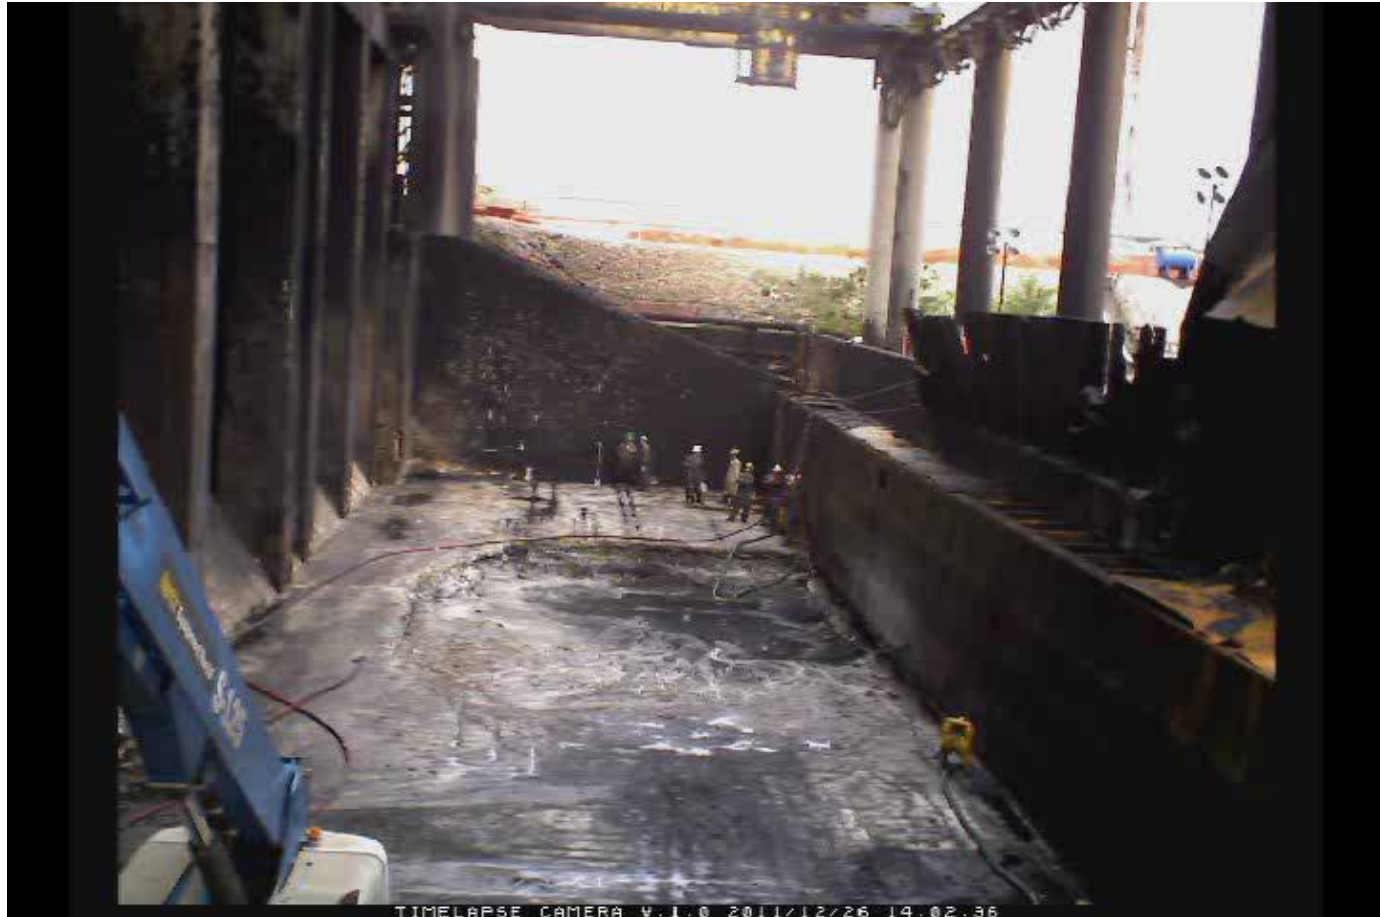
- Coke Pit Floor

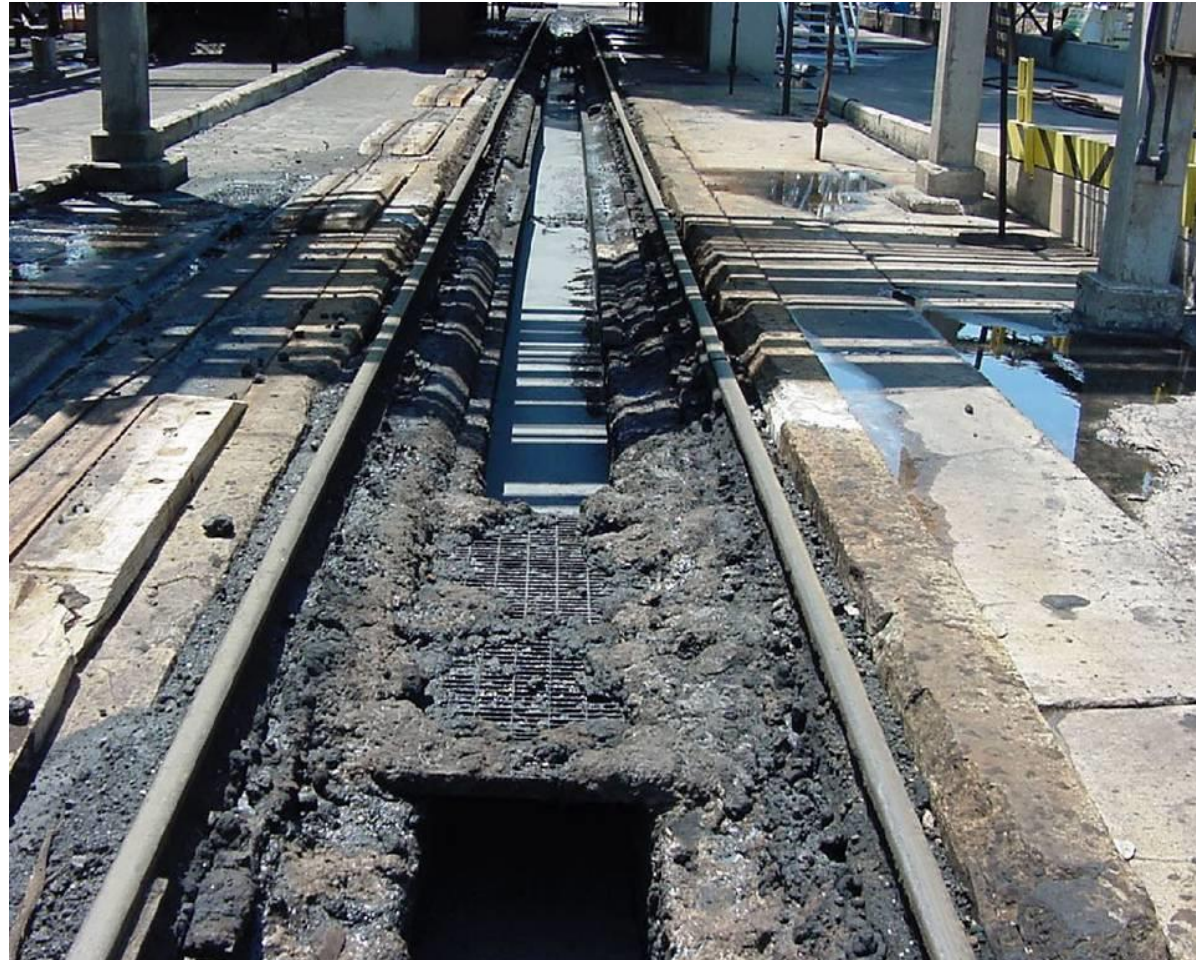
- Coker Railway & Sluiceway

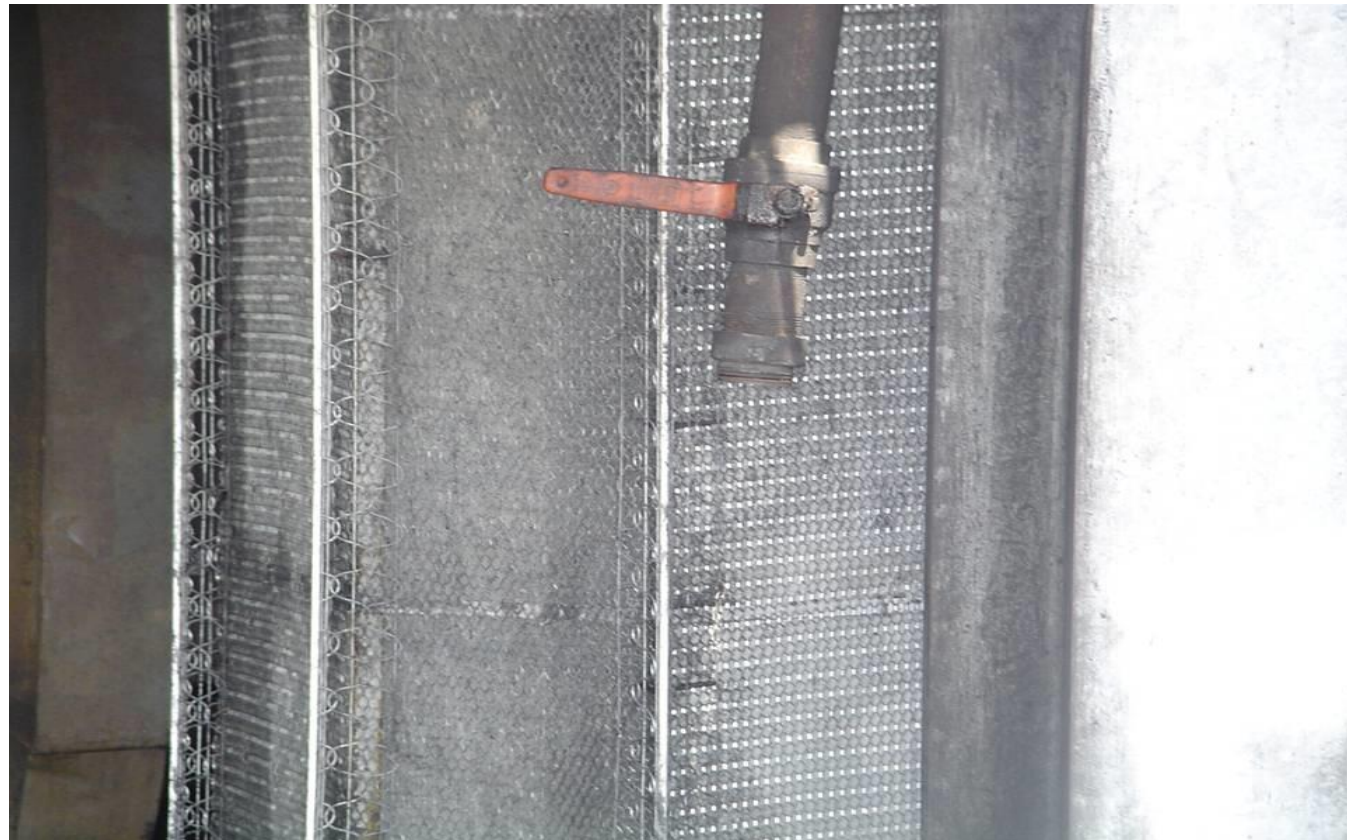
- Coker Fireproofing

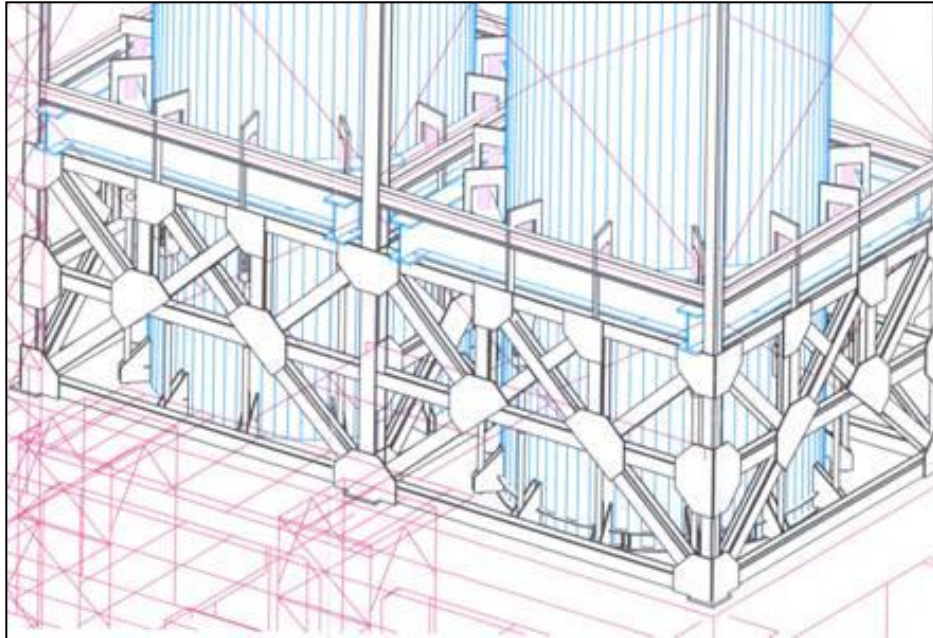
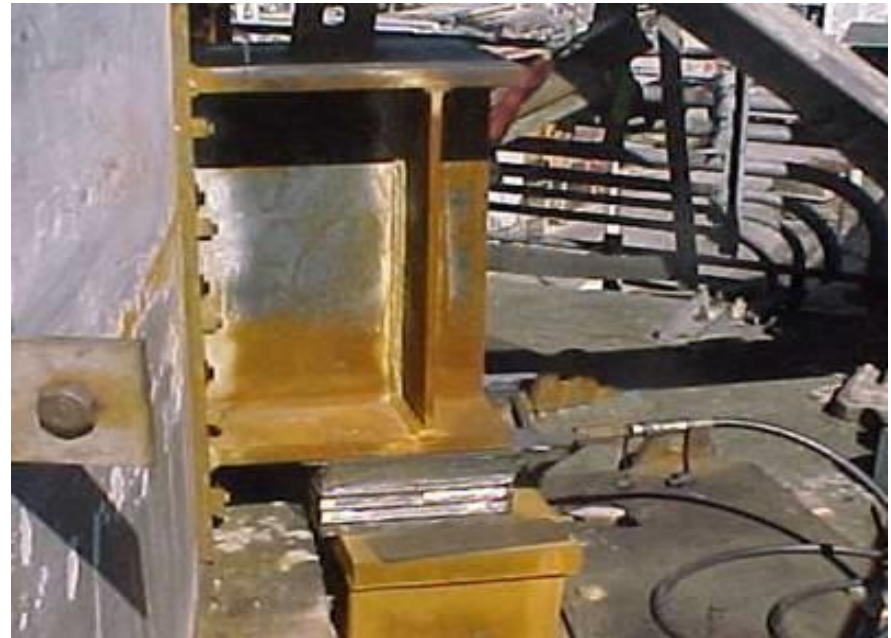
- Supporting Coke Drums

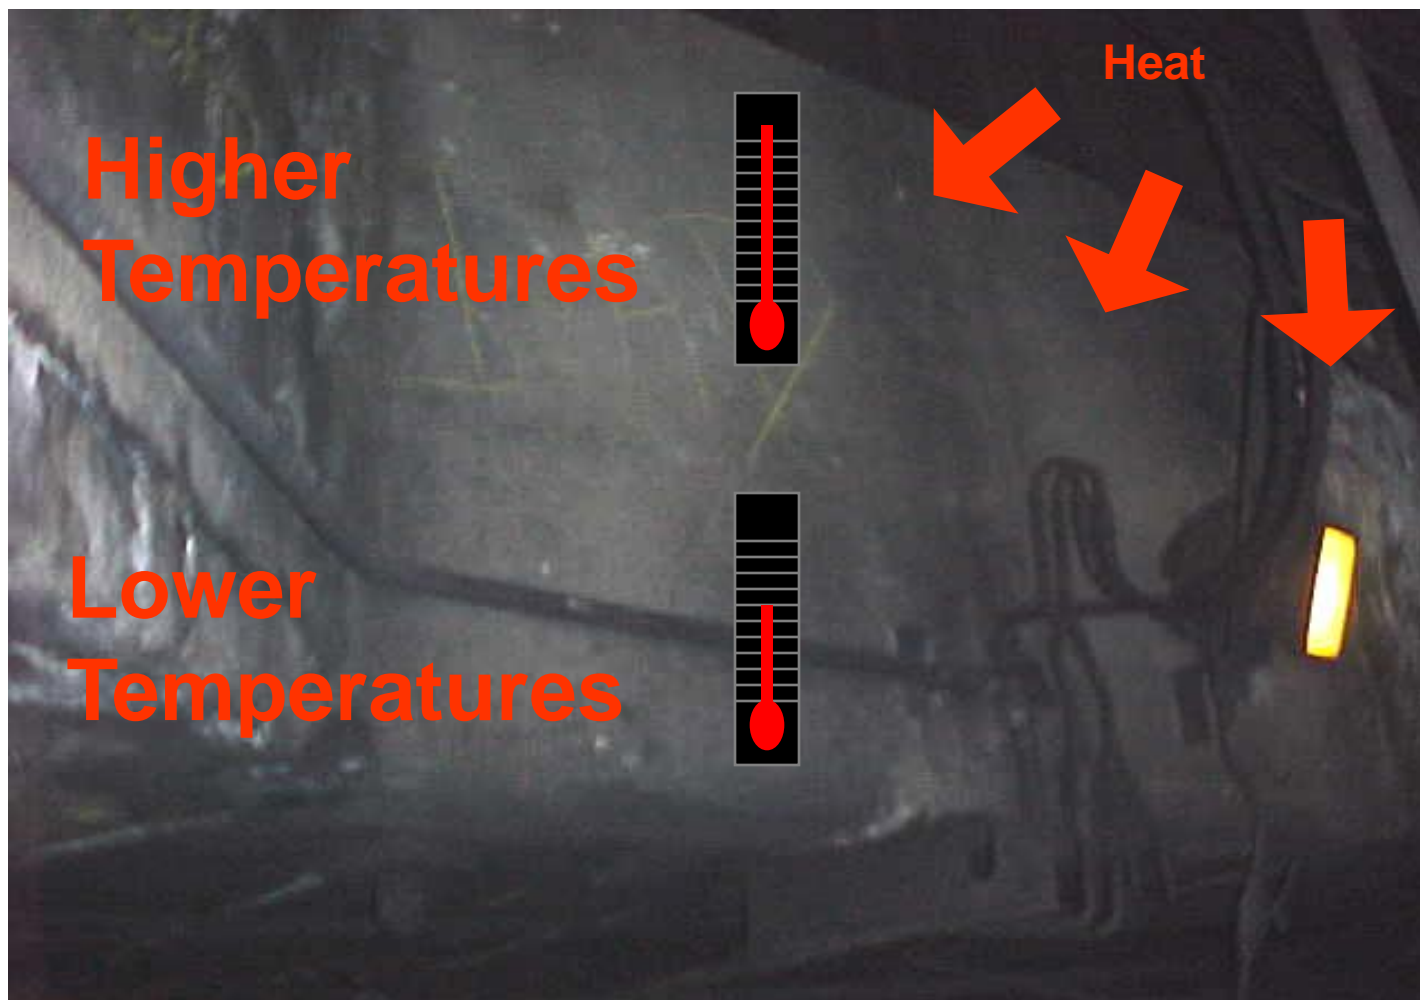
# Thermocouple/Infrared Thermometer Readings

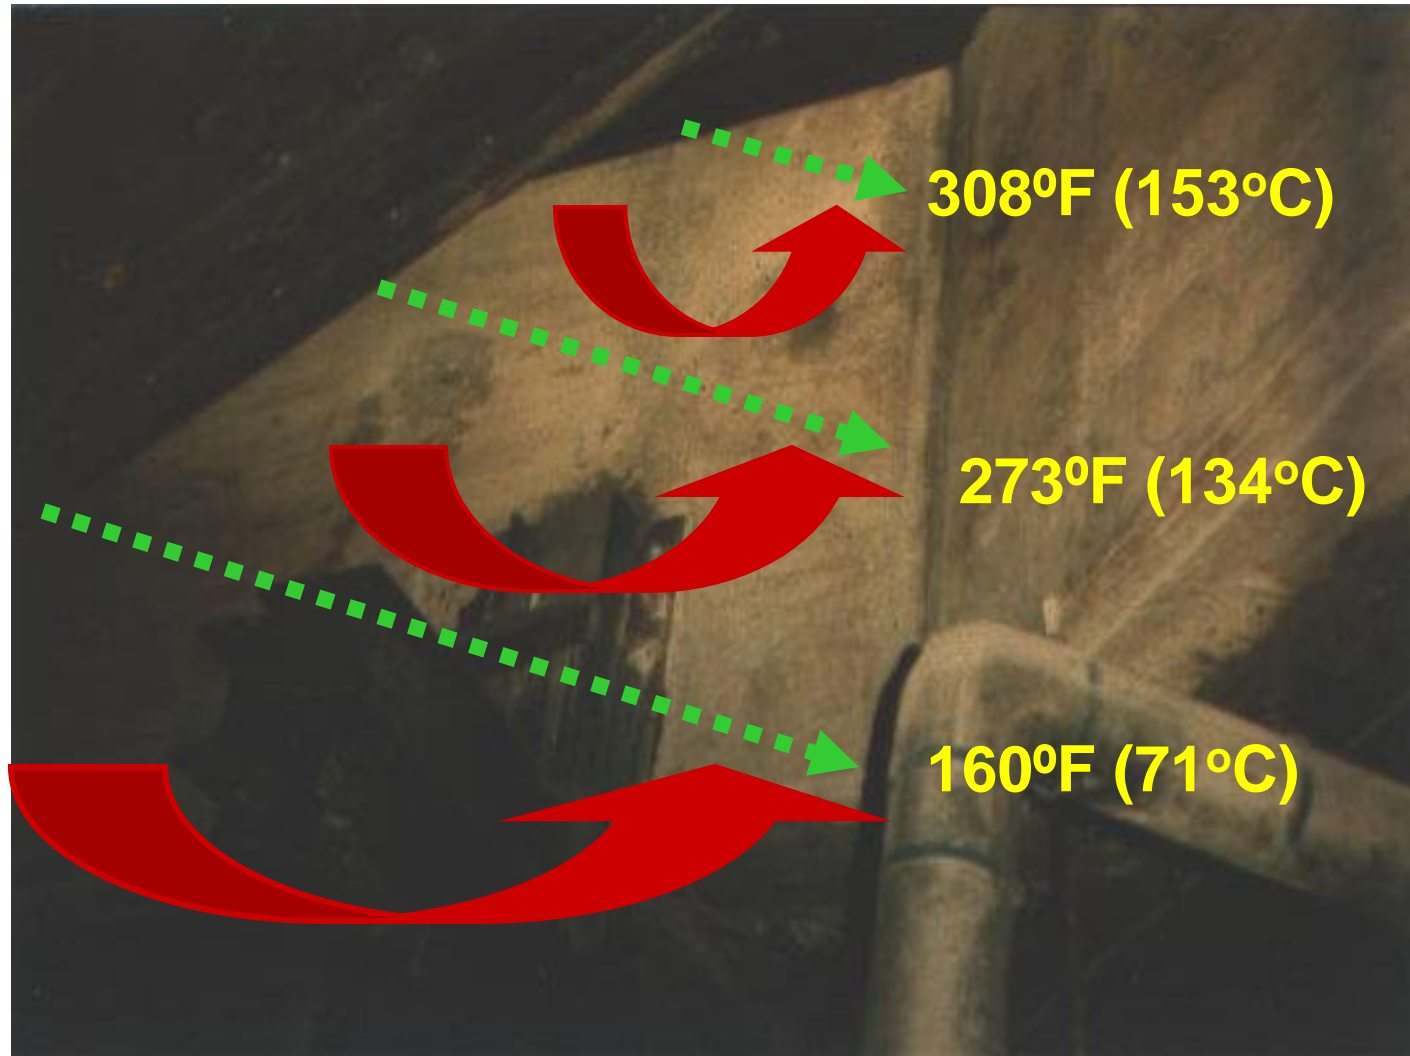
# Measured Temperatures on Octagonal or Circular Penetration Faces

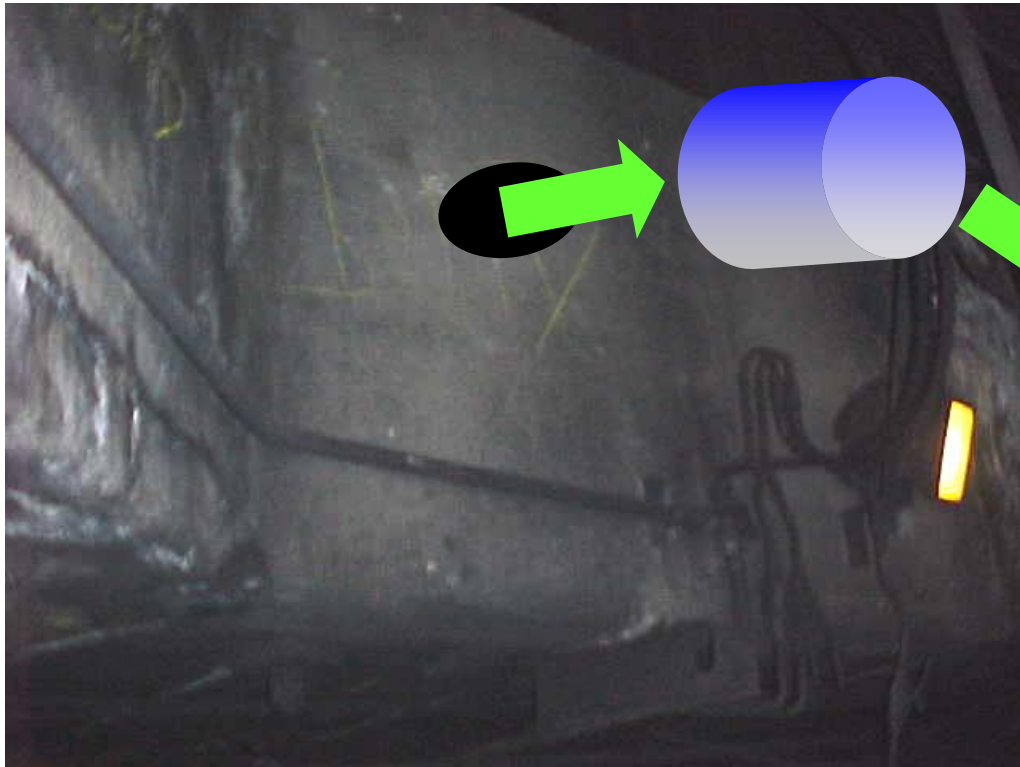
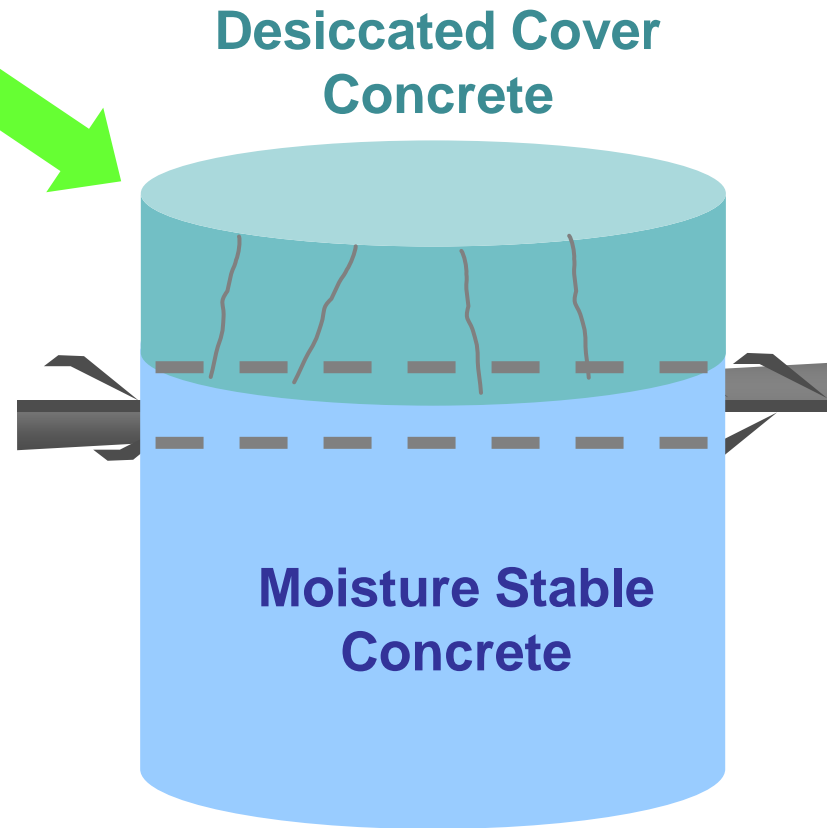
# Microcracking of Cover Concrete

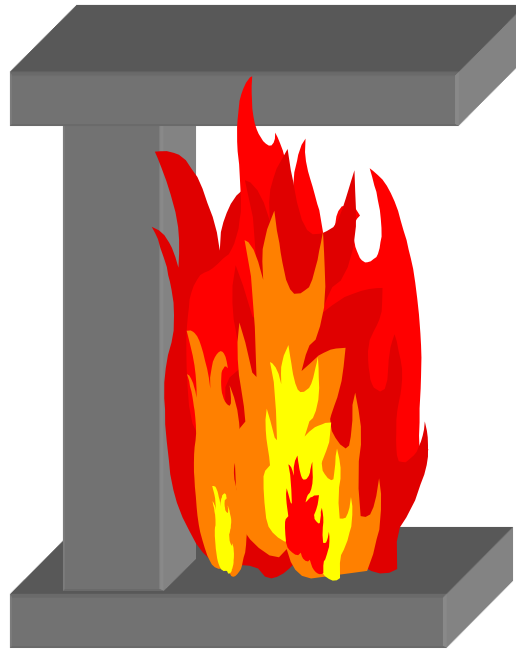
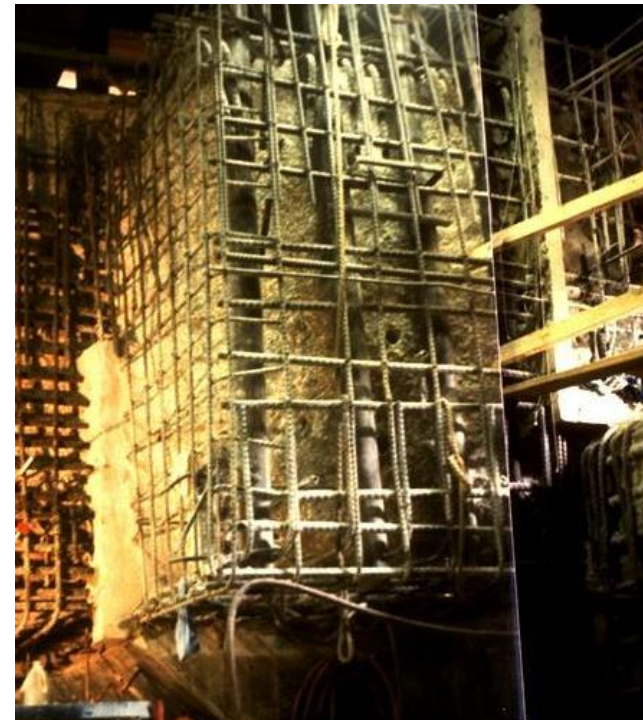
# Fire Damage

- Aggregate swells
- $\text{H}_2\text{O}$  to steam
- Chemical change

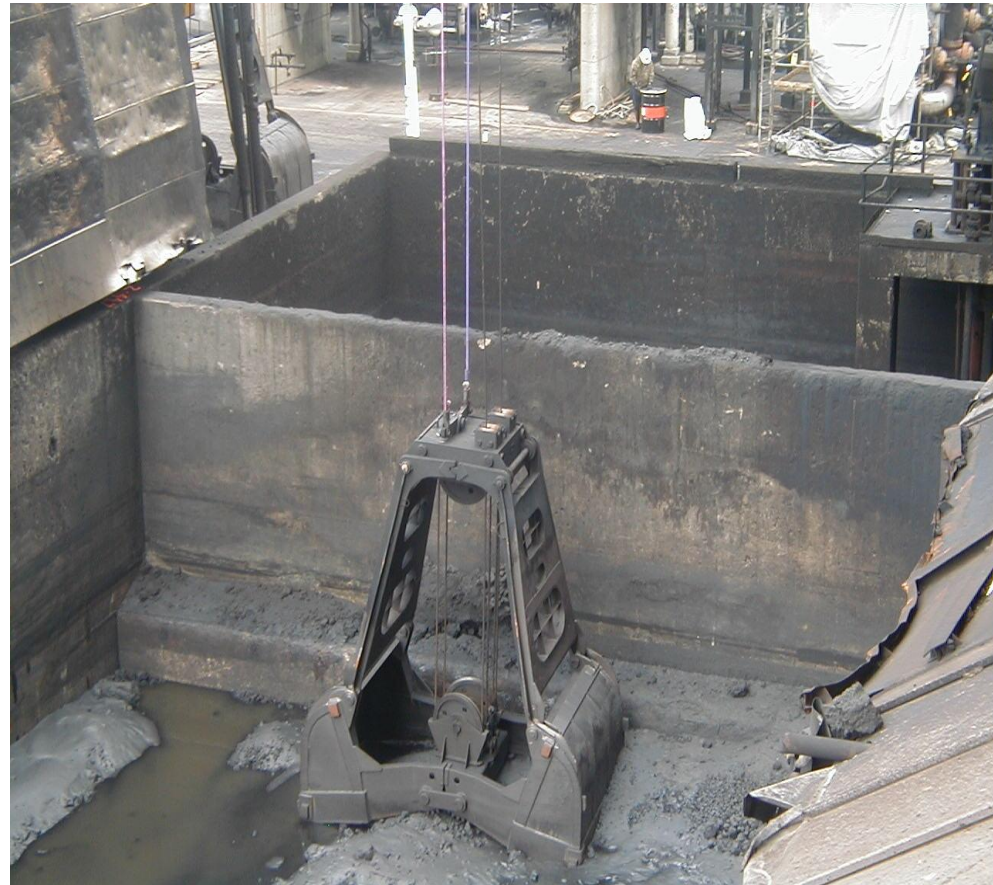
# Impact Damage

- Impact of steel bucket edge on Coke Pit Walls and Basin
- Front-end loaders on Basin

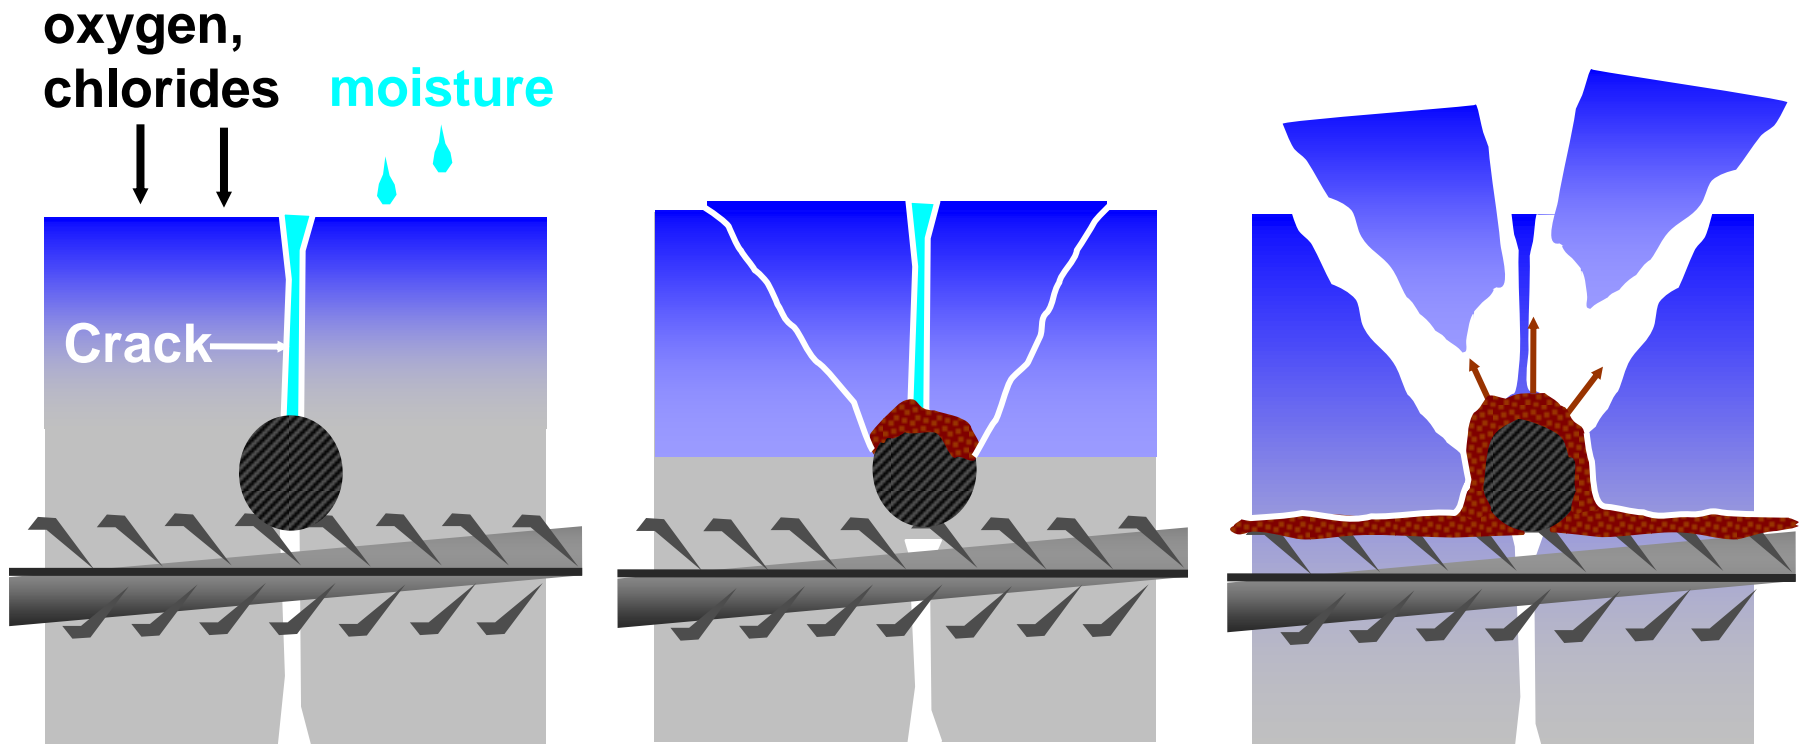
# Chloride-Induced Corrosion

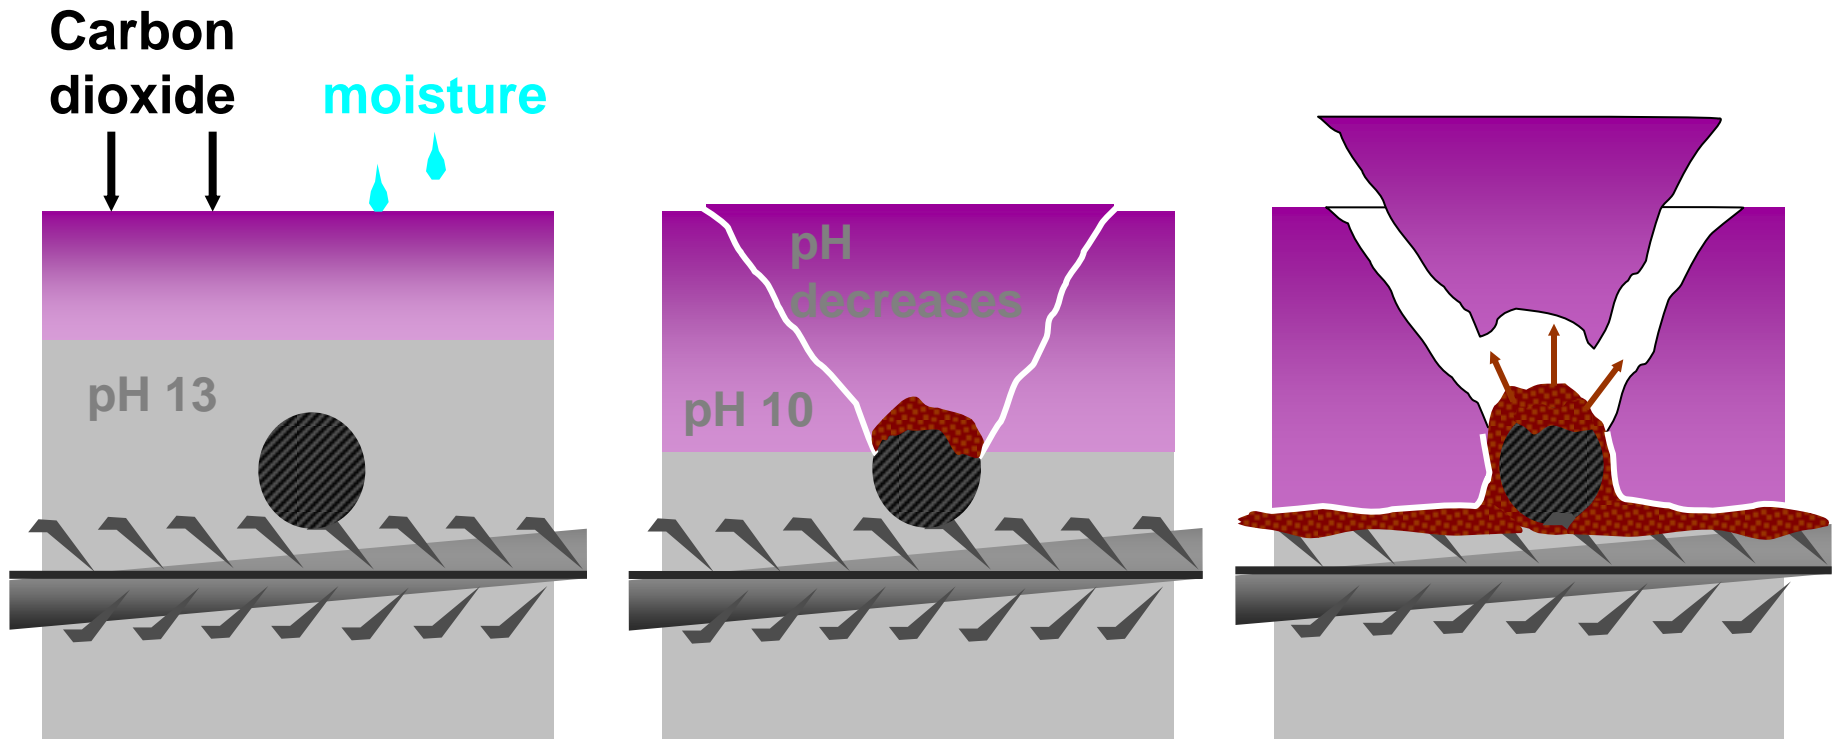
# Carbonation-Induced Corrosion
