# Successful Approach to the Repair of Reinforced Concrete Support Structures in Delayed Coking Units

STRUCTURAL TECHNOLOGIES, LLC – Houston, Texas – USA

**REFCOMM**  
BAHRAIN 2015

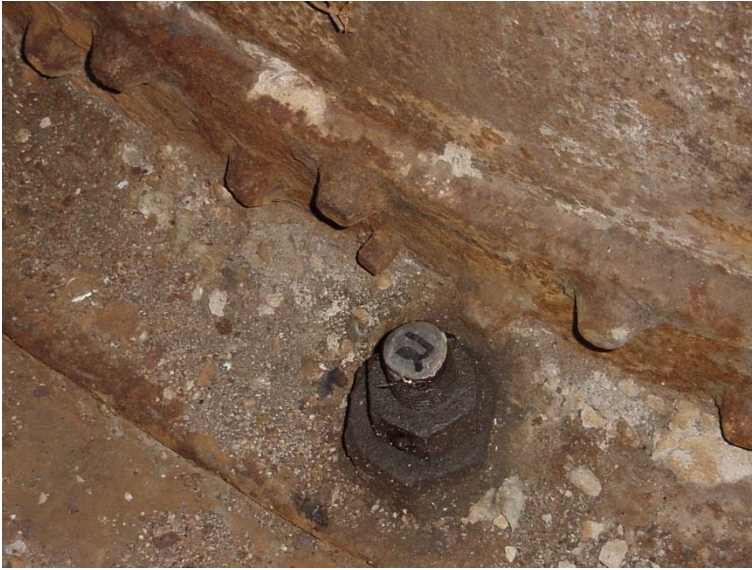
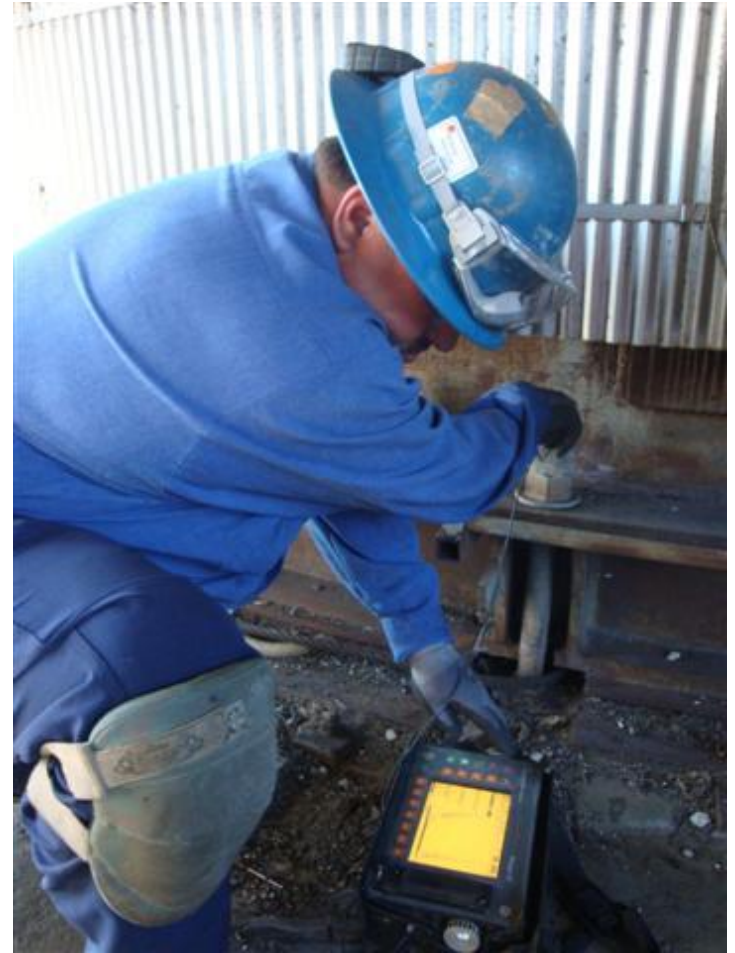
# Anchor Bolt In-situ Testing

Employing Ultrasonic Technology – Anchor Bolt tops are ground smooth & plane. A Technician then attaches a Transducer to the prepared surface for a “flaw” detection reading.

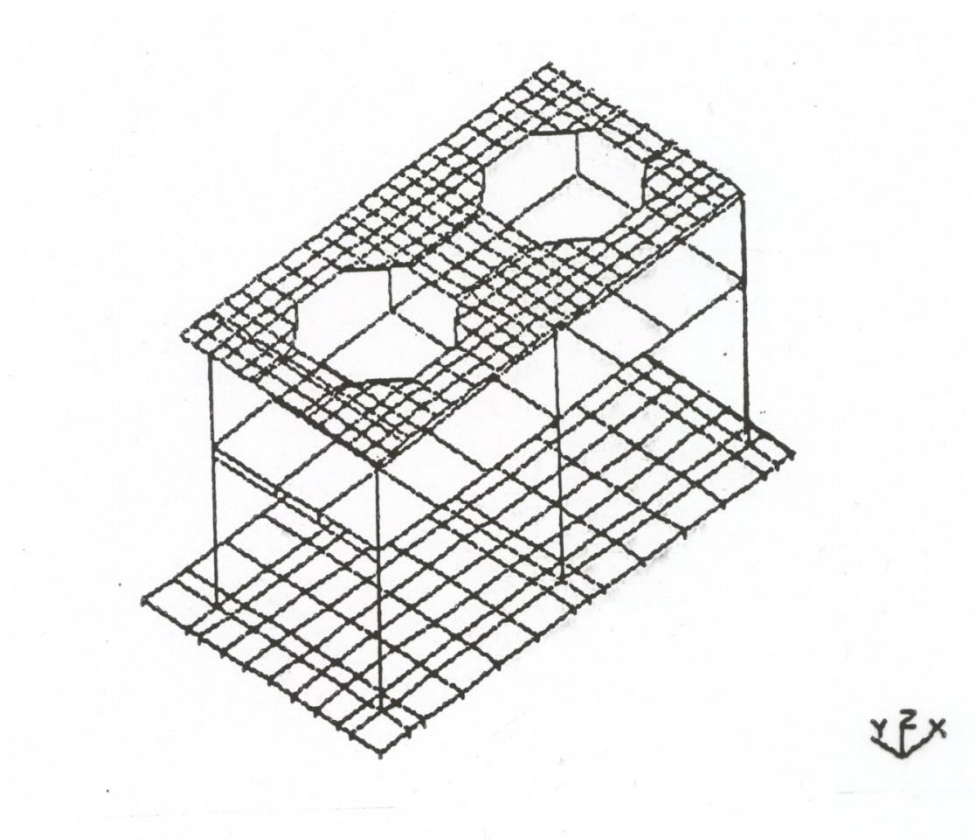
# Finite Element Analysis

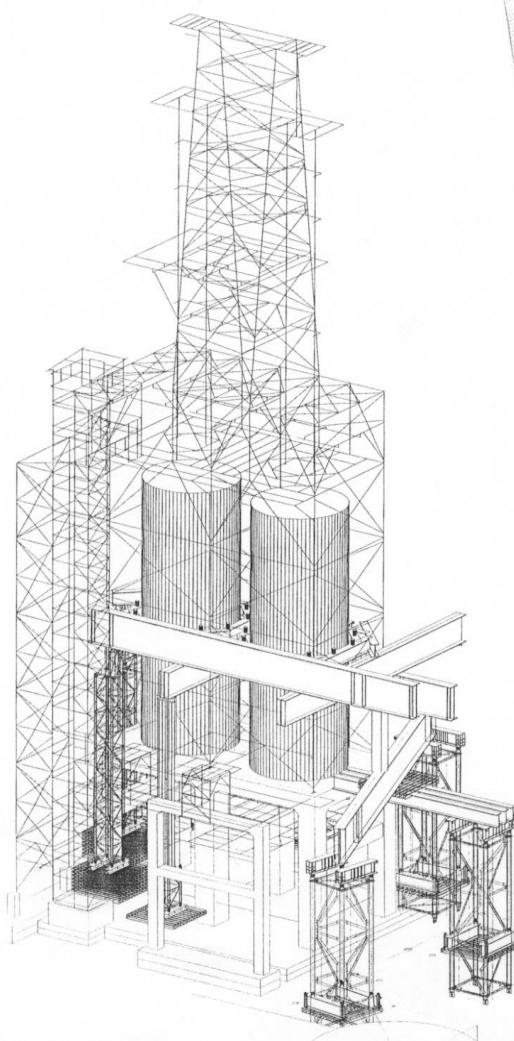
# Engineered Coke Drum Support Structure Shoring Plan

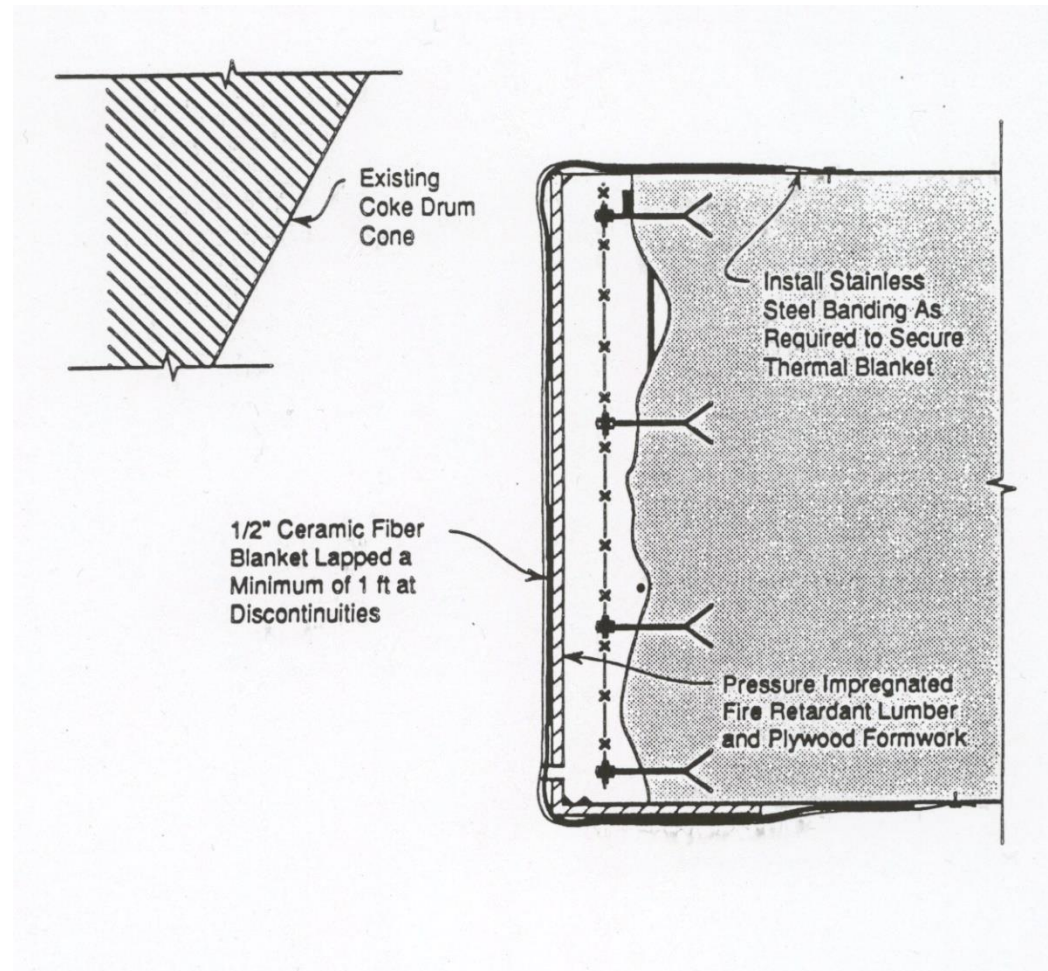
# Thermal Insulating Detail for Octagonal or Circular Slab Opening Repairs

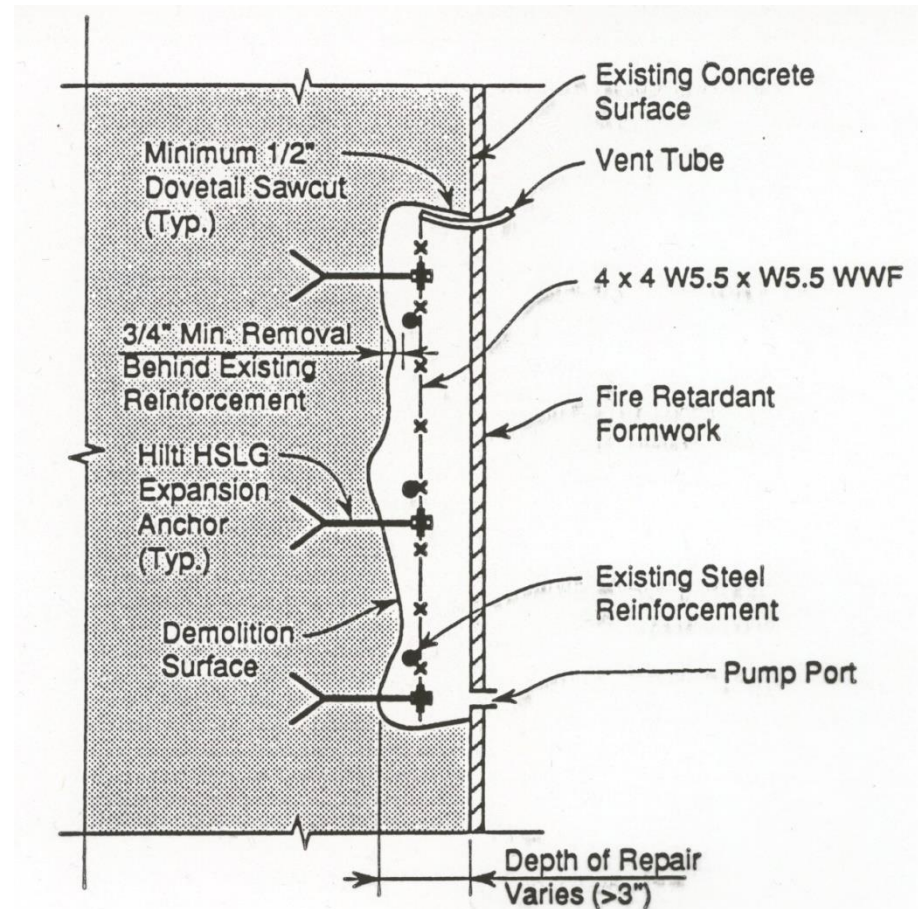
# Formed Deep Repair Detail for Beams and Columns

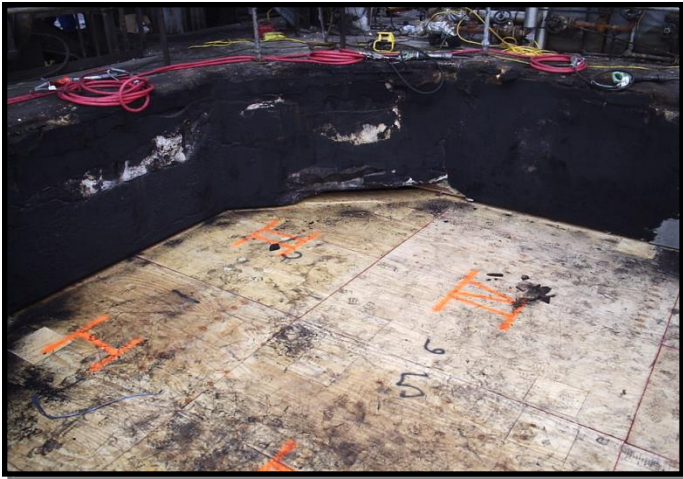
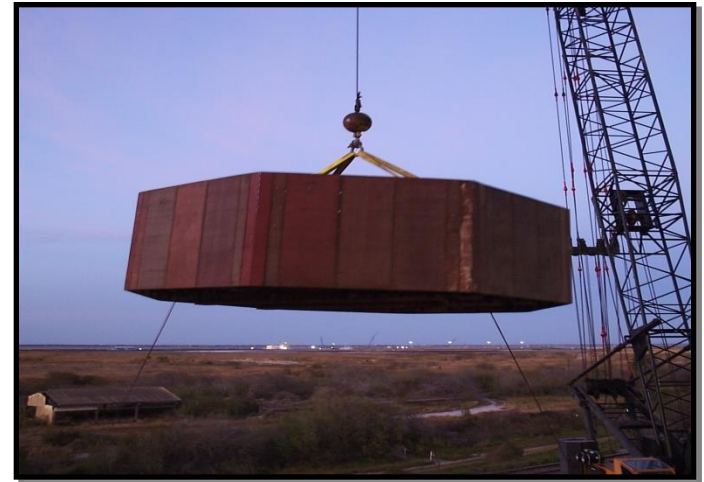
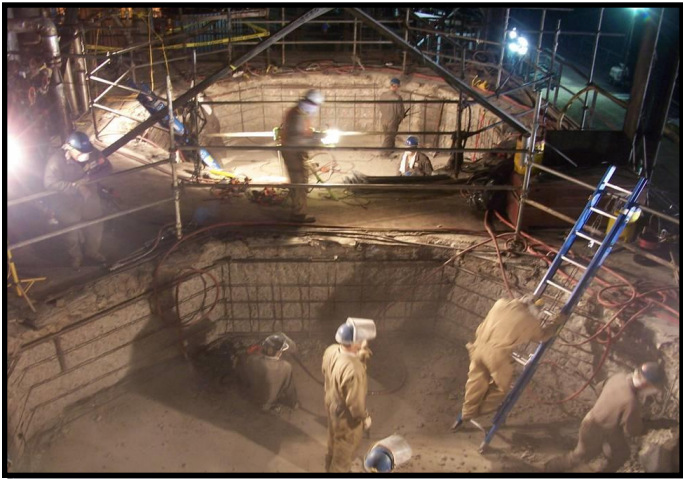
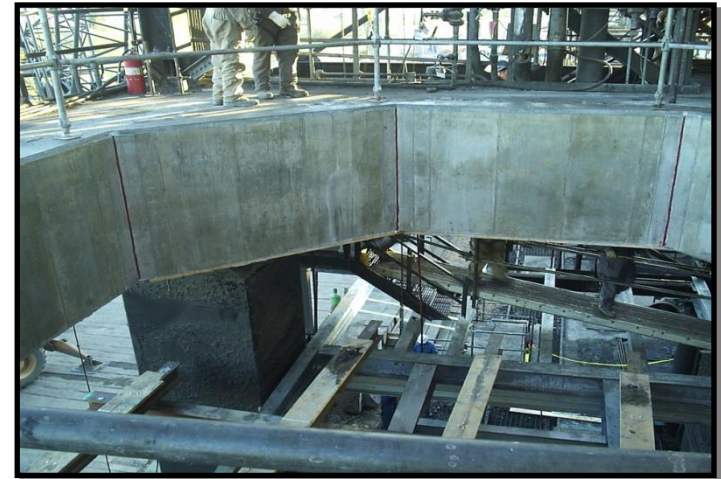
# Octagon Wall Repair

Octagon Wall: Before

Flying Form Work

Octagon Wall: During

Octagon Wall: After

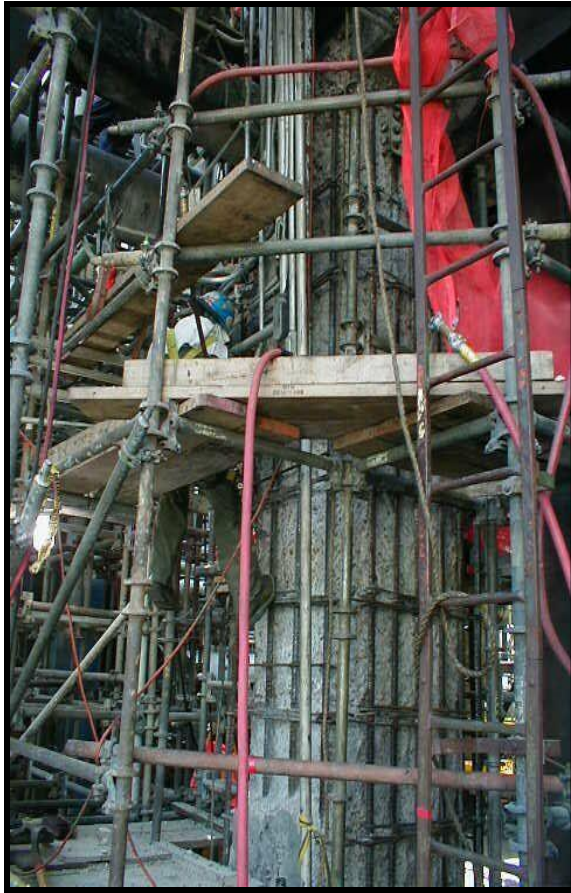
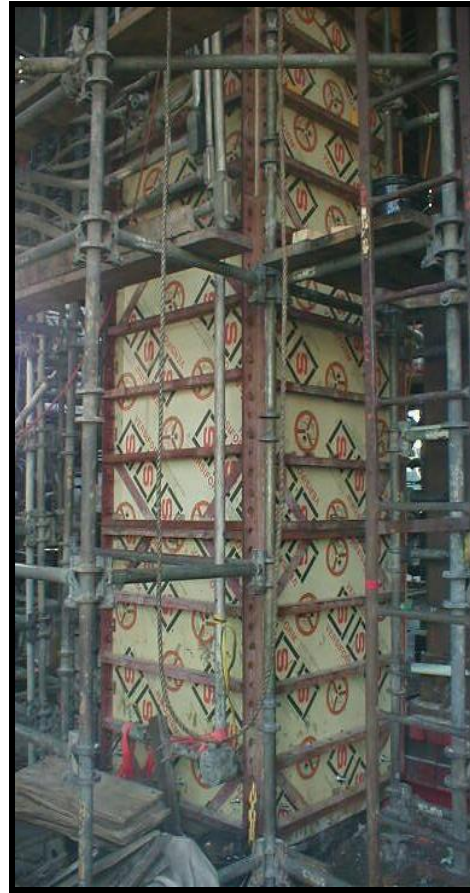
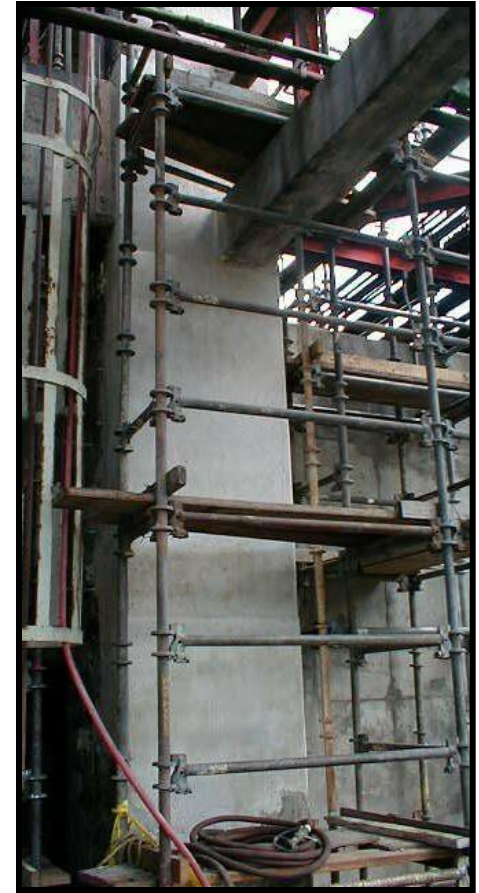
# Coker Column Repairs

Demo

Formed

Repaired

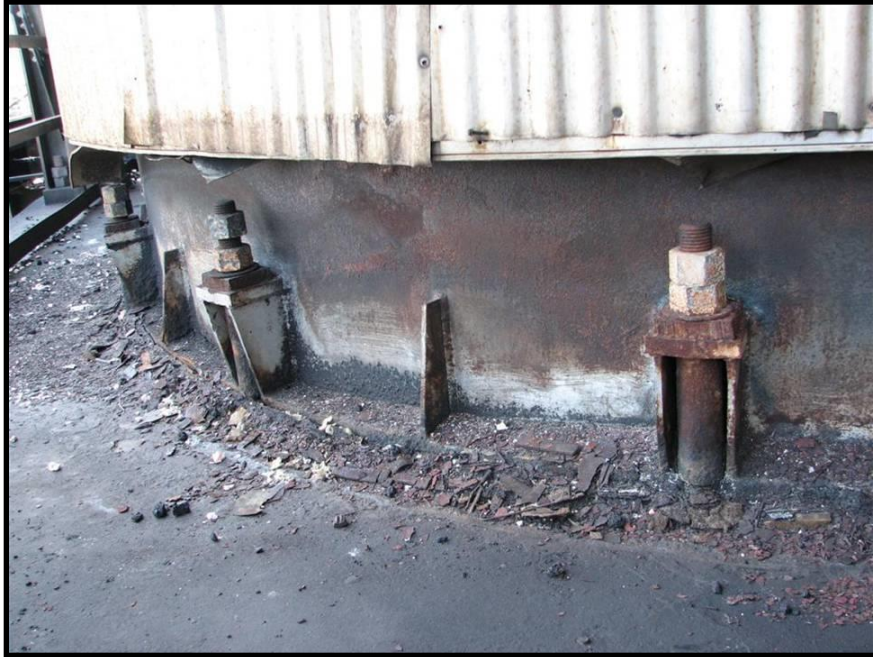
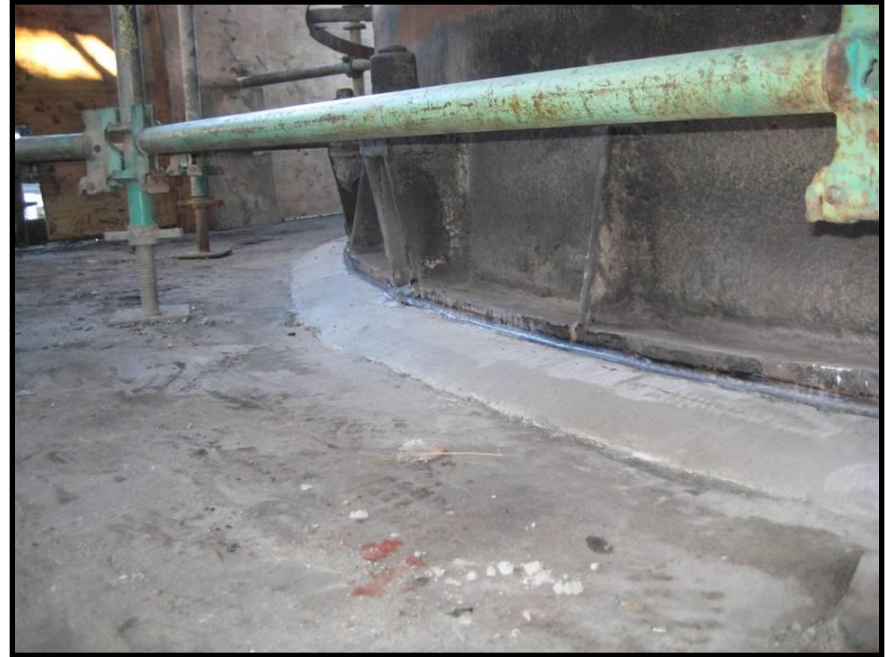
# Anchor Bolt Repair

**Before**

**After**

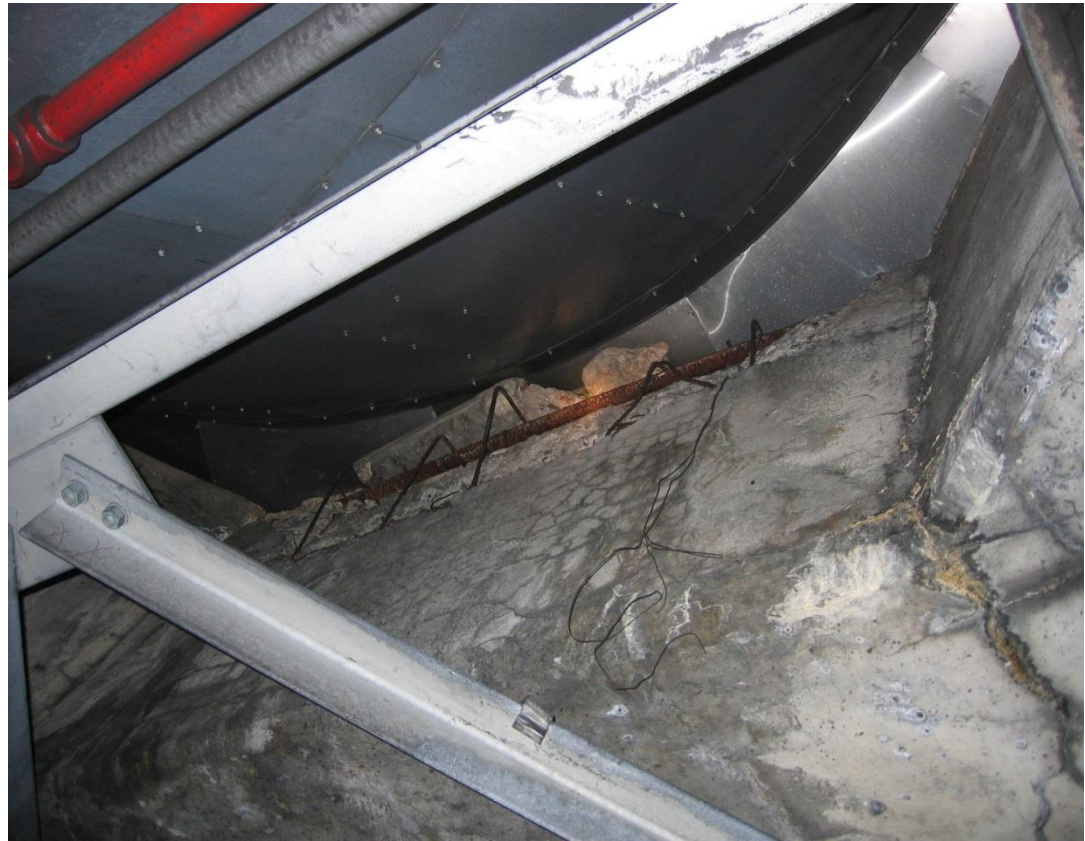
- Despall Structure

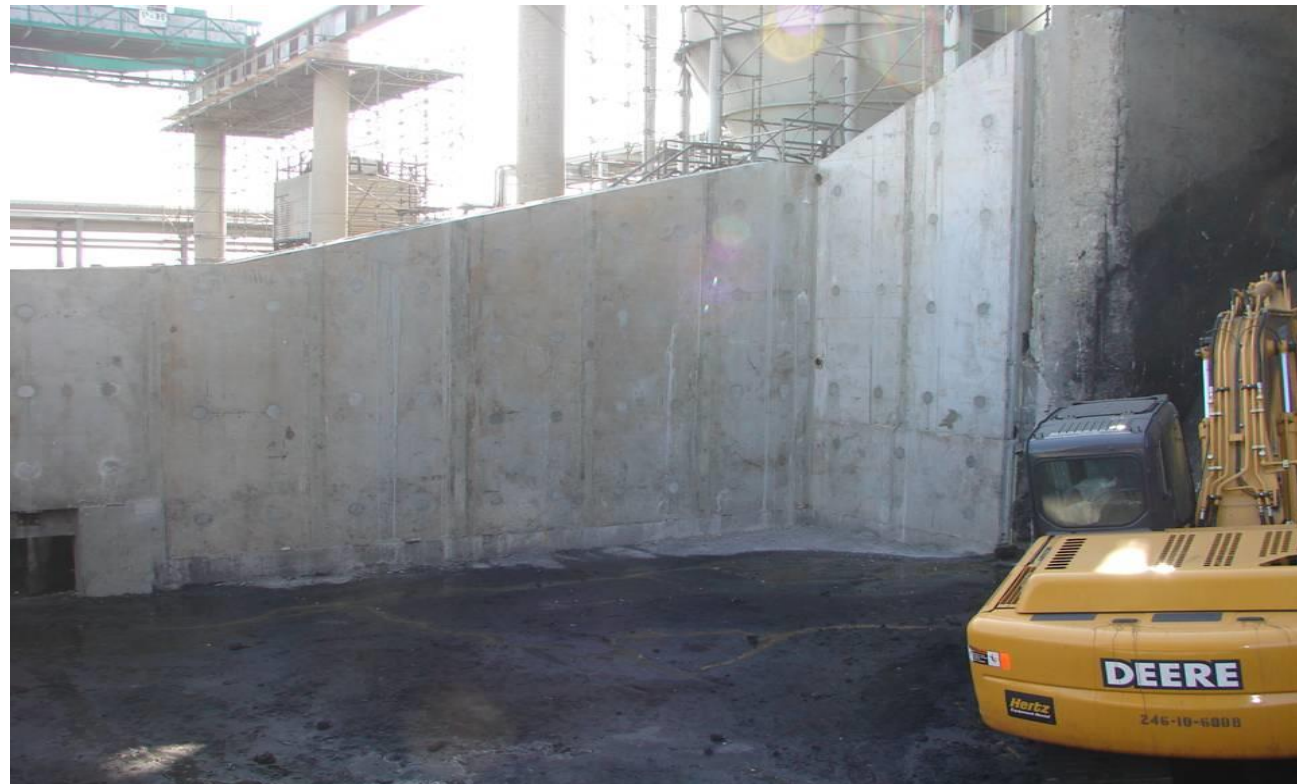
- Pre-cast Panelized Repair of Coke Pit Walls

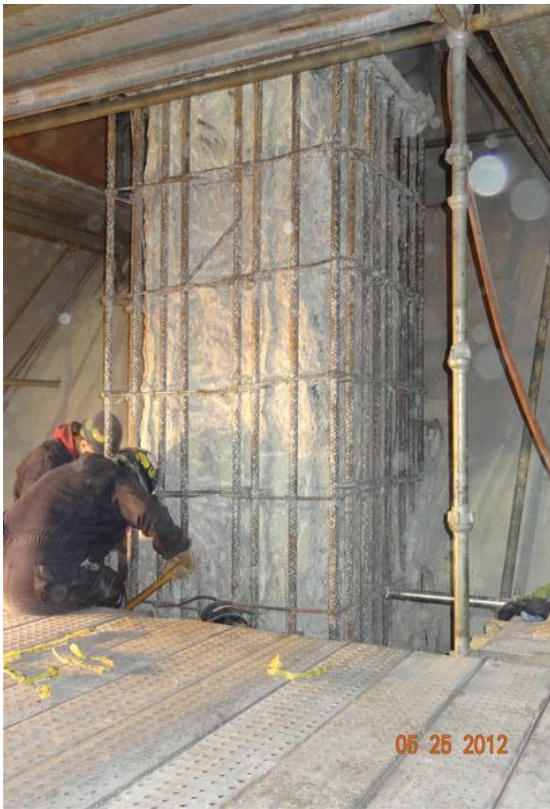
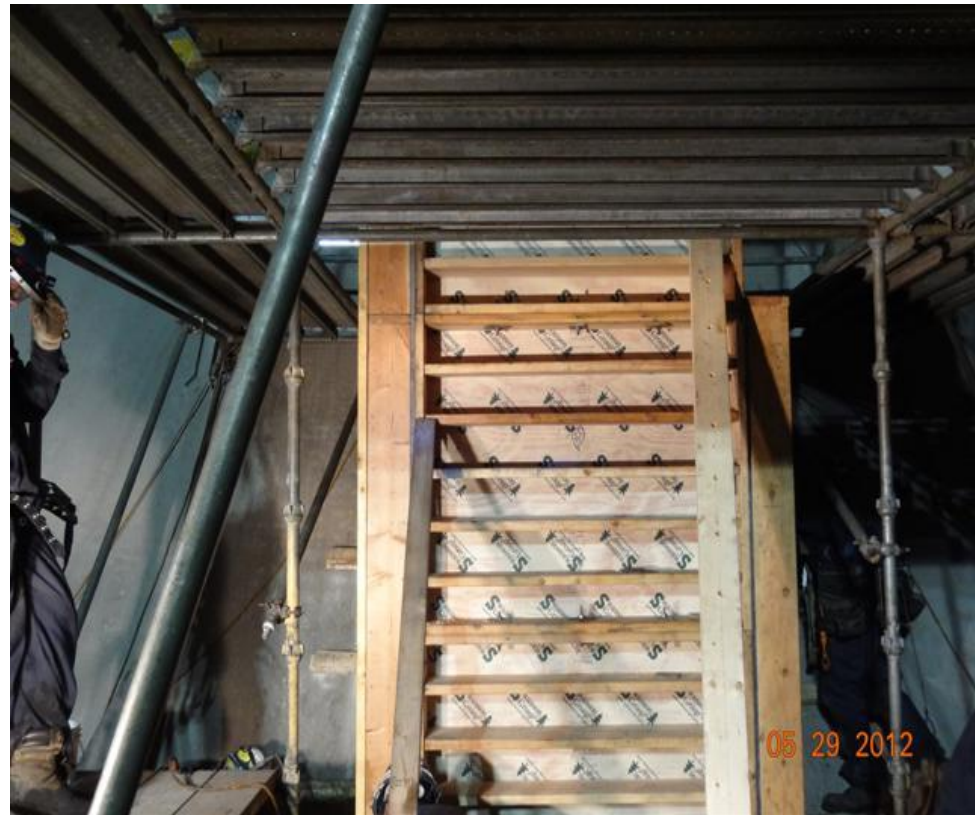
- Column Strengthening

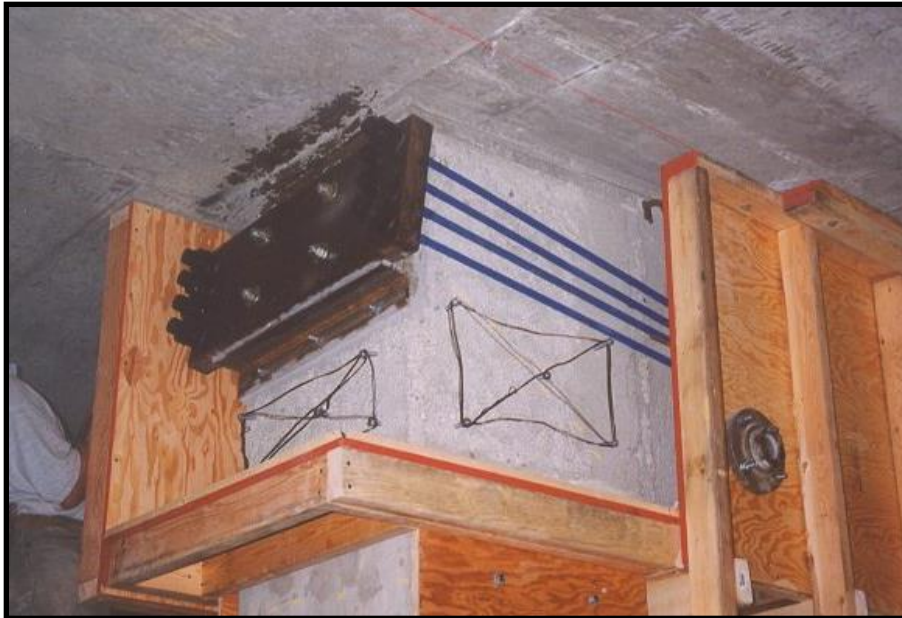
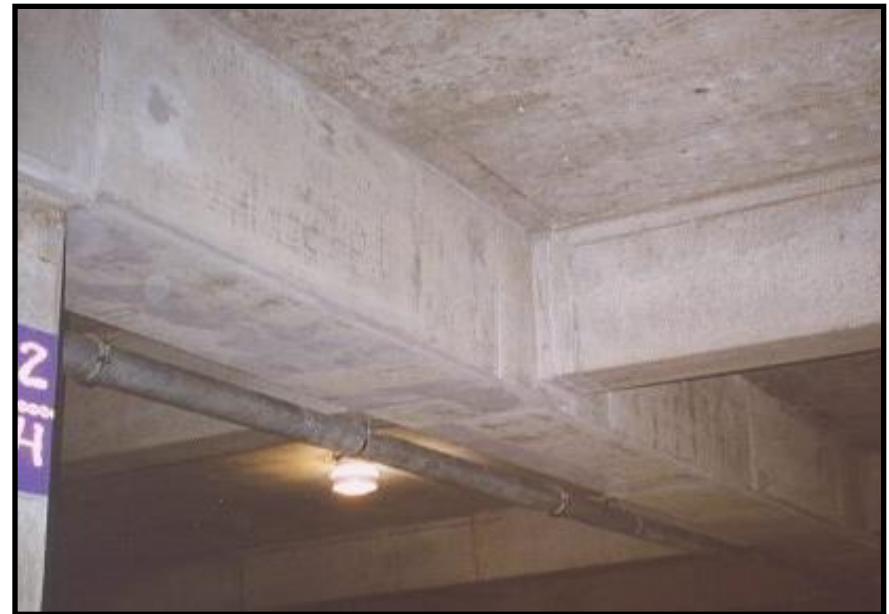
- Flexural Strengthening – External P-T Encased in Concrete

Before

After

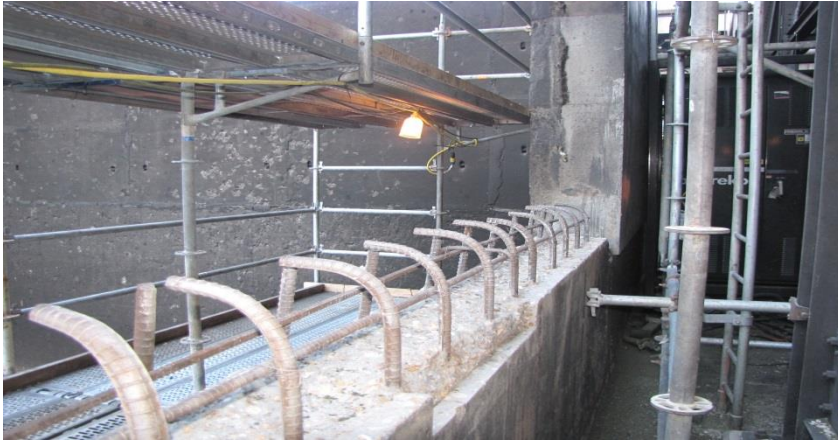
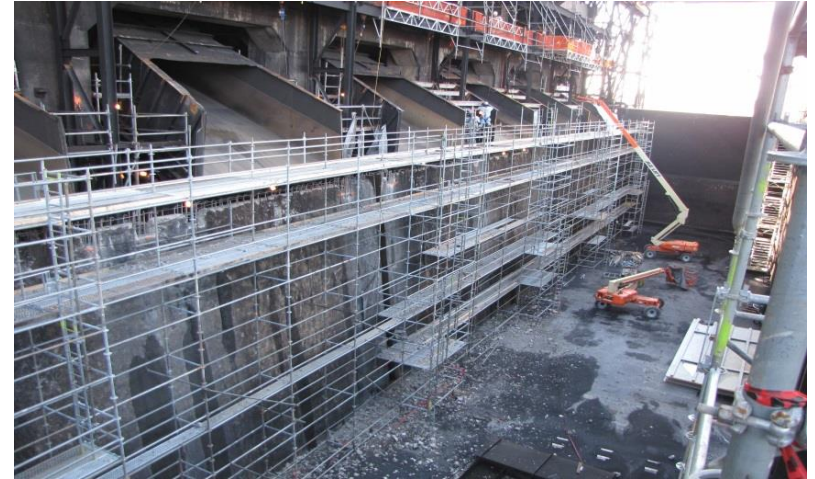
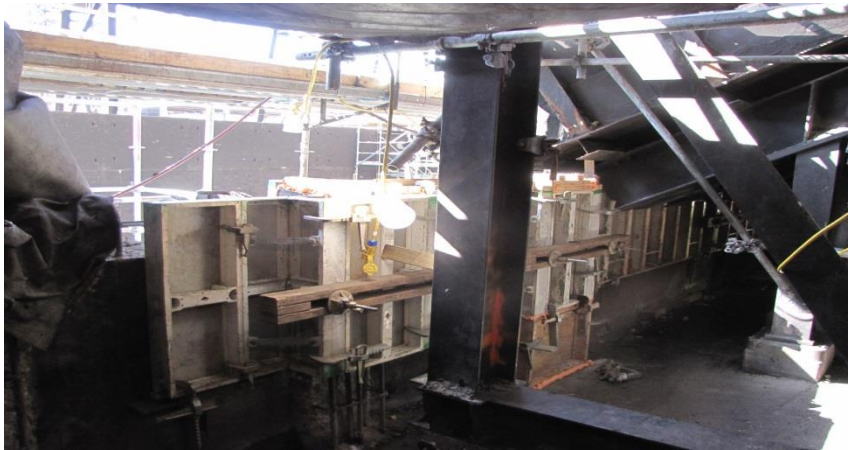
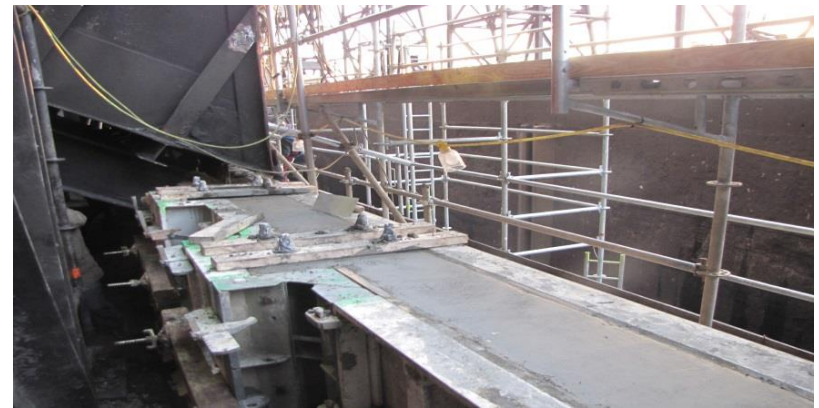
- Repair-In-Kind
